Obsidian Energy Ltd. SWAT Consulting Inc.

Remediation and Reclamation of a Wellsite

RemTech 2023

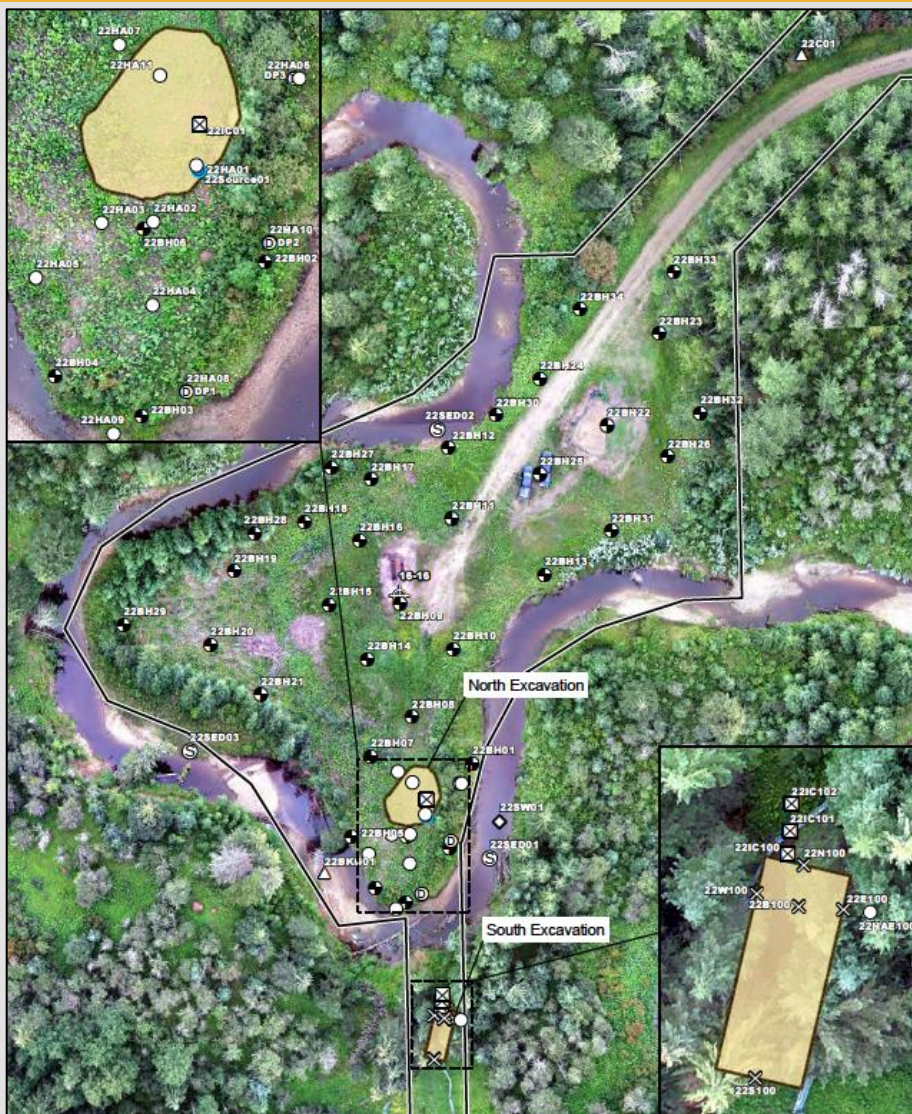
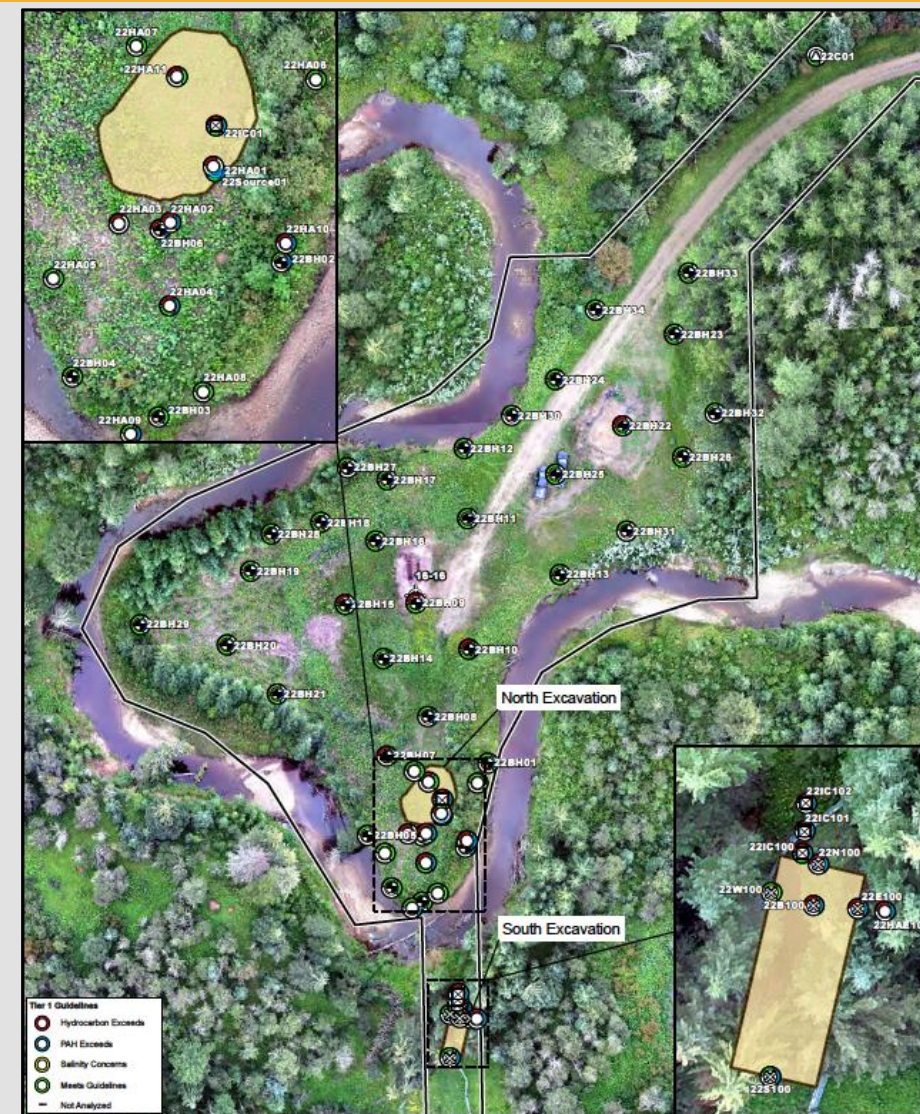
Initial Details -Phase 2 Drilling

- A Phase 1 ESA and Phase 2 ESA drilling program were completed in February 2022 and identified historical impacts within key APECs (former AST area, former wellhead, and along the former pipeline ROW).
- Primary CoCs were PHCs and PAHs.

- Delineation concluded potential impacts within the banks of the creek and possibly within the creek bed along the south edge of the 'peninsula' where impacts were also identified along the ROW south of the creek.
- Initial tree clearing and some minor remediation work along the pipeline ROW was completed in February 2022 during site decommissioning.

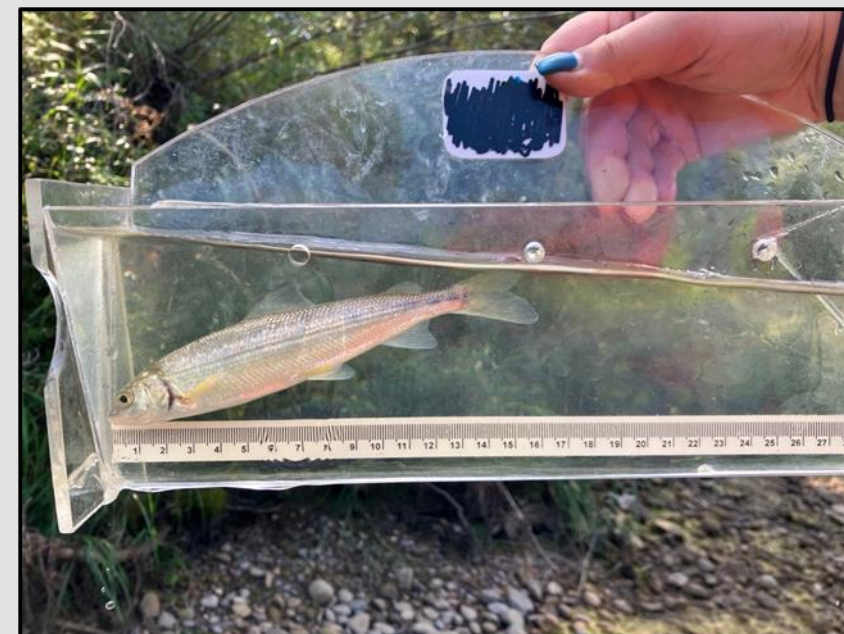
Mountain Whitefish captured and relocated during fish salvage operations.

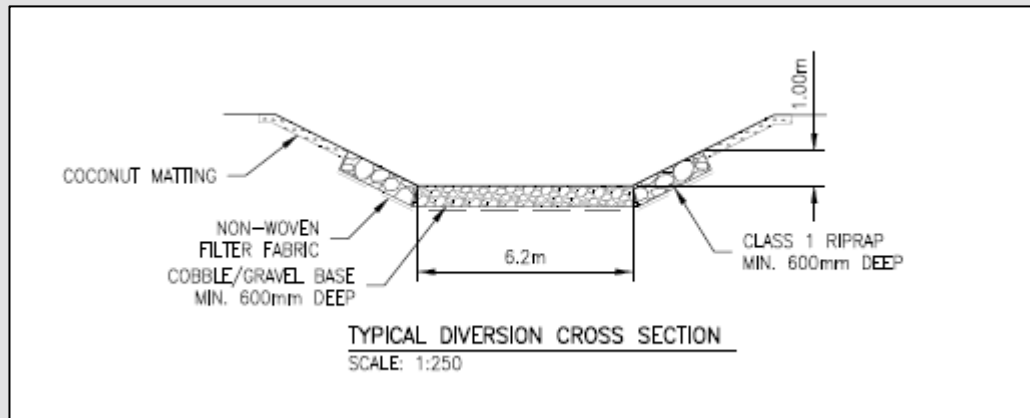
Remediation – Diversion Channel Design

• Channel Location and Design:

- Constructed to bisect the lease in an area where the geomorphology and natural hydrology of the creek would have naturally eroded away over time.
- Designed to act as an overflow channel following the completion of the remediation and reclamation program so as not to disrupt primary flow through the original creek channel.
 - Diversion channel was constructed with a base 0.3 m higher than the natural base of the creek.
- Design included cobble/gravel base to mimic the substrate within Paddy Creek and rock armoring along the banks to prevent erosion, as well as coconut matting along the top of the banks.

- Limited the environmental impact of the diversion channel by constructing it in a location that would naturally erode over time and raising the base of the diversion channel 0.3 m above the base of the creek to ensure that primary flow would revert to the original creek channel.

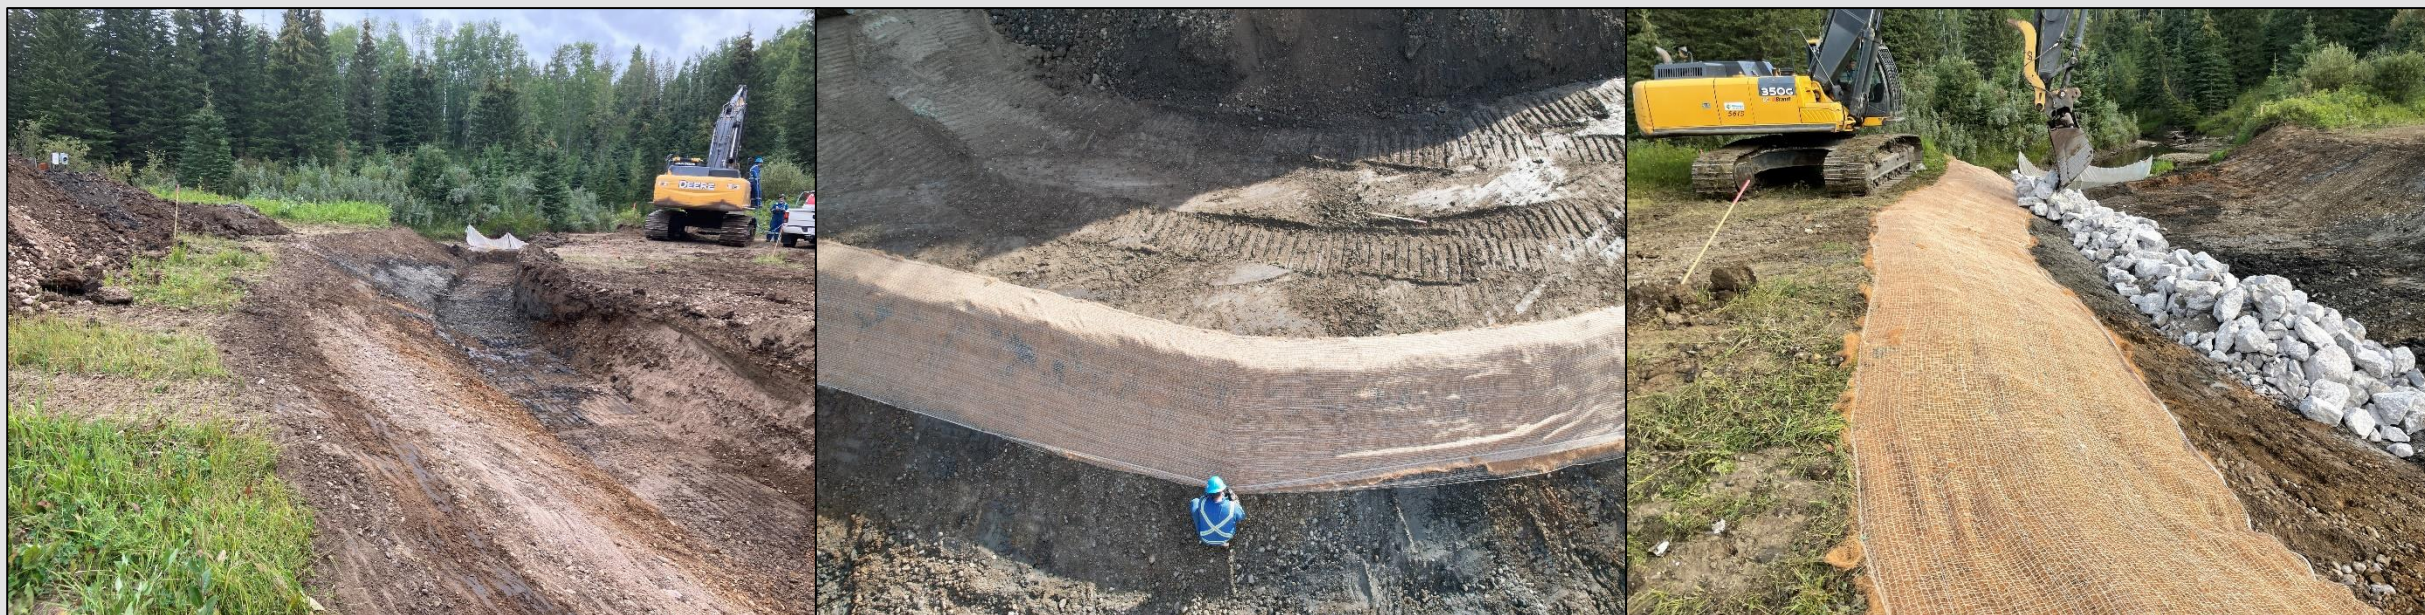
Remediation – Diversion Channel Construction

- **Channel Construction:**
 - Constructed between August 27 and 30, 2022.
 - Per the design, gravel was spread across the base of the channel and the banks where rock armored with coconut matting installed across the top portion of the bank.
 - A temporary access bridge was placed across the channel to facilitate remediation and reclamation work. Concrete lock blocks abutments were used to support the bridge.

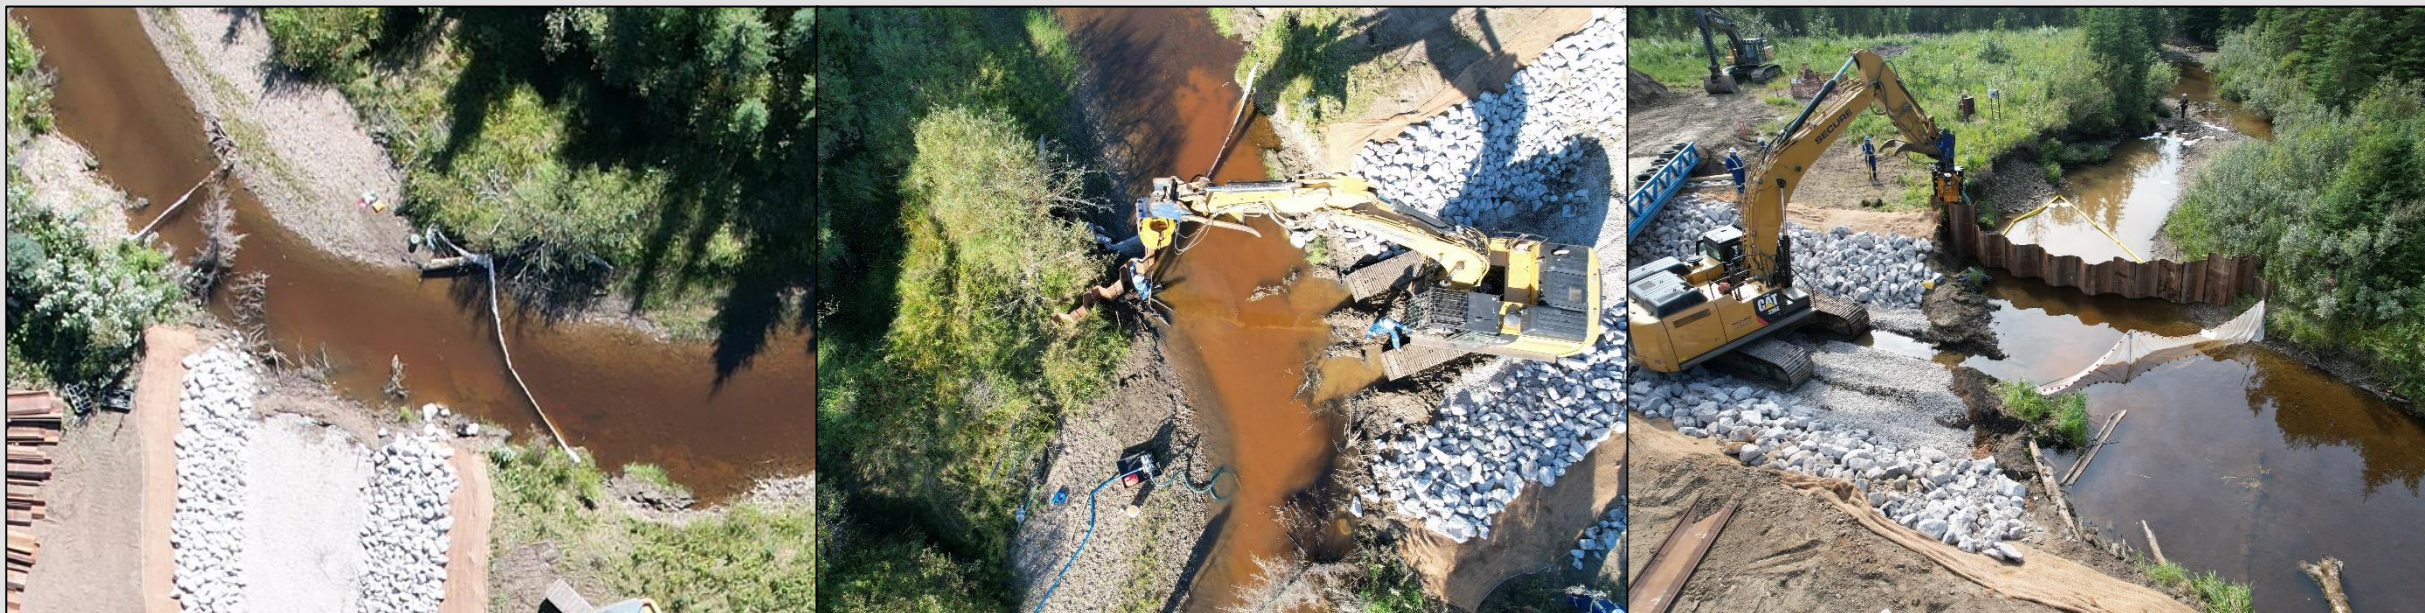
Remediation – Sheet Piling Dams

- Sheet piling dam locations were isolated with block netting and fish salvage operations were completed within the isolated sections to avoid fish mortalities.
- The sheet piling dams were installed on September 1, 2022.
- Following installation, fish were captured and relocated from the isolated section of the creek before and during dewatering activities.
 - A total of 894 fish were captured and relocated; species included Burbot, Longnose Dace, Longnose Sucker, White Sucker, Lake Chub, Trout Perch, Northern Pike, Spoonhead Sculpin, and Mountain Whitefish
- Clay plugs were installed on the isolated side of the sheet piling dams after dewatering to control water infiltration, to help maintain water levels within the flowing section of the creek, and to encourage flow through the diversion channel.

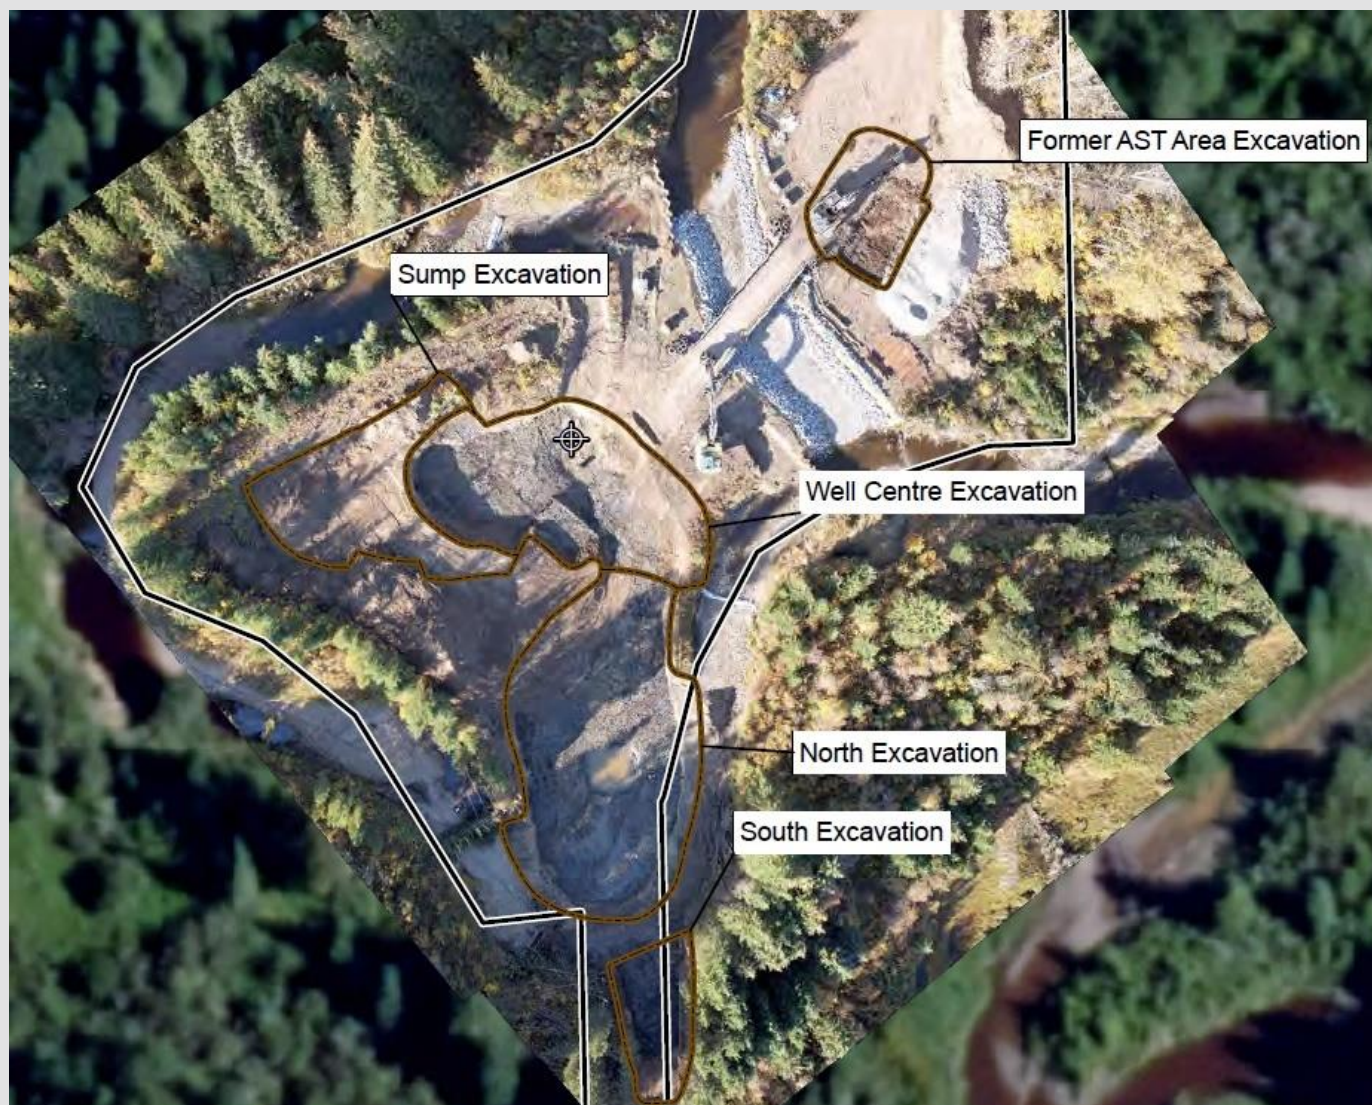
Remediation – Excavation of Contaminated Soils

- Most of the excavation of PHC and PAH impacted soils occurred between September 8 and November 16, 2022, with final hot spot removal completed on June 7, 2023.
 - 9,301.28 tonnes of contaminated soil was excavated and transported to an accredited facility for offsite disposal.
 - 135.8 m³ of impacted fluid and hydrovac slurry was recovered and transported to an accredited facility for offsite disposal.
- Final confirmatory samples collected from the walls and bases of the excavation areas met applicable guidelines for all CoCs.

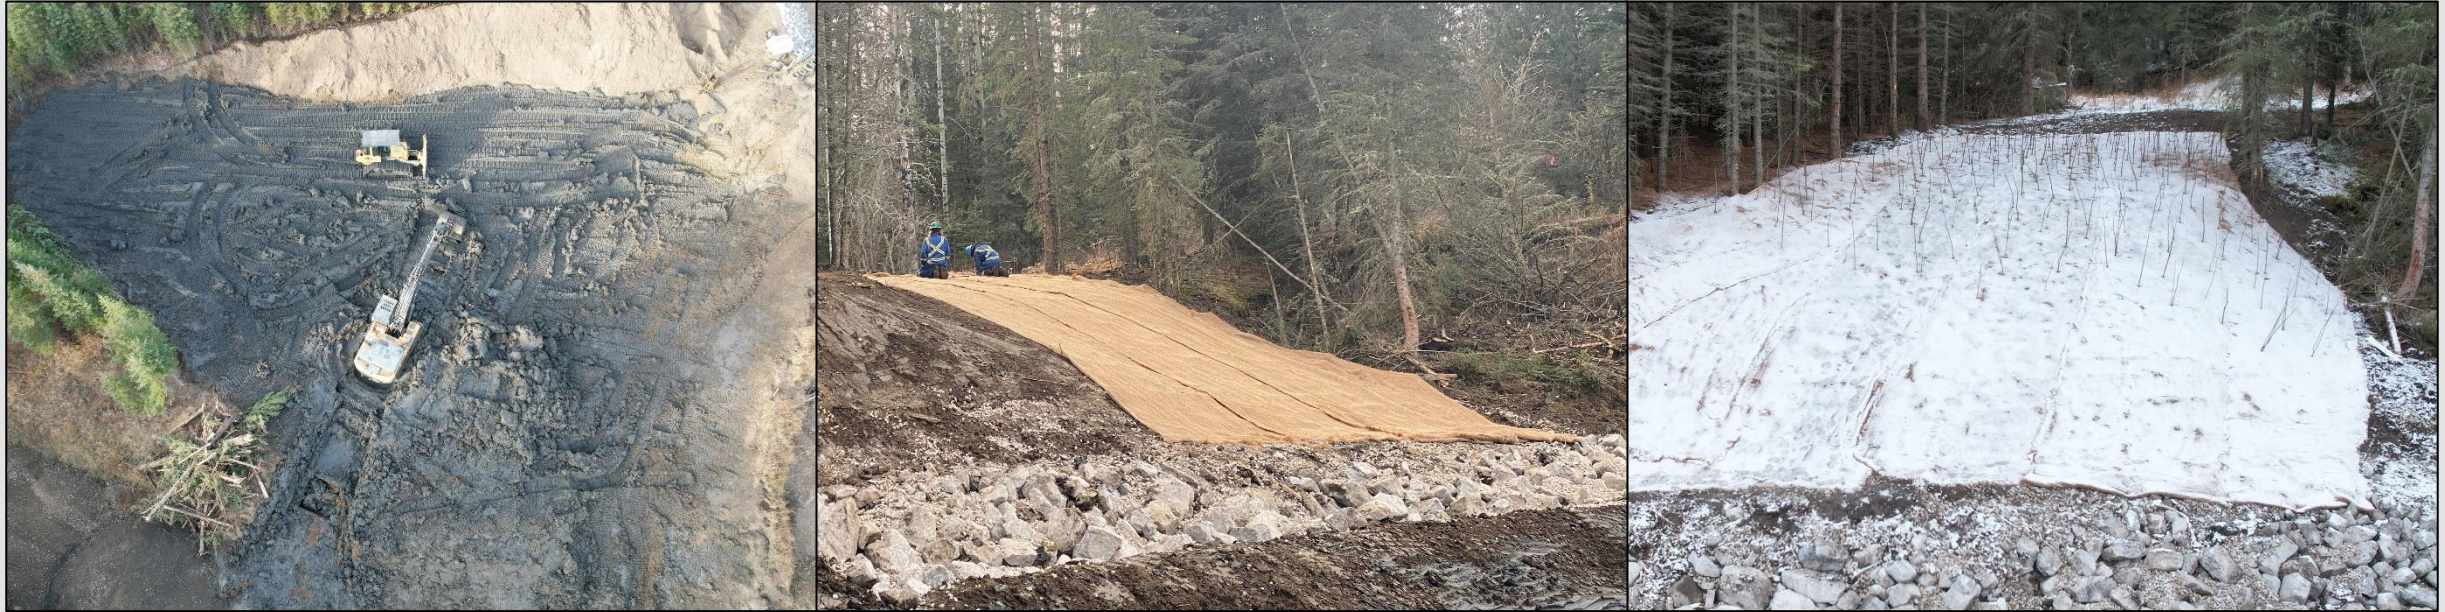
Reclamation – Backfilling, Contouring, and Erosion Control

- The following reclamation work was completed at the site in October and November 2022:
 - Cut and cap the abandoned well to a depth 1.0 m below the natural creek bed to ensure adequate soil cover should the creek erode that section of the island.
 - Unimpacted material salvaged during remediation (topsoil and subsoil) and the clean material excavated during the construction of the open water pool was used to backfill the open excavations and contouring was completed to maintain drainage across the site.
 - Erosion control measures were installed and included coconut matting along the reconstructed creek banks, straw wattles installed along the top of the rock armoring on the banks, and live staking using willows harvested from the area.

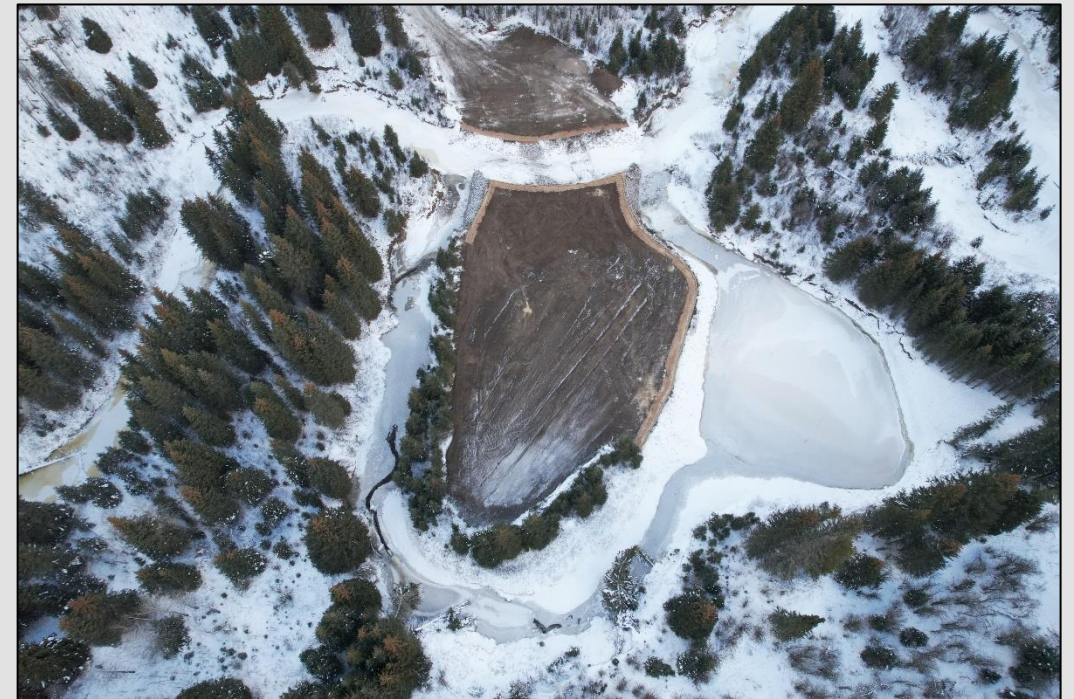
Reclamation – Paddy Creek

- As part of the reclamation plan approved by the AER, Obsidian proposed to redefine the creek banks and bed on the south edge of the island to enhance fish habitat while minimizing the risk of sedimentation that would result by re-establishing the excavated section of the island. An open water pool for overwintering was constructed in the area and woody debris was buried along the base of the pool to enhance fish habitat within the creek.

- Excavated to a maximum depth of 4 to 5 m below the natural creek bed.
 - Salvaged woody debris was buried in the base of the pool and gravel was spread across the base of the pool and any disturbed section of the creek to mimic the natural substrate.

- Water from the upstream side of the creek was pumped into the open water pool and rock check dams were installed along the approach to limit sedimentation once flow was restored to the isolated section of the creek.

- The disturbed banks of the creek were reconstructed and contoured to match surrounding topography. The base of the banks were armored with rock and coconut matting was placed across the top portion of the bank to limit erosion and sedimentation within the creek. Straw wattles were installed along the top edge of the rock armoring.

- Once most of the earthwork within the isolated work area was completed and the open water pool was full the sheet piling dams were removed.

- Enhanced fish habitat within Paddy Creek by constructing additional over wintering habitat.
 - Enhanced wildlife habitat and additional nesting for birds once tree planting has been completed and the trees reach maturity.

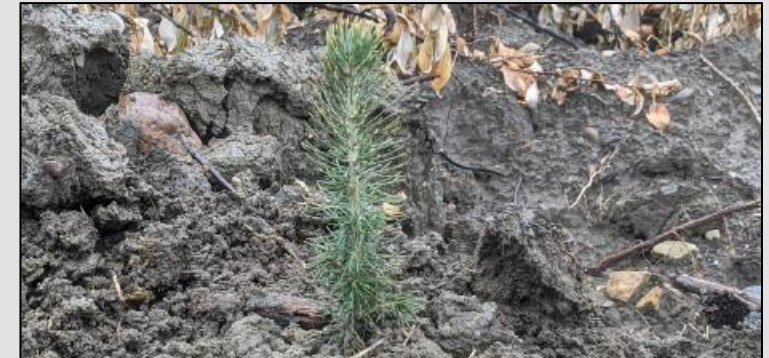
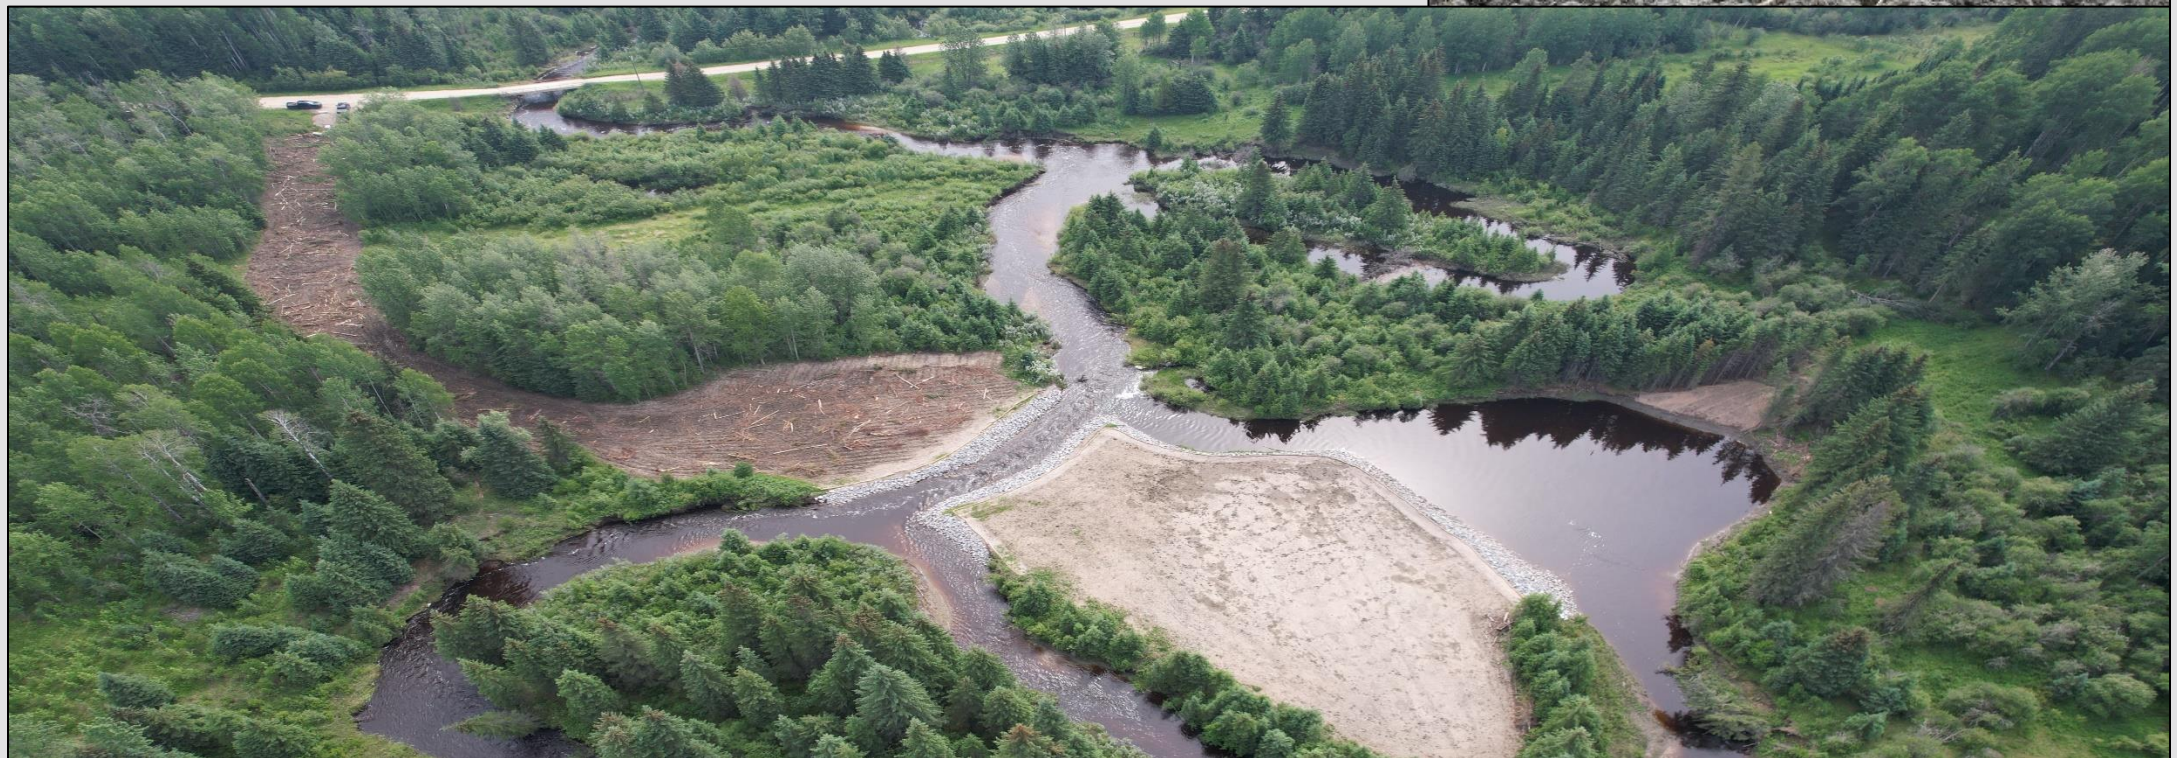
Reclamation – Access Road

- Between June 5 and 10, 2023, reclamation of the north portion of the site and the access road was completed and included stripping, recompacting, and recontouring the north portion of site and access road. The final approach has not yet been reclaimed but the work will be completed later this year.
- On June 19, 2023, tree planting and additional willow staking was completed within the disturbed areas.
 - 1,080 white spruce seedlings were planted.
