Utilizing Electrical Hydrogeology for Regulatory Approval of an MNA Remedy

Kyle Spears
Hydrogeologist/Technical Sales Manager
Aestus, LLC

Case Study: Pipeline Break, AR

Case Study: Former Fueling Station, Oklahoma

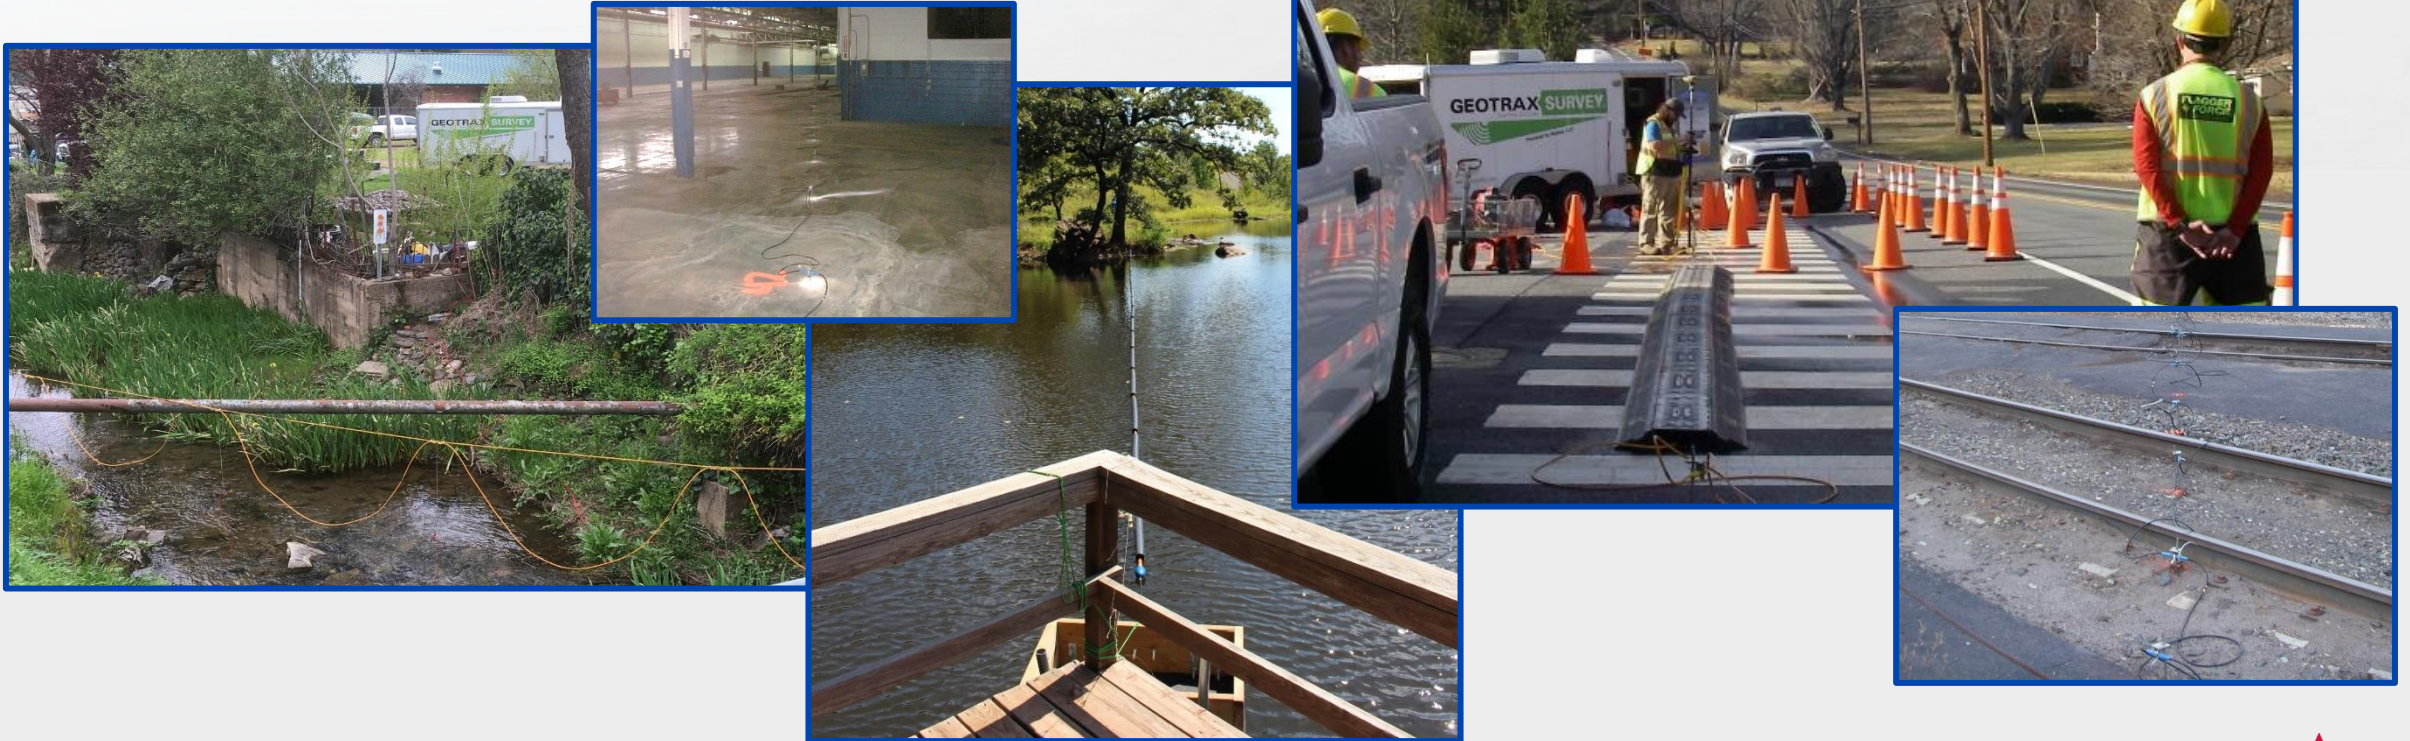
GeoTrax Survey™ Field Deployment

- Must be in a straight line
- Line length = 5 x imaging depth

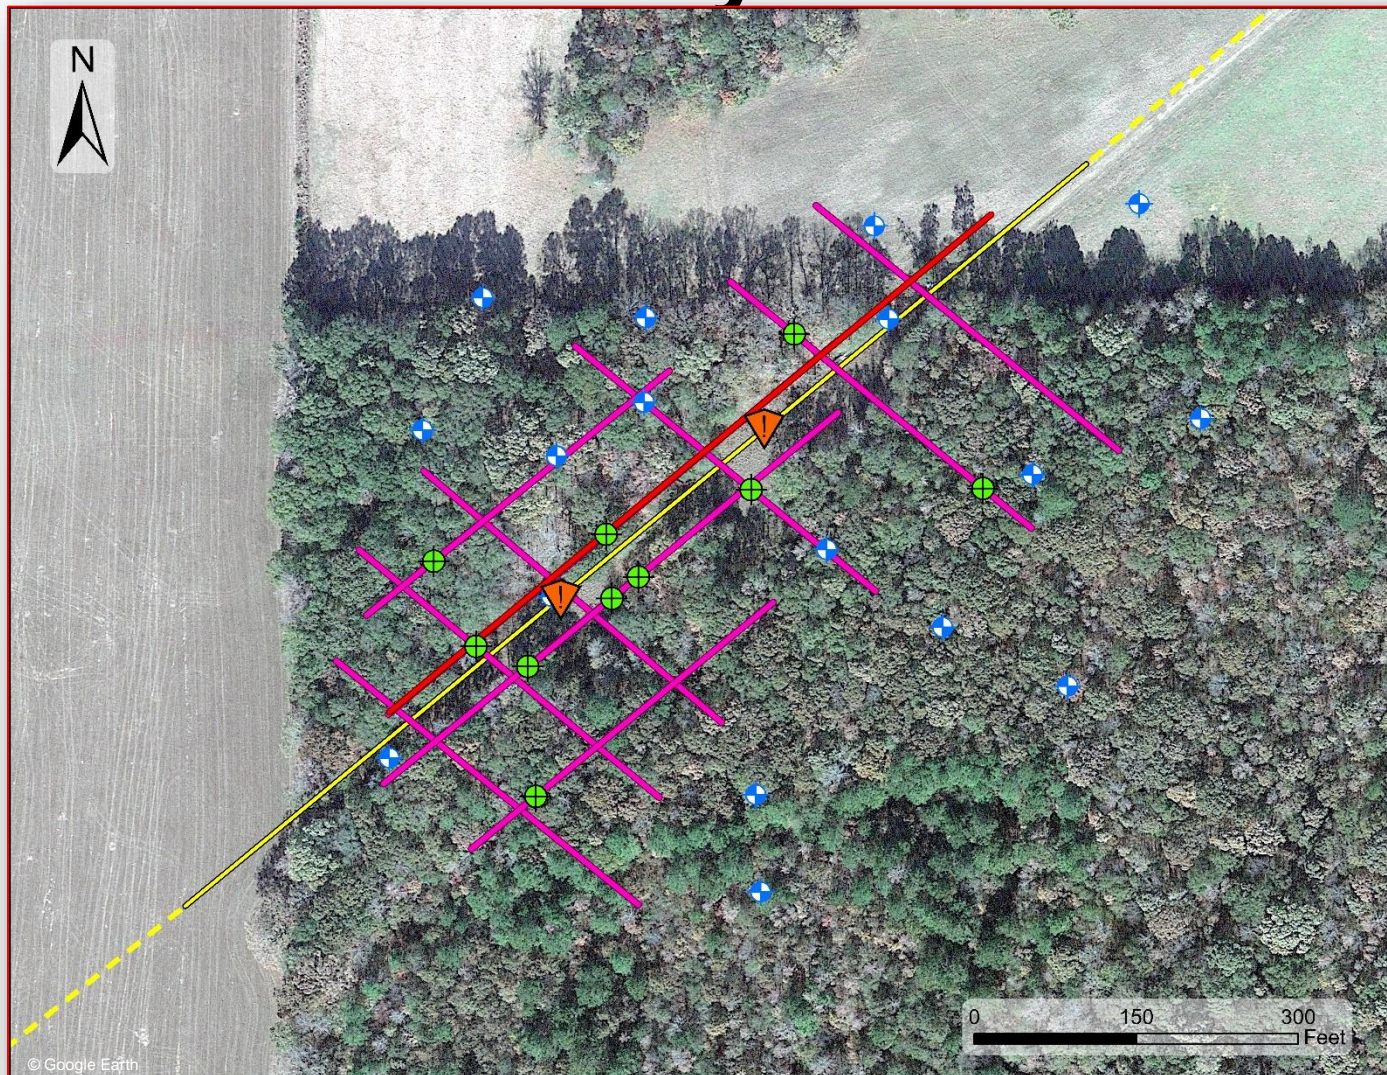
Case Study: Pipeline Break, AR GeoTrax Survey™ Lines and Wells

SURVEY LINE SPECIFICATIONS
Total Number of GeoTrax Survey™ Lines = 13

E 1	E 56	
		2.0 Meter Electrode Spacing (12 Lines)
STA-01		Line Length ~361 feet (~110 m) Image Depth ~72 feet (~22 m)
		4.00 Meter Electrode Spacing (1 Lines)
STA-13		Line Length ~722 feet (~220 m) Image Depth ~144 feet (~44 m)

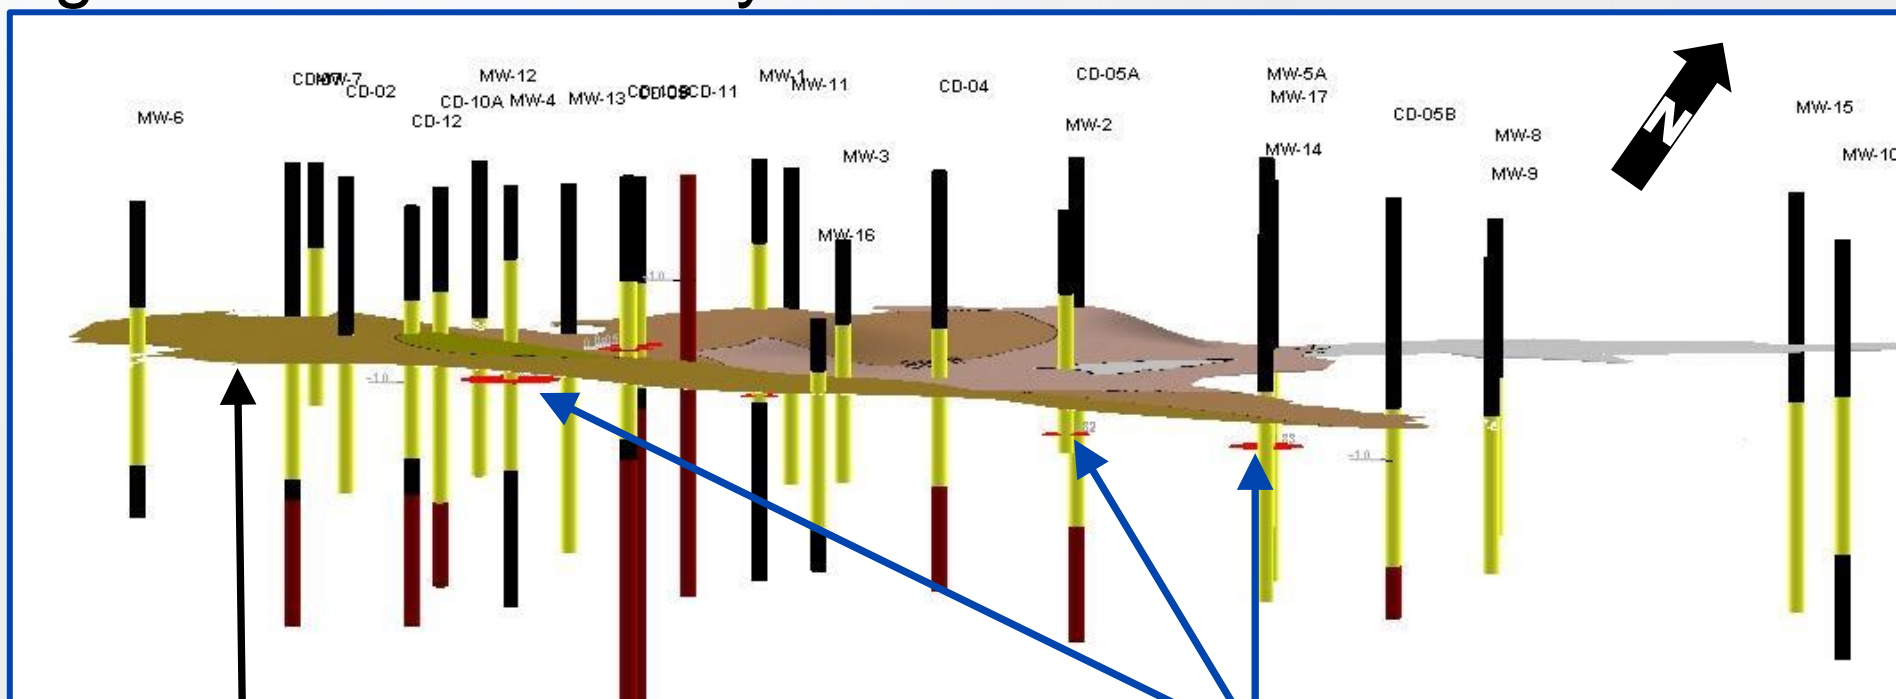
Updated CSM (Graphical Explanation)

“Blob” anomalies crossing the coarse grained layer were targets for higher saturations of hydrocarbons

Modeled base of
coarse layer

Hydrocarbons mostly in finer grained
sediment below coarse layer

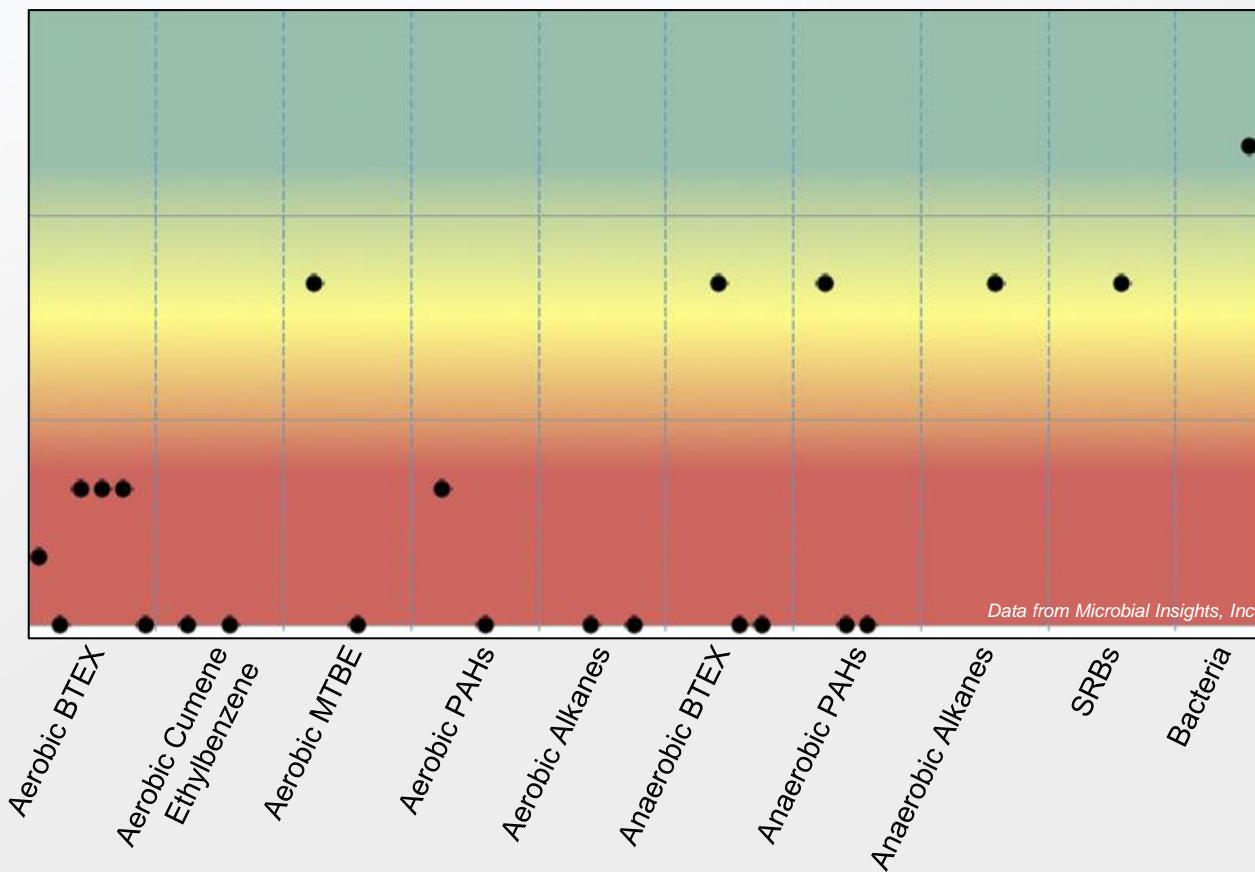
MW-13 Microbial Populations

Case Study: Pipeline Break, AR Understanding the Conductors

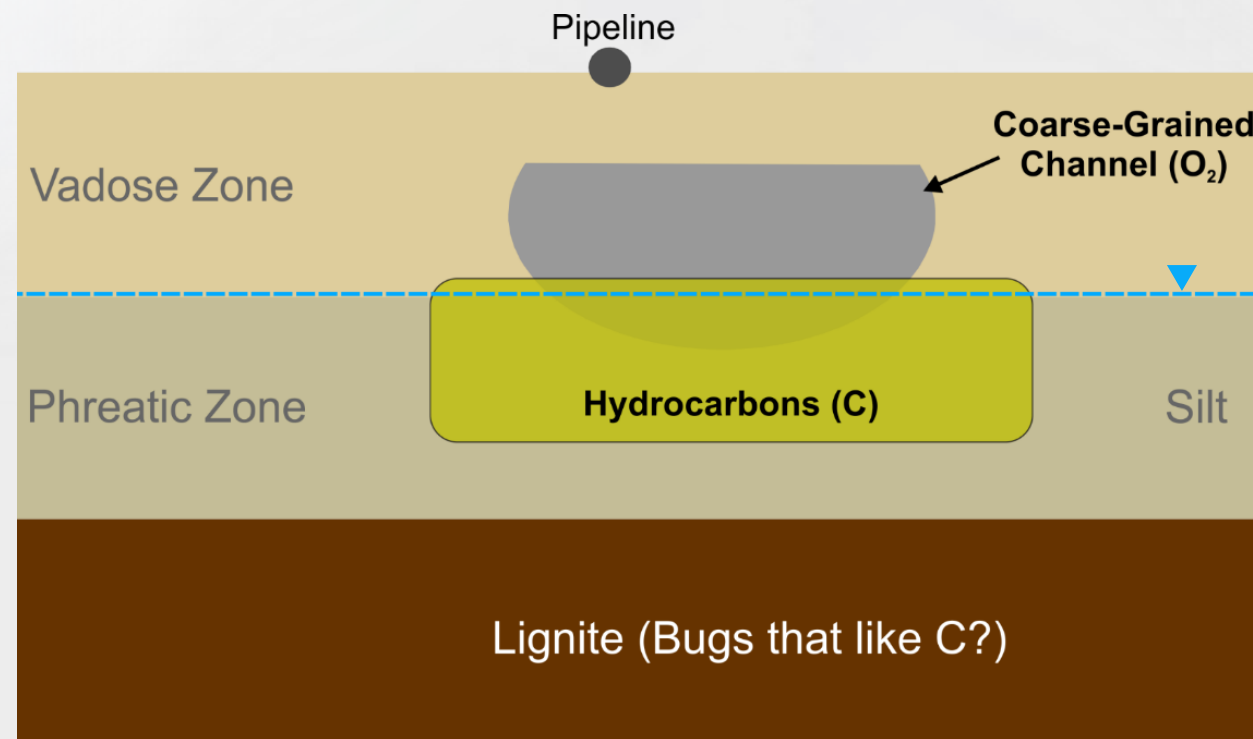
Geologic CSM: Pipeline Break, AR

- Hydrocarbon generally in finer grained sediment below coarse grained layer
- Hydrocarbon limited by lateral extent of coarse grained layer
- Electrical “blob” anomalies crossing the coarse grained layer were targets for hydrocarbons
- No evidence of deep hydrocarbons, just lignite

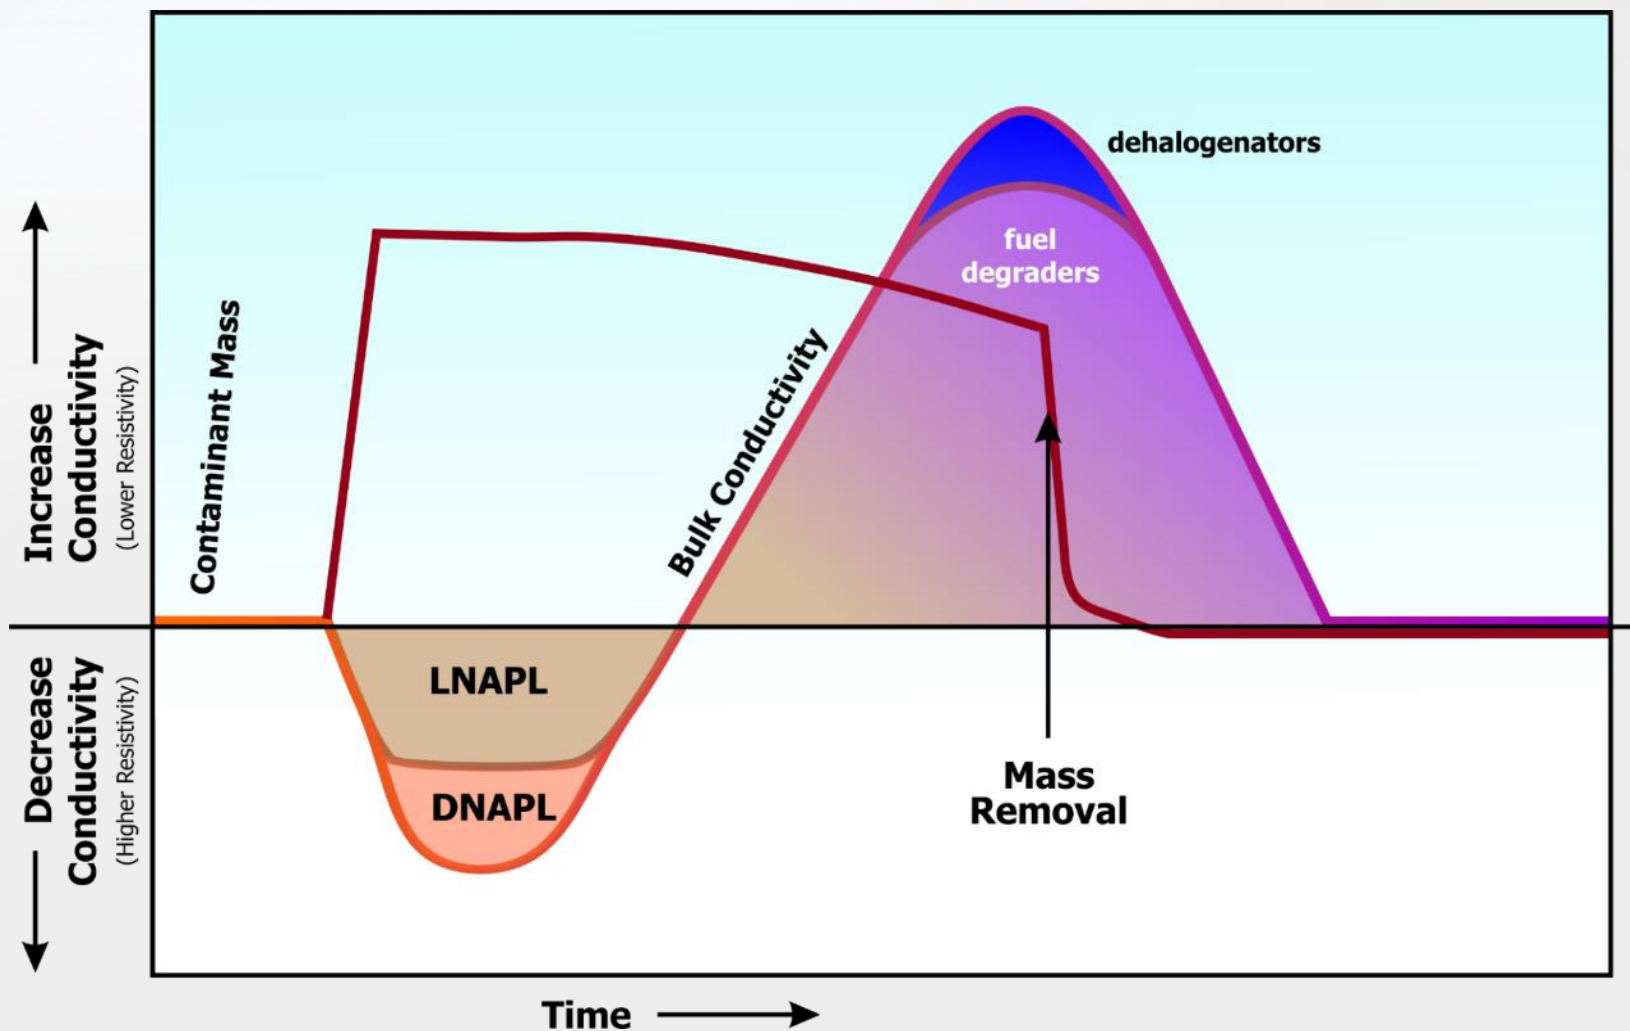
Electrical Properties of Microbes

Modified from
Che-Alota et al., 2009

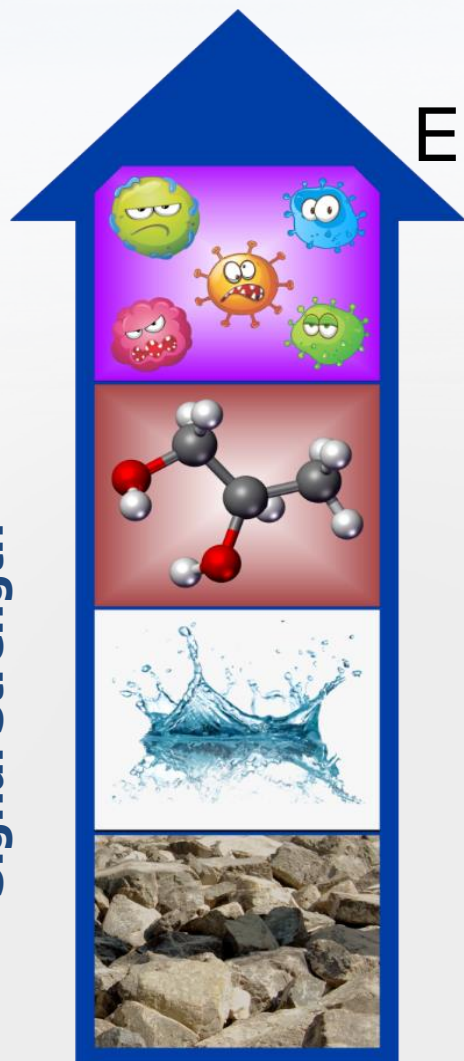
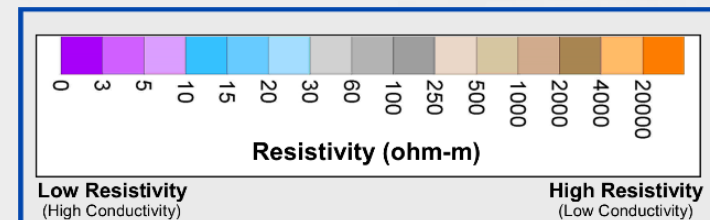
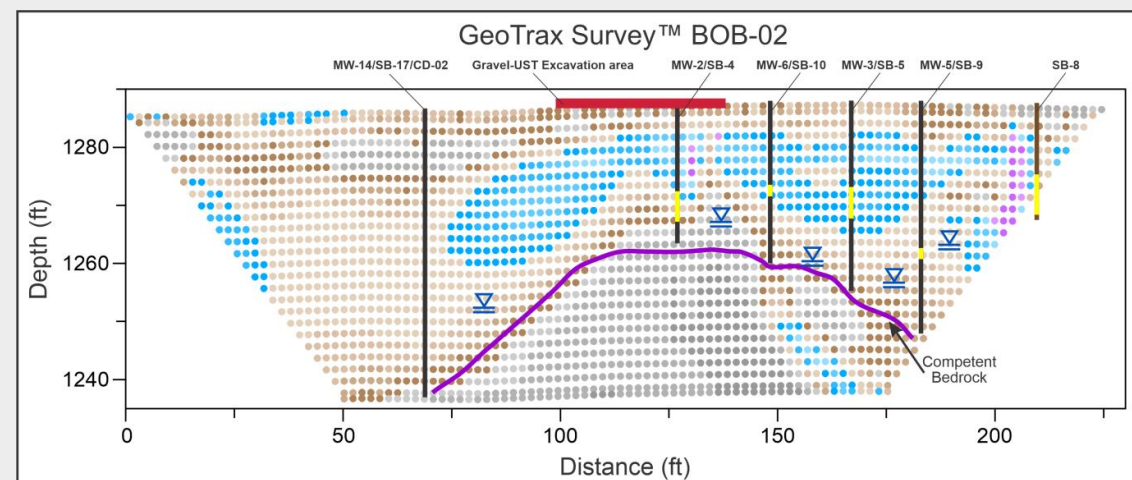
What Does Aestus See?

Each data point (pixel) equals the sum of:

1. Biological activity
2. Contamination/ Injectates/etc.
3. Groundwater/Fluids
4. Soil and rocks

Signal Strength
