Regina Wastewater Treatment Plant

Contaminated Sludge Remediation

October 2023

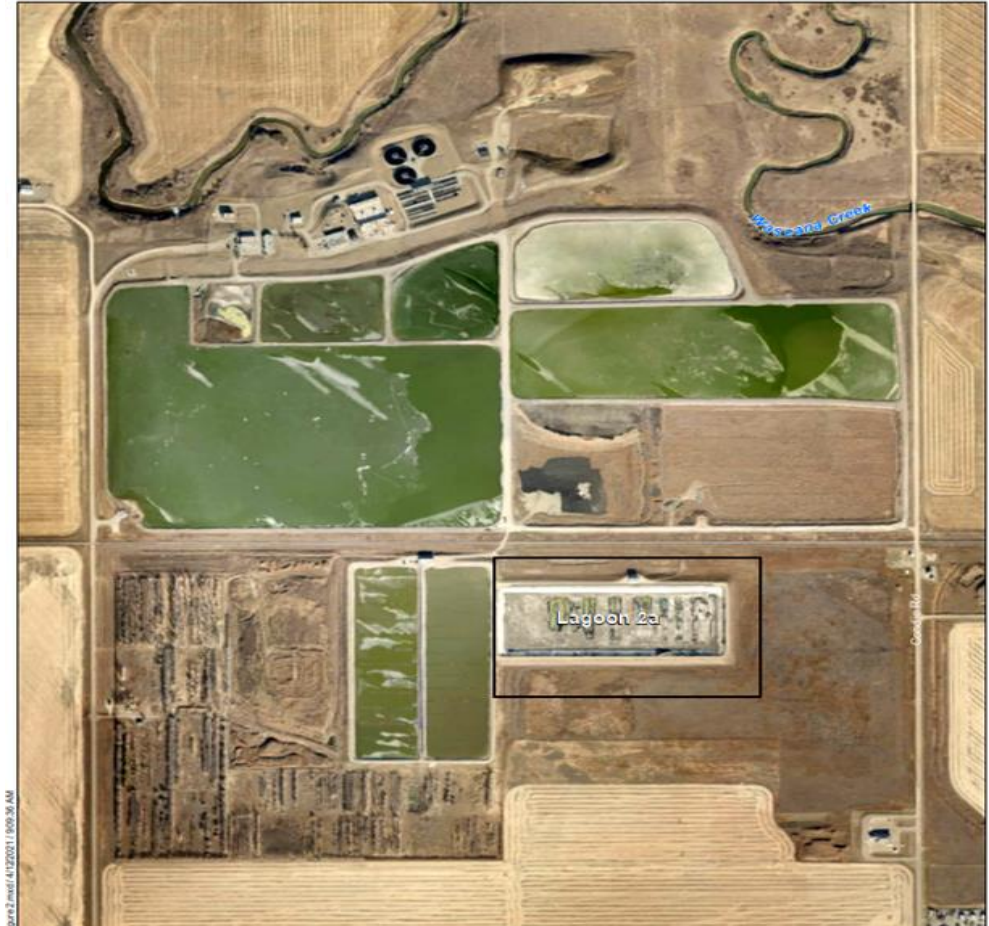
System Overview

Regina WWTP System

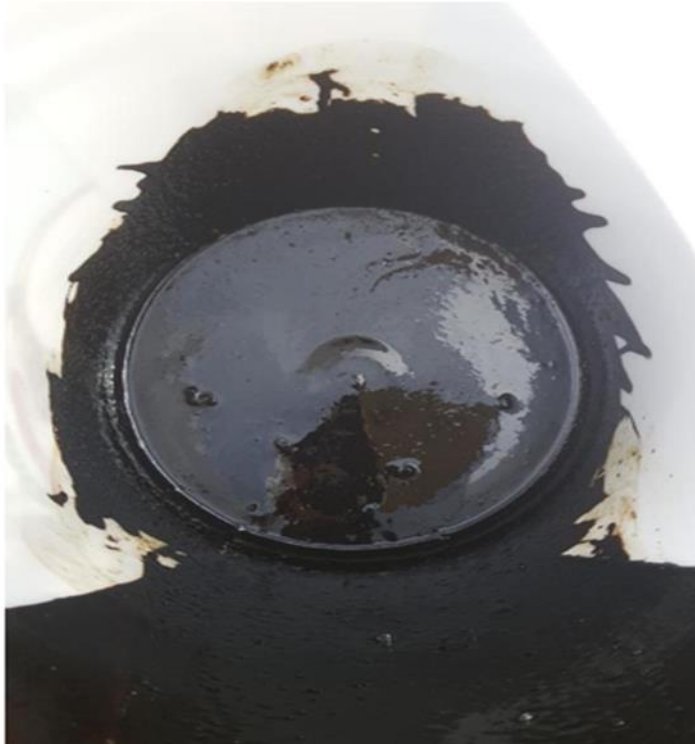
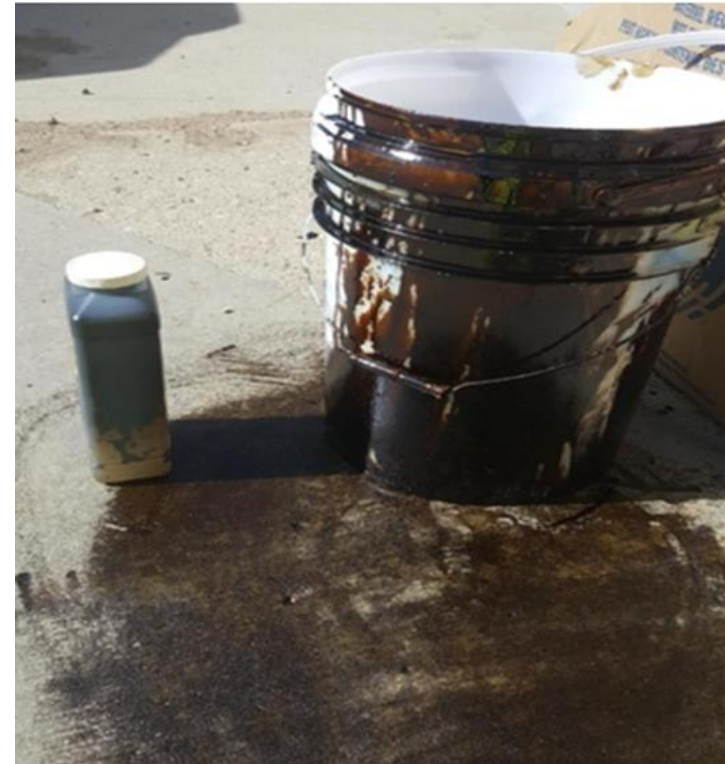
May 22 & 23, 2020

- May 22, 2020: the City of Regina's operators called to inform that they were seeing tar in the influent and to be alert as it was on its way to the WWTP through the 5km forcemain.

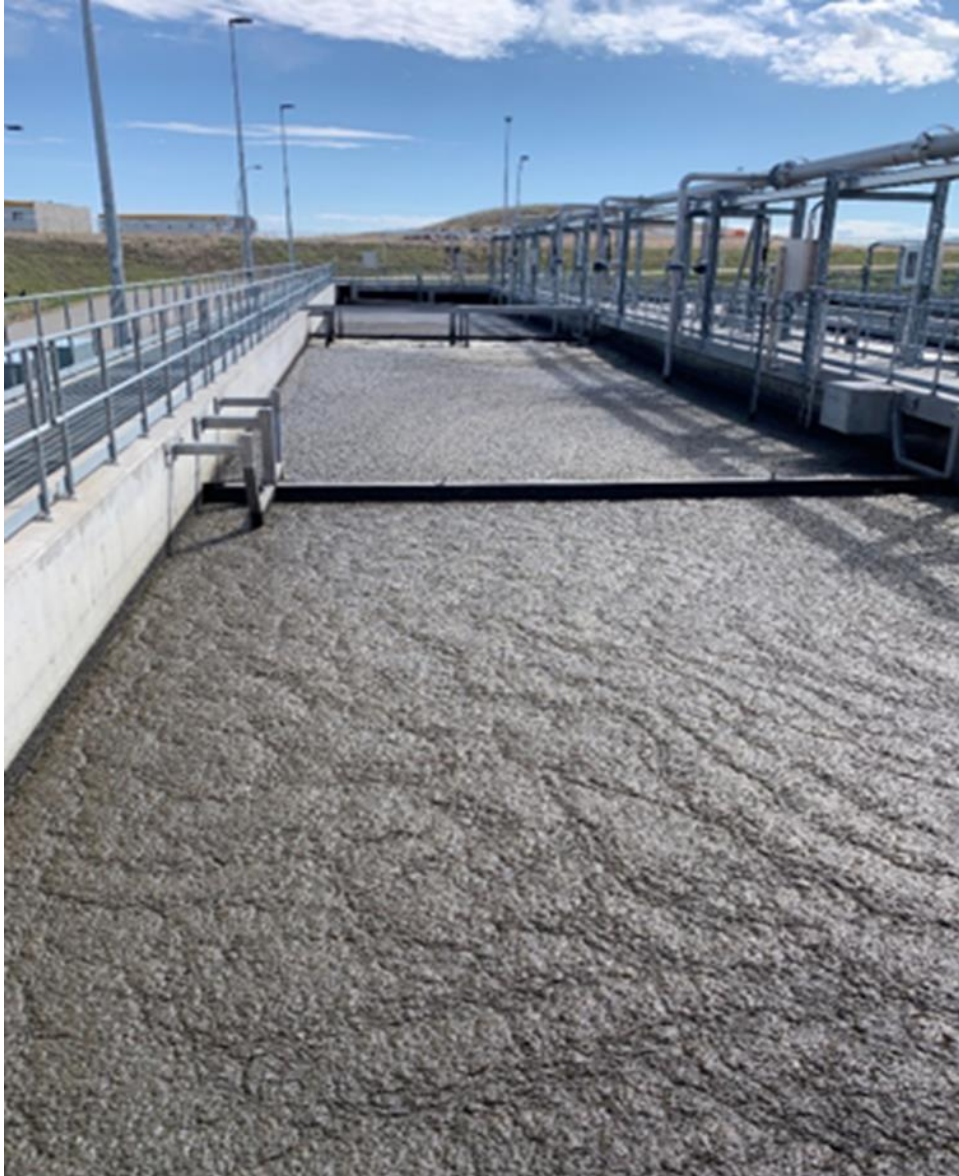
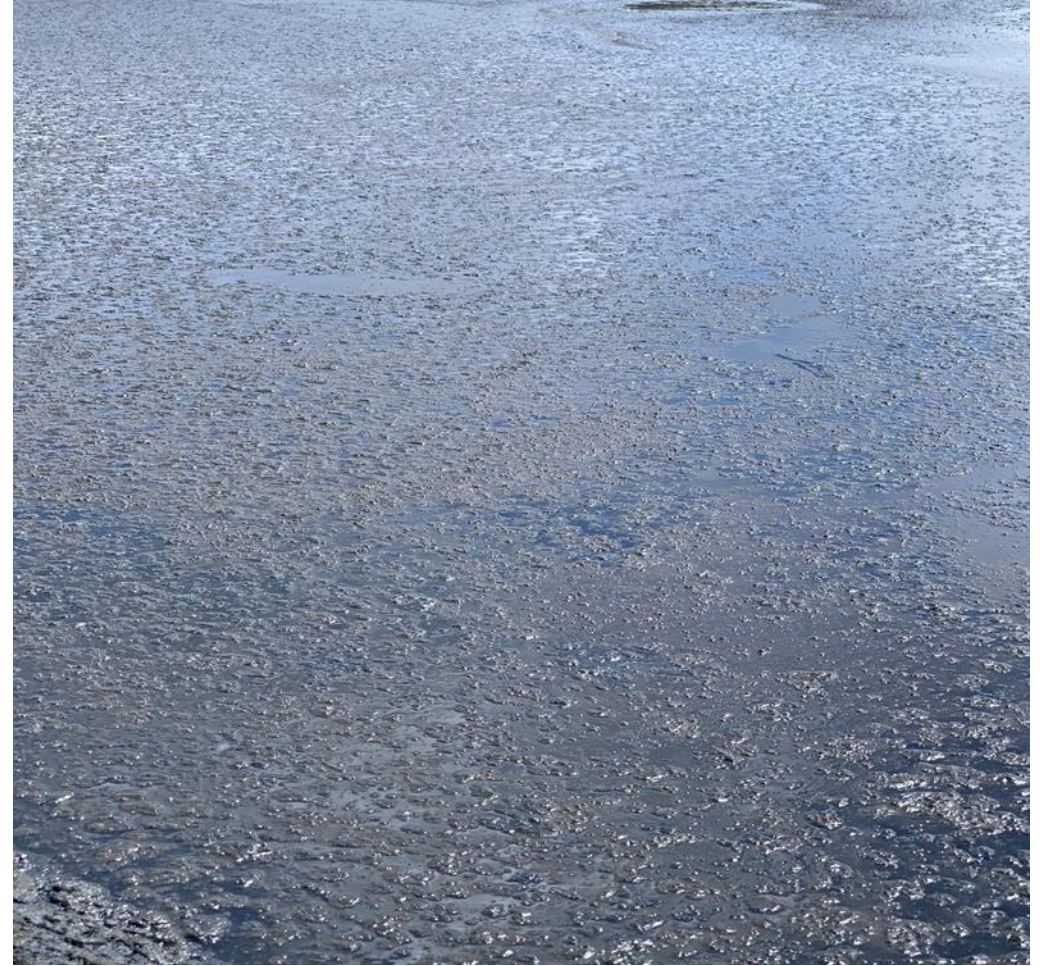
- Cell 2A is used as the containment cell in the WWTP network and used for storm surge retention.
- Cell 2A had some 33,000 m^3 of sludge prior to the event (important issue for later on).
- The old aeration system is still in place and used to maintain aerobic conditions as needed.
- Was part of the old WWTP aerated cell configuration.

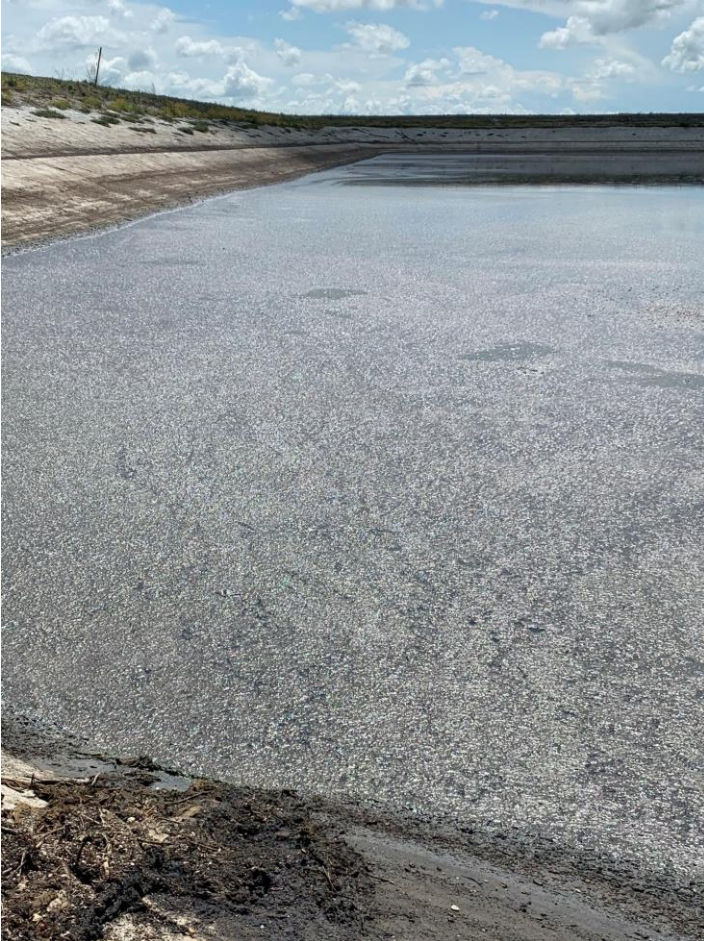
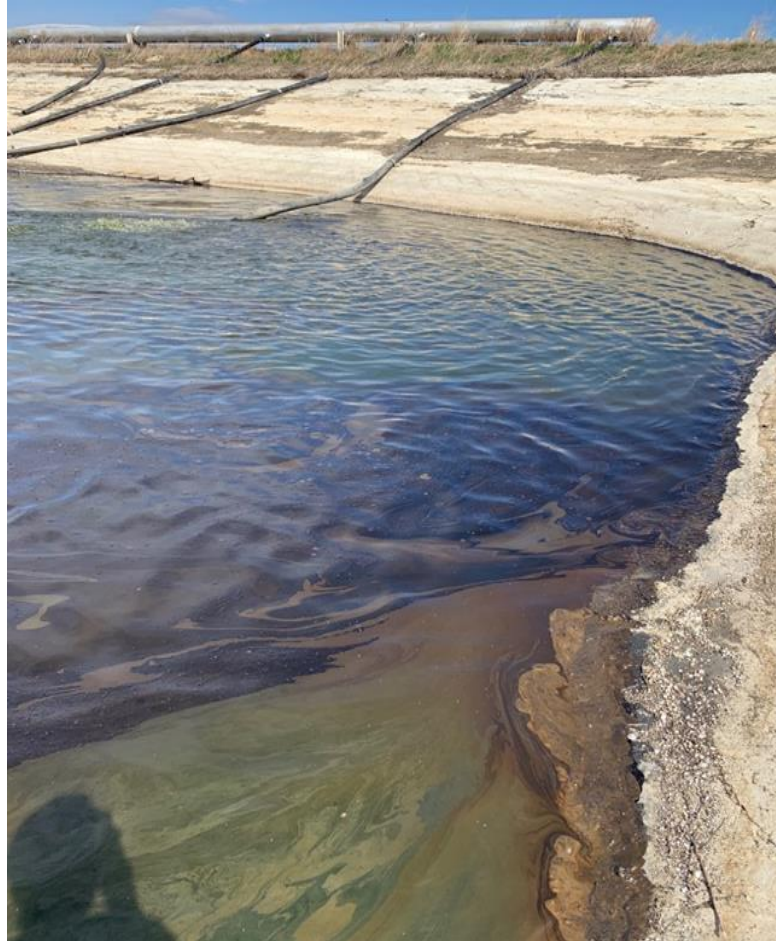
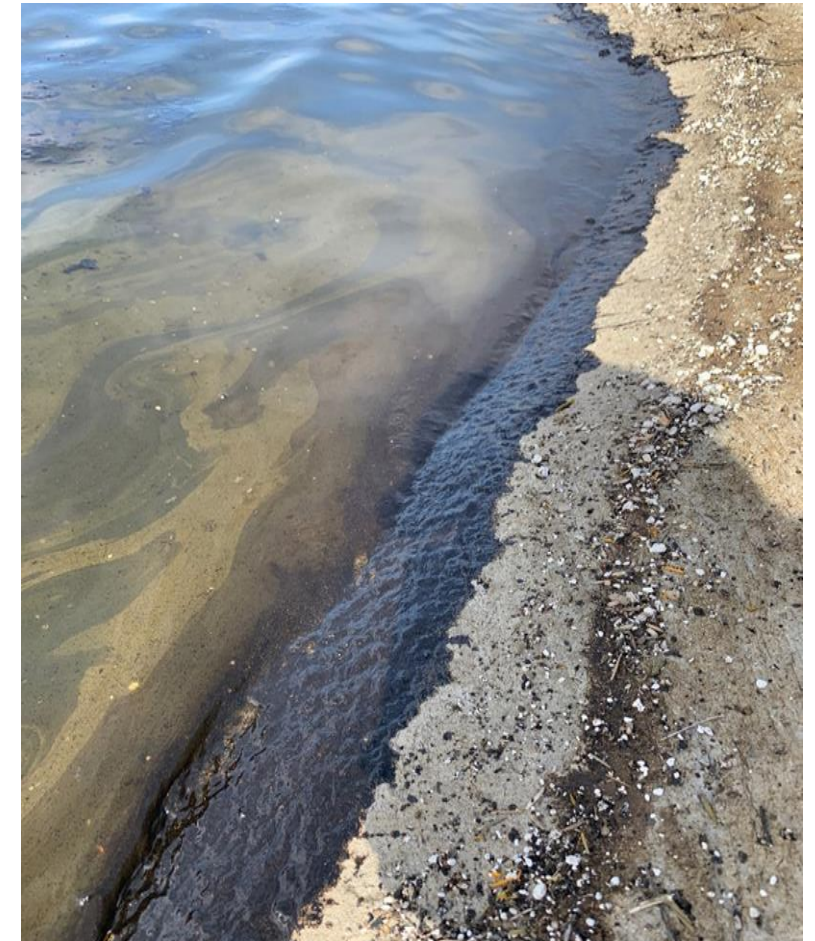
The Oil Slick

May 22 & 23, 2022 – Impacts seen on Cell 2A

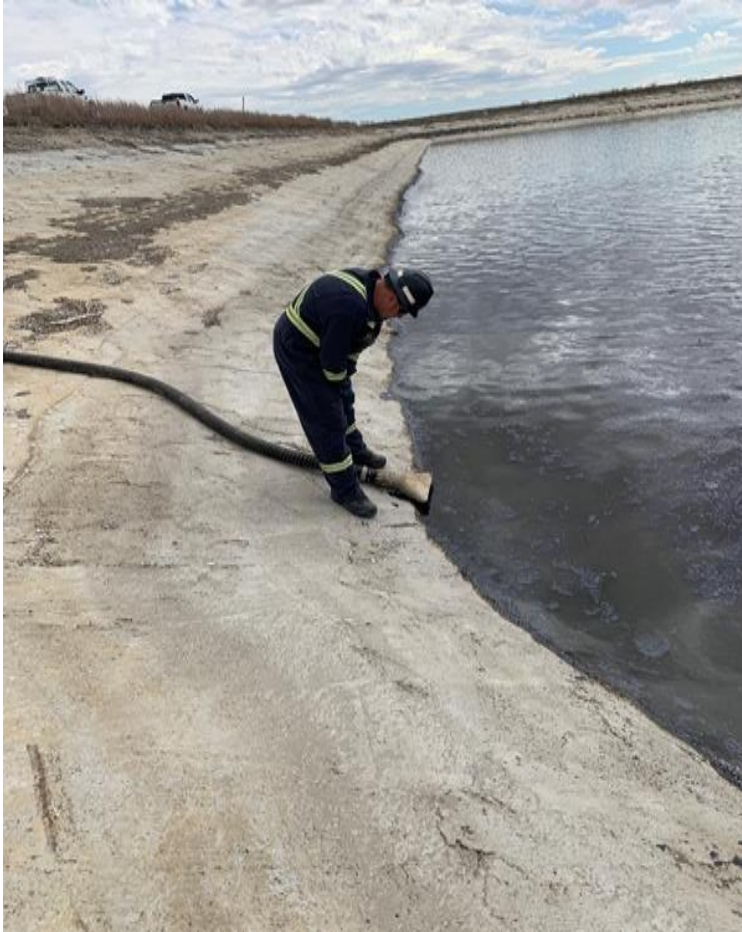
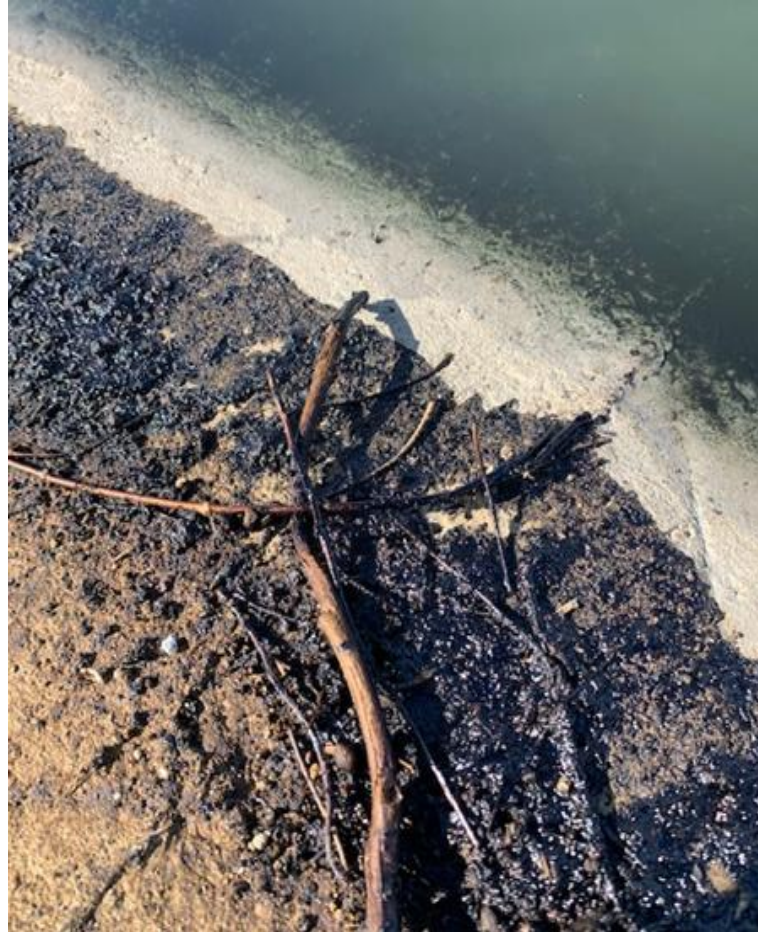
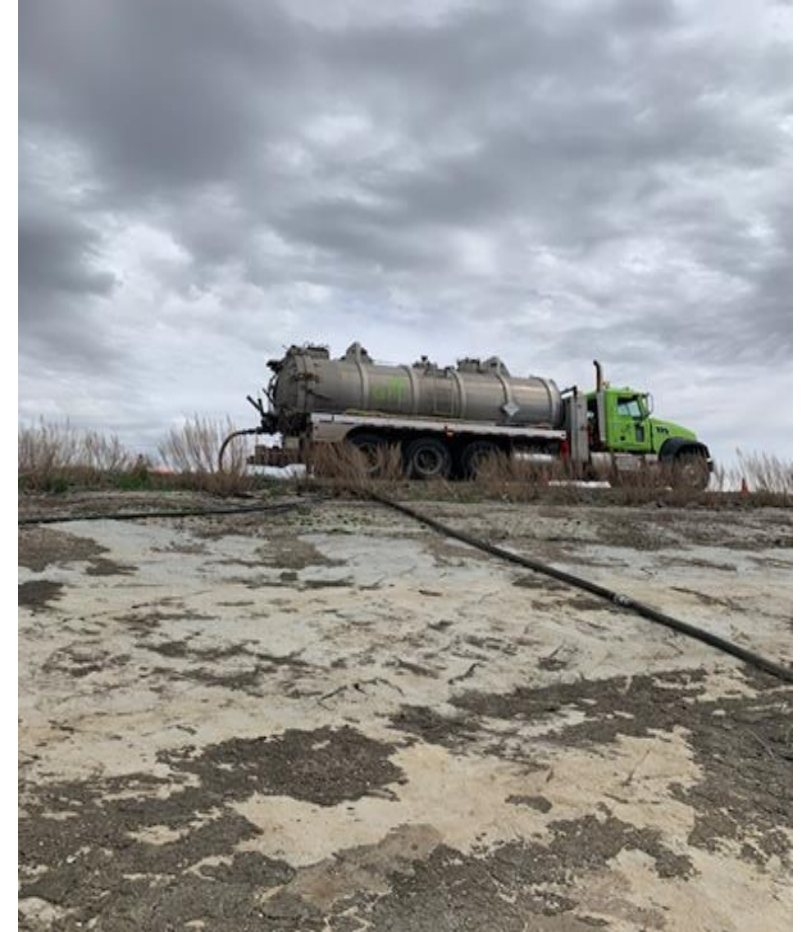
Initial Cleanup Attempt

May 22 – 29, 2022 – attempted to clean using Hydrovac

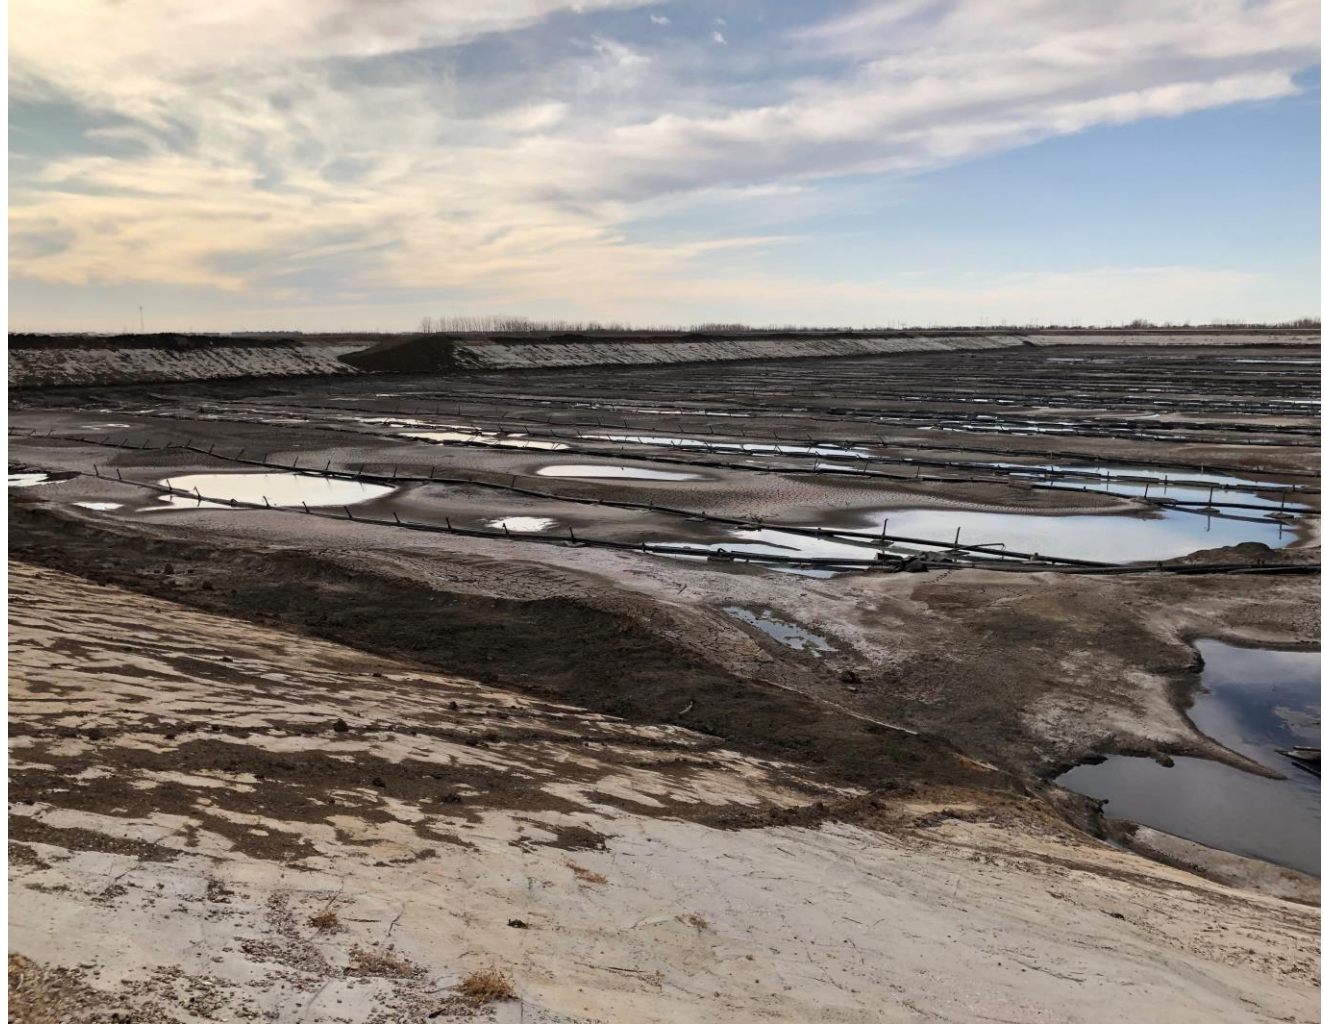
Step 1 - Dewatering

- Water column held very little oil
- Majority found in sludge
- Decision to pump Cell 2A dry – oil boom used and floated around the intake
- Attempt to dry sludge

Oops - Sludge did not dewater

- Track hoe was used to remove the surficial sludge and pile it onto the bank.
- Dried contaminated sludge would then be transported to the designated disposal facility.
- The approach did not work out as:
 - Sludge was too moist to be able to stay on the bank.
 - The natural drying process did not work as efficiently as expected.
 - Did not have sufficient temporary storage space onsite for the estimated quantity.
 - Delays caused by rainy weather.

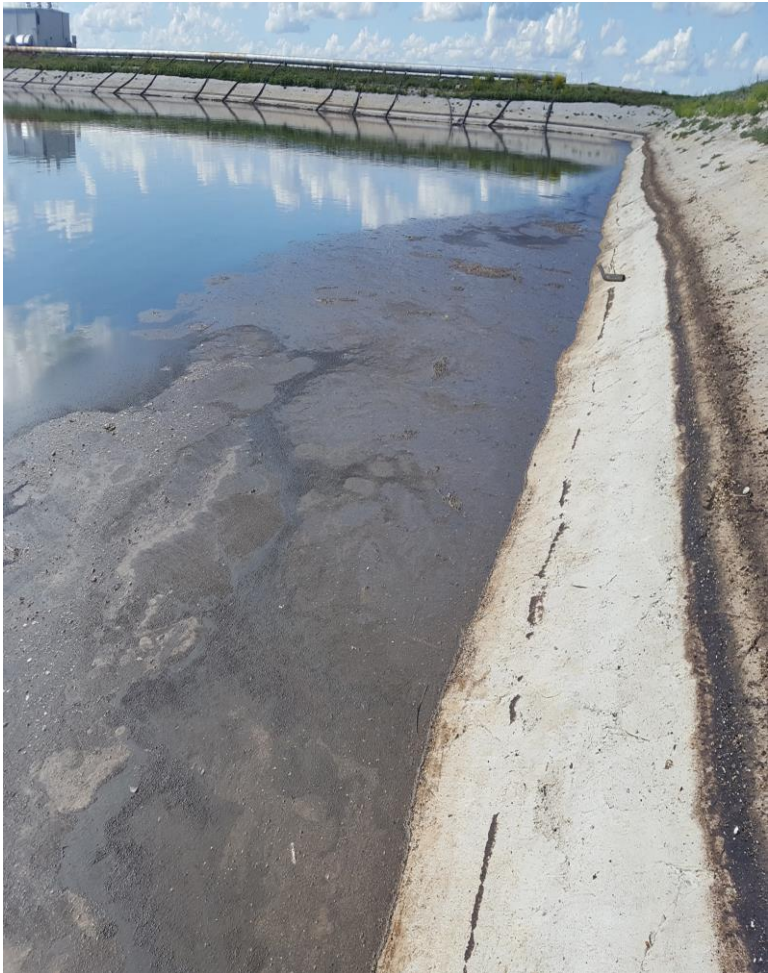
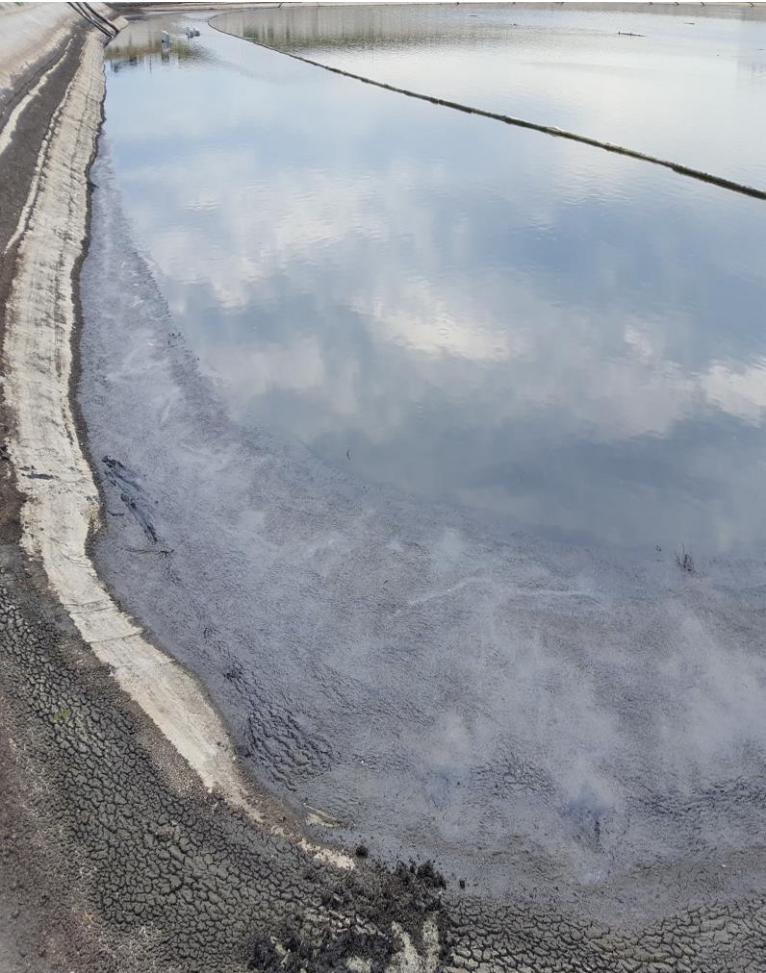
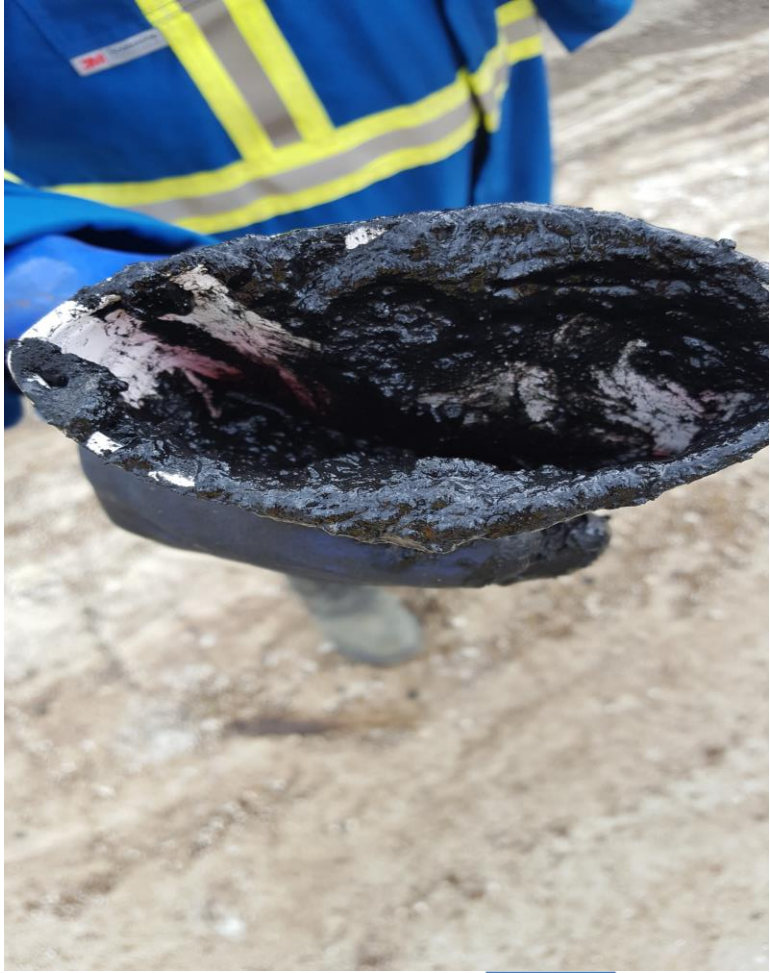
What it looks like

- Associated Environmental conducted a visual assessment in June.
- It was observed that the oil was on the surface, floating within the water column and settling on the sludge.
- Water and sludge samples were collected to assess the general concentrations as a starting point.
- Initial results showed F2 – F4 concentrations in the sludge ranged from 20,000 mg/kg to 40,000 mg/kg
- F1 fraction was minimal – very heavy hydrocarbon chain
