# Digital Solutions for Post-Remediation and Reclamation Vegetation Management

## A Case Study from northeastern Alberta

ESAA Rem Tech 2025  
October 16, 2025

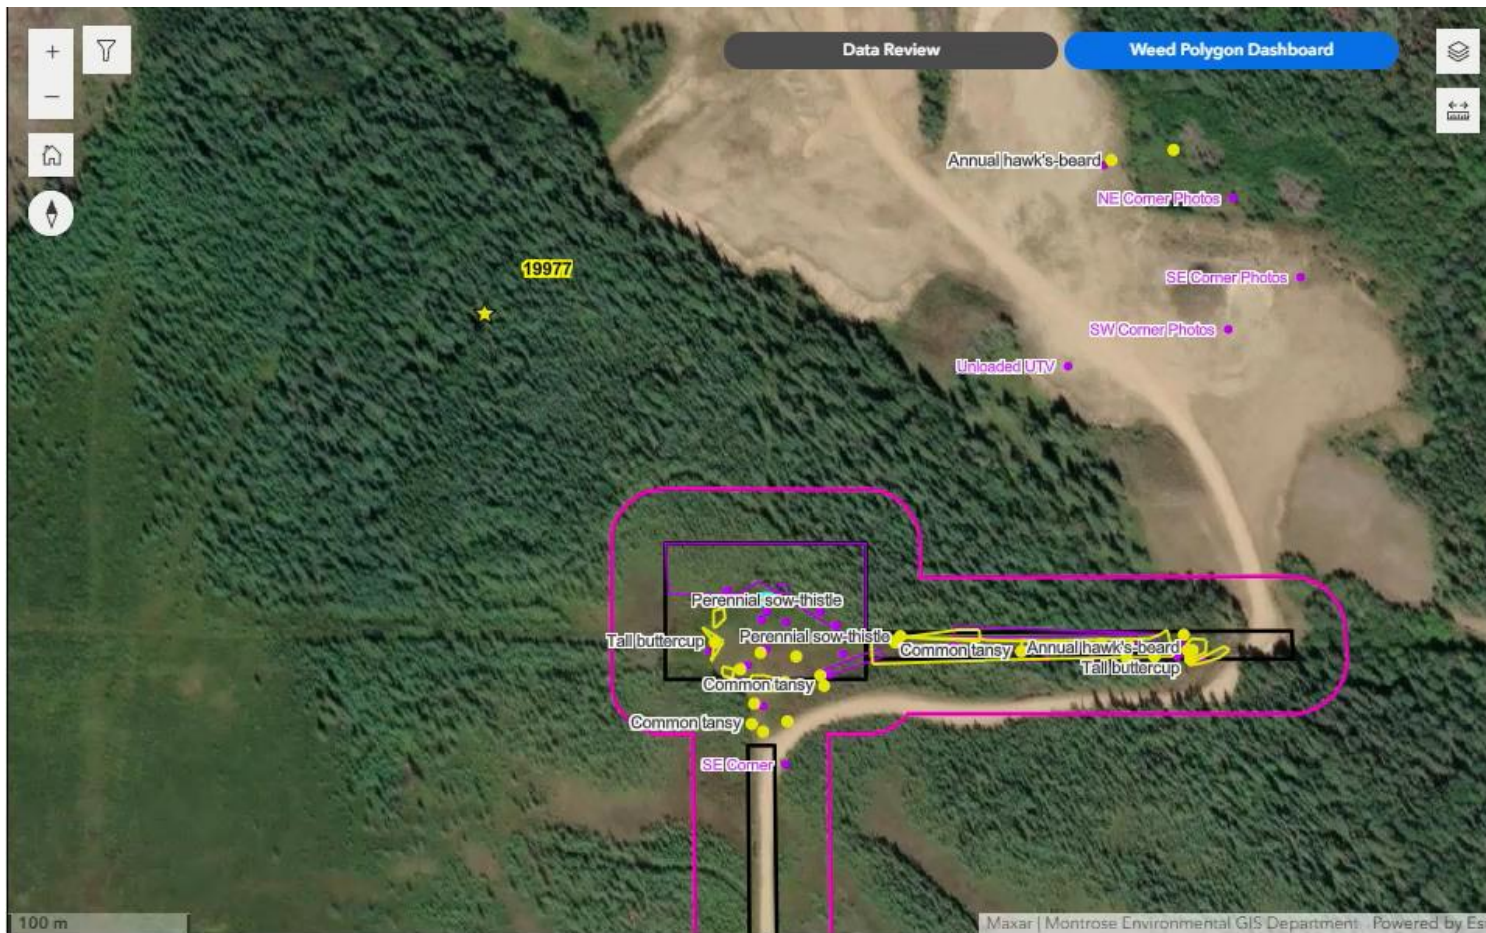
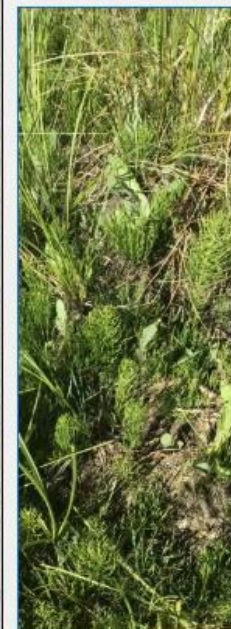
# Photos & Attributes

2024-06-22

Primary weed species: 3% cover Perennial sow-thistle (73 sq m)

Secondary weed species: 0% cover (73 sq m)

Treated: Yes

Weed Control Method: Herbicide

Comment: Close to standing water, along tree line.

2024-08-07

Primary weed species: 1% cover Common nettle (261 sq m)

Secondary weed species: 0% cover (261 sq m)

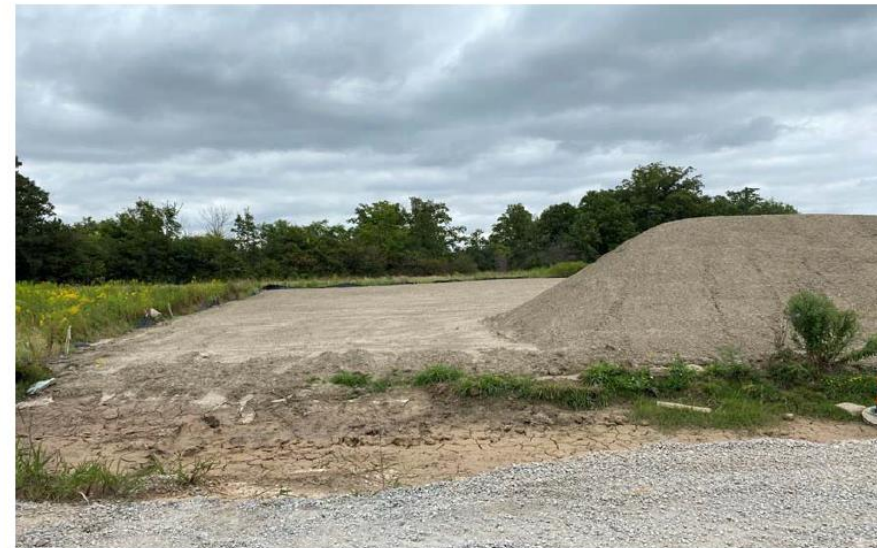
Photo 3. August 29, 2024 - Topsoil temporary staging area

| Feature Type | Date | Time | Comments | Status |
|---|---|---|---|---|
| ESC Barrier adjacent to CA regulated lands | 2024-08-29 | 14:05 | Topsoil placement as part of site decommissioning. | Not Applicable |
