# In-Situ Microbial Remediation of a Historical Crude Oil Release within a Wetland Jasper National Park, Alberta

October 16, 2025  
RemTech 2025 Presentation

Murray Ostrander - Alta Tech Environmental Services  
Heather Anderson - Trans Mountain

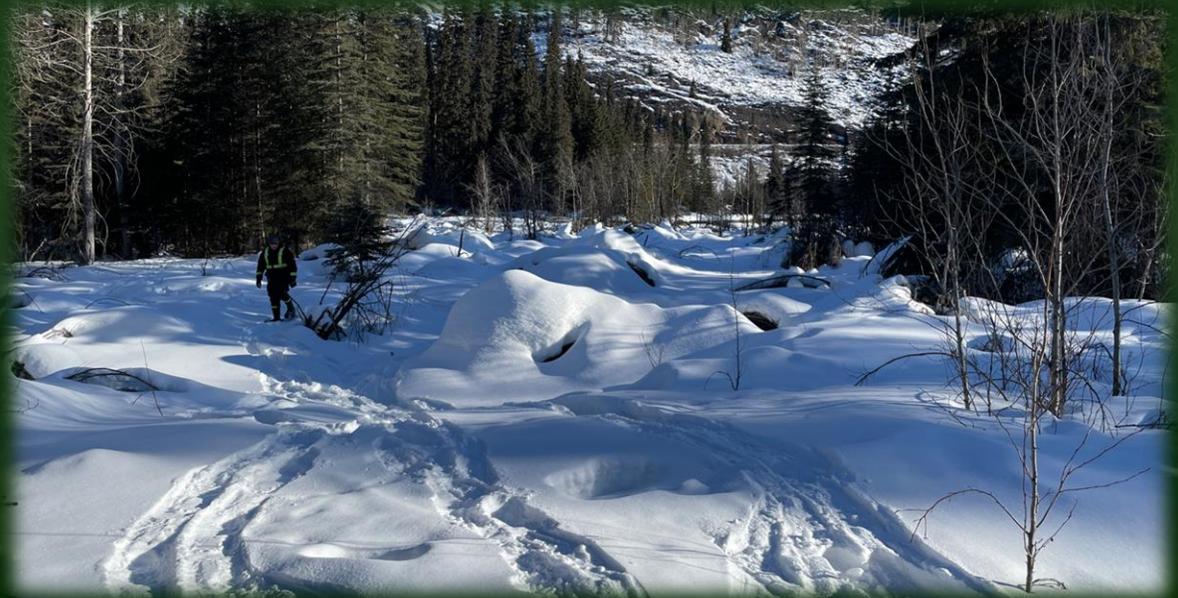
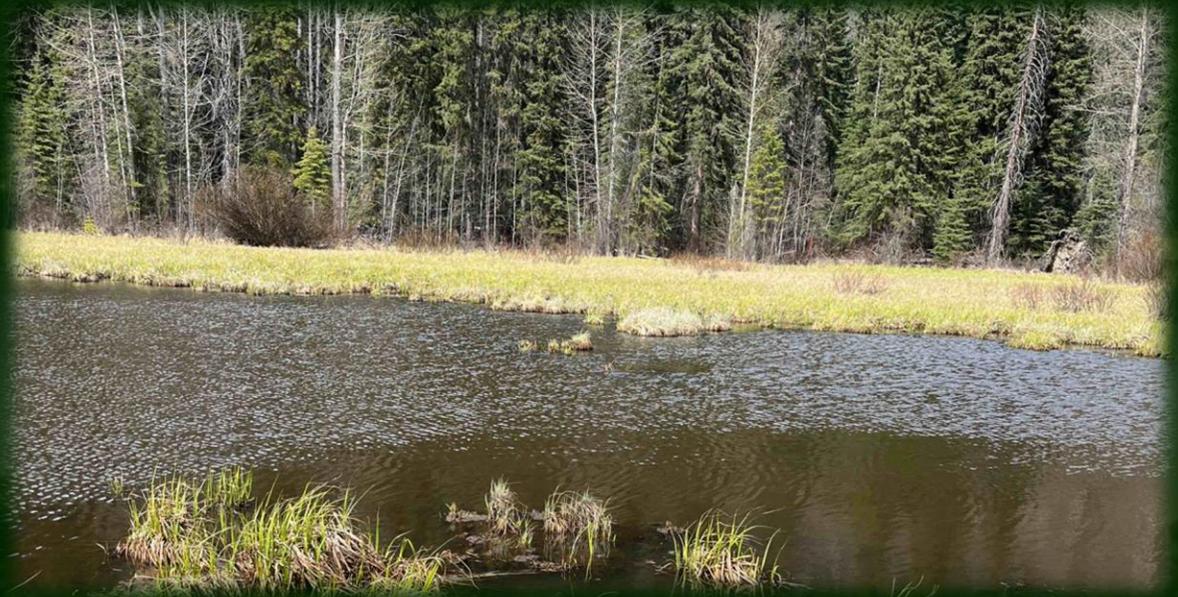
- The site includes areas on and off the Trans Mountain Pipeline Right of Way.
- Remote area with no road access.
- Access is further limited by high snow volumes, dense vegetation and waterbodies

Marsh, fen, swamp, and forest habitats.

Subsurface conditions vary and include sand, silt, clay, and peat.

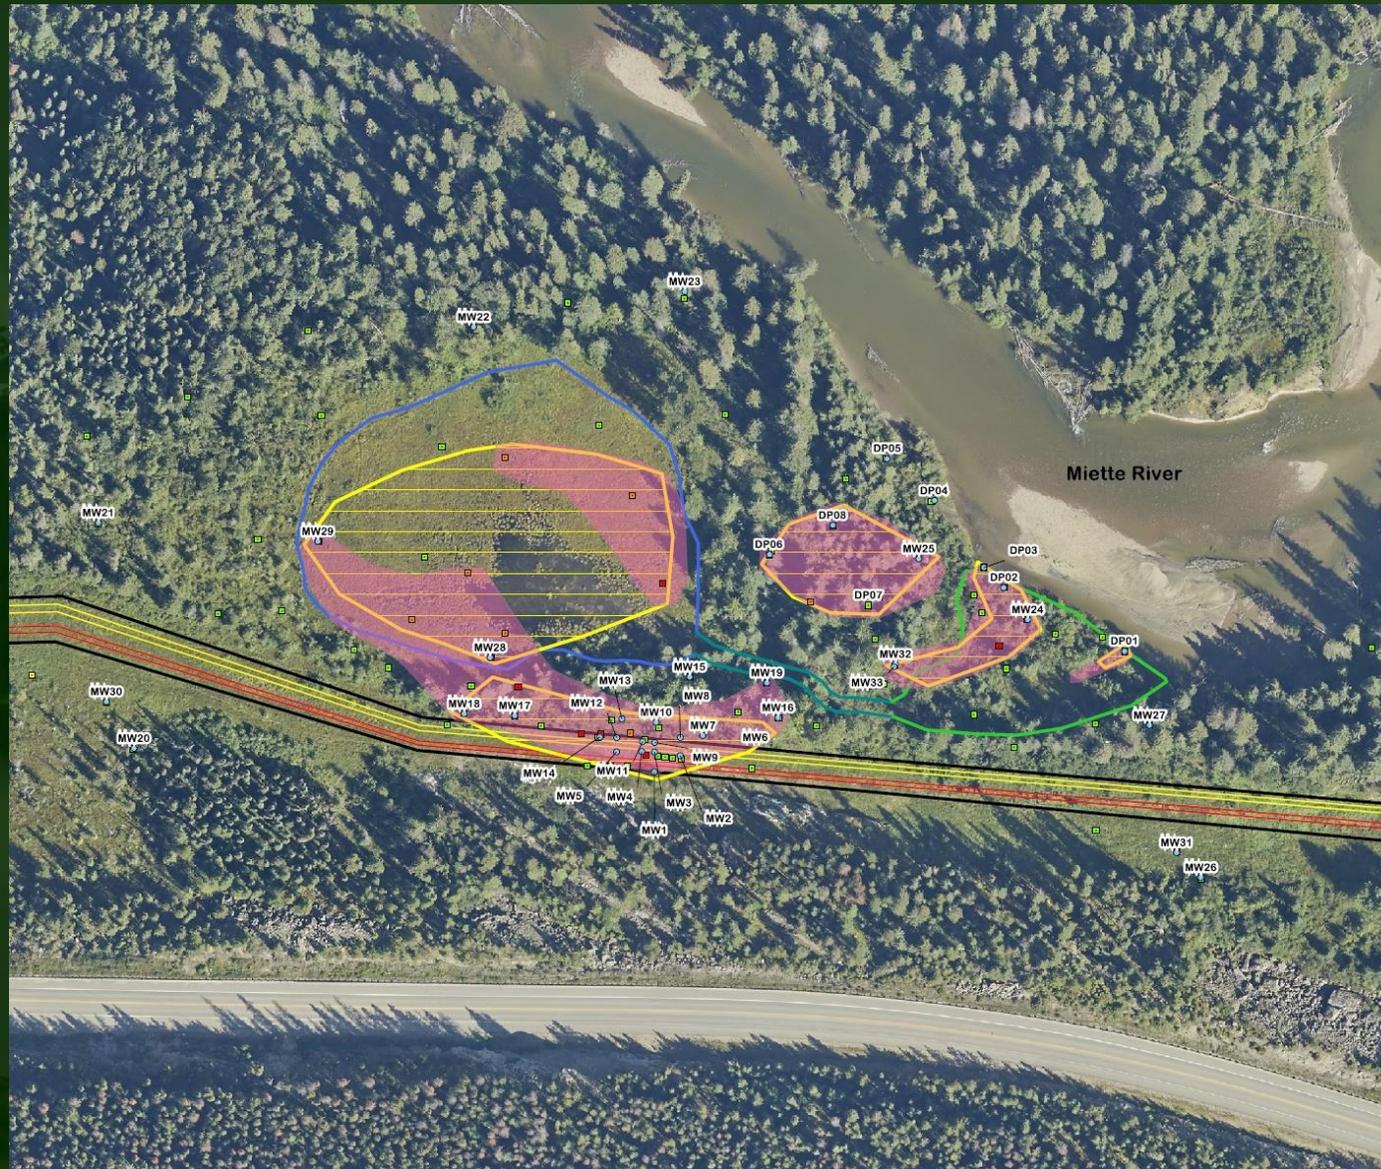
Figure 8

- ROW: clay/gravel fill
- Marsh: Peat
- Swale: Silty Sand
- Shrubby fen: Clay/Silt Sand
- Area adjacent to Miette River: Sand

Site Remediation Locations

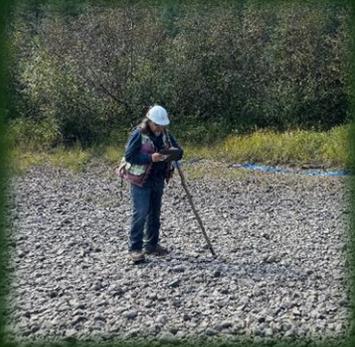
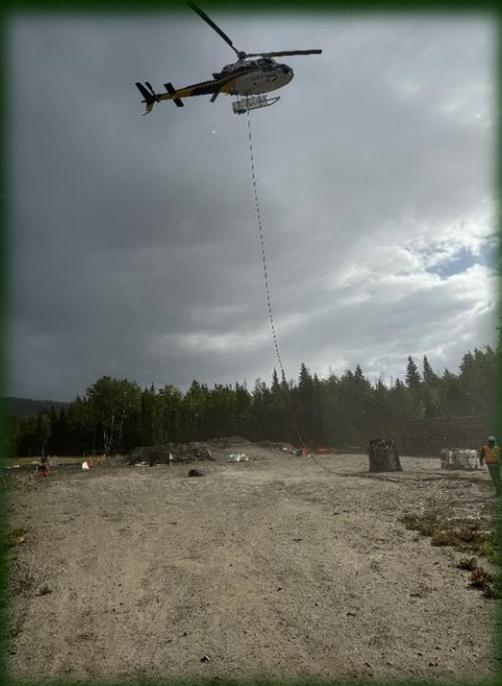
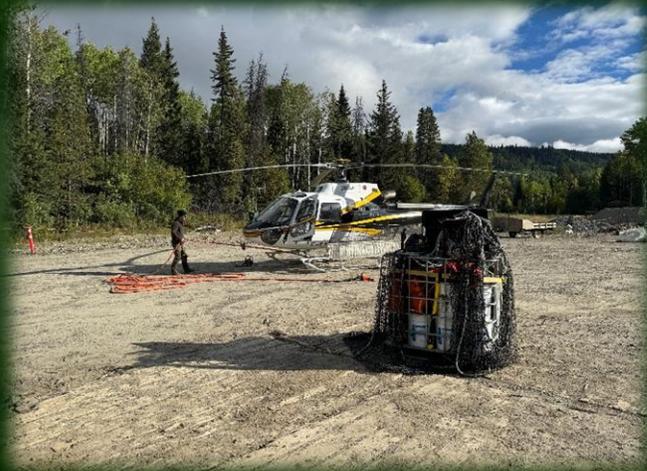
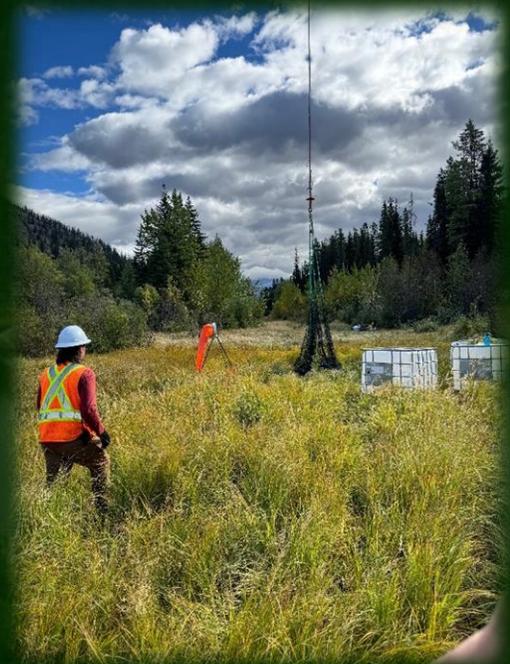
- Indigenous monitor onsite during injection
- Monitoring groundwater and surface water to confirm microbes not migrating to River
- No vehicle traffic to site to protect watercourses and Site, mitigation approach:
  - Helicopter used to transport equipment and supplies to and from Site
  - Foot traffic only to and from site
- No animal attractants left at Site overnight:
  - Food and waste
  - Gasoline fuels, attract bears

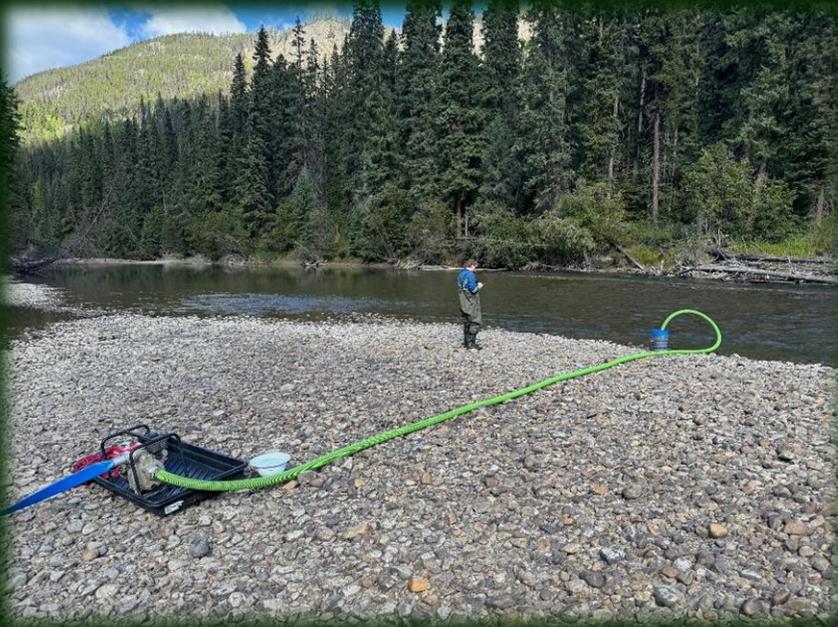
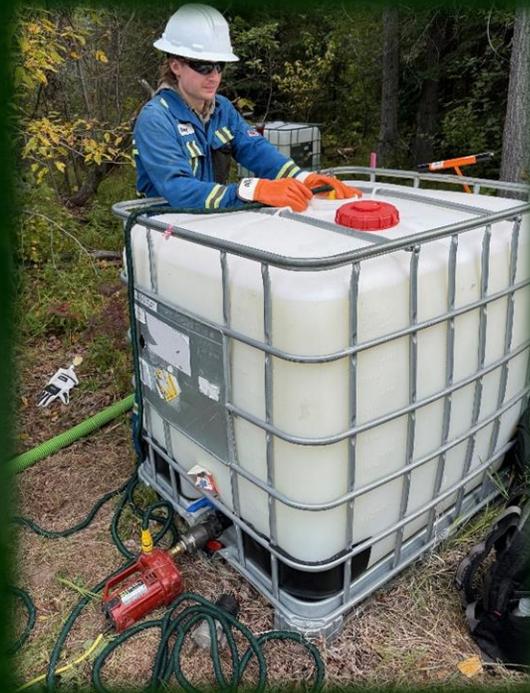
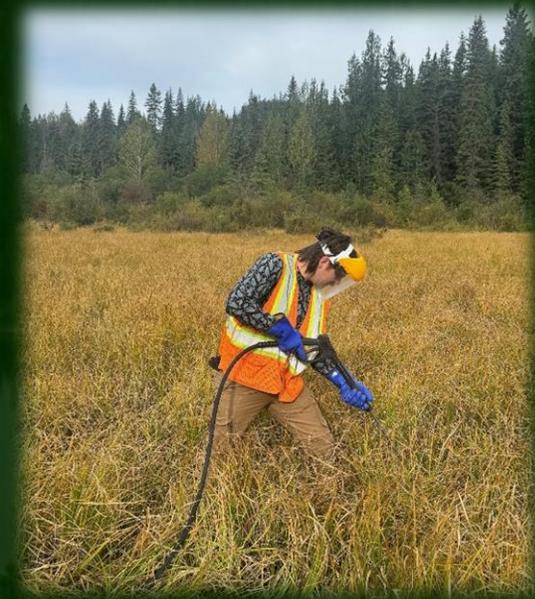
- SIMPCW Resources was Project Partner
- 1st Injection, September 2024 - microbe injection across the Site.
  - Indigenous monitoring was onsite for injections, provided input along the injection.

- Helicopter used to transport equipment and supplies to Site.
  - All equipment was operated by hand to minimize environmental impacts.
  - Microbes sensitive to pressure, application pressure set to  $\leq 1000$  psi.

- Shallow impacts, 0 – 2 mbgs, ideal for hand equipment injection of microbe treatment for the four areas of the Site; ROW, Peat Area, Sand and Clay. Injection spacing and pressures varied based on area.

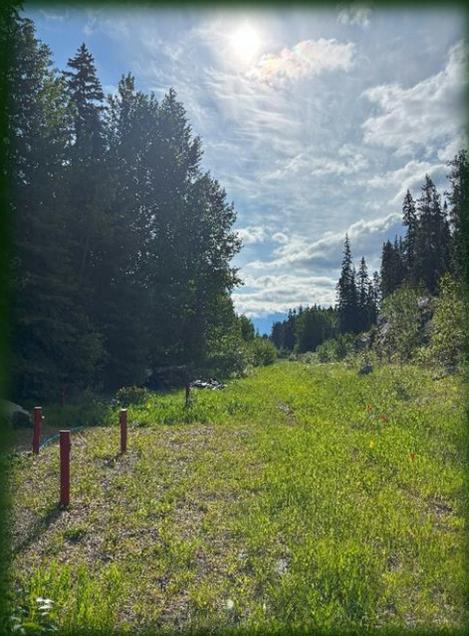
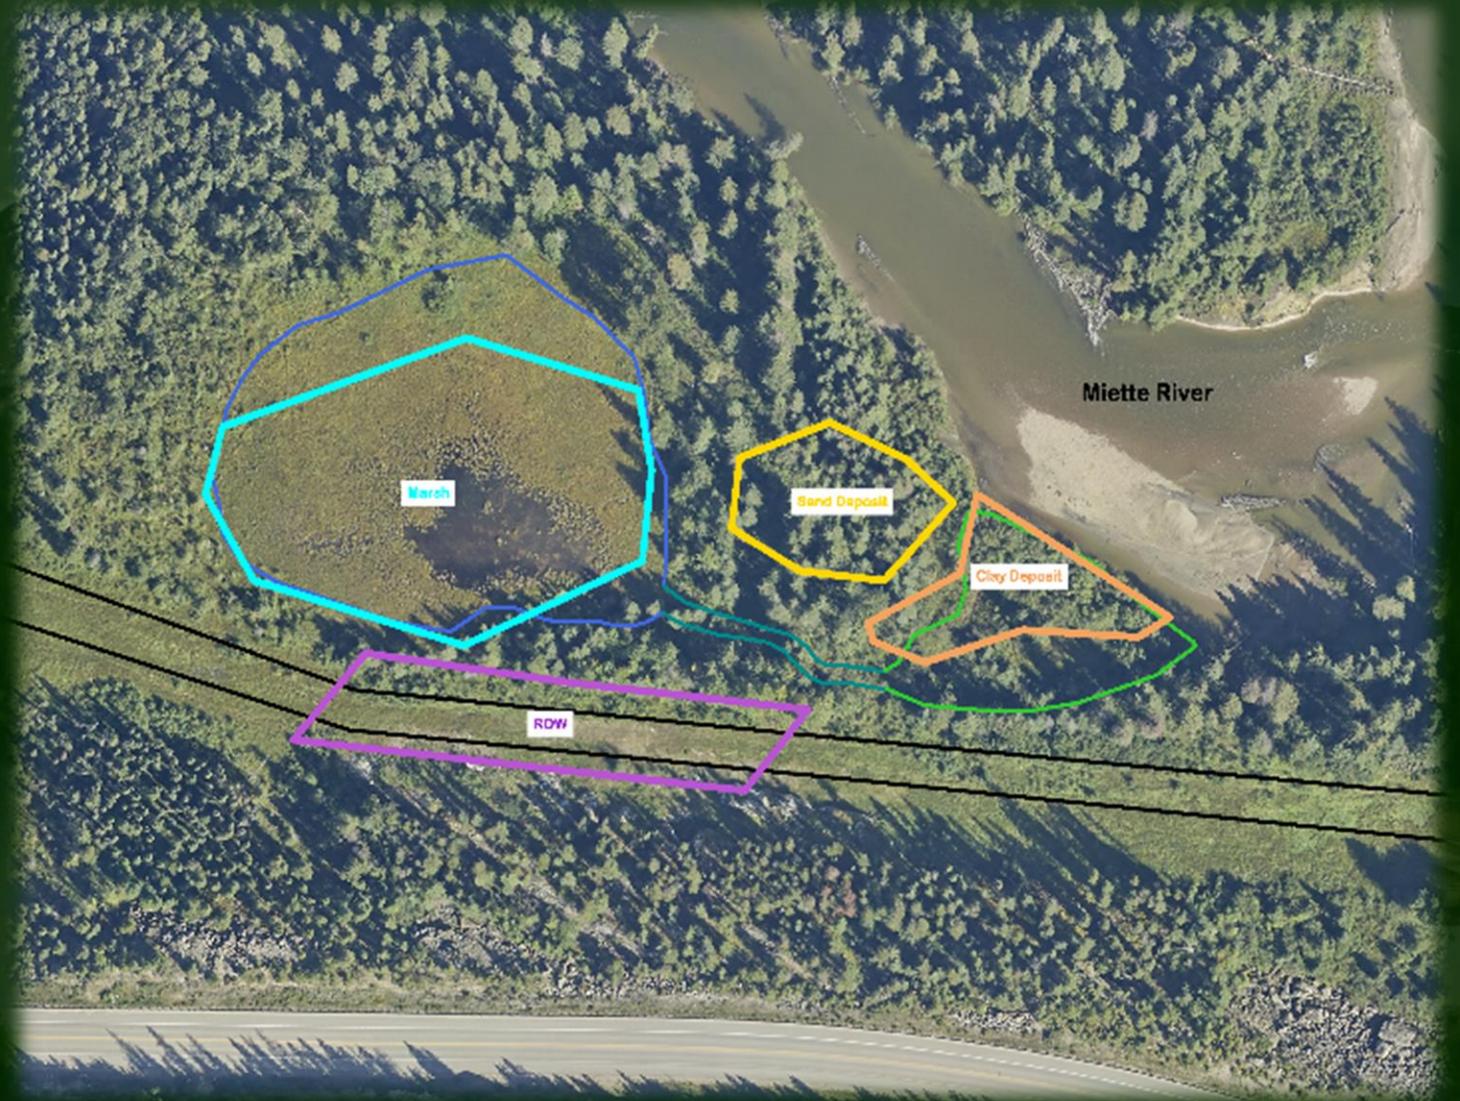
# Remediation Area - ROW:

- Soil - clay/gravel fill
- $n - 0.3$
- $K \sim 1 \times 10^{-5}$  to  $1 \times 10^{-6}$  m/s
- No ground disturbance within 5m of underground pipelines
- Surface application was completed within 5 m of the pipe, and injection was completed outside of this distance

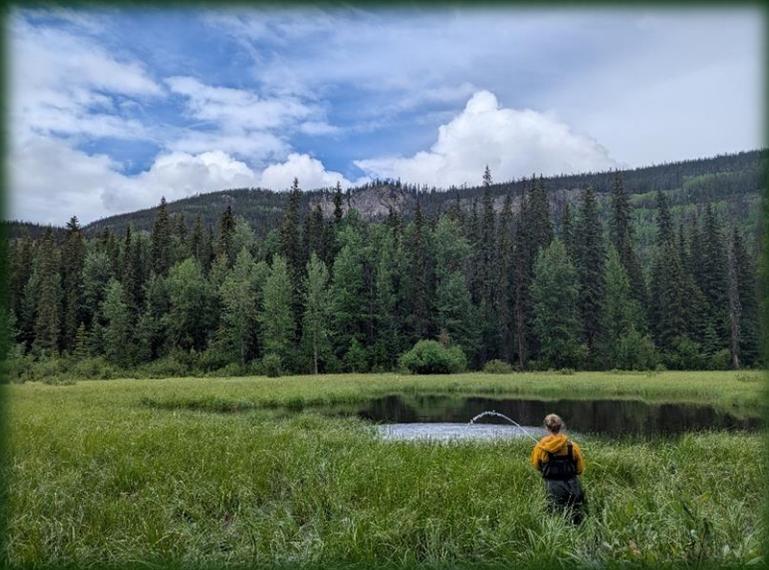
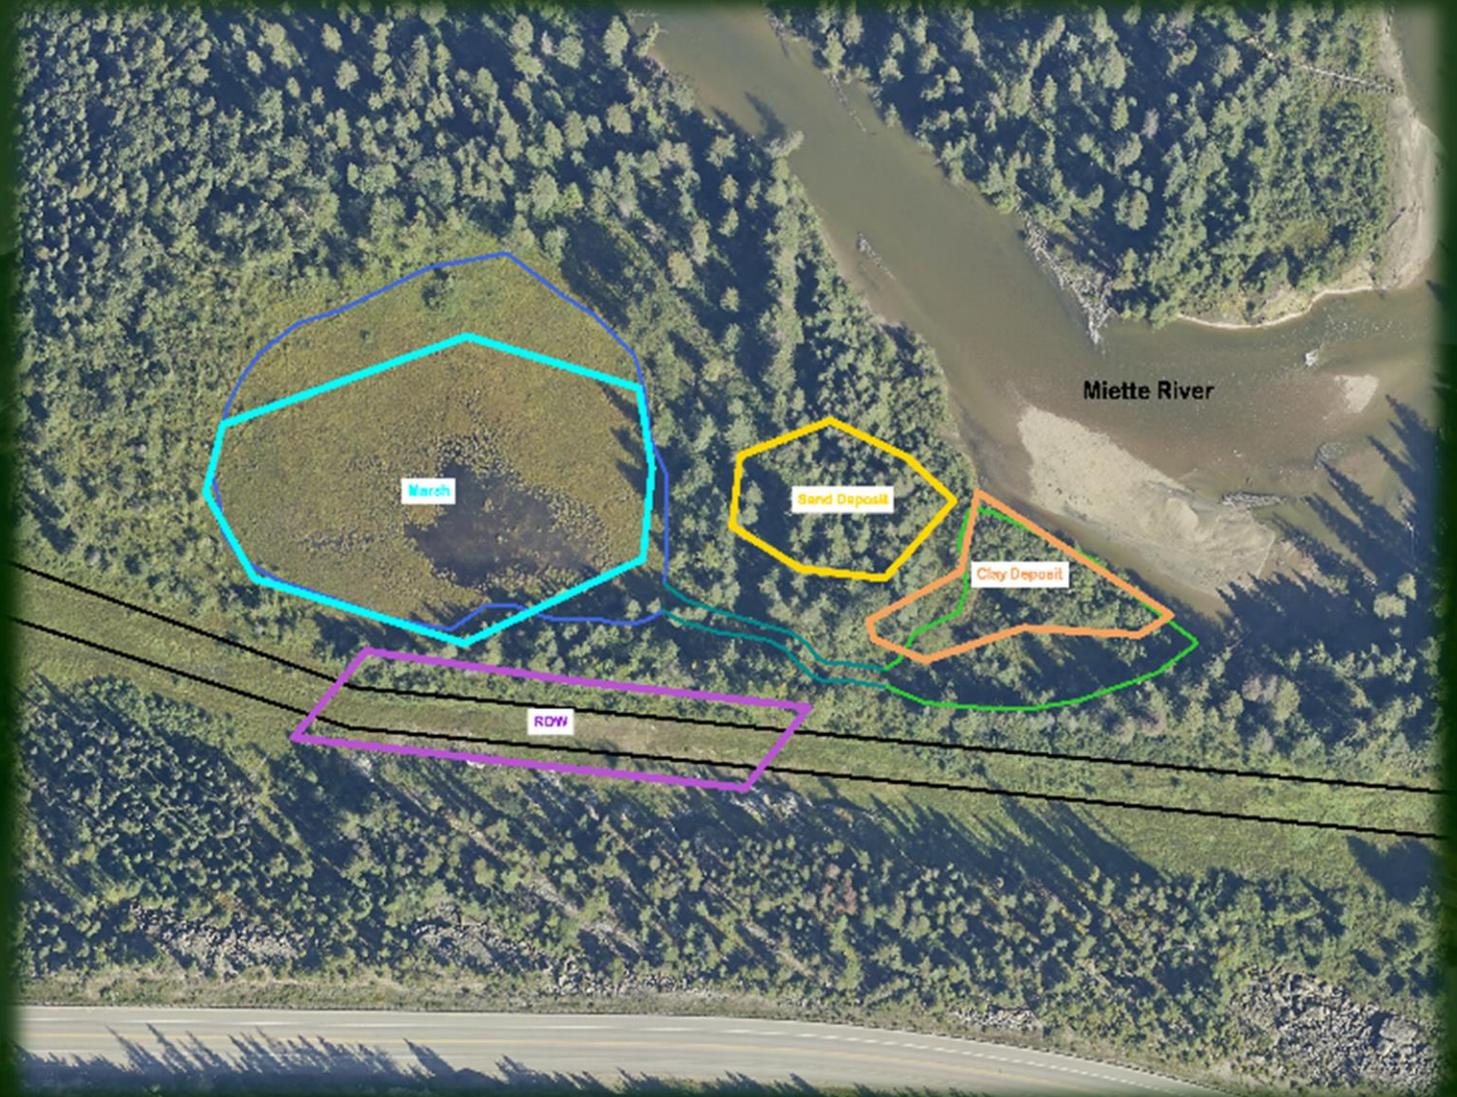
## Remediation Area - Marsh:

- Soil - Peat
- $n - 0.4 - 0.5$
- $K \sim 1 \times 10^{-5}$  to  $1 \times 10^{-4}$  m/s
- Microbe solution injected at low pressure with coarse spacing

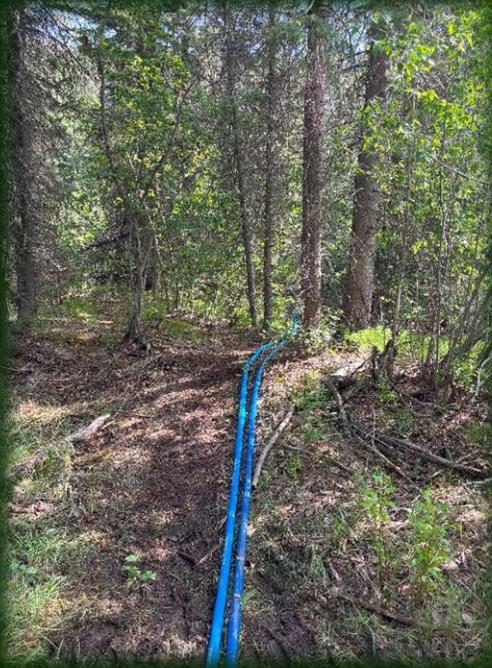
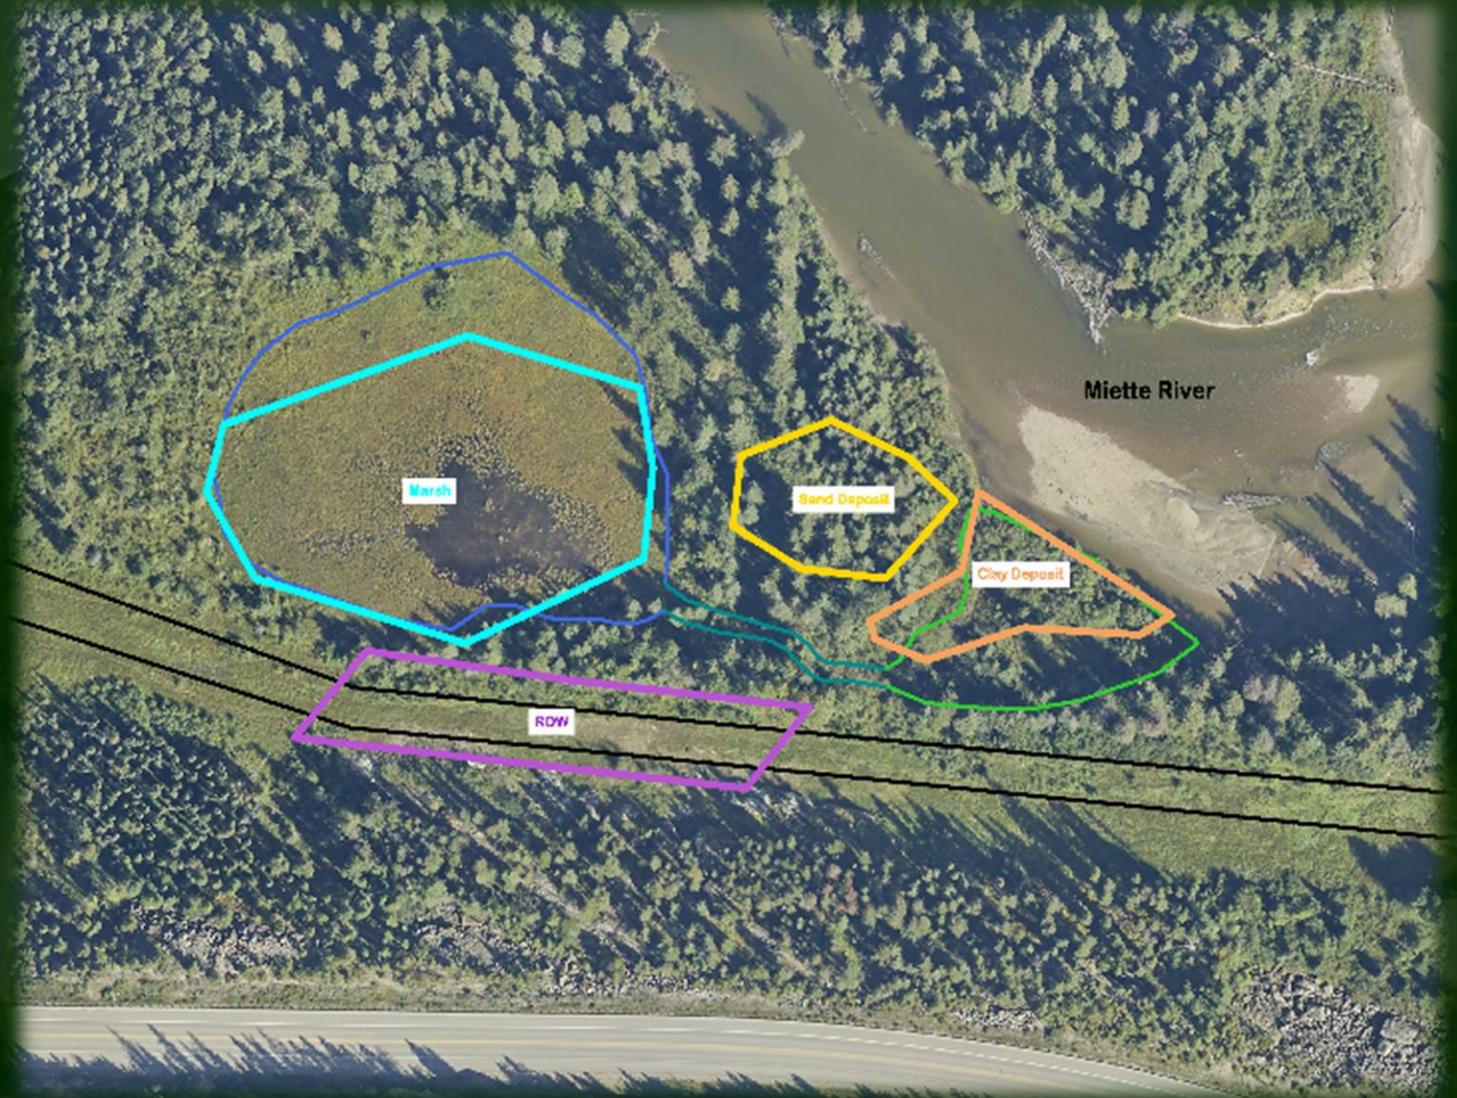
## Remediation Area – Sand Deposit:

- Soil - Sand
- $n \sim 0.3$
- $K \sim 1 \times 10^{-4}$  to  $1 \times 10^{-5}$  m/s
- Microbe solution injected at low pressure with coarse spacing

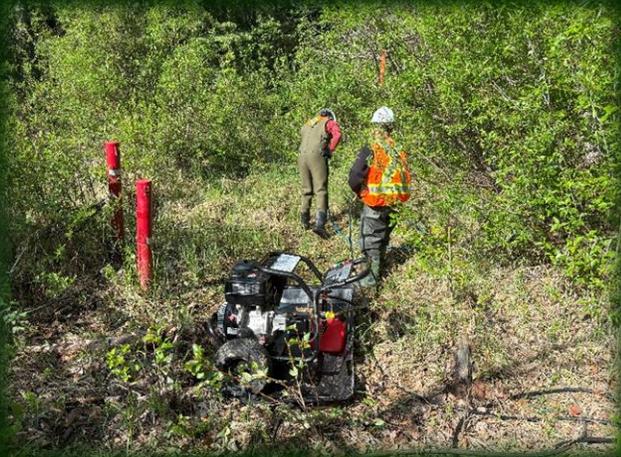
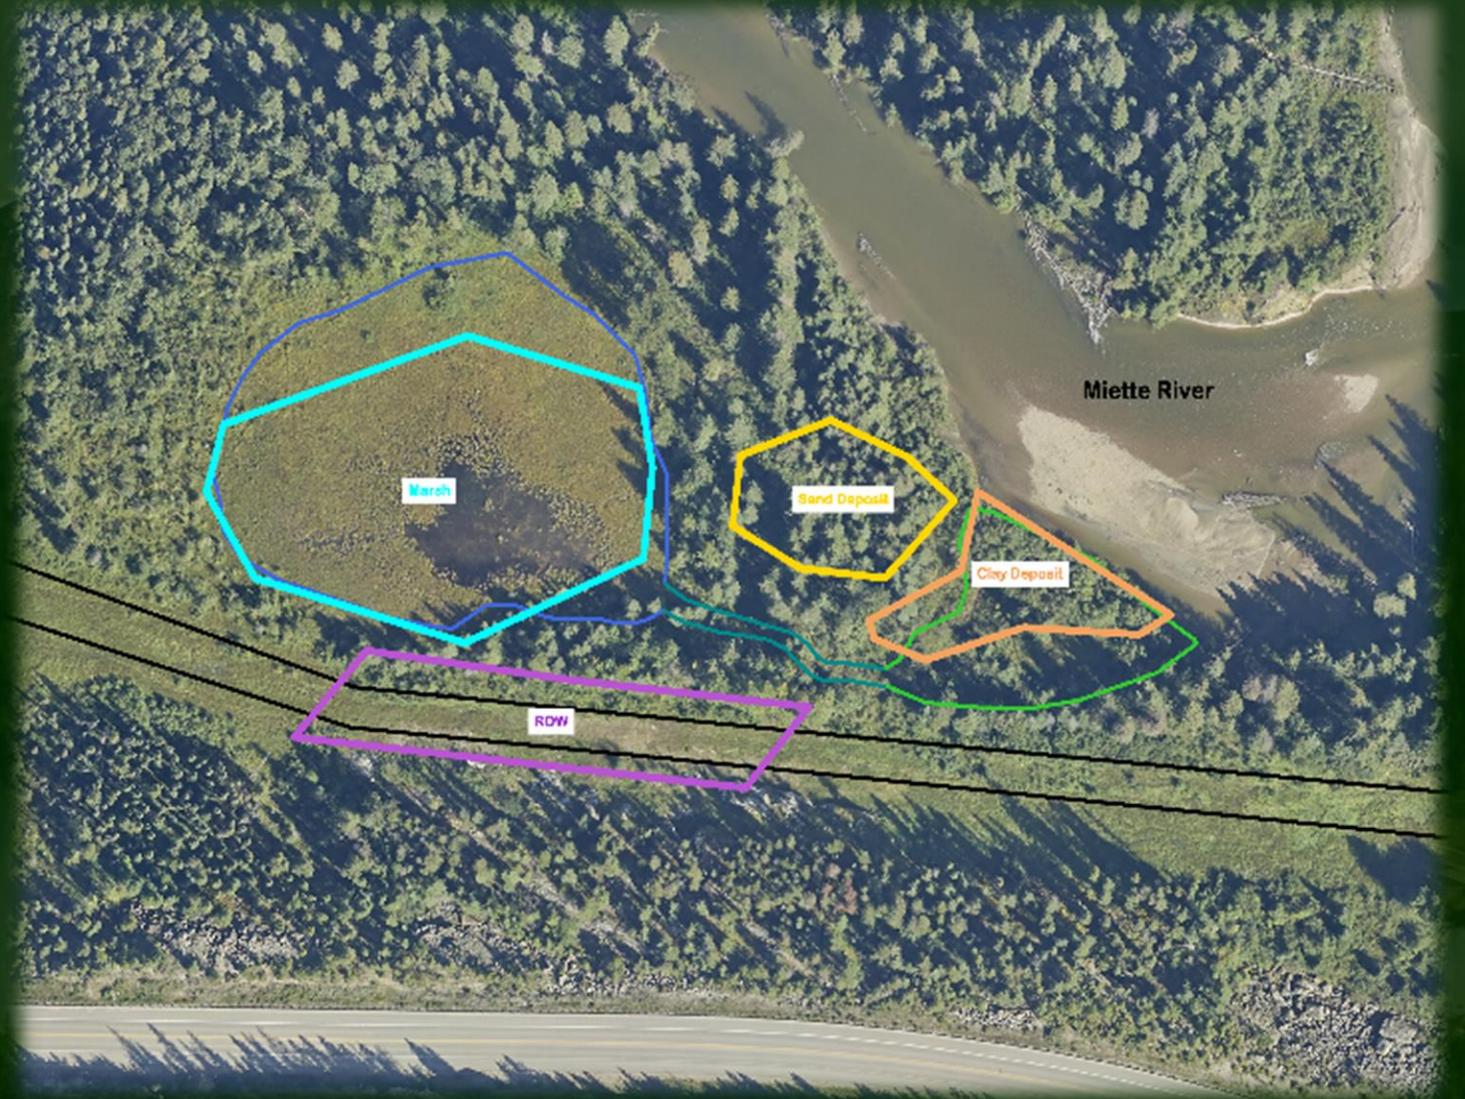
## Remediation Area – Clay Deposit:

- Soil – Clay / Silt
- $n \sim 0.4$
- $K \leq 1 \times 10^{-7} \text{ m/s}$
- Microbe solution injected at higher pressure with finer spacing

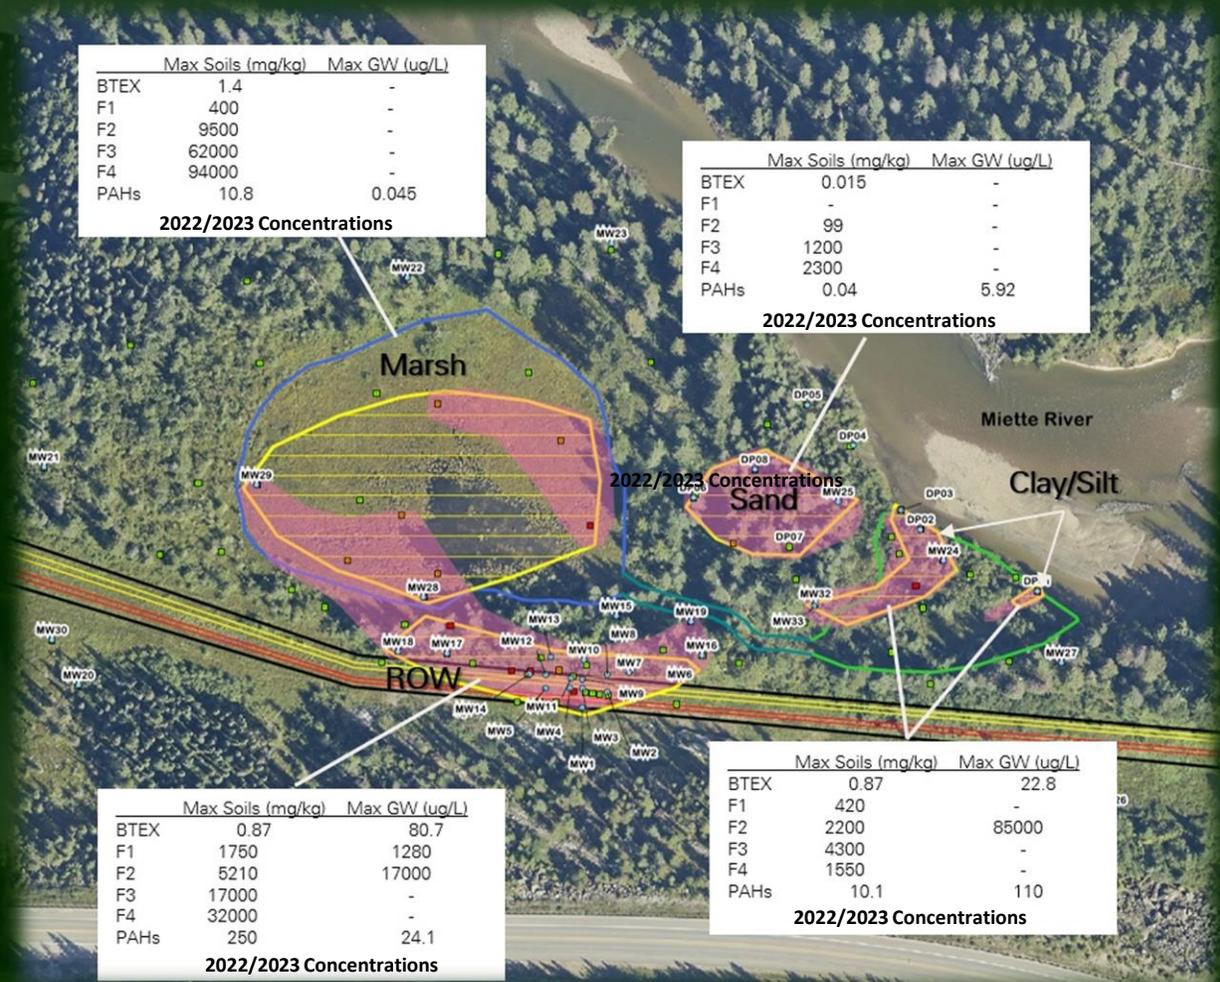
# October 2024 Results, 3 Weeks Following 1<sup>st</sup> Injection

- 30 – 80 % reduction (60% Average) of hydrocarbon (BTEX, F1-F4) impacts observed across Site.
- Most Reductions observed in Marsh and Sand Areas
- No significant reduction observed at the Clay area
- No significant reduction in PAHs observed

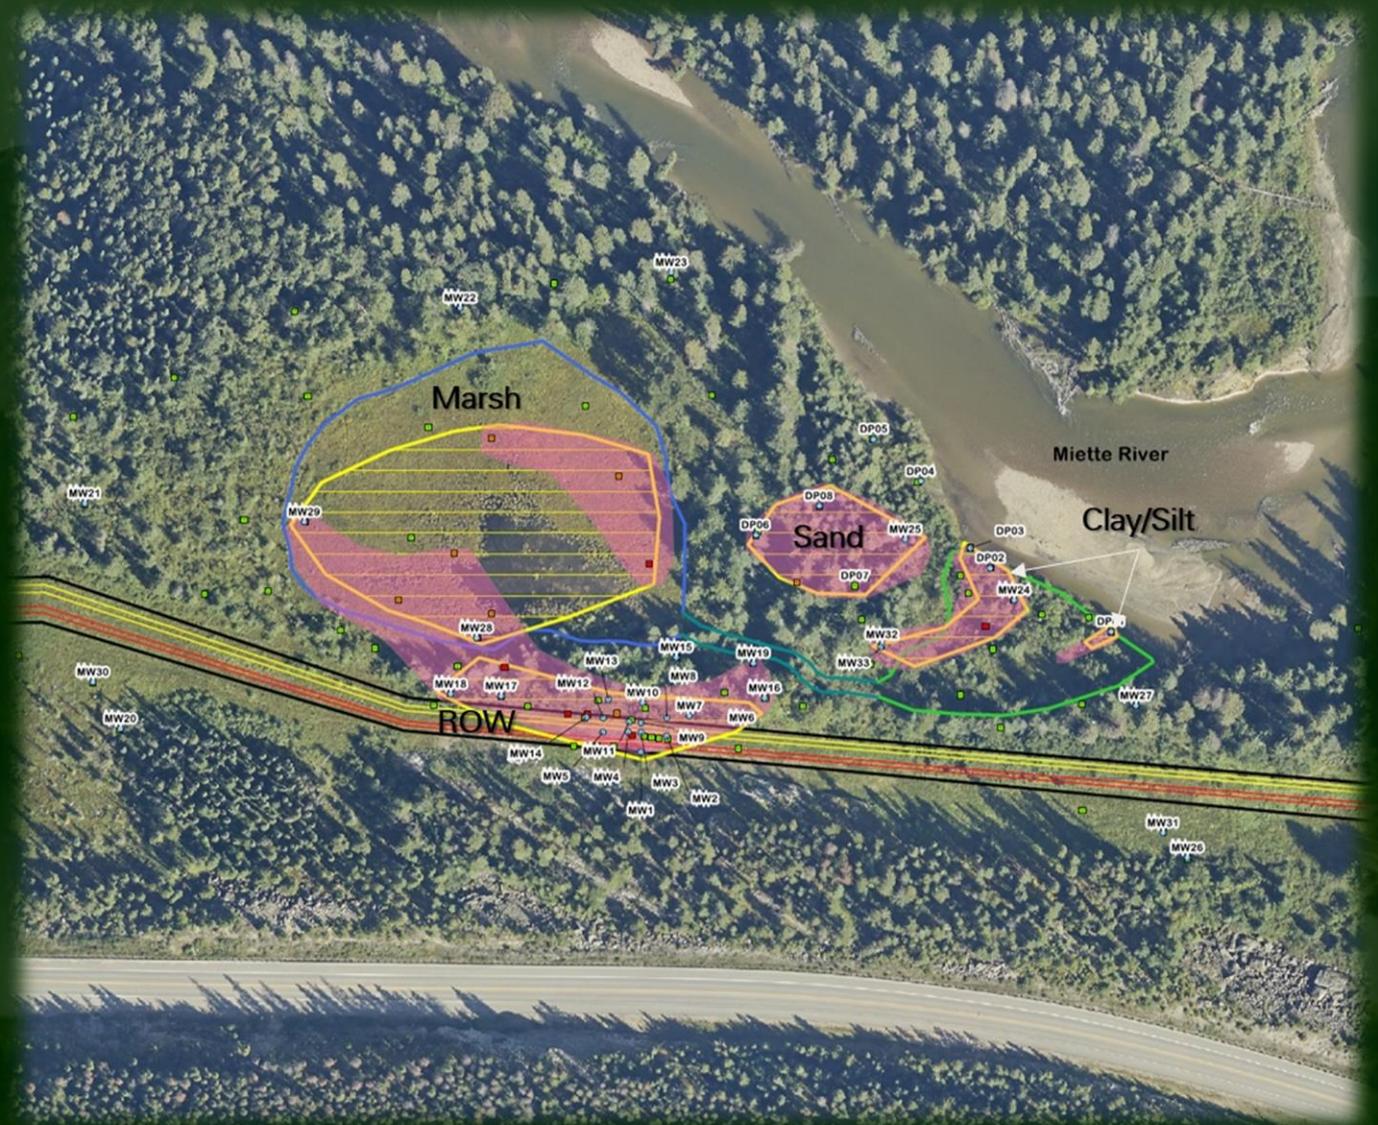
## July 2025 Results, 5 Weeks Following 2<sup>nd</sup> Injection

- Continued concentration (BTEX, F1-F4) reductions, 50% to 100%.
- In Clay areas, hydrocarbon impacts reduced 40% – 100%, indicating success of higher-pressure injection and closer injection point spacing.
- PAH concentrations, most samples had 40% to 100% concentration reductions. 30% of PAH samples had no change compared to 2024 showing success of increasing R15%
- 70% of Site now remediated to CCME Guidelines.
- Addition of R15 resulted in reduced PAH concentrations

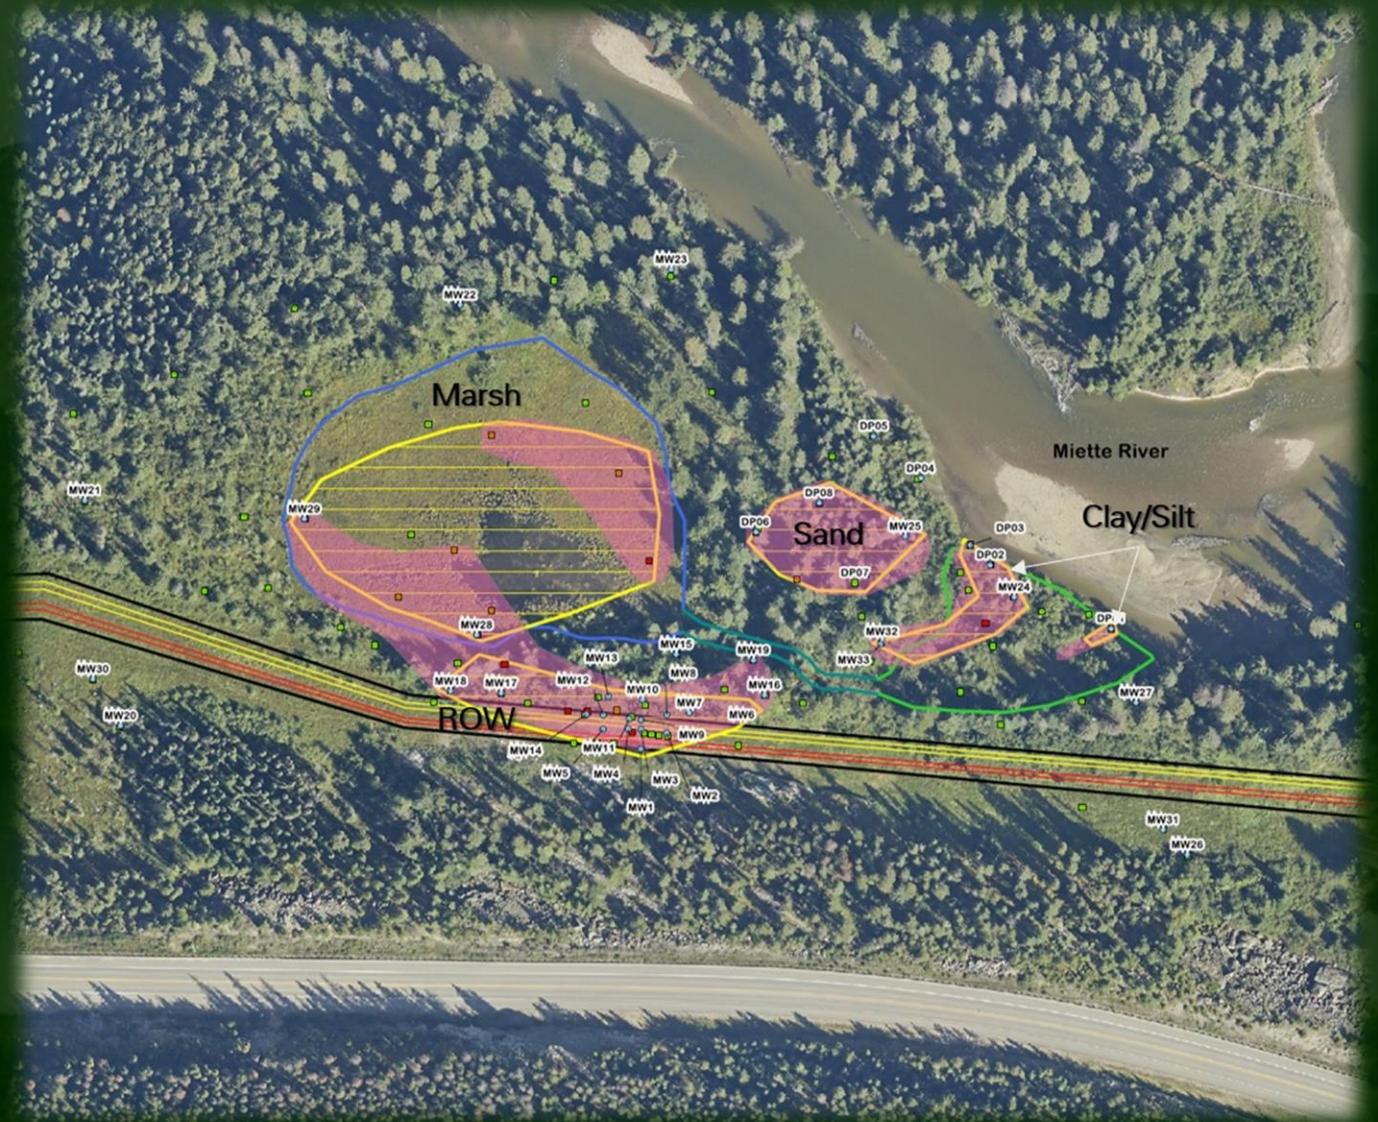
# Sept 2025 Results, 3 Months Following 2<sup>nd</sup> Injection

- 30 to 100% reduction in PHCs in soil, lowest reduction at one location at ROW and one location at Clay area
- 20 to 100% reduction in PAHs in soil in most locations, except one location on ROW and one location at Clay area, few locations had increases of naphthalene and pyrene
- 20 to 90% reduction of PAHs in groundwater, except at ROW, increases of naphthalene and pyrene in Sept 2025 in a few locations
- Confirmed, addition of R15 resulted in reduced PAH concentrations
- Another 5 – 10% remediated
