MANAGING AND REDUCING ENVIRONMENTAL LIABILITIES AT THE TOWN OF SLAVE LAKE

A SUSTAINABLE SALT REMEDIATION STRATEGY

Zion Yua, M.Eng., P.Eng., PMP – Associate and Assistant Branch Manager

October 16, 2025

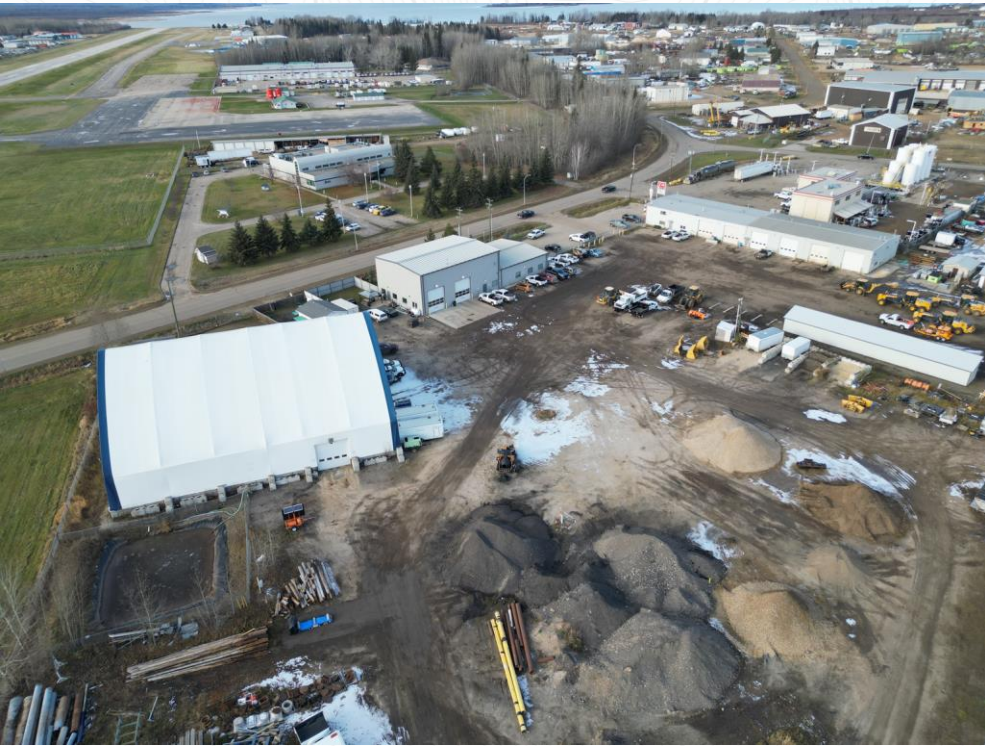
Project Information

- Active town maintenance yard that managed winter salt and sand (pickled sand).
- Pickled sand originally stored and handled directly on the gravel yard resulted in salt infiltration into the soil and groundwater.
- Site assessments by previous consultants between 2004 and 2009.
- Alberta Environment and Protected Areas recommended additional assessments and requested a RAP and RMP for the site in 2009.

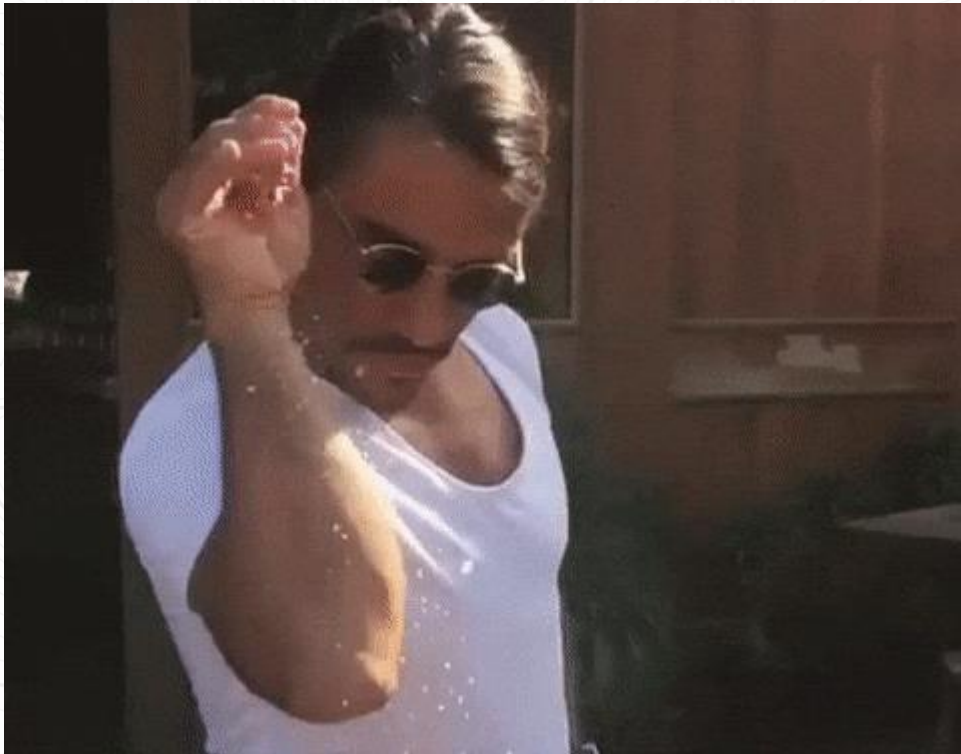
Contaminant of Concern - Salt

- Commonly NaCl, CaCl₂, MgCl₂, KCl
- Environmental impacts from improper storage or management of salt.
- Potential environmental impacts from salt (SCARG, 2001):
 - Degradation of soil chemical properties and impaired vegetative growth
 - Degradation of soil physical properties caused by excess sodium concentrations
 - Degraded surface water or groundwater quality.

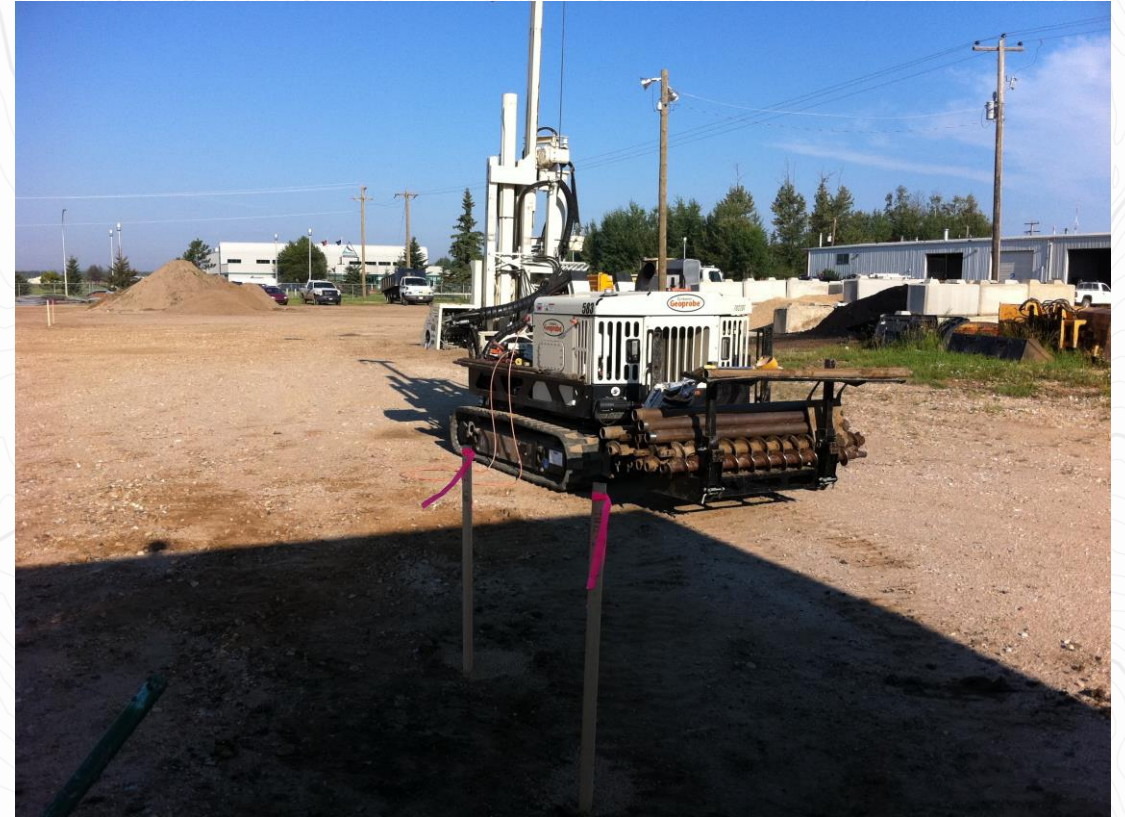
Phase 3 Environmental Site Assessment

- Thurber completed Phase 3 ESAs in 2012 and 2013.
- Expanded the existing monitoring well network:
 - Road allowance area west of 7 Street
 - Sawridge First Nations land east of the site
 - Nested wells to evaluate vertical gradients
 - Sentinel wells around the site perimeter
- Delineated the salinity impacts in the soil.

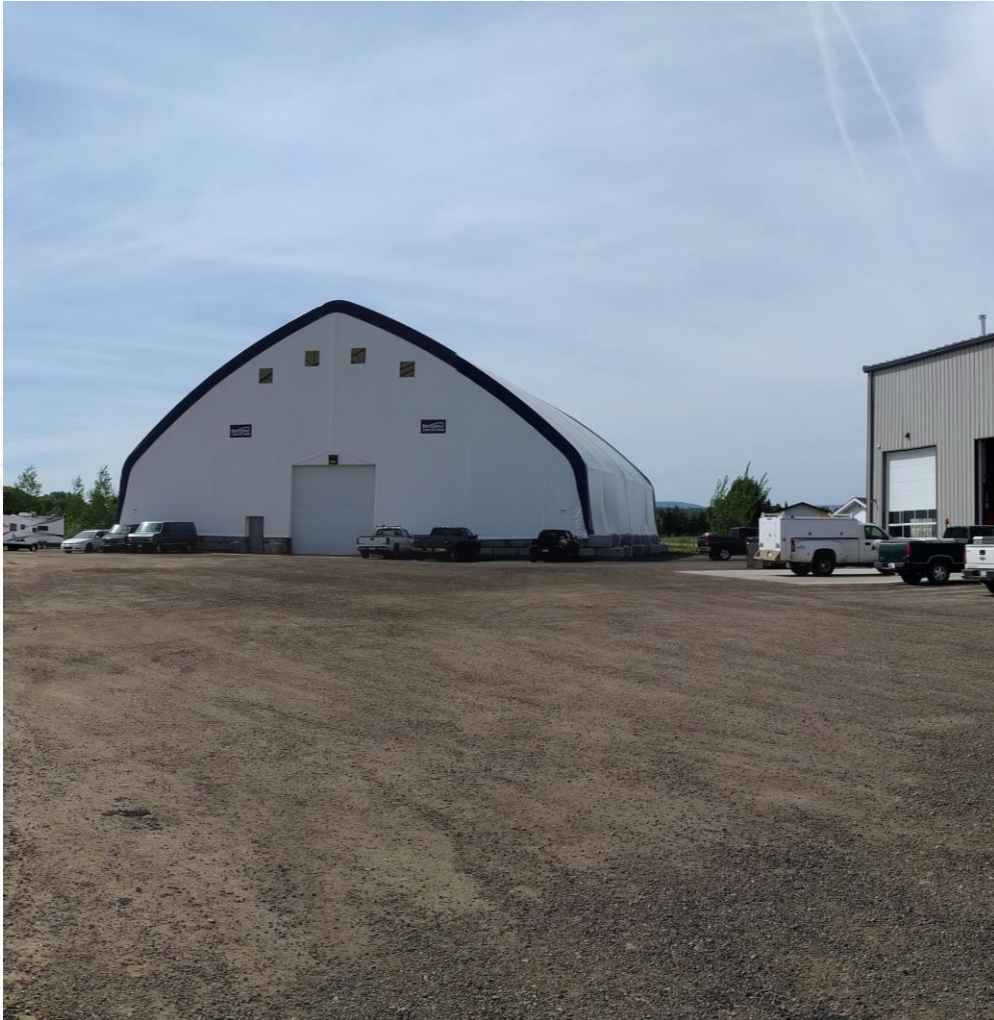
Operational Improvements

- Winter salt and sand had been stored on the gravel yard.
- Operational Improvements:
 - Asphalt pad for the salt and sand stockpiles
 - Retention pond for leachate management
 - Quonset over the asphalt pad

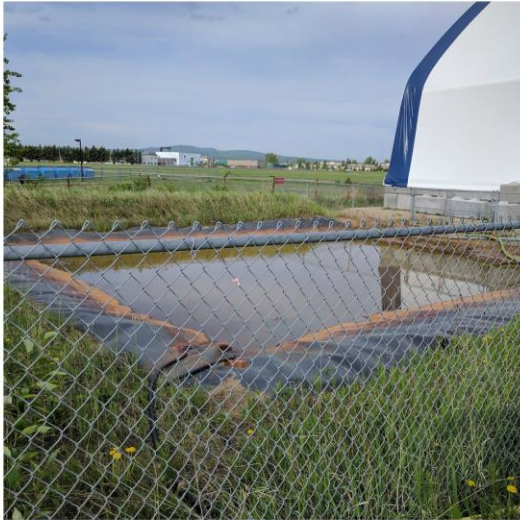
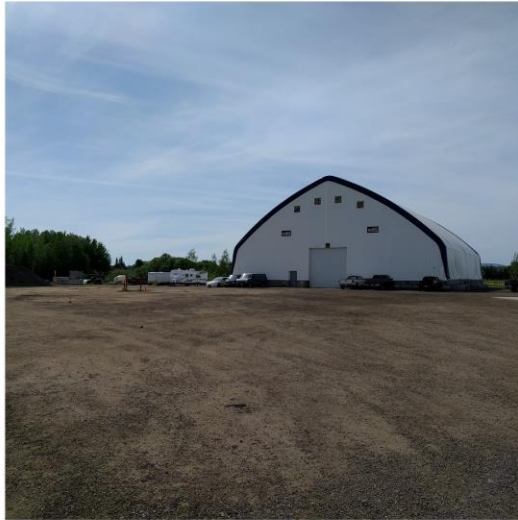
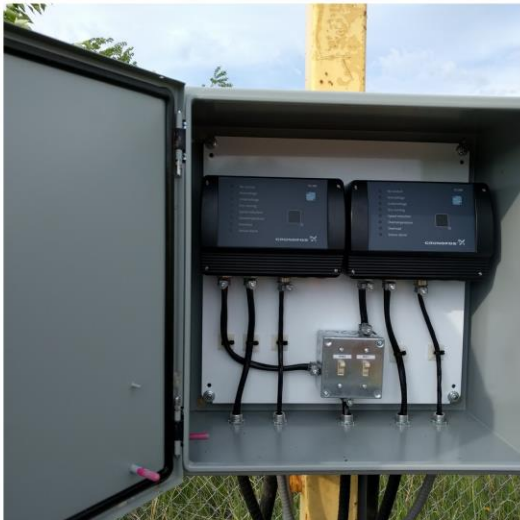
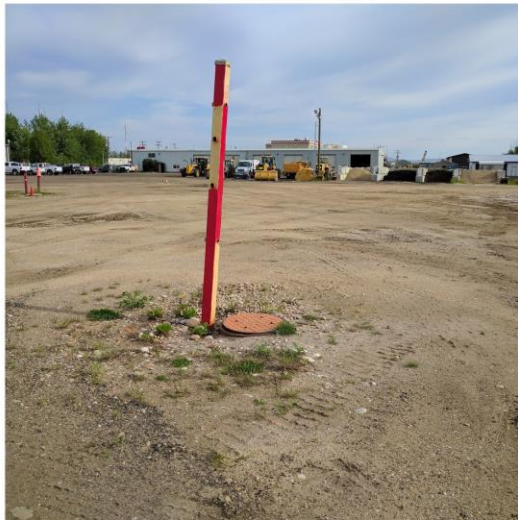
Groundwater Recovery and Disposal

- Groundwater recovery system (GWRS) installed at a large diameter (150 mm dia.) recovery well (RW1) with a submersible pump.
- A pilot test conducted in 2014.
- RW1 and RW2 and associated infiltration trenches installed in 2015.

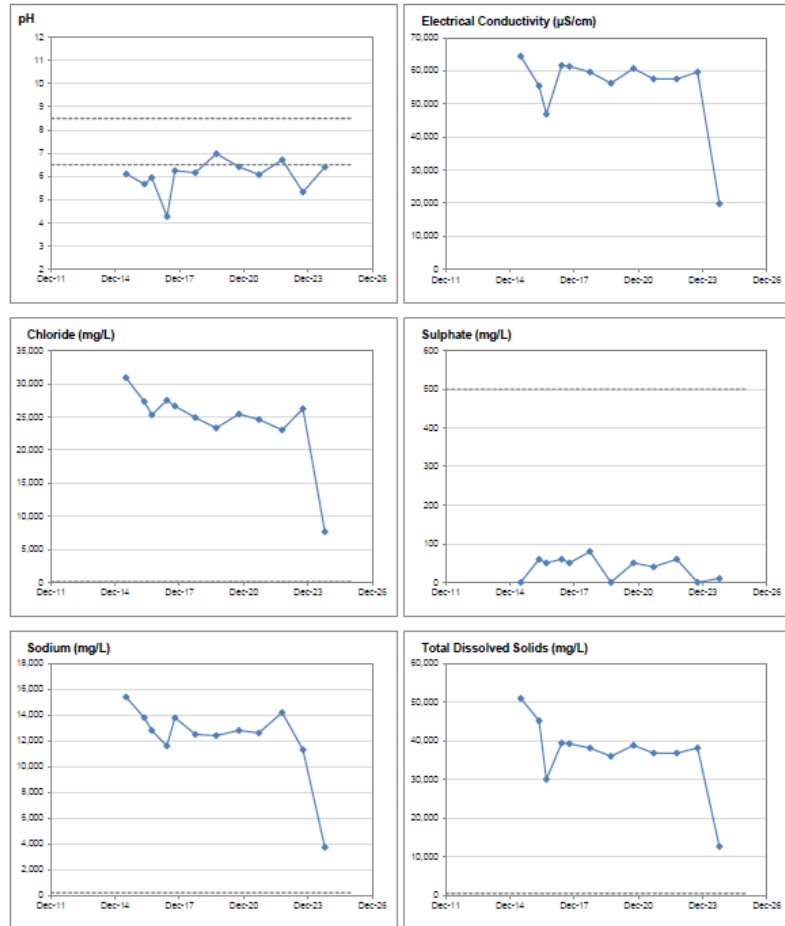
GROUNDWATER TREND CHARTS - MONITORING WELL TH15-7
2024 SOIL AND GROUNDWATER ASSESSMENT ACTIVITIES
TOWN OF SLAVE LAKE - PUBLIC WORKS YARD
1009 - 7 STREET NE, SLAVE LAKE, AB

- Annual and semi-annual GWMPs.
- Decreasing chloride trends and retracting salinity plume.
- EM surveys completed at the site in 2012, 2018, and 2022.
- Results of the 2021 SST Evaluation
 - Limited reduction in the remedial excavation requirements.
 - Confirmed that the current RMP was protective of the nearest receptors.
