# In-Situ Remediation of Petroleum Hydrocarbons – Combining Remedial Techniques

Remediation Technologies Symposium 2013

October 17, 2013

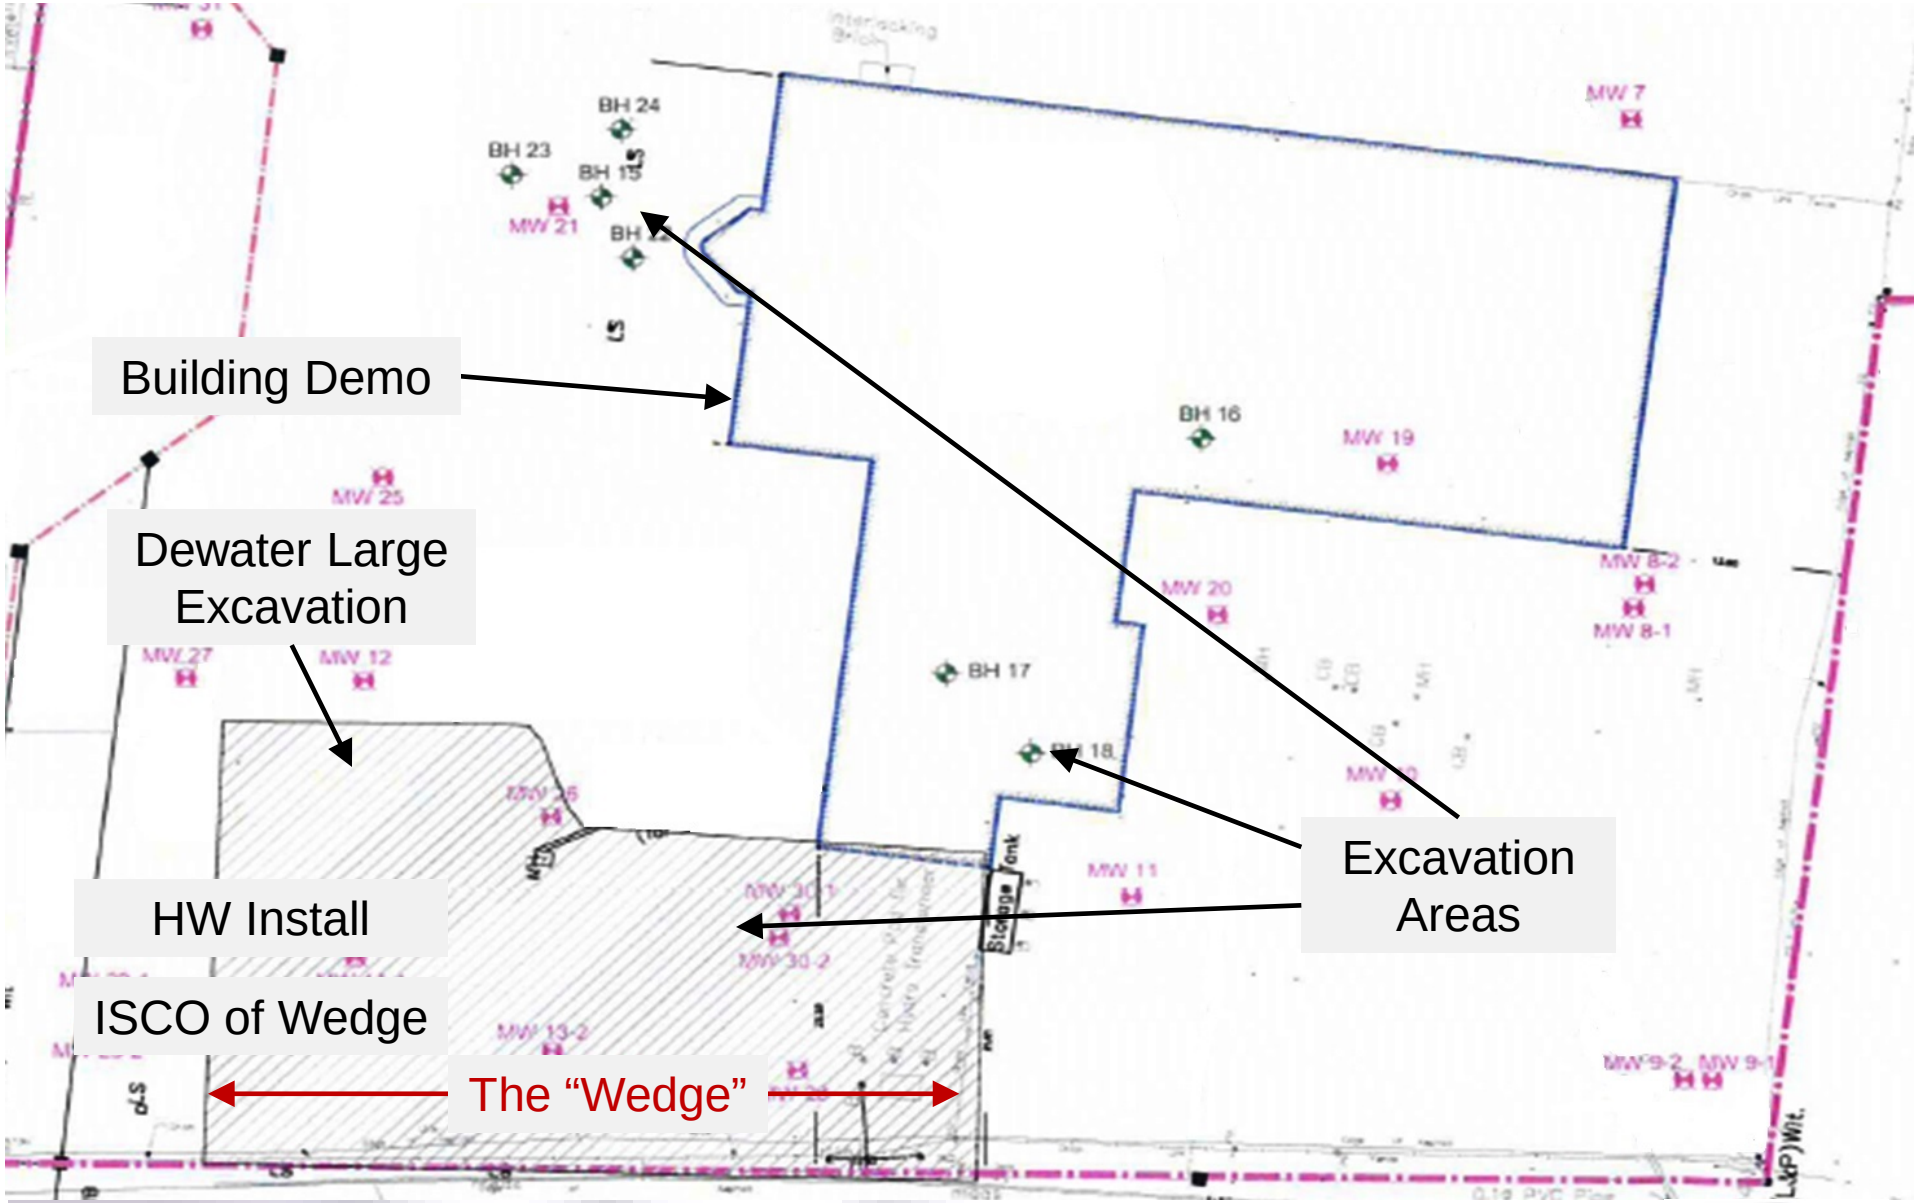
- 45 wells (between 5 m to 16 m bgs)
- Water table ~ 2 m bgs, impacts to ~ 8 m bgs
- Large Excavation: 50 m x 30 m (1,500 $m^2$)

1) Demolish existing building
2) Excavate impacted soil except property boundary wedge
3) Dewater the excavation, treat & discharge
4) Install horizontal wells to treat gw & the wedge
5) ISCO for remaining PHCs in gw & in soil in the wedge
6) Confirmatory sampling

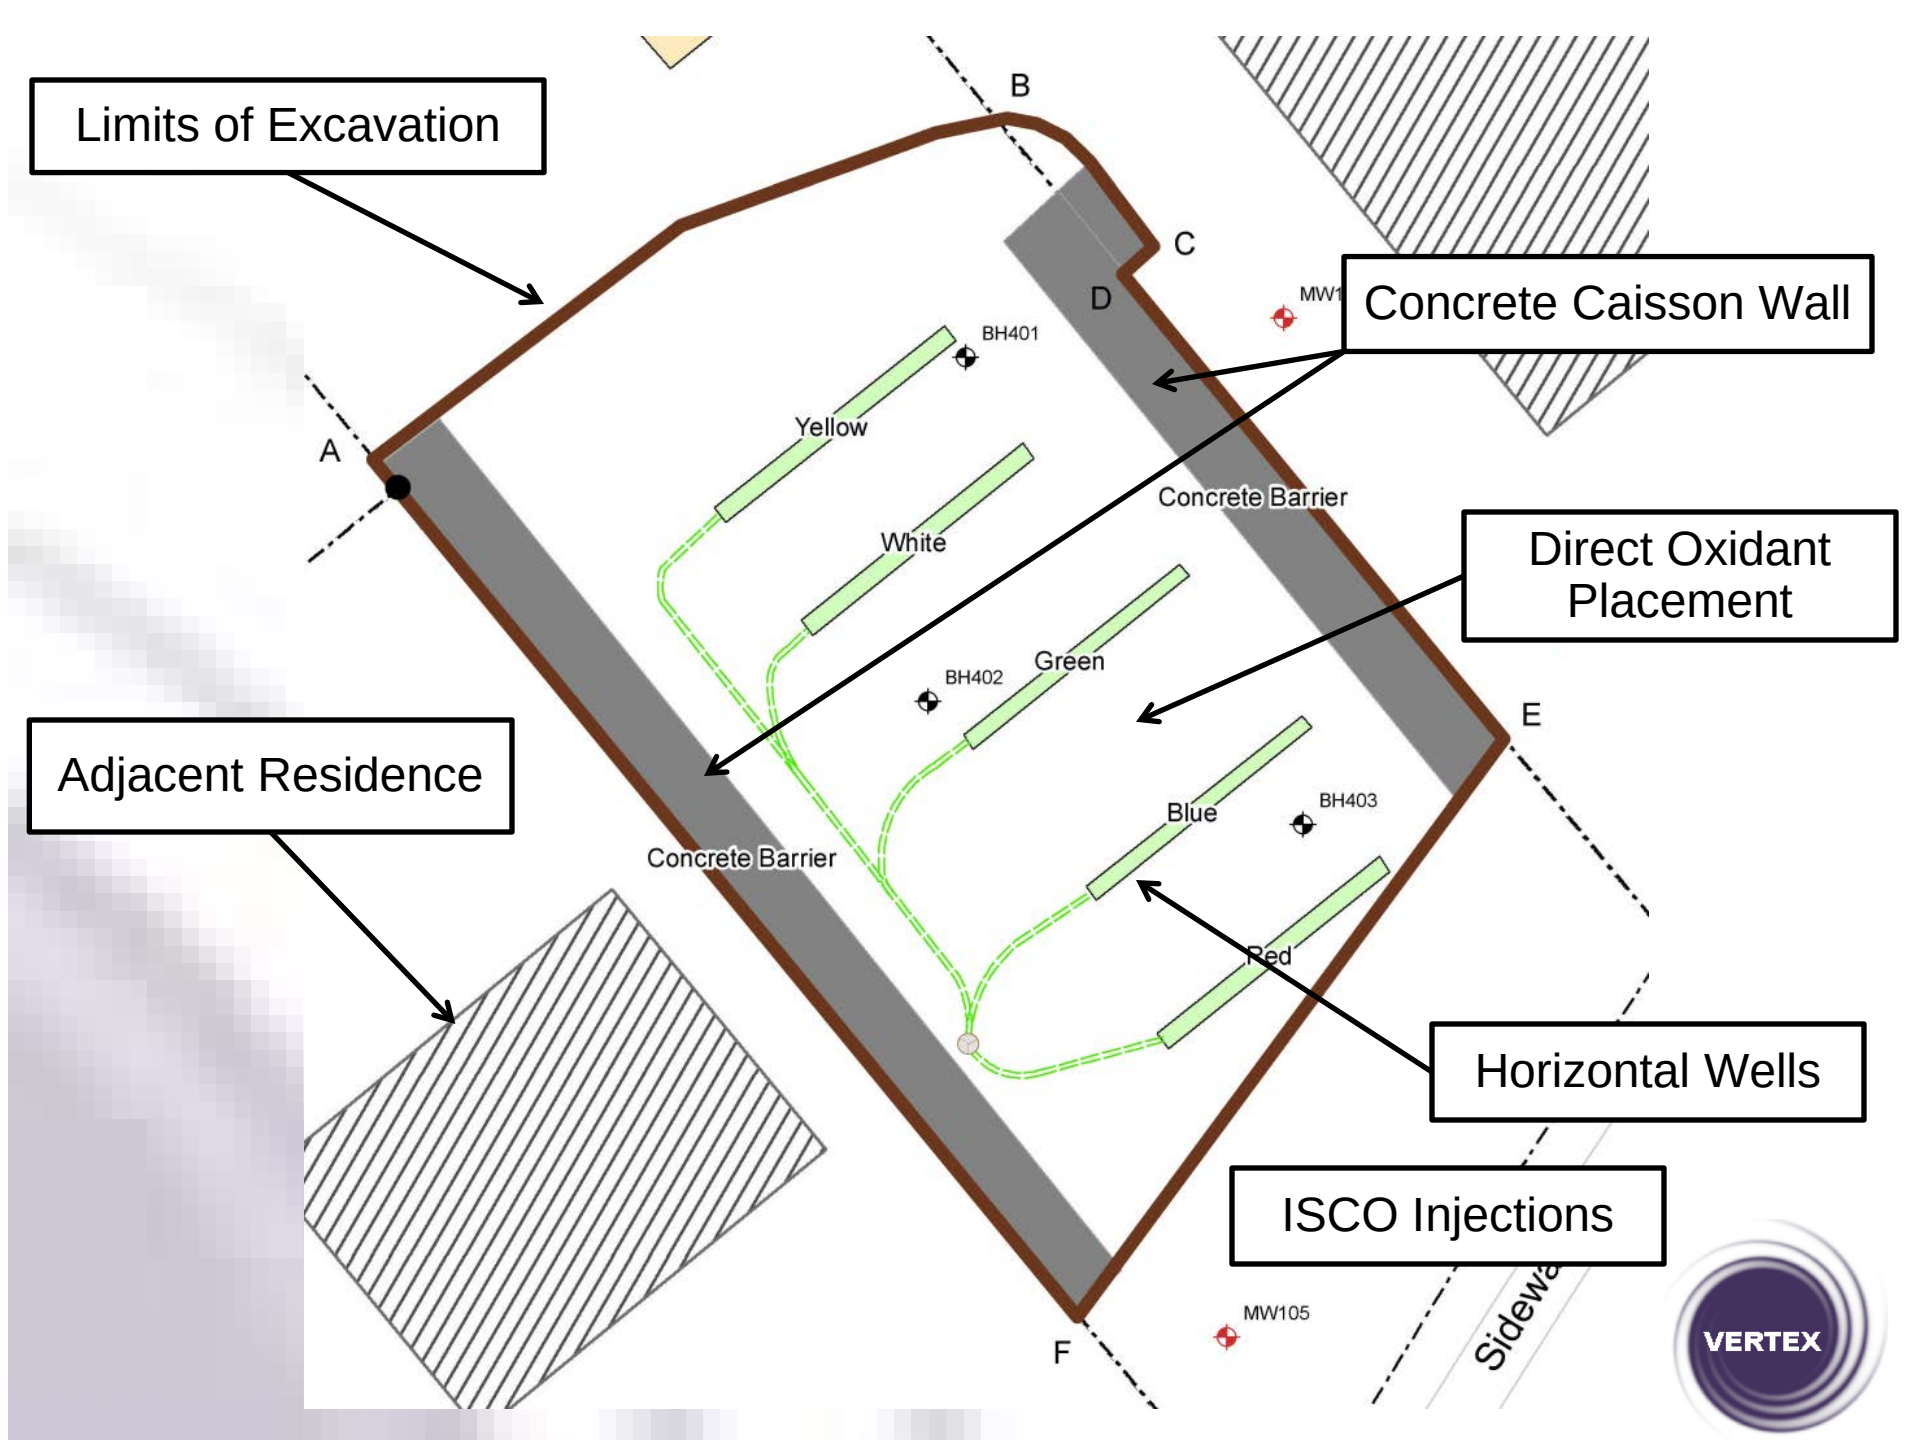
Horizontal wells installed in the trenches at the base of the excavation
