Using Stable Isotopes in a Multiple-Lines-of-Evidence Approach to Evaluating Sources and Degradation of Trichloroethylene

October 12, 2016

RemTech 2016

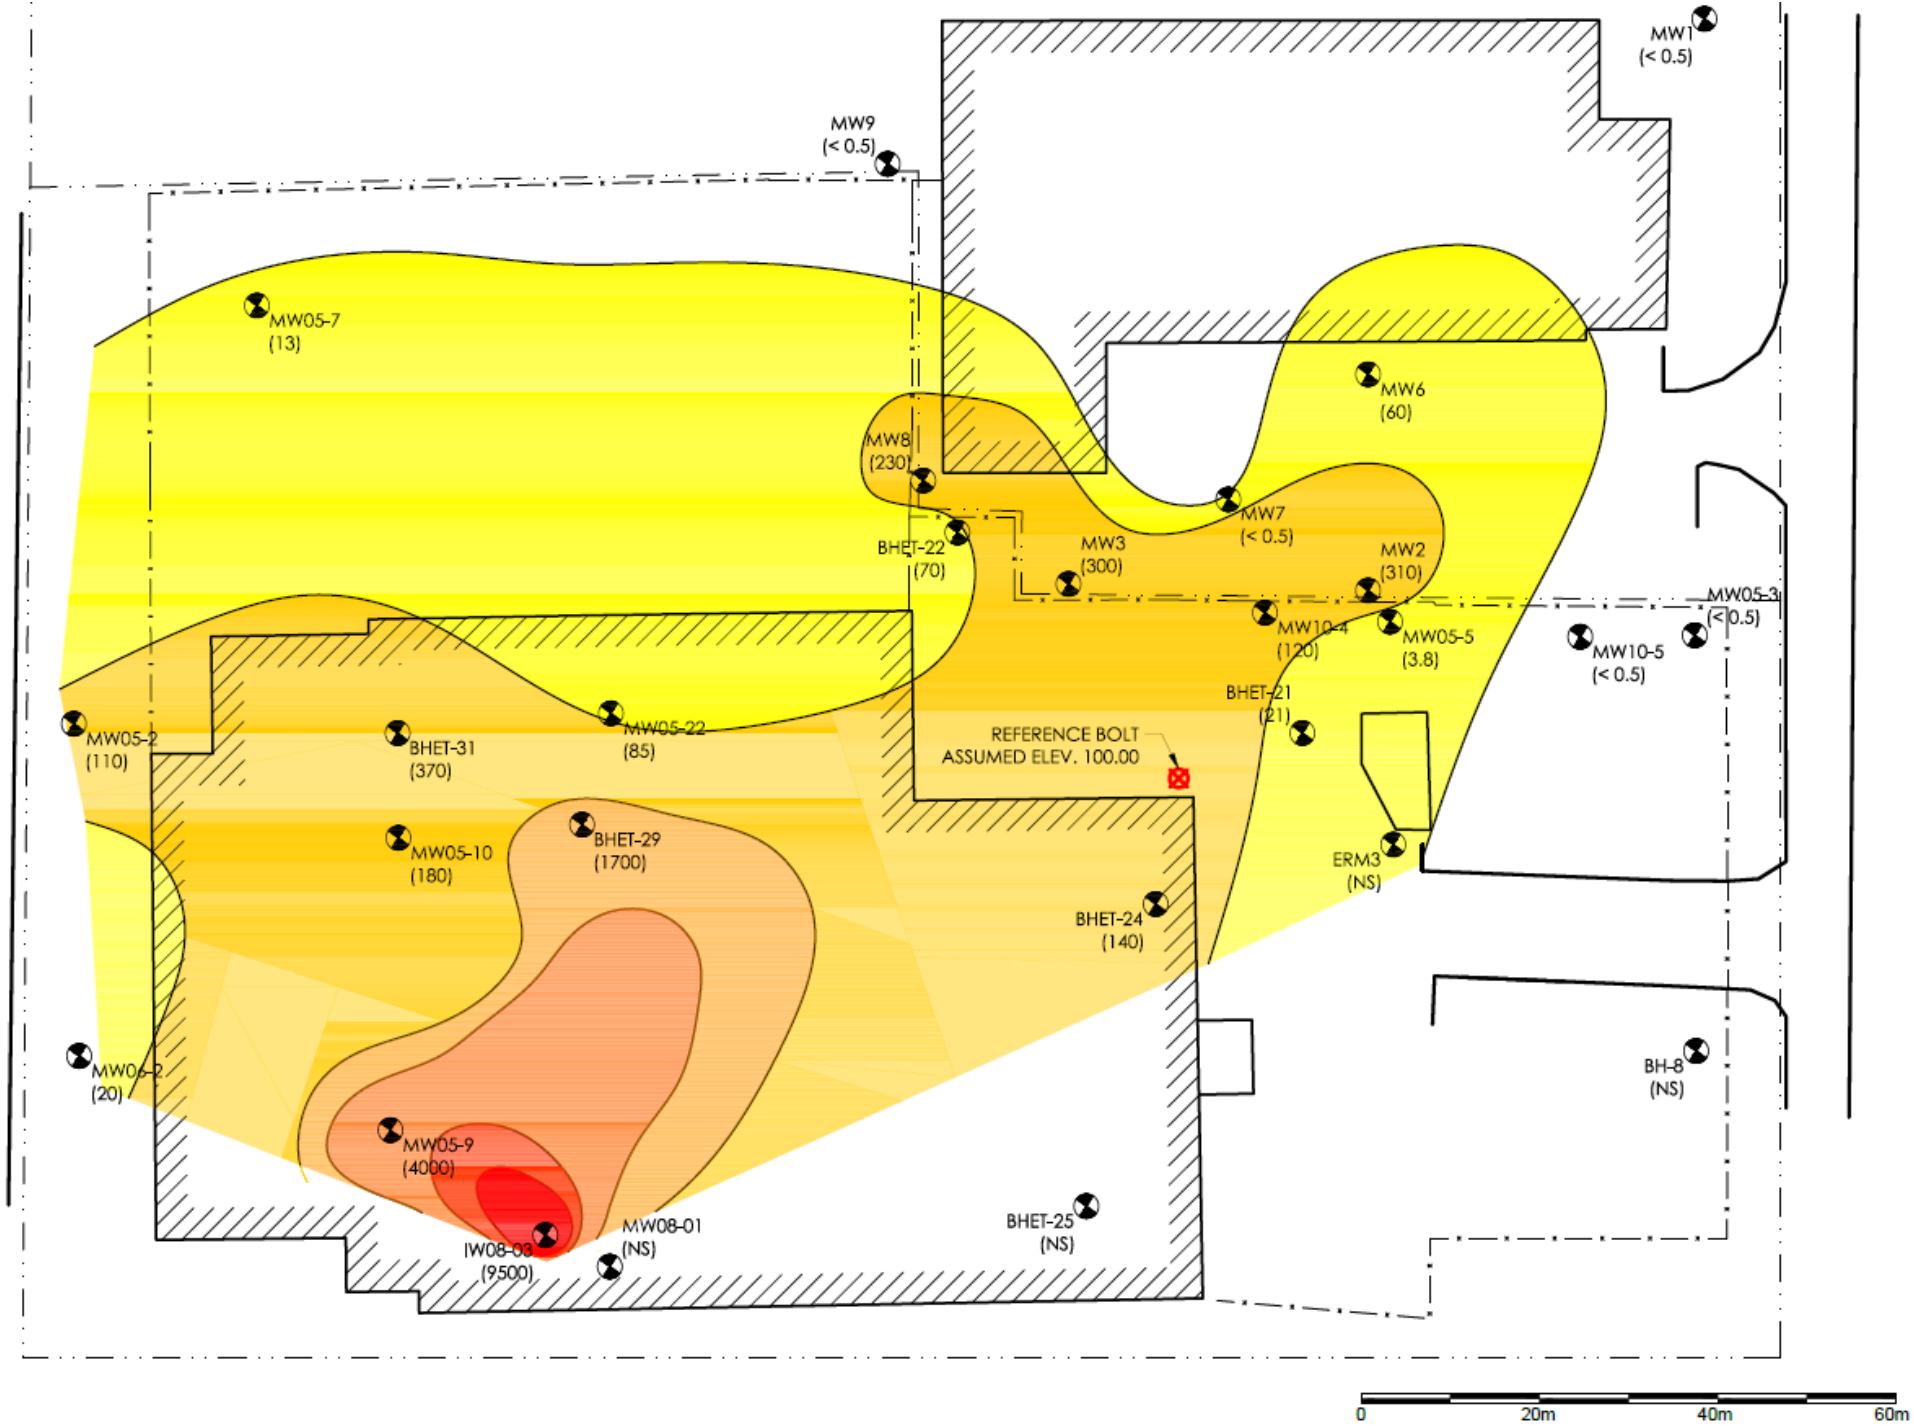
Figure 2
Approximate Extent of cVOC Impacts to Groundwater

- Groundwater samples collected at Property A (16 wells) and at Property B (7 wells).
- The nature, extent, and character of the cVOCs in groundwater were evaluated.
- The same cVOCs were documented at Property A and at Property B.
- Larger concentrations of TCE and cis-1,2-DCE were measured in groundwater at Property A compared to those measured in groundwater at Property B.

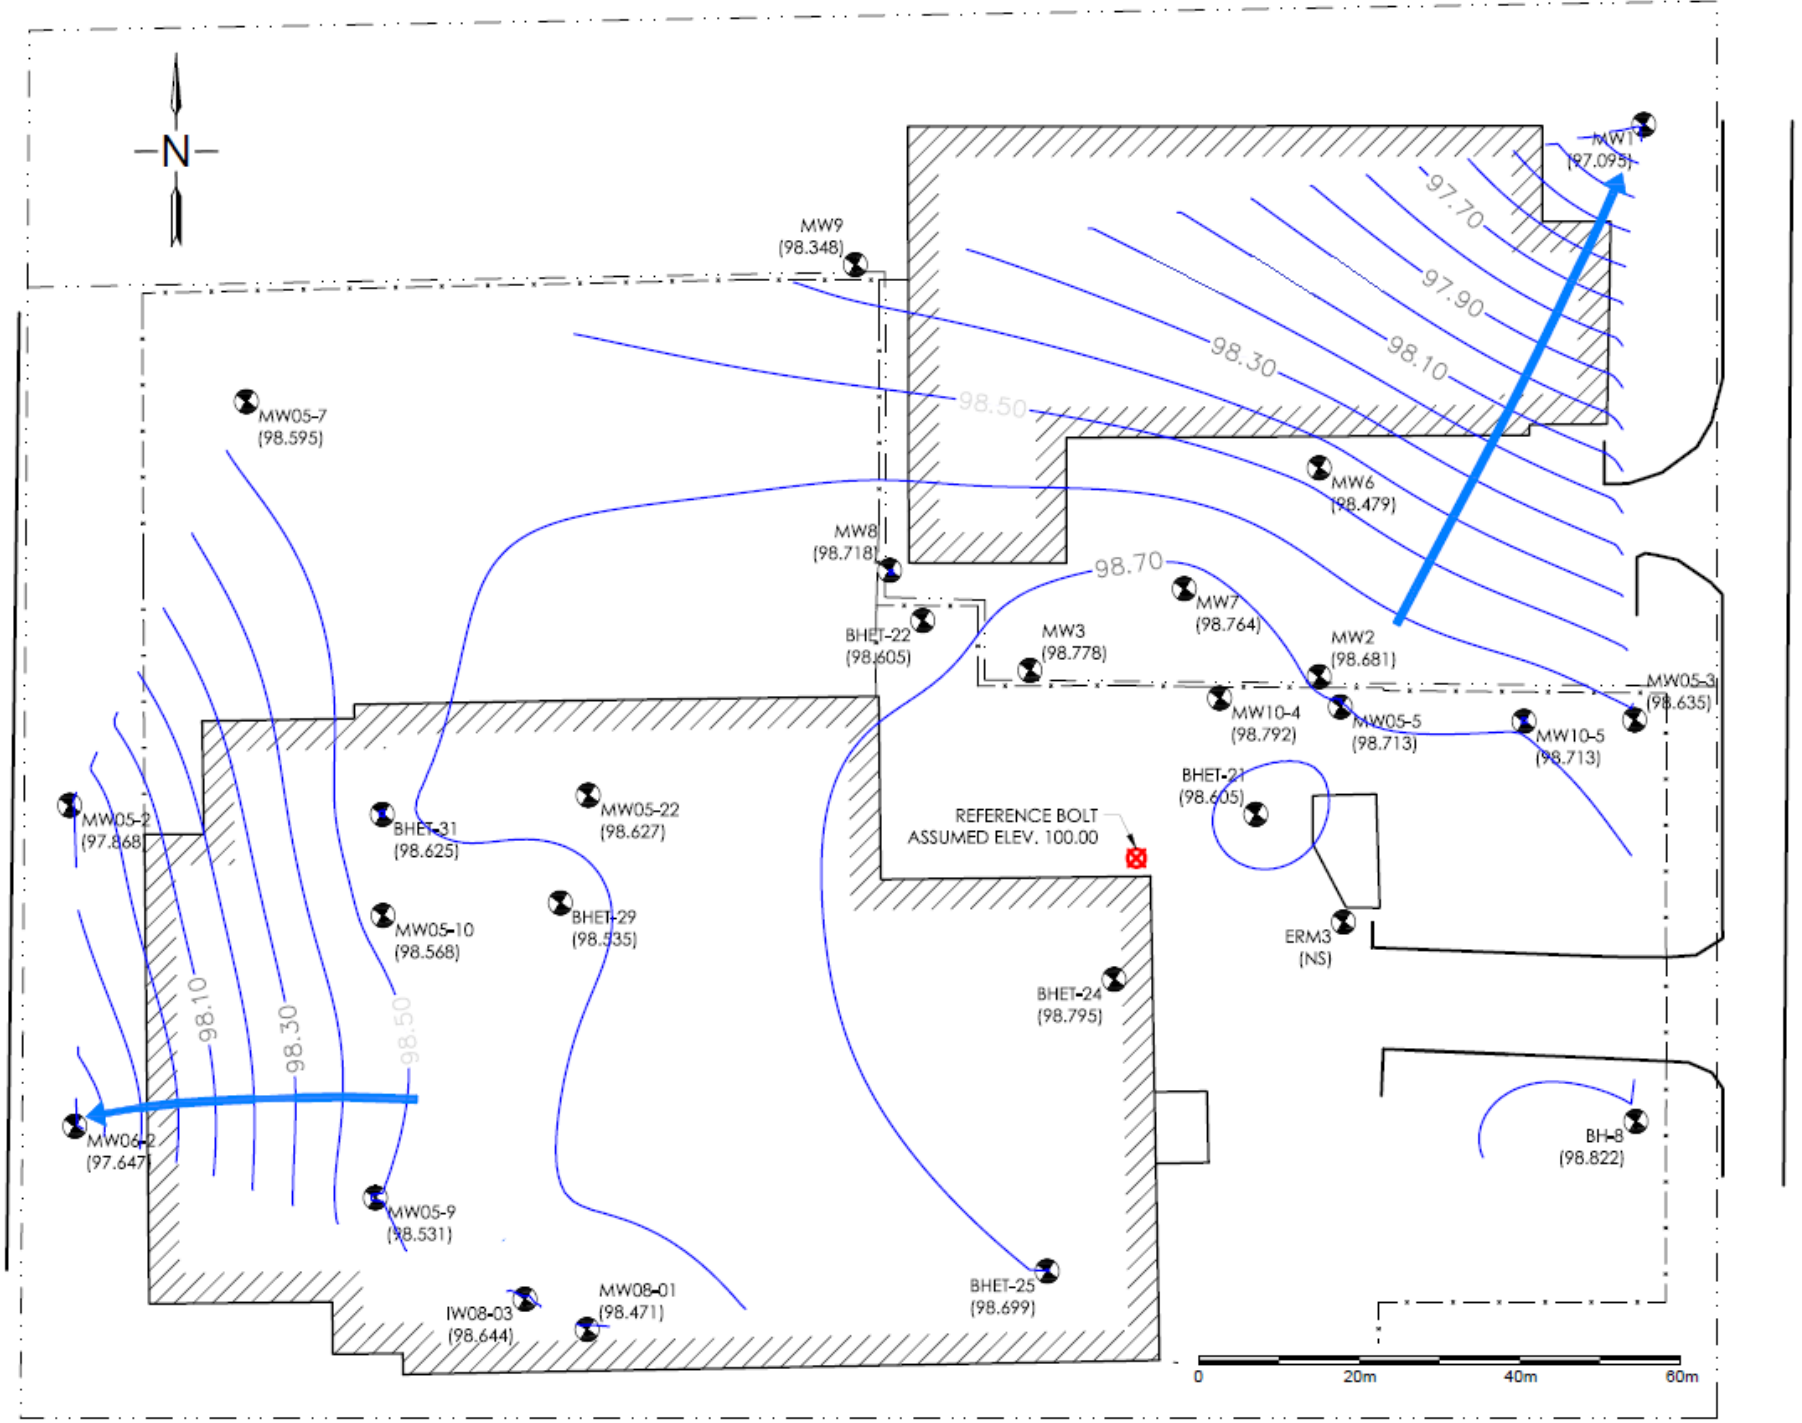
Figure 3
Interpreted Groundwater Flow Direction

- Two components of shallow groundwater flow direction; northeast and west.
- Principal direction of flow is toward Property B.
- Slug tests were conducted at several monitoring wells to estimate hydraulic conductivity.
- Groundwater flow velocities estimated to be 2 to 4 m/year.
- Estimated velocities are within expected range considering plume dimensions.

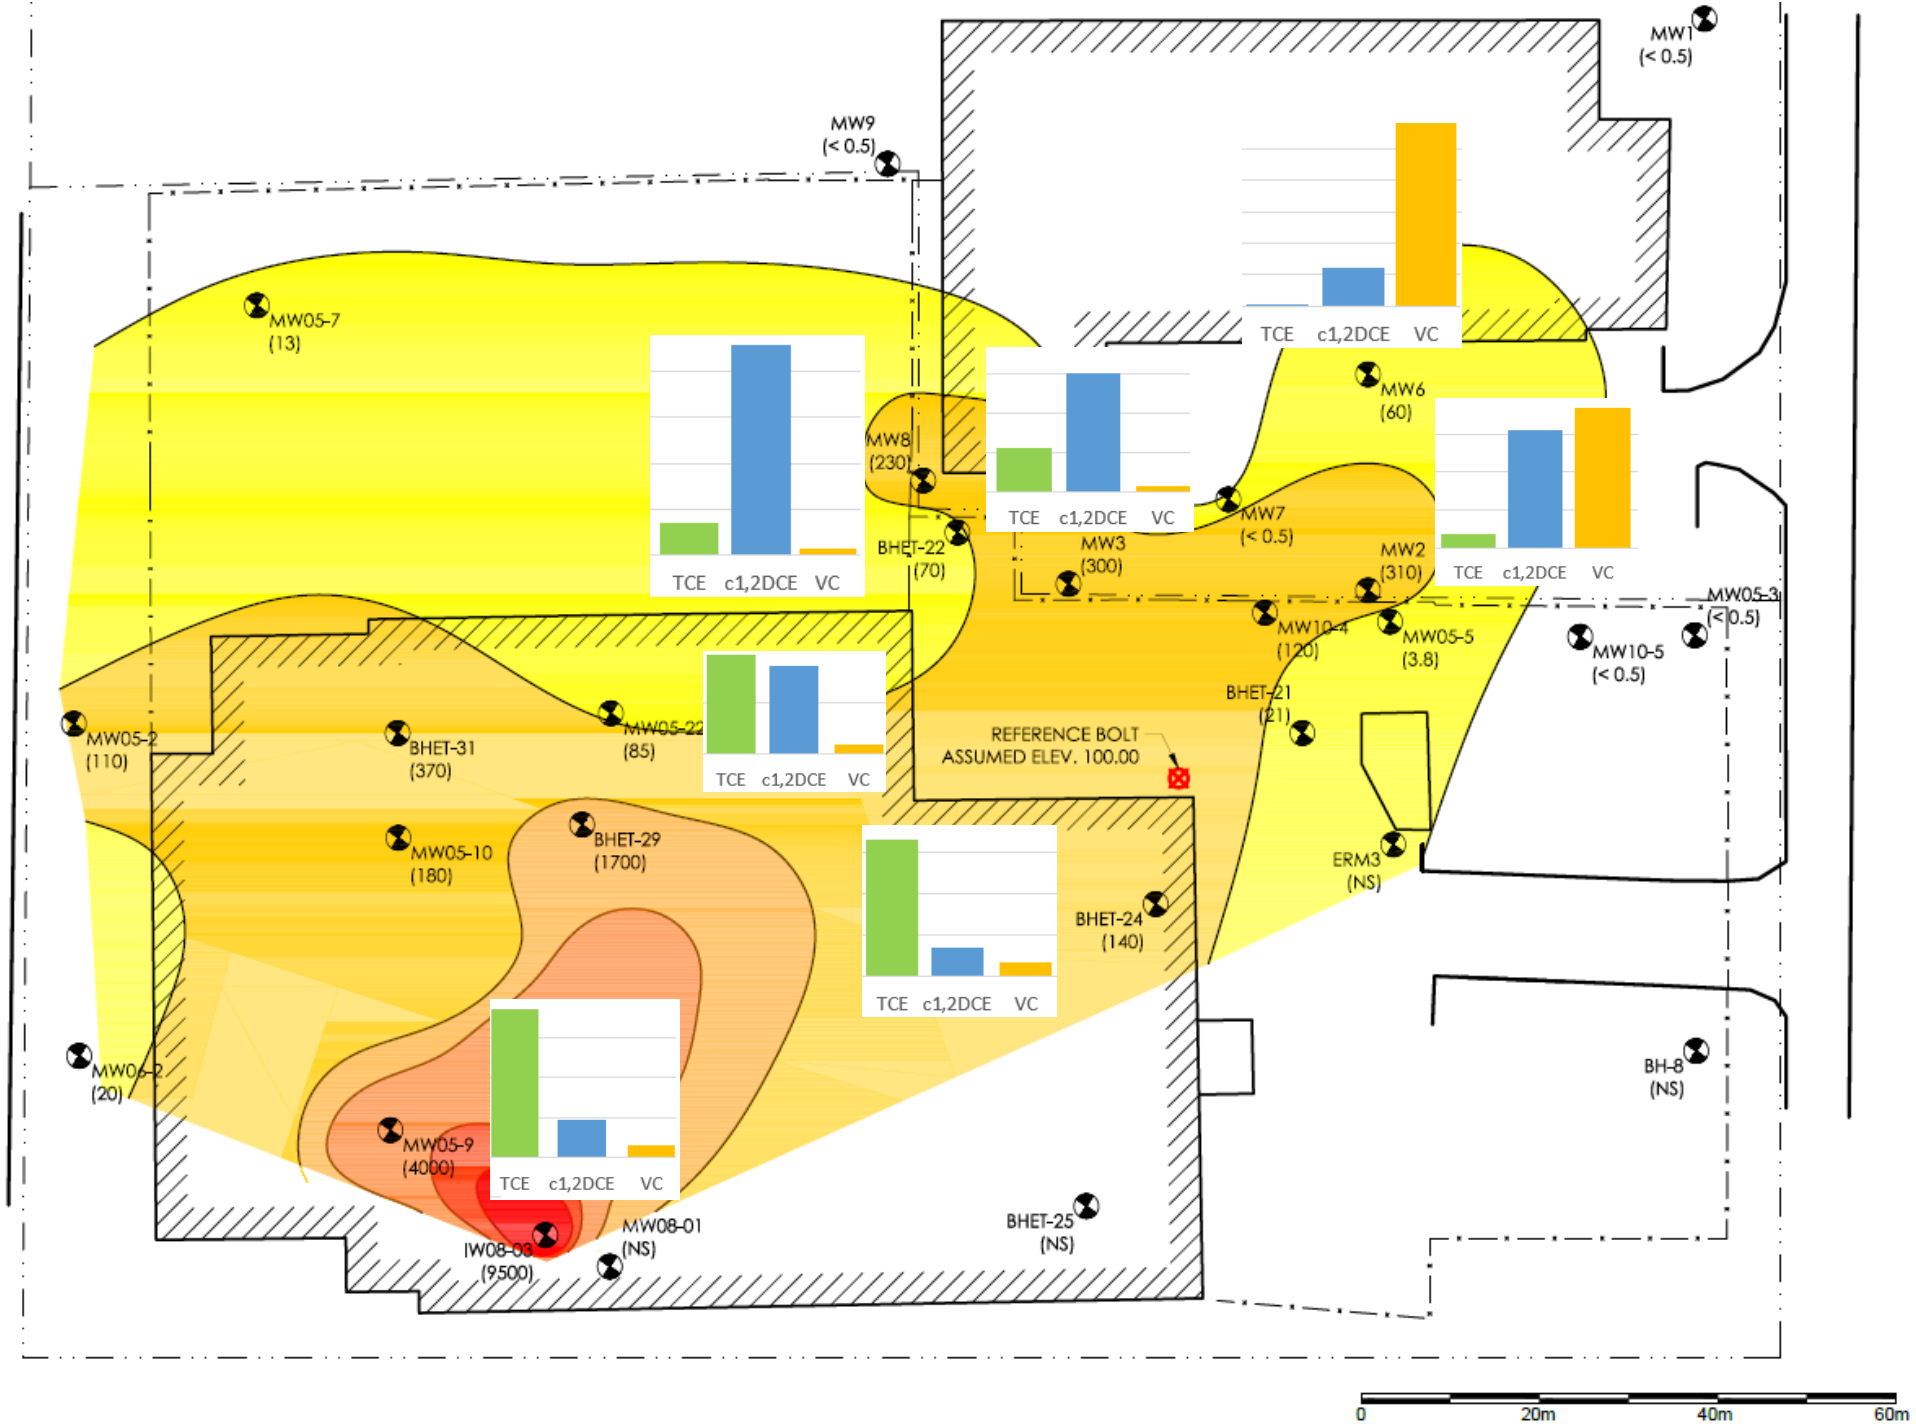
Figure 4
Select cVOC ratios: TCE to Degradation Compounds

- The presence or absence of parent compounds and their breakdown compounds can provide evidence for source area identification.
- Parent-compound to daughter-compound concentration ratios of chlorinated ethenes are frequently stable within source zones, but will decrease as a result of natural attenuation along the groundwater flow path.
- Abrupt increases in parent-compound to daughter-compound ratios indicate a contribution from additional sources of chlorinated ethenes.

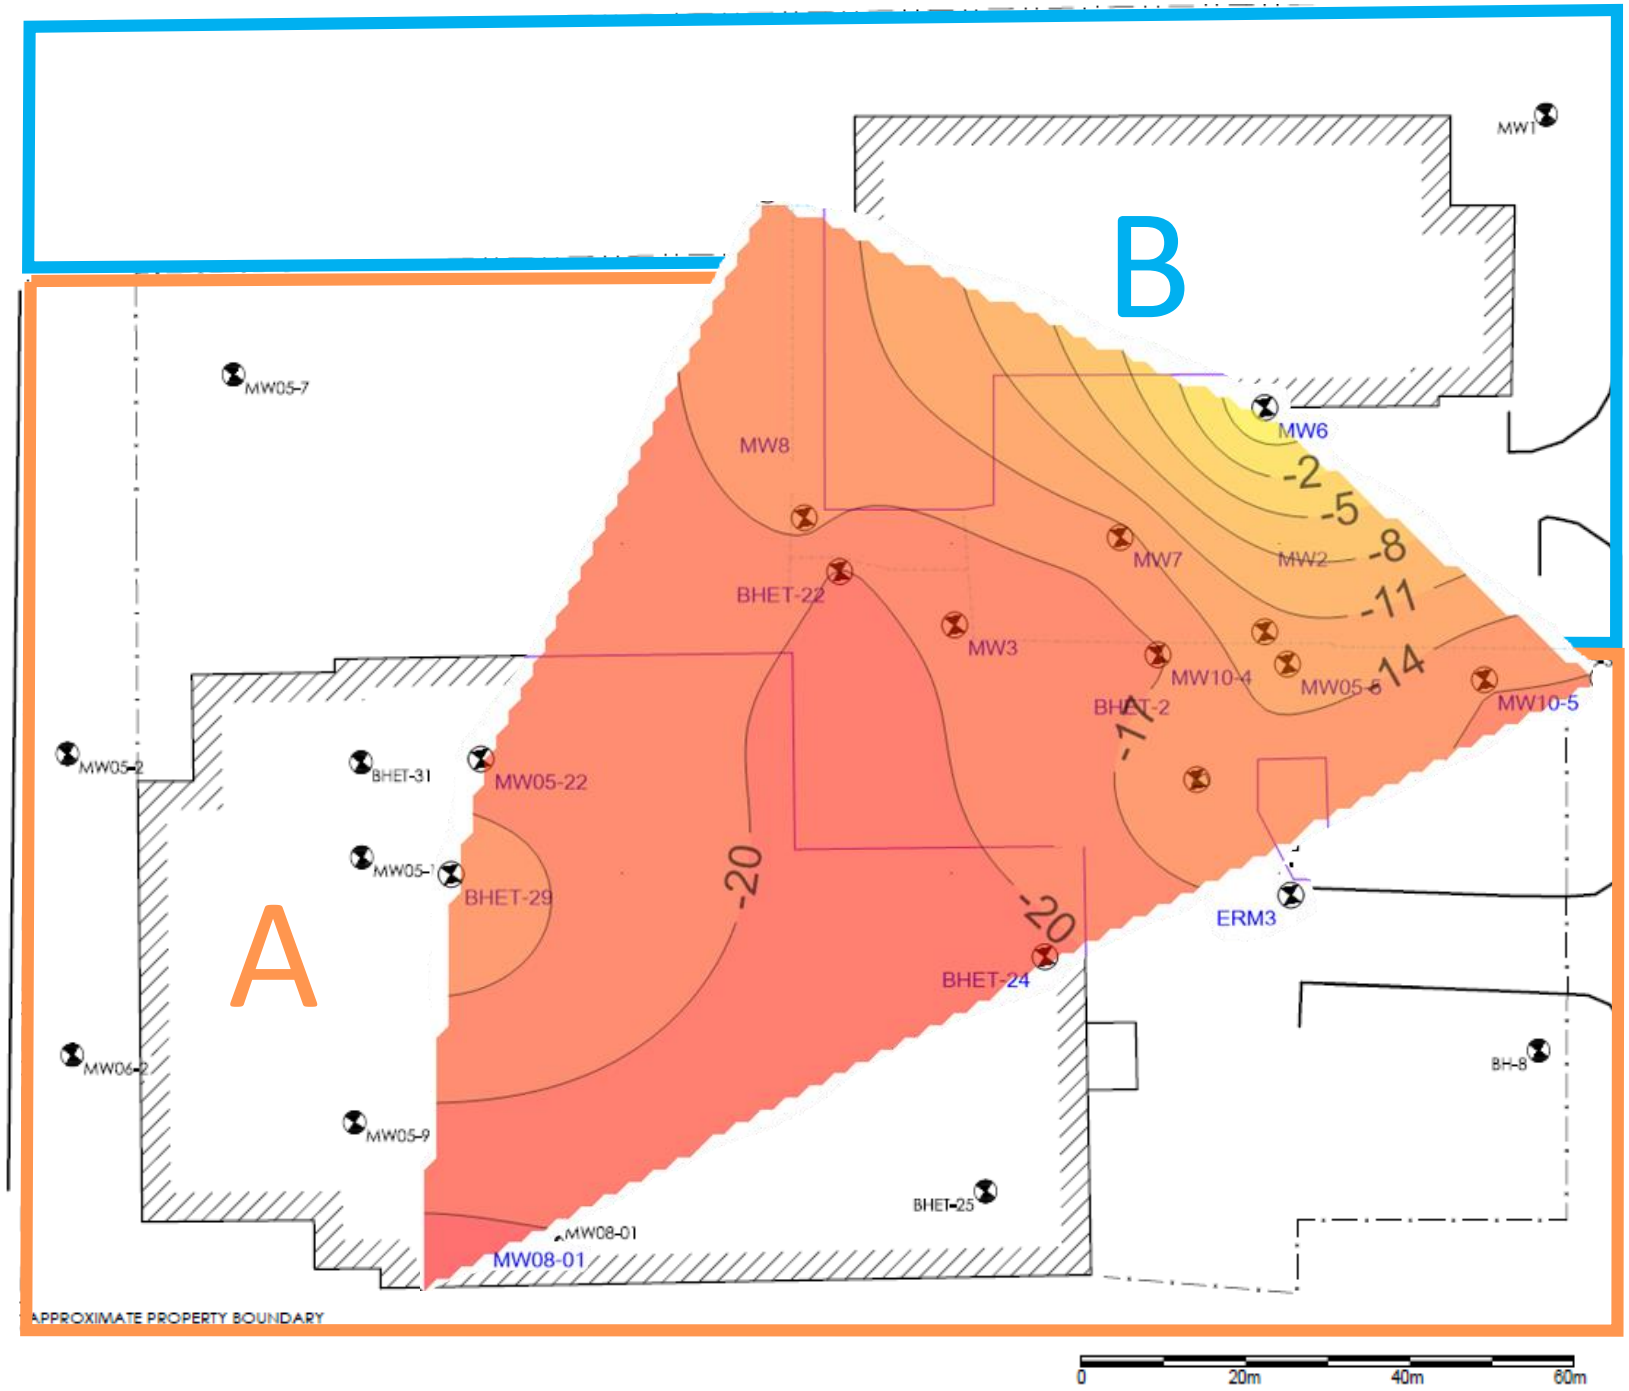
Figure 6
^{13}C Enrichment Contours

- Lower (more negative) $\delta^{13}C$ values in the suspected source areas.
- Enrichment in the $\delta^{13}C$ along the groundwater flow path.
- Results indicated that it was unlikely that a source of TCE impacts to groundwater was at Property B.
- $\delta^{13}C$ values from TCE in samples from Property B were consistent with TCE degradation along the groundwater flow path from Property A.
