CASE STUDY

A Transformer Repair Facility

**Soil and Groundwater Remediation,
Richmond, BC**

Liliana Jerade, M.Eng., P.Eng.

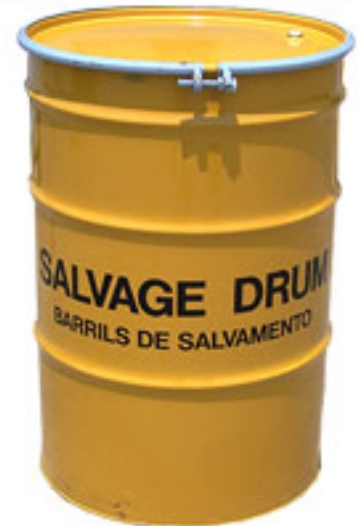
- The Site operated as a repair facility of PCB-containing transformers from 1968 until 1998.
- The transformers were serviced, cleaned and stripped inside the building, repaired in a concrete pit and washed in a pressure washing area inside the shop.
- Drums of chemicals containing PCBs and solvents were stored outside the building in different locations.

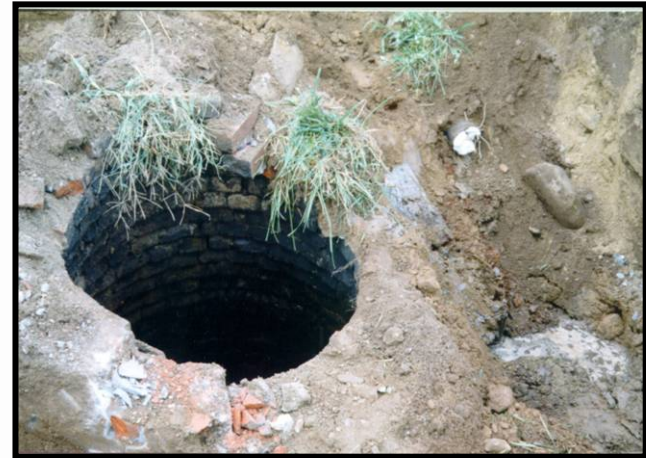
- The delineation program for the Site took approximately 3 ½ years to complete.
- Consisted of advancing 116 boreholes and 43 groundwater monitoring wells.

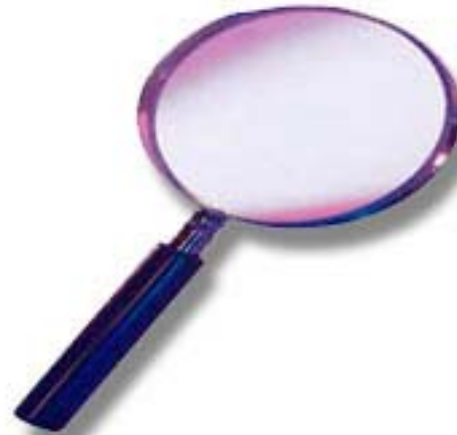
- The delineation program identified PCBs, metals, petroleum hydrocarbons and chlorobenzene in three different mediums throughout the Site:
 - Soil
 - Groundwater
 - Concrete

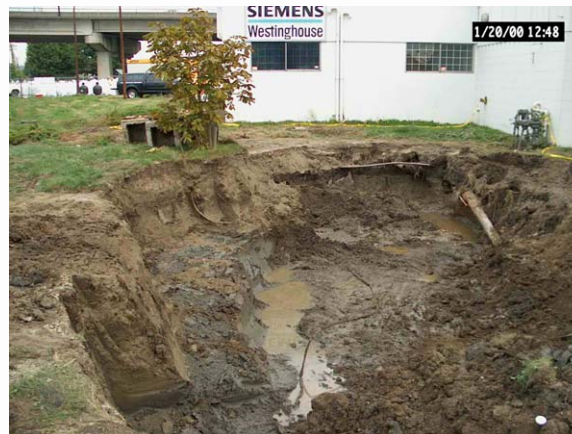
- **Metals – Excavation and Off-Site Disposal**
 - Most cost-effective
 - Fastest way to remove contamination from a Site
 - Short term disturbances to the Site

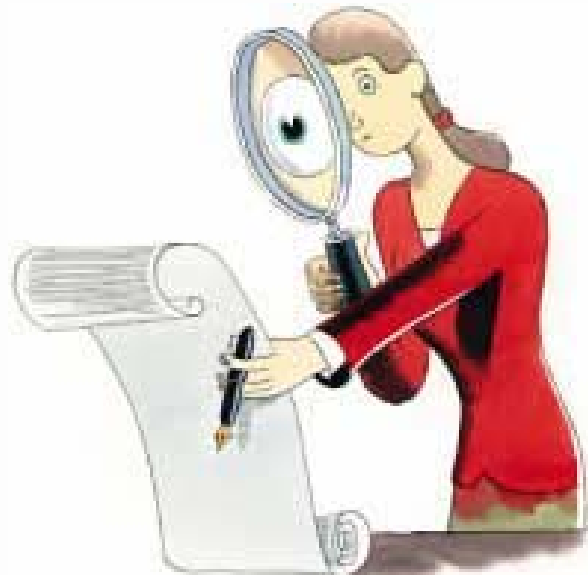
- Groundwater remediation from ZOC 3 was achieved after one month
- Remediation work for the contaminated plume in ZOC 4 took 10 months to complete

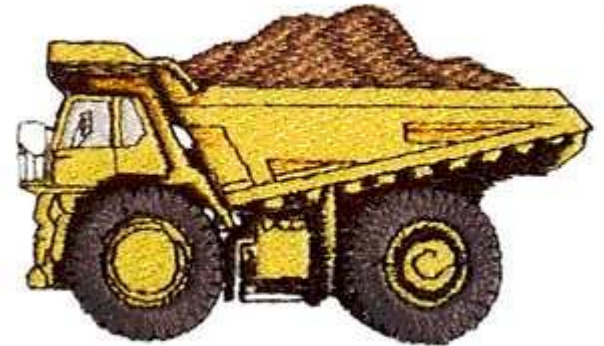
- **Soil:**
 - Six areas at the Site were excavated. Total soil removed from the site:
 - 542 tonnes of soil with PCBs exceeding HWR
 - 345 tonnes of soil with PCBs and metals exceeding commercial standards
