8-Mile Channel

Remediation

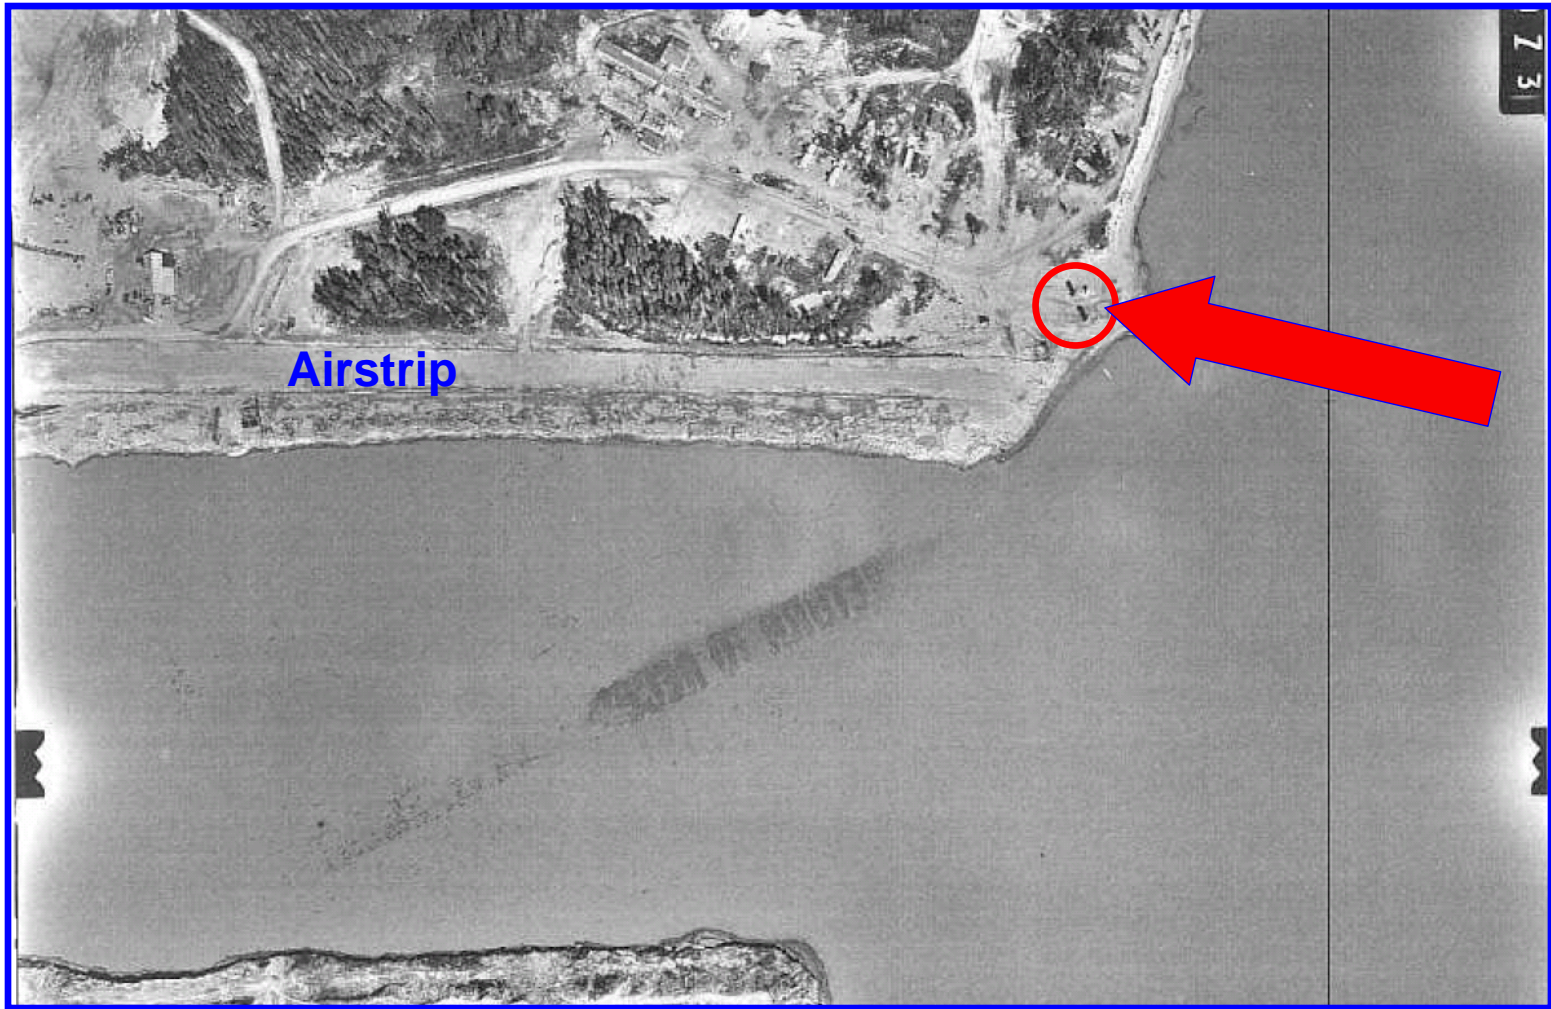
- Final inspection with Norway House Cree Nation
- Evidence of PHC contamination at shoreline
- Soil grab sample analyses confirmed contamination

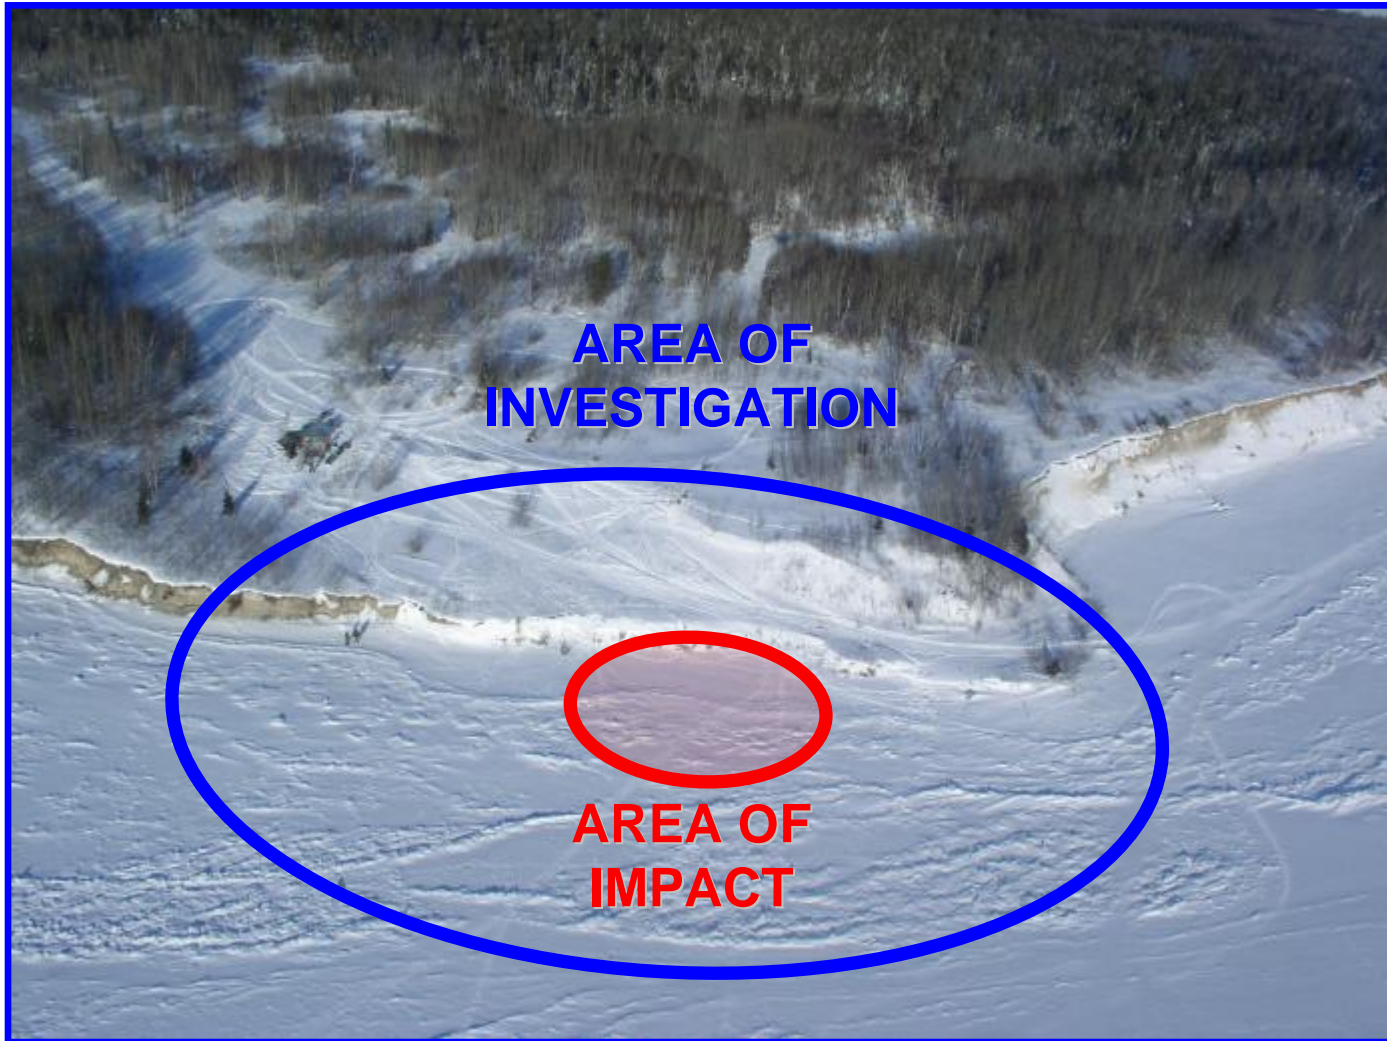
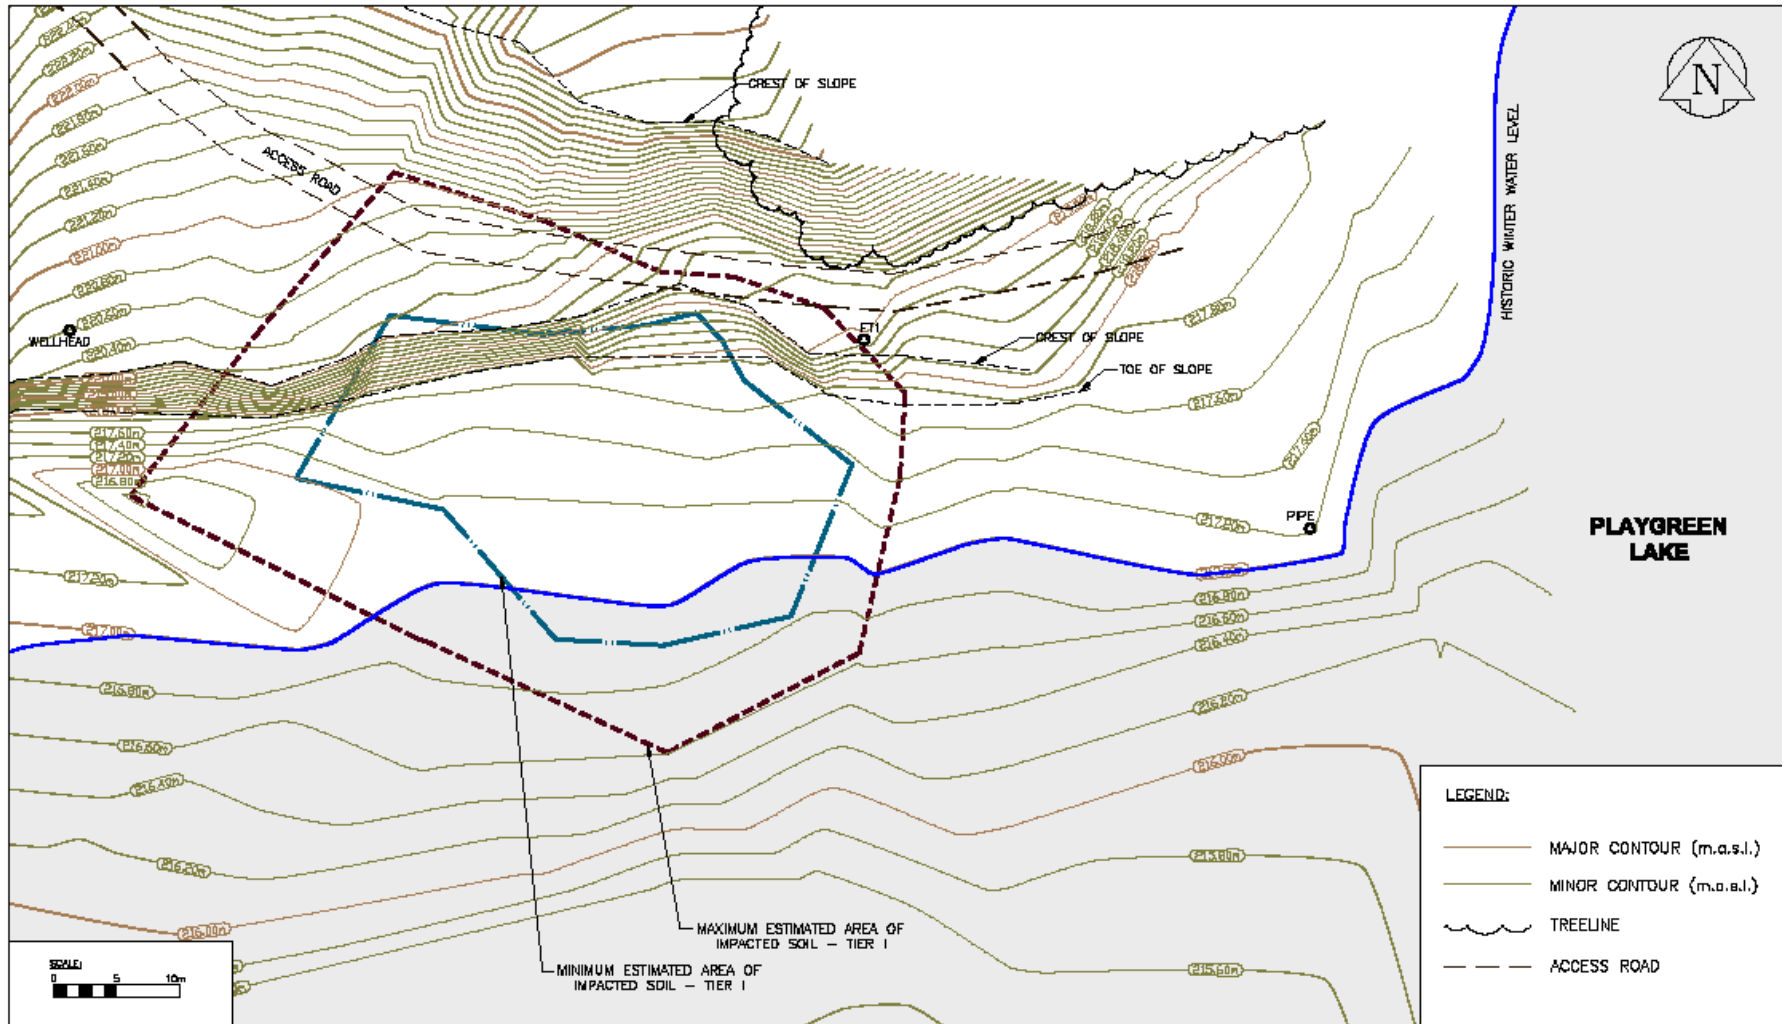
- Conducted in March 2007
- Compared to CCME Tier 1 parkland criteria
- Established horizontal and vertical limits of contamination:
 - $V \approx 4000 \text{ m}^3$
 - $A \approx 1800 \text{ m}^2$
 - Max. depth $\approx 4 \text{ m}$
 - Approx. 50% below summer water level (by vol.)
 - Approx. 25% below winter water level (by vol.)

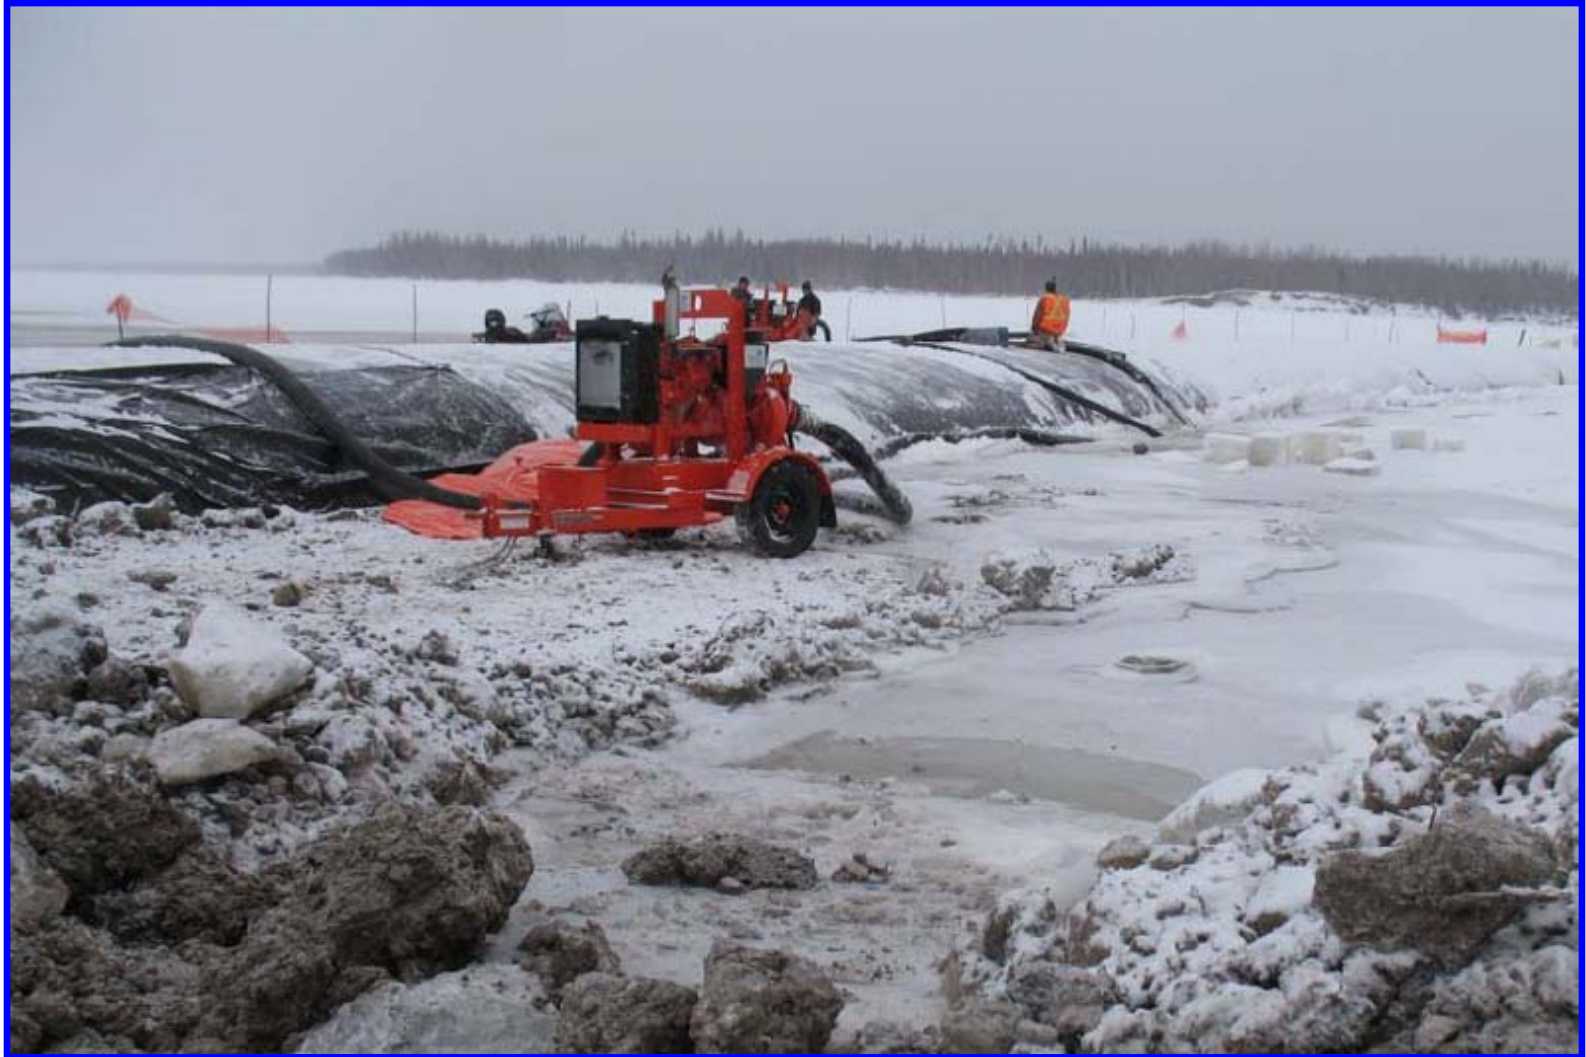
- Seepage under the dam at SE corner
- Shored dam using silty backfill dike along inner face
- Dewatering successful, though continuous

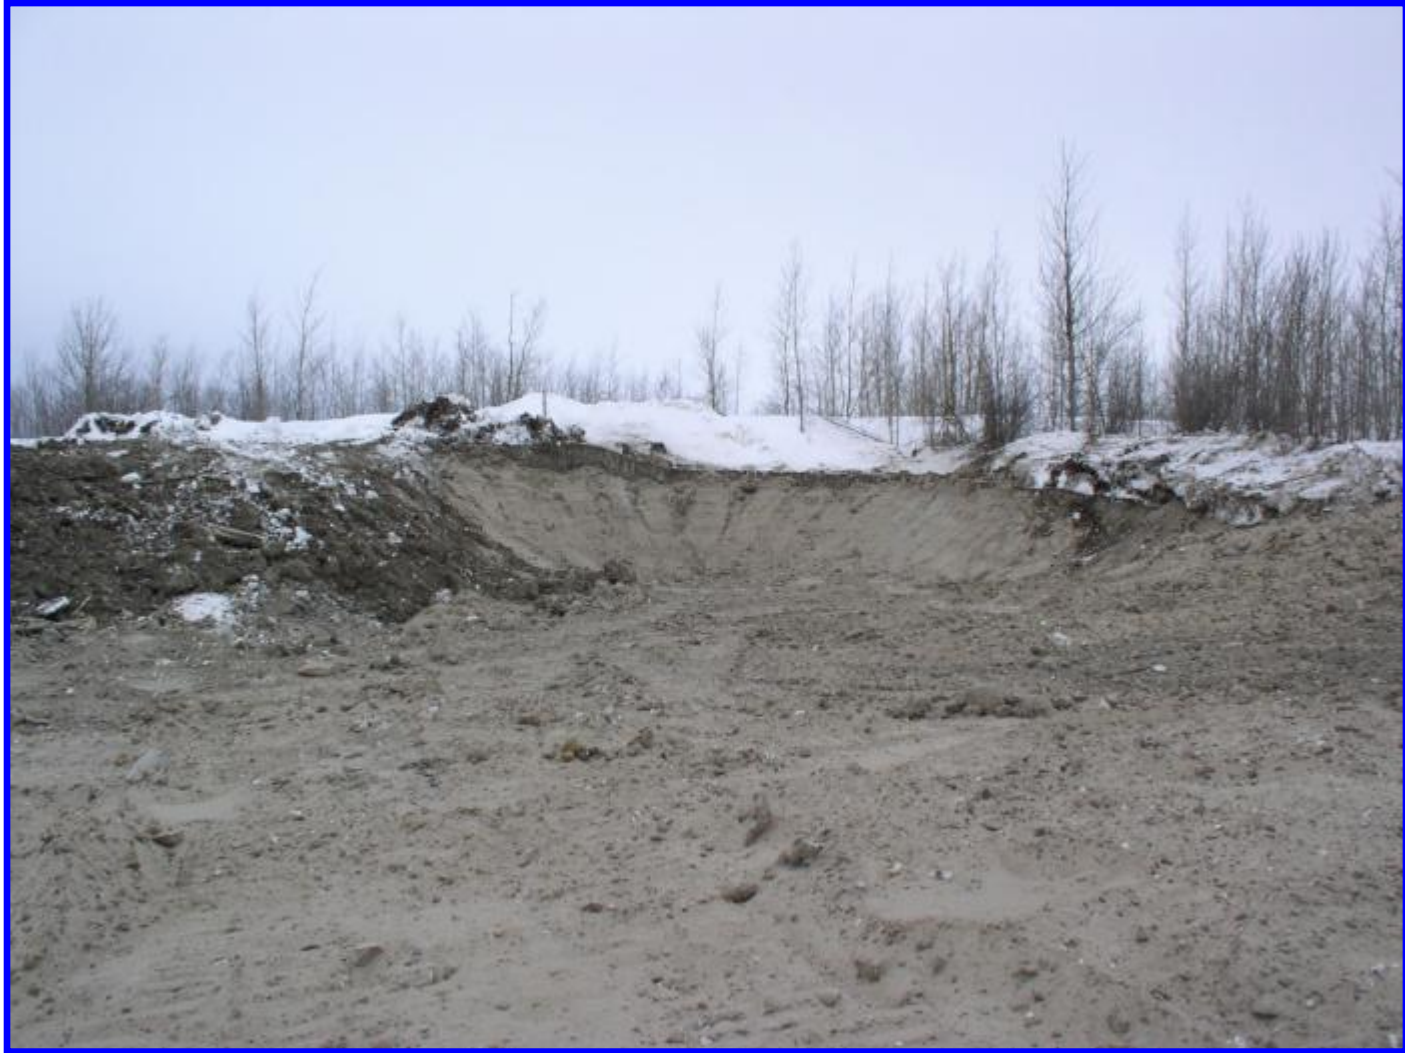
- Texture consistent with channel bottom material
- Initial samples showed no contamination
- Discovered limited debris and evidence of PHC impact during final removal of borrow

- Potentially contaminated material was disposed of in treatment cell
- Debris was removed by hand to maximum extent and diverted to Norway House in solid waste stream
- Test pitting determined contamination was very limited ($< 20 \text{ m}^3$) and debris was isolated
