## Remedial Excavation of Metals-Contaminated Sediment and Creek Restoration

Melissa Hamilton, P.Eng.

RemTech 2011 Friday, October 21, 2011

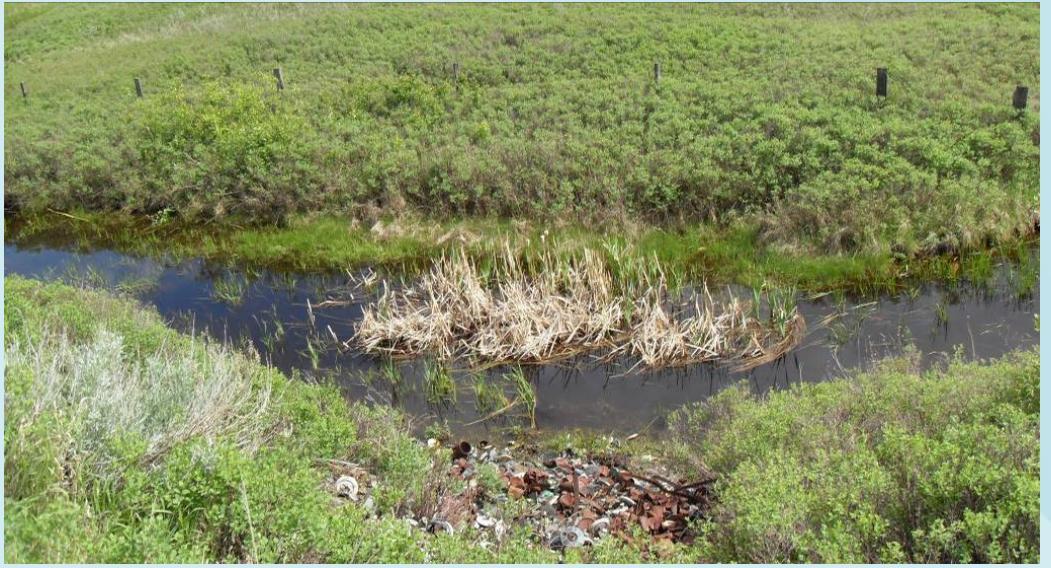
- Site Location and Description
  - Industrial right-of-way adjacent to a creek in Saskatchewan
  - Agricultural land (grazing cattle) on adjacent third-party owned property
- Battery Debris On-Site

- Preliminary Sampling Program
  - Another consultant collected soil and sediment samples in May 2009
  - Metals impacts identified adjacent to and downstream of the battery pile

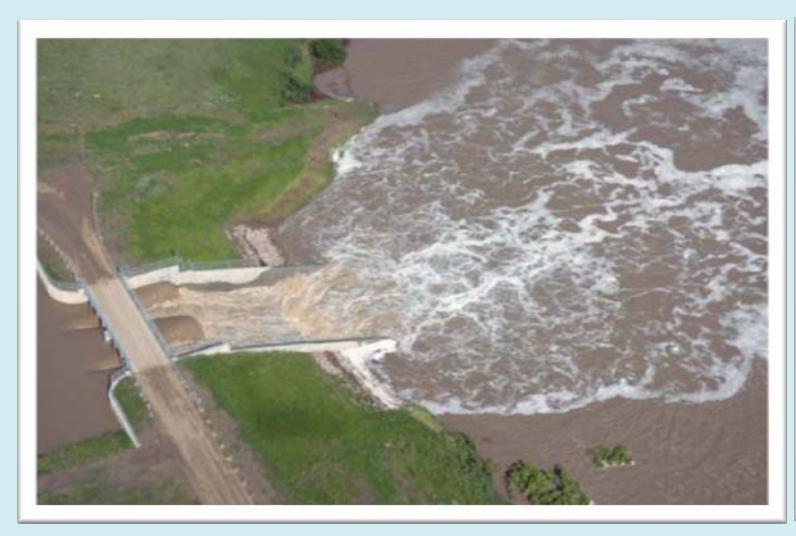
- In June 2010 there was a major flood event in southern Saskatchewan
- Peak flow in Maple Creek in June 2010 was a 1-in-3,700 year event
- Flood water volumes were at 1-in-250 year quantities
- Overland flooding in the area of the site and creek flows ~10x greater

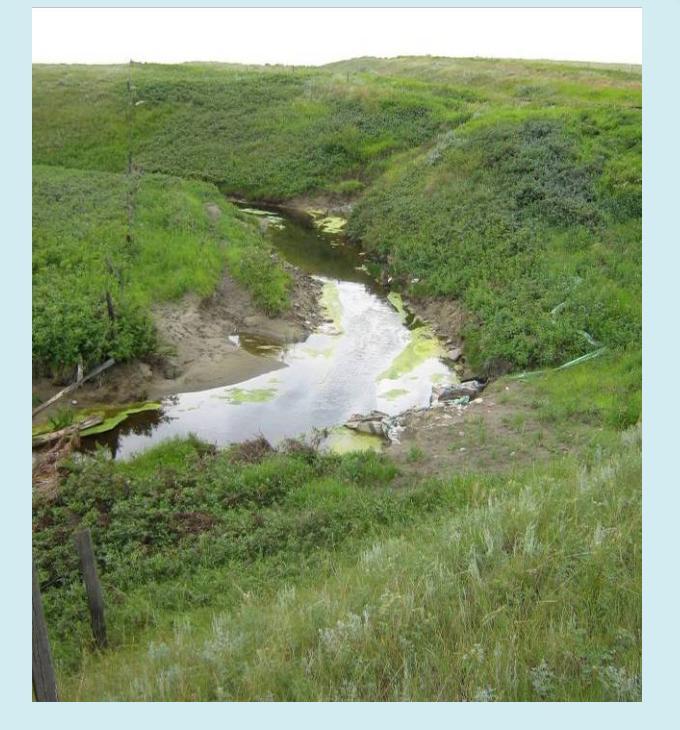
- On-site in July 2010 for follow-up sediment sampling
- Flooding and subsequent erosion in the creek exposed additional battery debris and impacted sediment

• Additional batteries on south bank of the creek (unearthed and deposited during flooding)

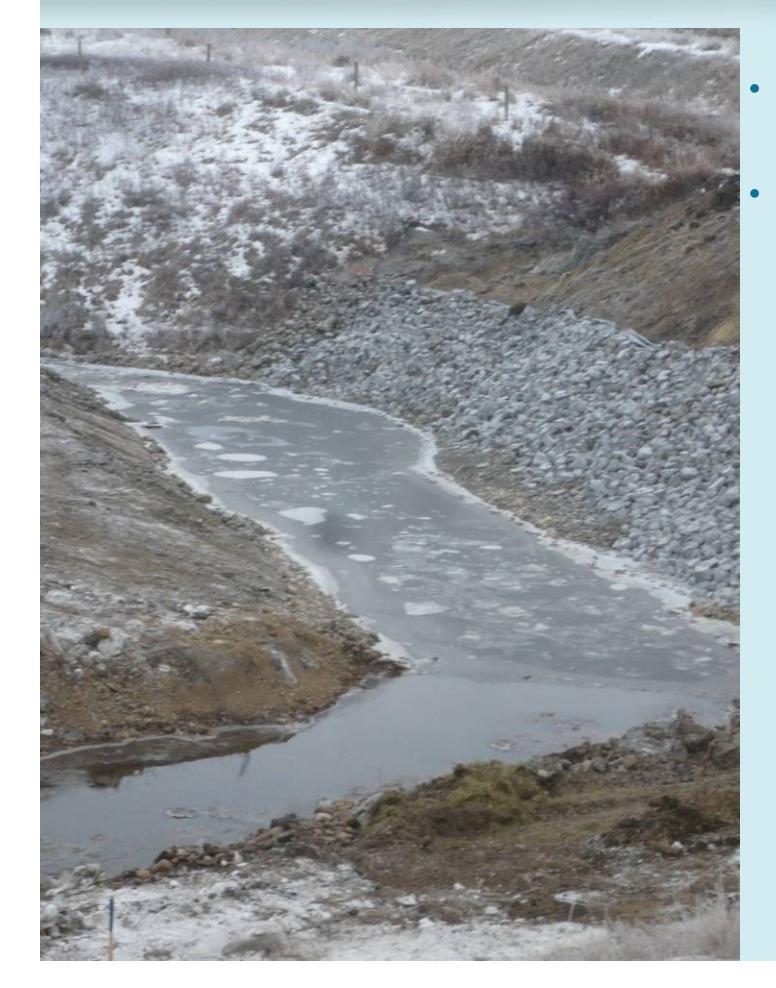
- Excavation of battery debris and contaminated soil and sediment on-site
- Creek bed and banks restored with approximately 1' of rock and 6" of small gravel to eliminate risk to aquatic life and prevent further erosion
