Remediation of an Abandoned Gold Mine in the Northwest Territories Colomac Mine

Caitlin Moore, P.Eng Environmental Monitor / Resident Engineer, Colomac Project 2010 – 2012

Greg Wright, M.Sc Project Manager, Colomac Project 2011 - 2013

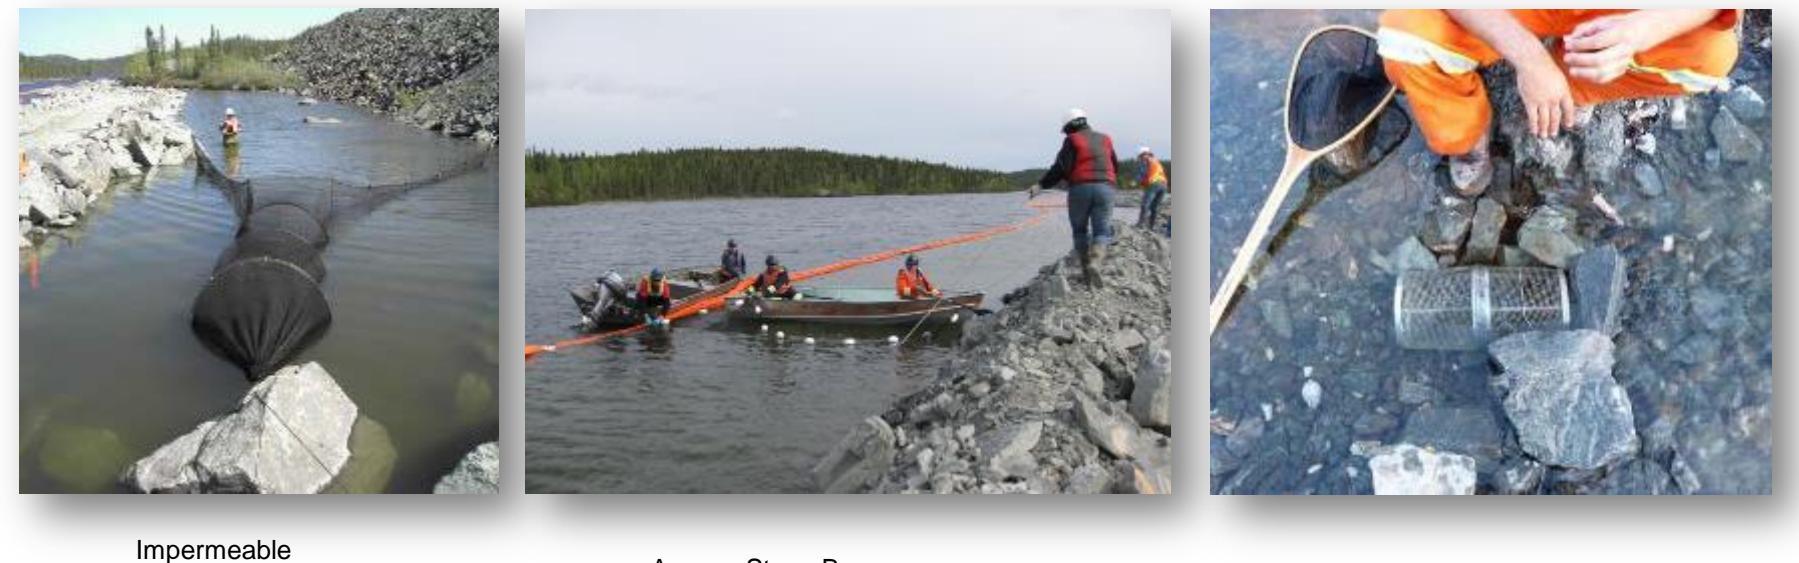
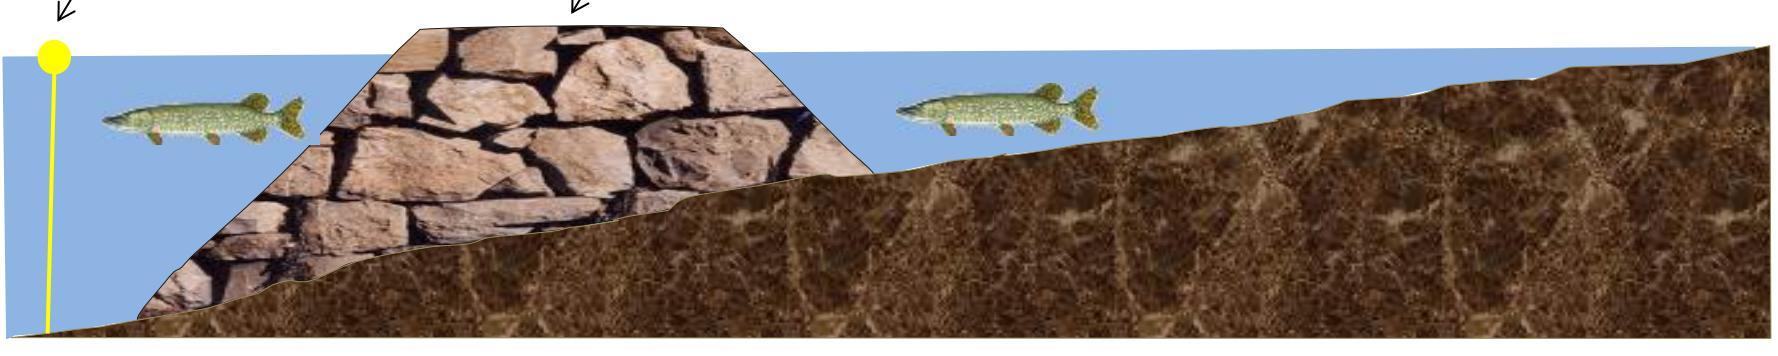
#### Steeves Lake Sediment Cap – Fish Salvage

Impermeable Silt Curtain

, Armour Stone Berm

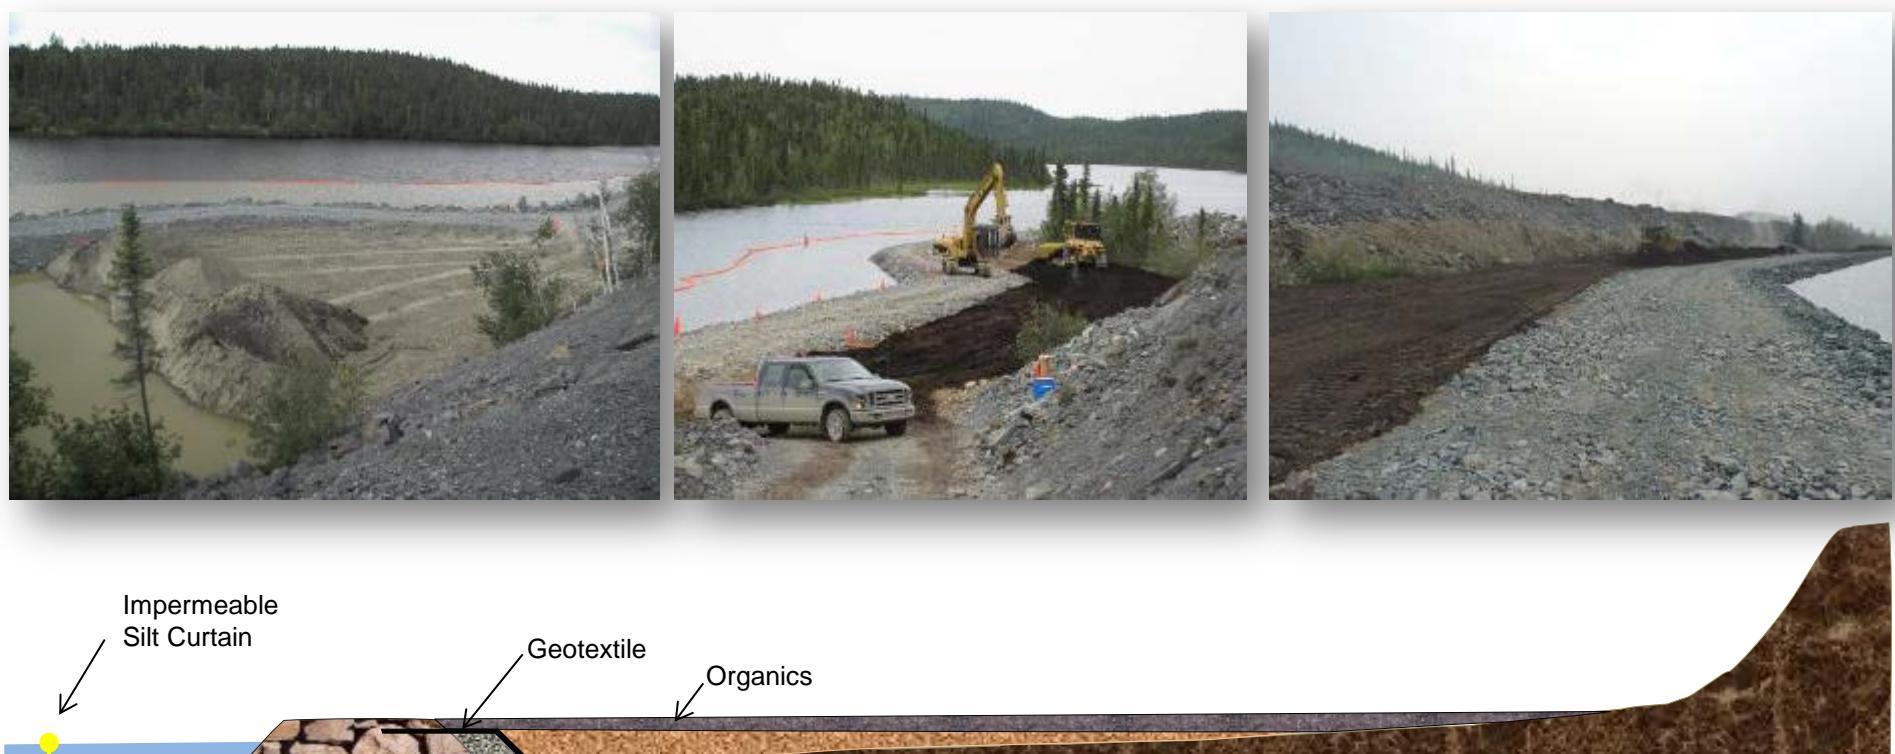
## Steeves Lake Sediment Cap – Rock Fill, Geotextile, Silty Till and Organics Placement

Silt Curtain Geotextile Organics
