Characterization and Remediation of Lac-Mégantic

Remediation Technologies Symposium (RemTech 2014) October 15 - 17, 2014

By Denis Millette, Eng., P. Eng., Agr., Ph.D.
Principal, Senior Hydrogeologist

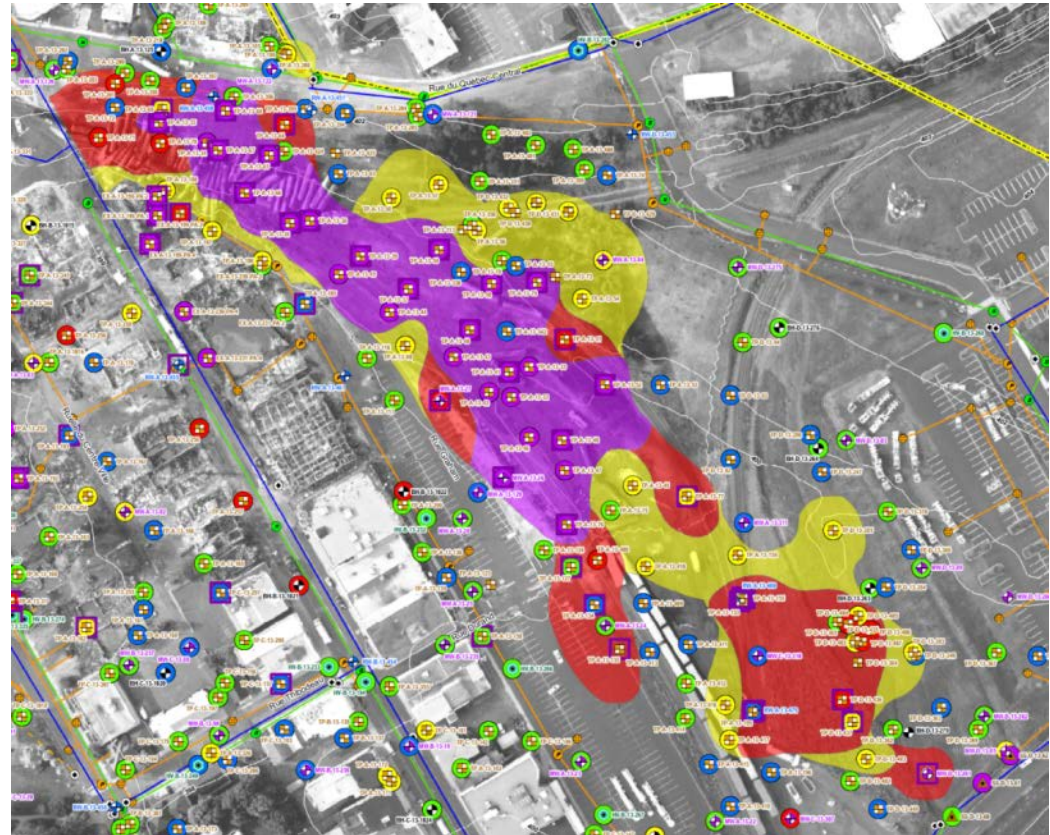
Presumed Enclaves of Impacted Soil (as of October 28, 2013)

The majority of contaminated soil was found in fill material.

Contaminated volumes > B (limit for residential use) estimated at 69,000 m³.

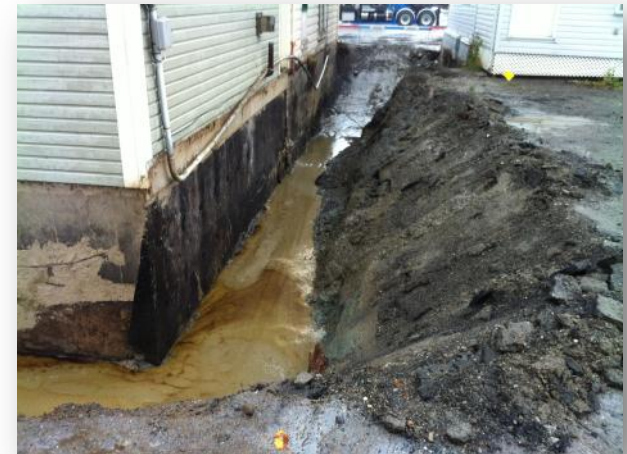
Characterization of Buildings

- Assessments were also carried out to evaluate:
 - Structural conditions
 - Management options for contaminated soil under buildings (excavation with shoring, demolition or temporary relocation, on-site treatment)
 - Market value and replacement cost of buildings.

Overall results: some buildings affected by the spill

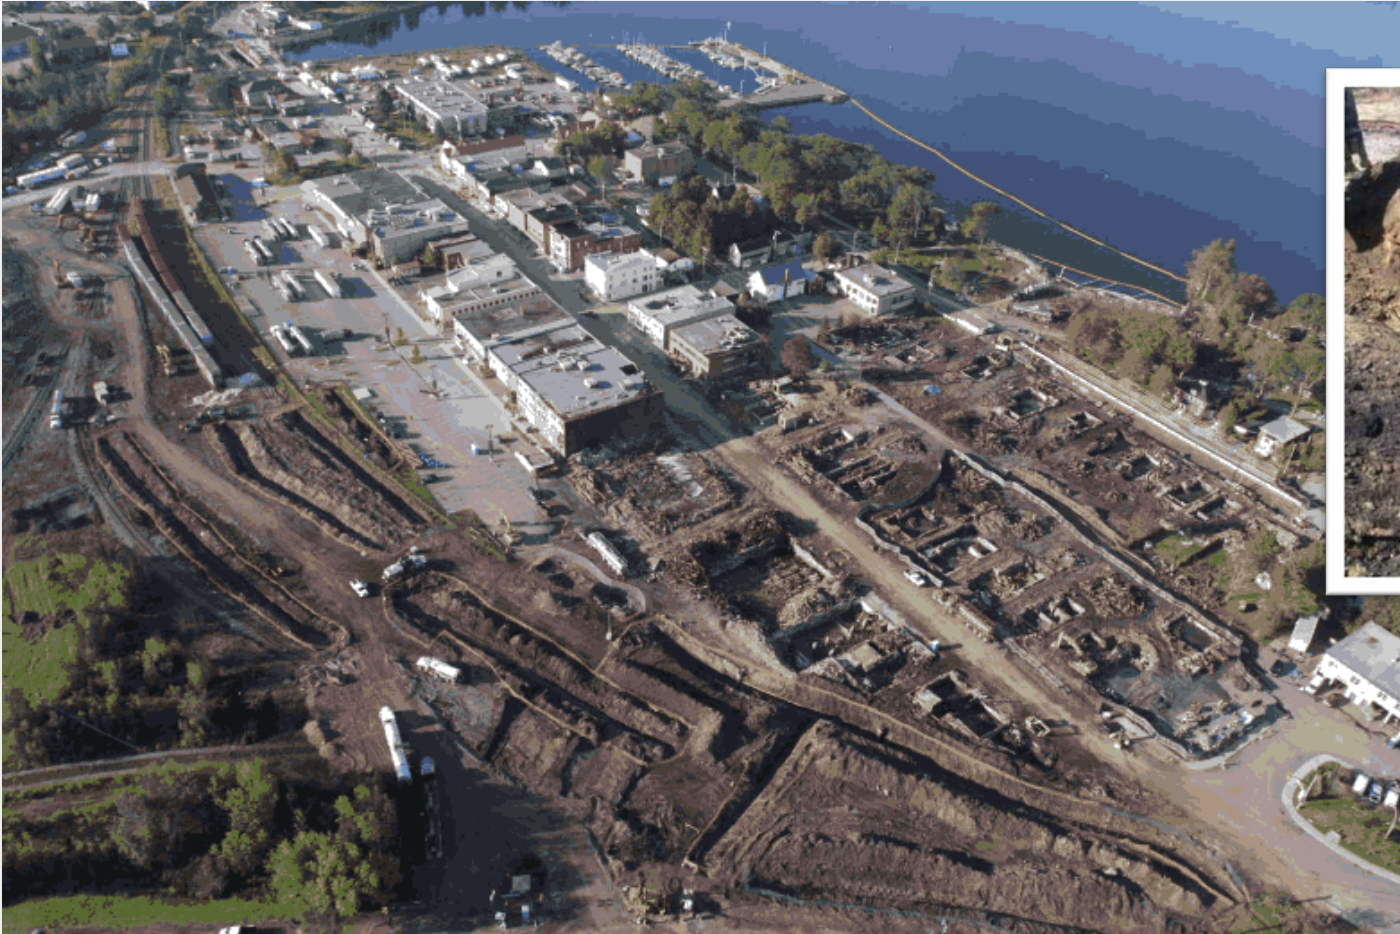
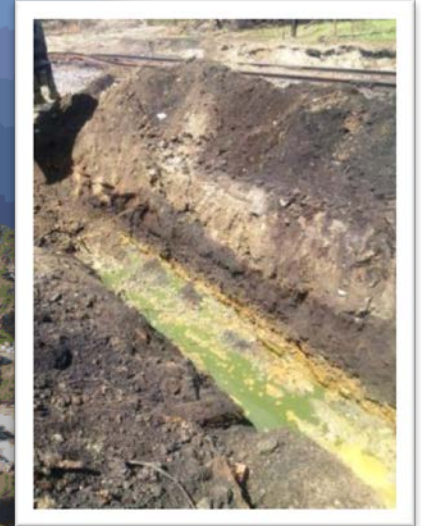
Completion of Installation of Recovery Trenches

- Over 1,100 linear metres of recovery trenches dug

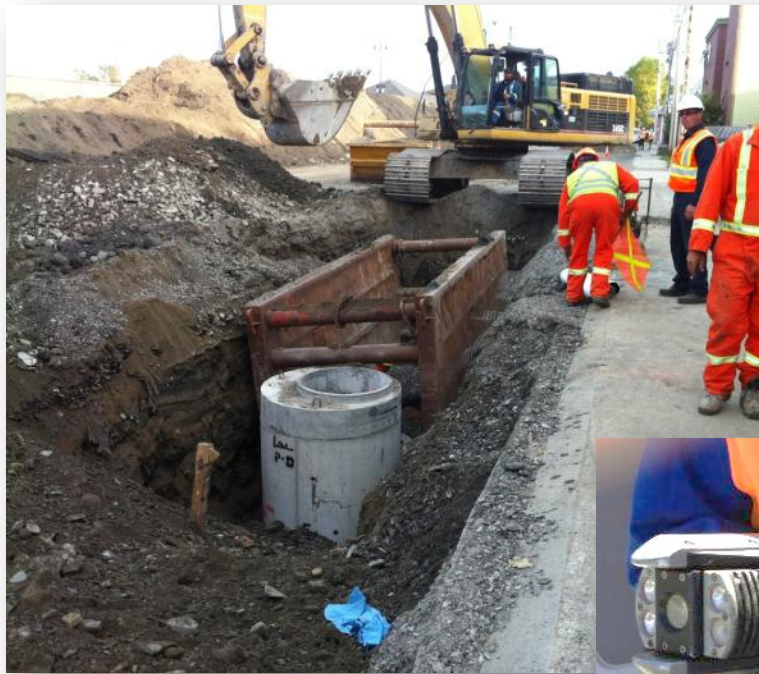
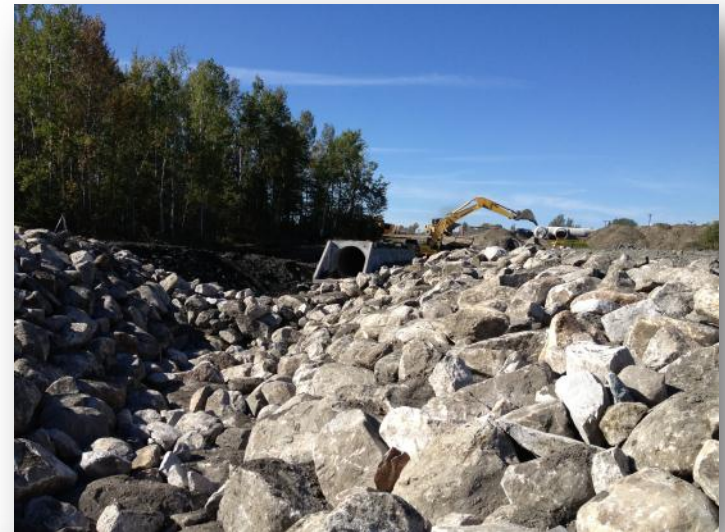
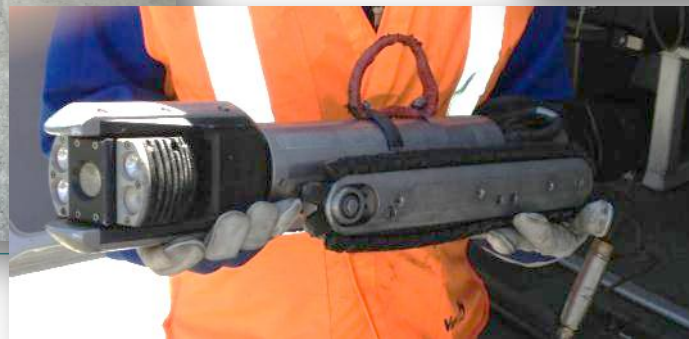
Sewer and Water System Replacement Plan

- Assessment of sewer network conditions via video inspections
- Sewer management plan
- Replacement of sewer and water infrastructure deemed priority / contaminated
- Other sewers temporarily isolated to avoid contamination

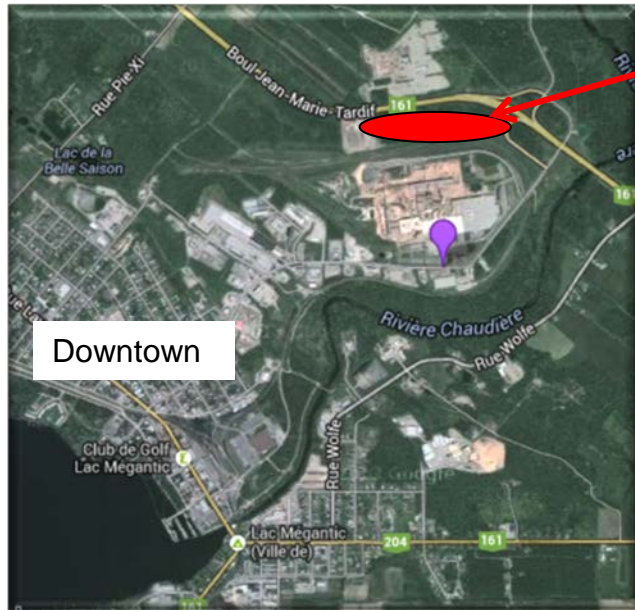
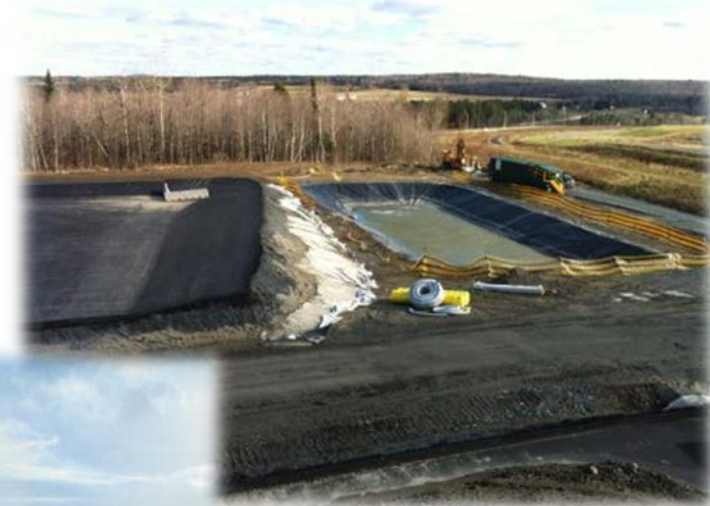
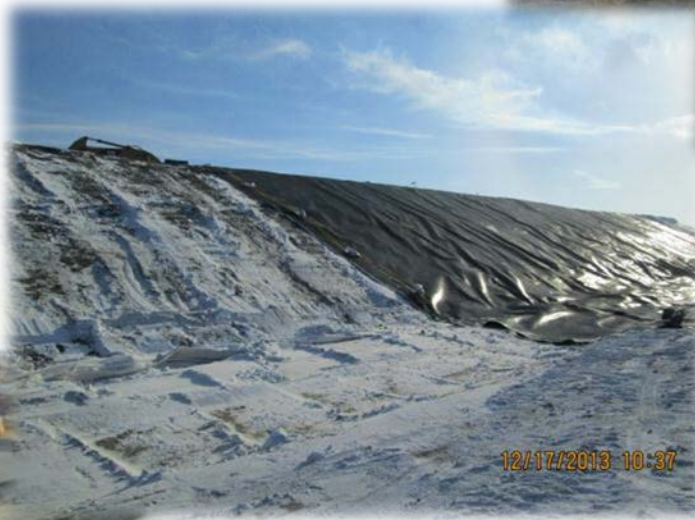
Construction of Three Temporary Storage Platforms for Soil Treatment

3 platforms 2 km from downtown, each with an approximate capacity of 30,000 m³

All three platforms are now filled.

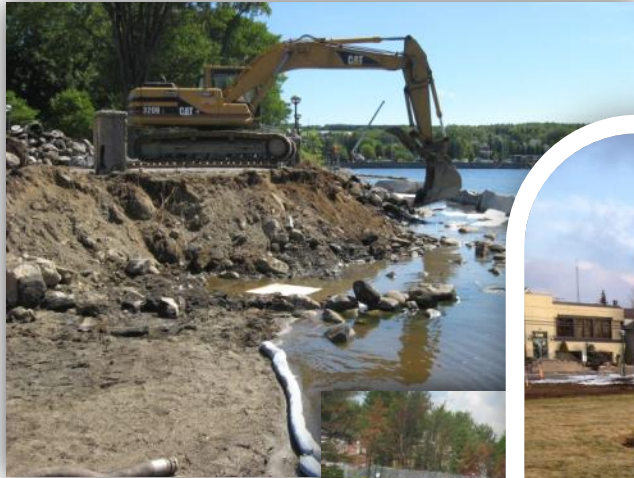
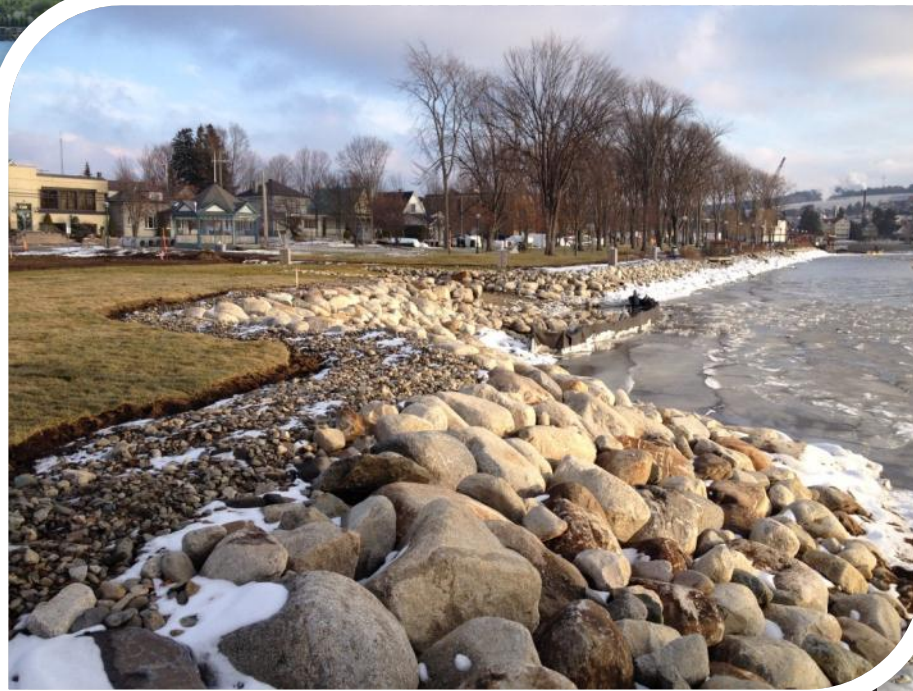
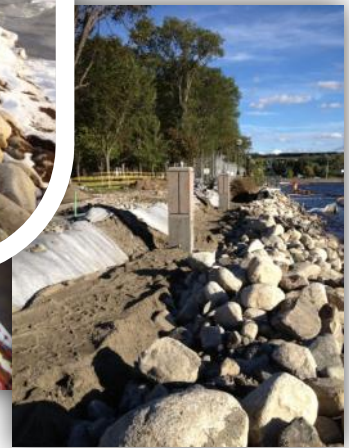
Remediation of Lac-Mégantic Shoreline at Parc des Vétérans and along the Fire Zone

- During the fire, part of the oil floating on Lake Mégantic was pushed by strong winds toward the eastern shore of the lake.

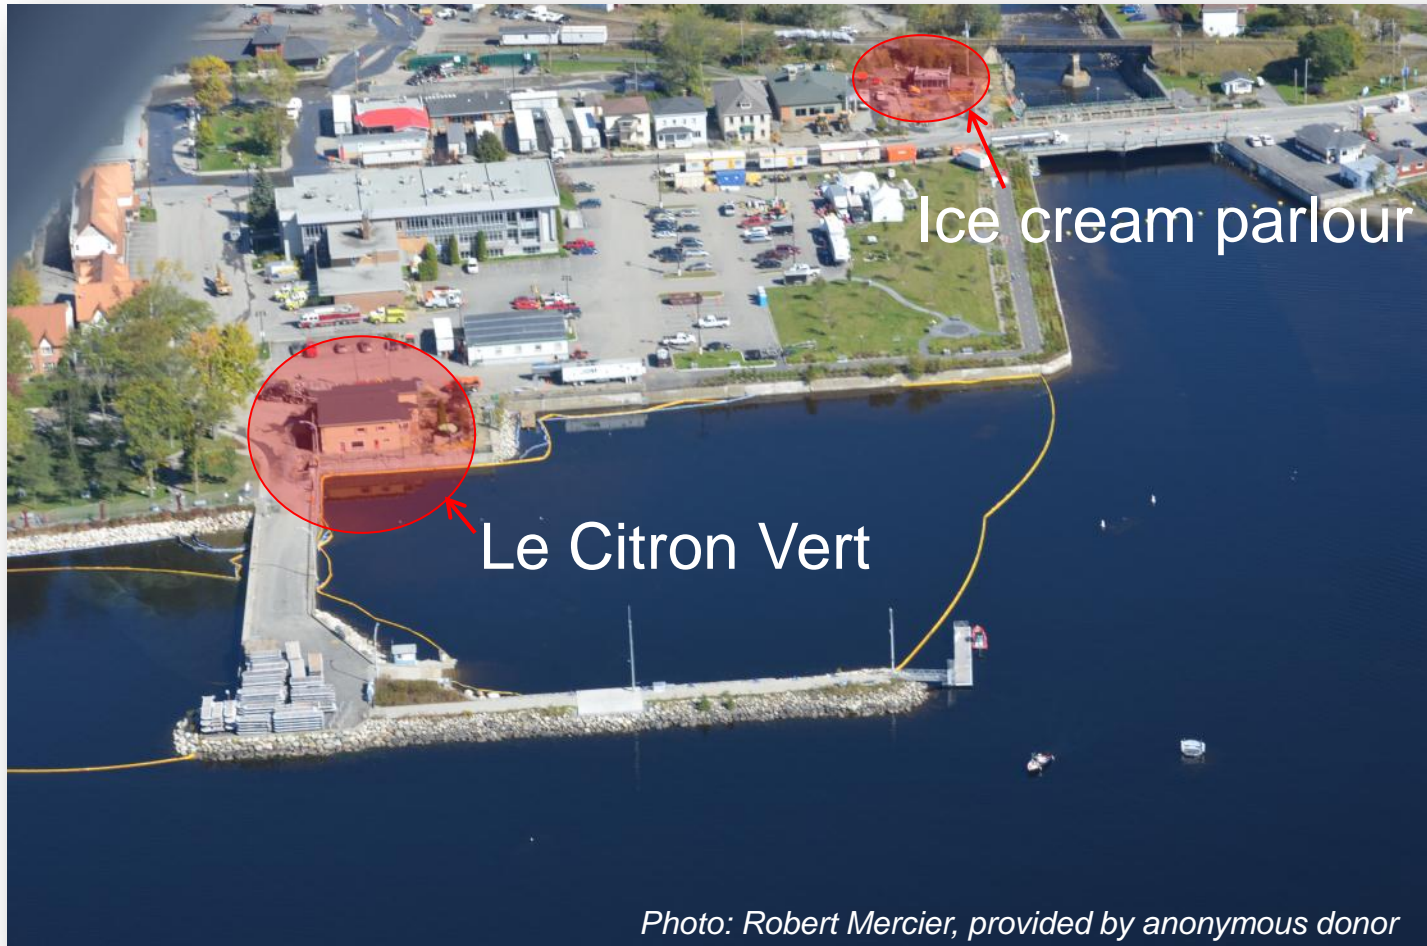
Decontamination of Low Points: Ice Cream Parlour and Le Citron Vert

Le Citron Vert: Pumping of Free Product (pre-excavation)

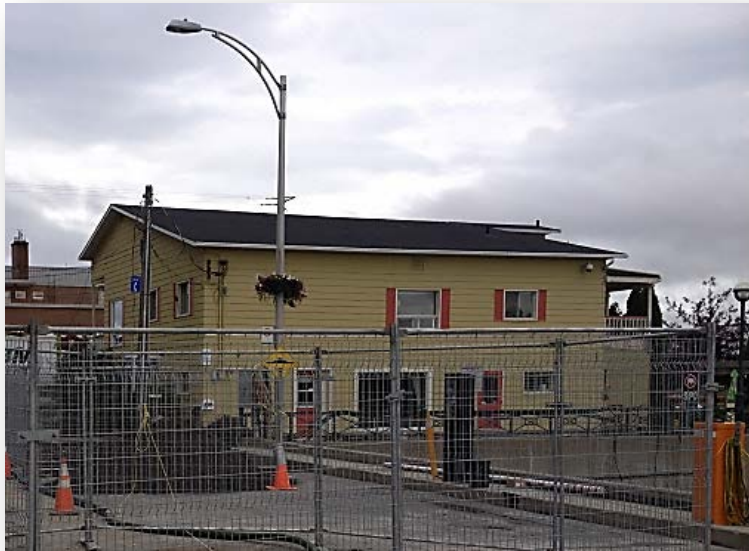
Remediation around Le Citron Vert Restaurant

View from Le Citron Vert restaurant

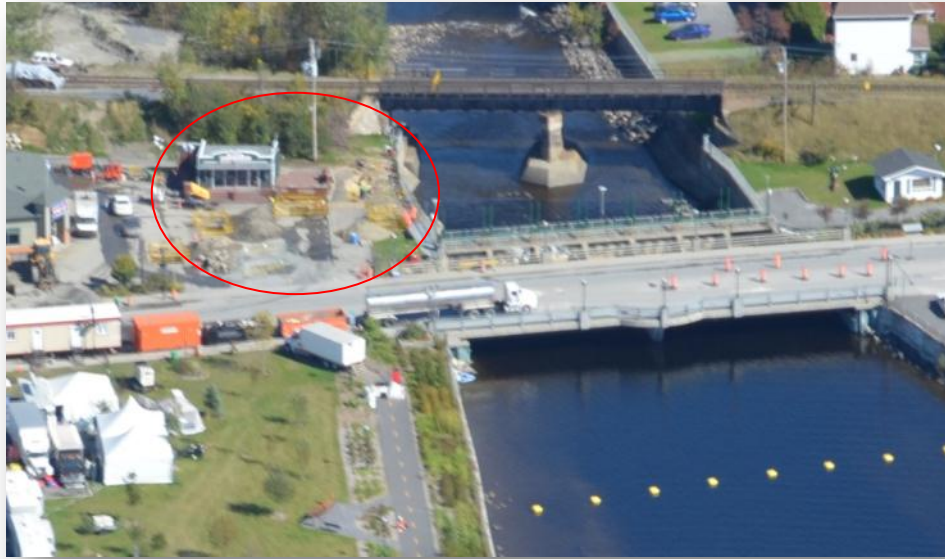
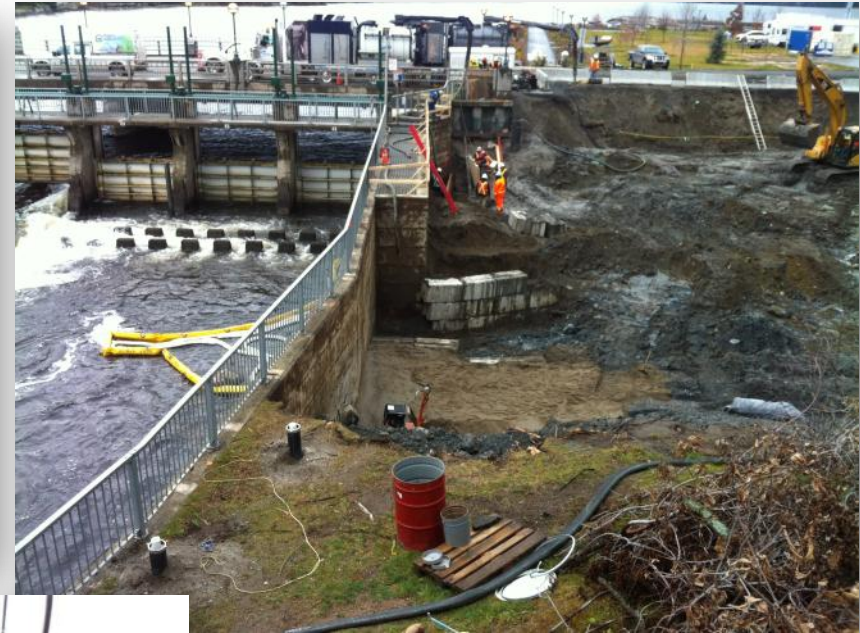
Remediation of Ice Cream Parlour Sector

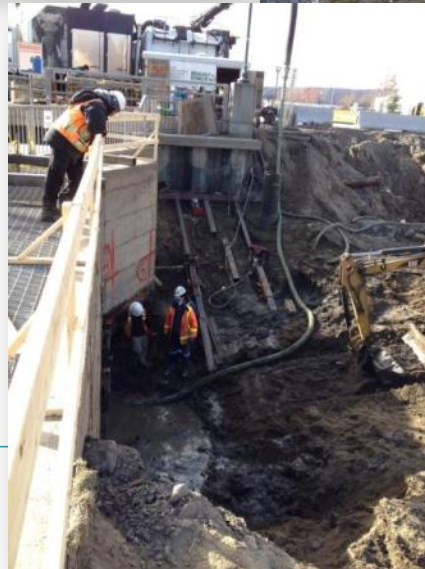
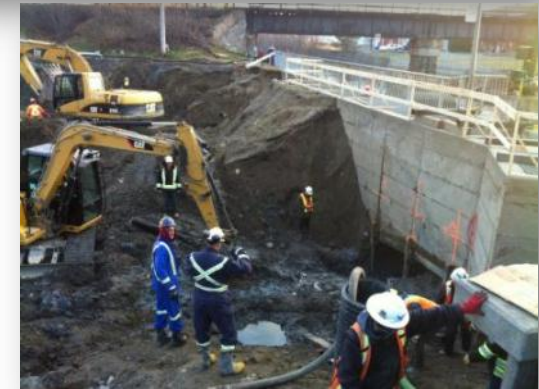
Major challenge of this remediation: work area besides a bridge and a major dam controlling the outflow of Lake Mégantic and the Chaudière River.

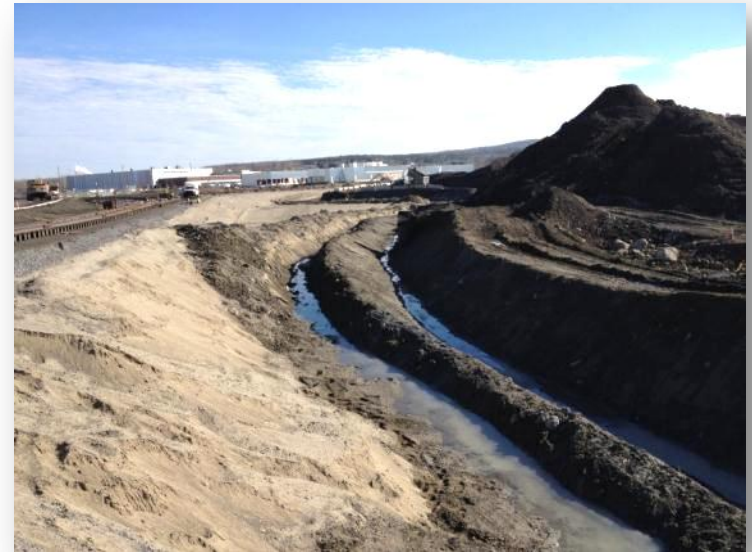
Runoff Control Strategy

- 1) Control the migration of surface runoff and groundwater downstream of contaminated soil to avoid recontaminating the newly installed sewer lines and the fill around them;
- 2) Avoid recontaminating clean fill;
- 3) Collect oily water in trenches for treatment.

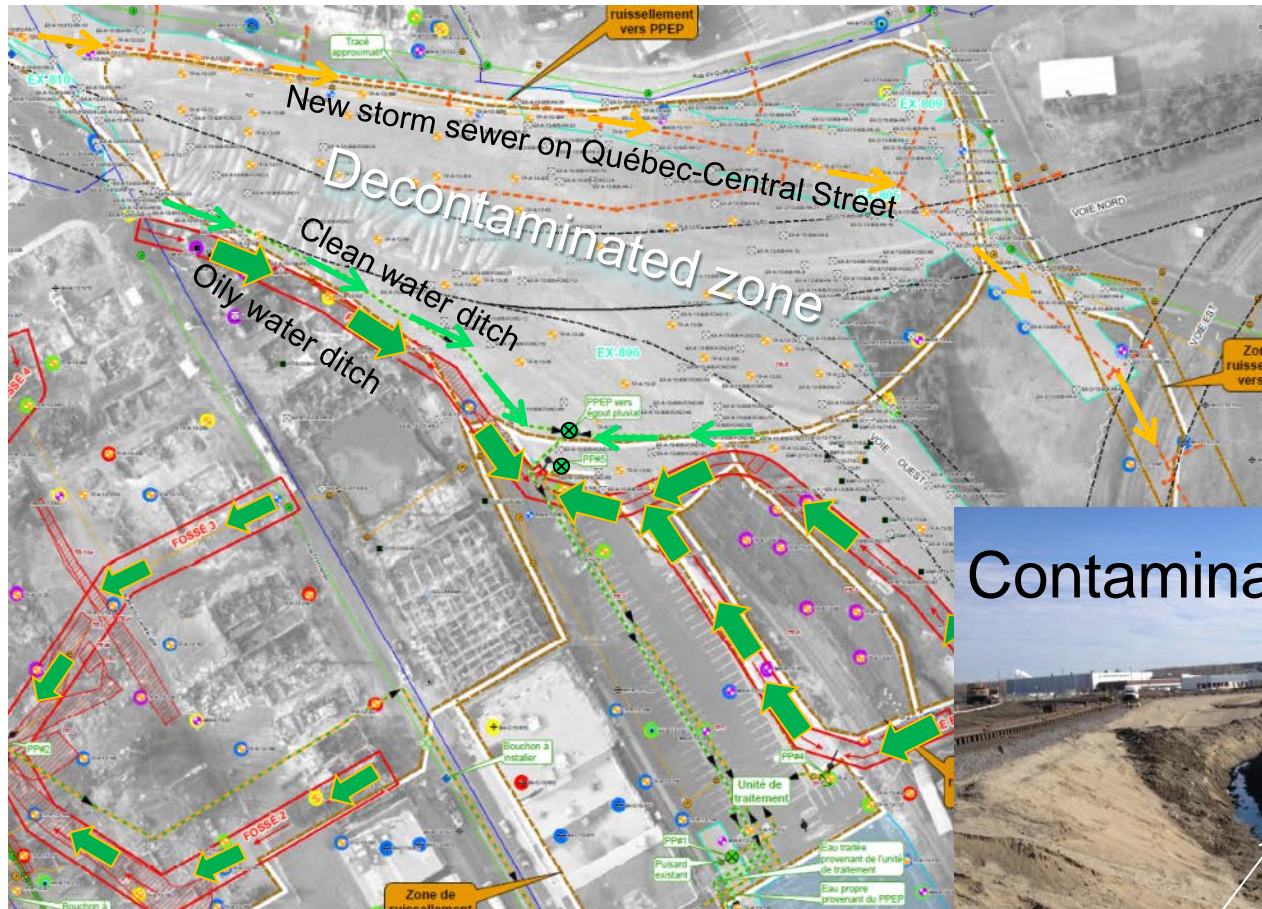
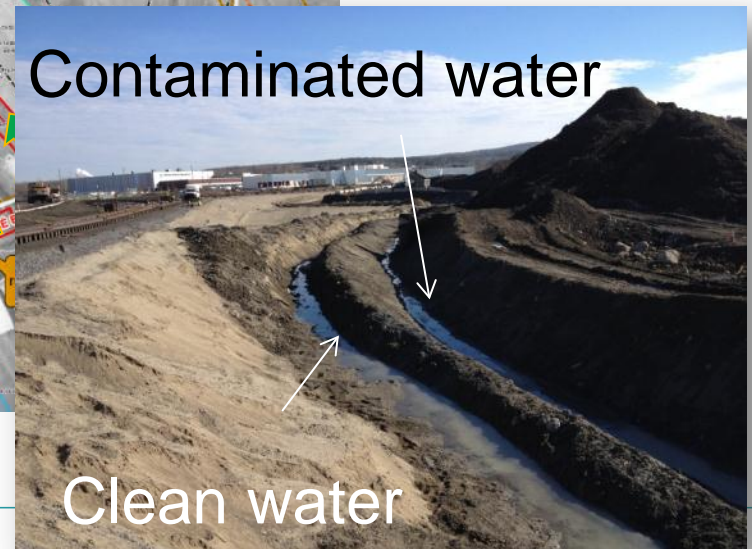
Runoff and Oily Water Control Strategy – Decontaminated Zone
