Risk Management and Corrective Action Related to a Leaking Brine Pond

Frans Hettinga & Aziz Shaikh

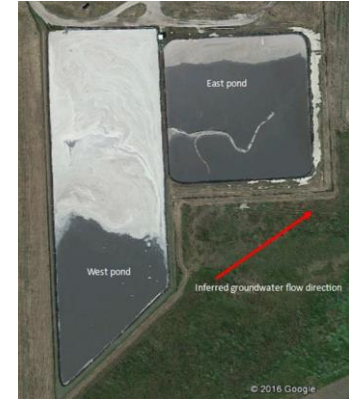
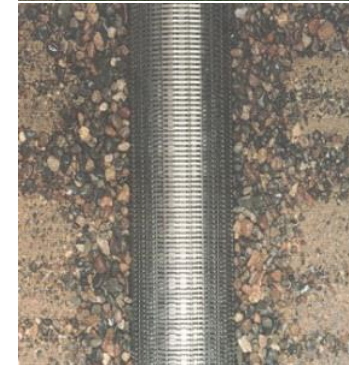
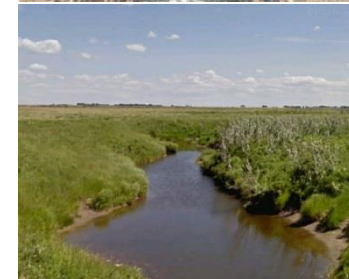
Problem – Source/Pathway/Receptor

- Source: leakages from brine ponds, capacity $\sim 60,000 \text{ m}^3$
- Pathway: shallow sand and gravel unconfined aquifer:
Water table 1 – 3 m below grade,
Hydraulic conductivity $1 \times 10^{-4} \text{ m/s}$ – $1 \times 10^{-5} \text{ m/s}$.
- Receptor: downgradient meandering creek within 500 m

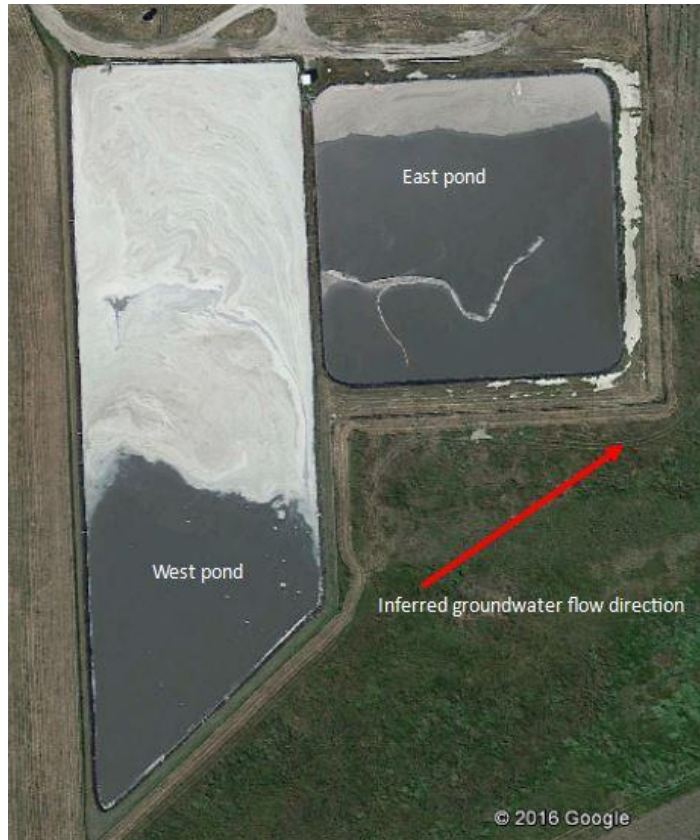
Main Concern: Brine Ponds

- ~60,000 m³ stored in two ponds
- Brine [NaCl] solution near saturation
- Older (west) pond is single lined
- Newer (east) pond is double lined with interstitial space and leak detection
- Operational spills occurred starting in 1990s
- In early 2000s also evidence of leaks

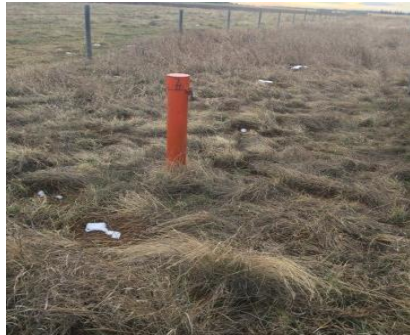
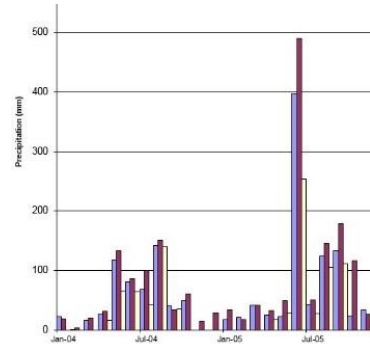
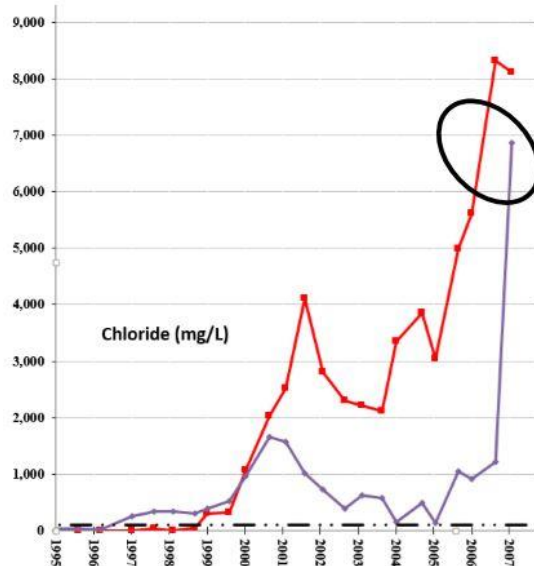
2004 - 2011

- Initially groundwater chloride concentrations in line with RMP predictions
- Increases in 2005 due to more rain and more infiltration
- Some improvement in 2008 but not to pre-2005 levels
- Leaks identified and repaired in 2008-2010
- No measureable impact on creek water quality
- Deeper (bedrock) groundwater quality not affected
