ASSESSMENT AND REMEDIATION OF A NON-AQUEOUS PHASE LIQUID HYDROCARBON PLUME IN FRACTURED BEDROCK

Ian Mitchell, M.Sc. P.Geo

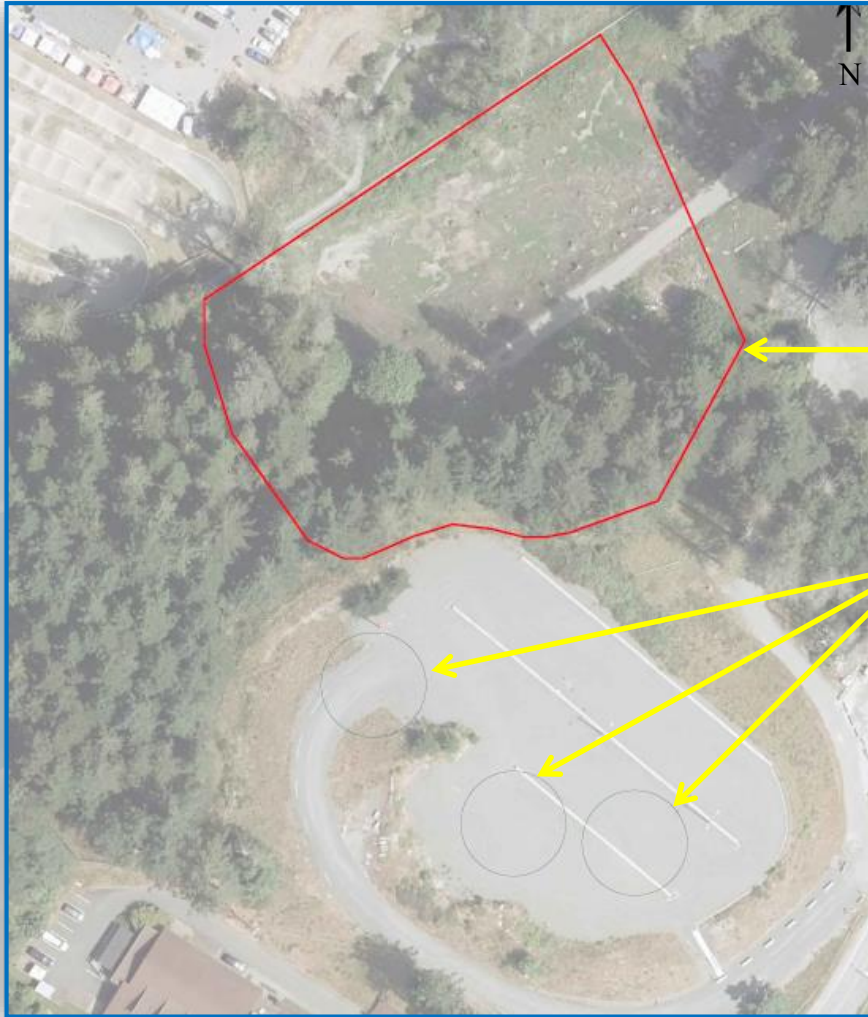
Site is a former fuel oil depot at the Department of National Defense Colwood, BC

Area under environmental investigation

Former fuel oil storage tanks, including a tank that held 40,000 barrels of Bunker C product located directly up gradient at higher elevation.

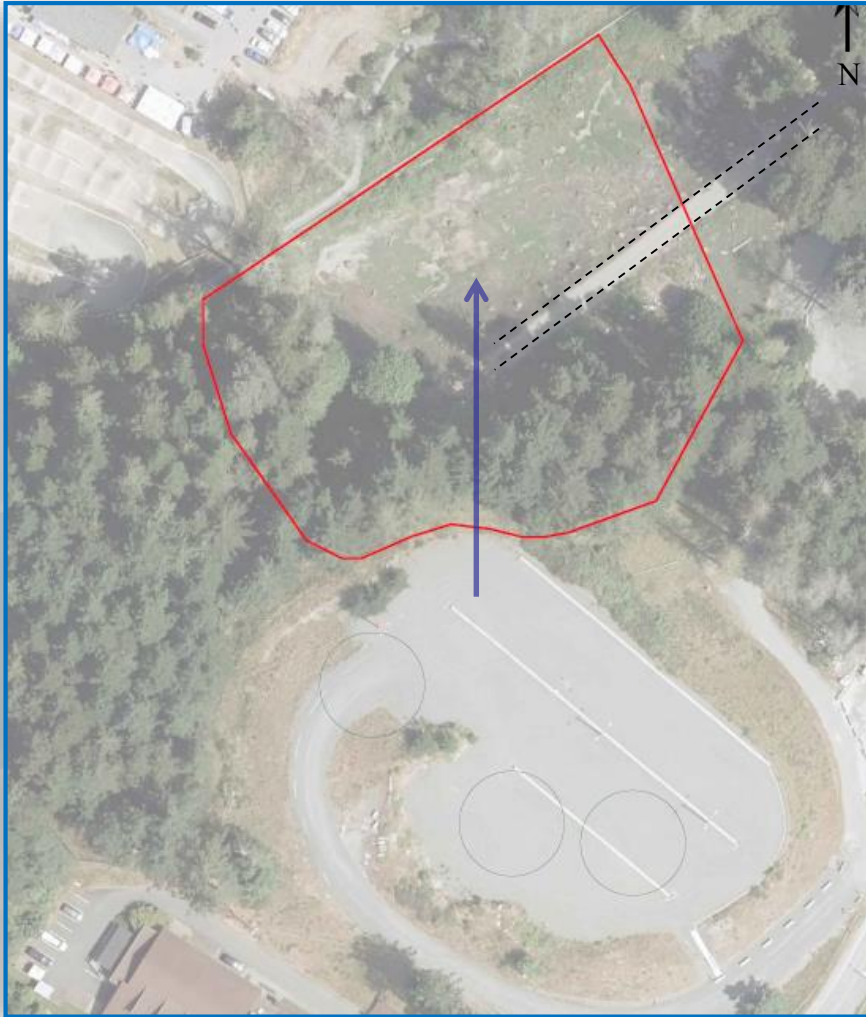
Moderately steep topography northward below the former tank farm

Numerous bedrock outcrops within treed areas

Groundwater flow towards the north

Site access road extended to create additional drill pads for investigation

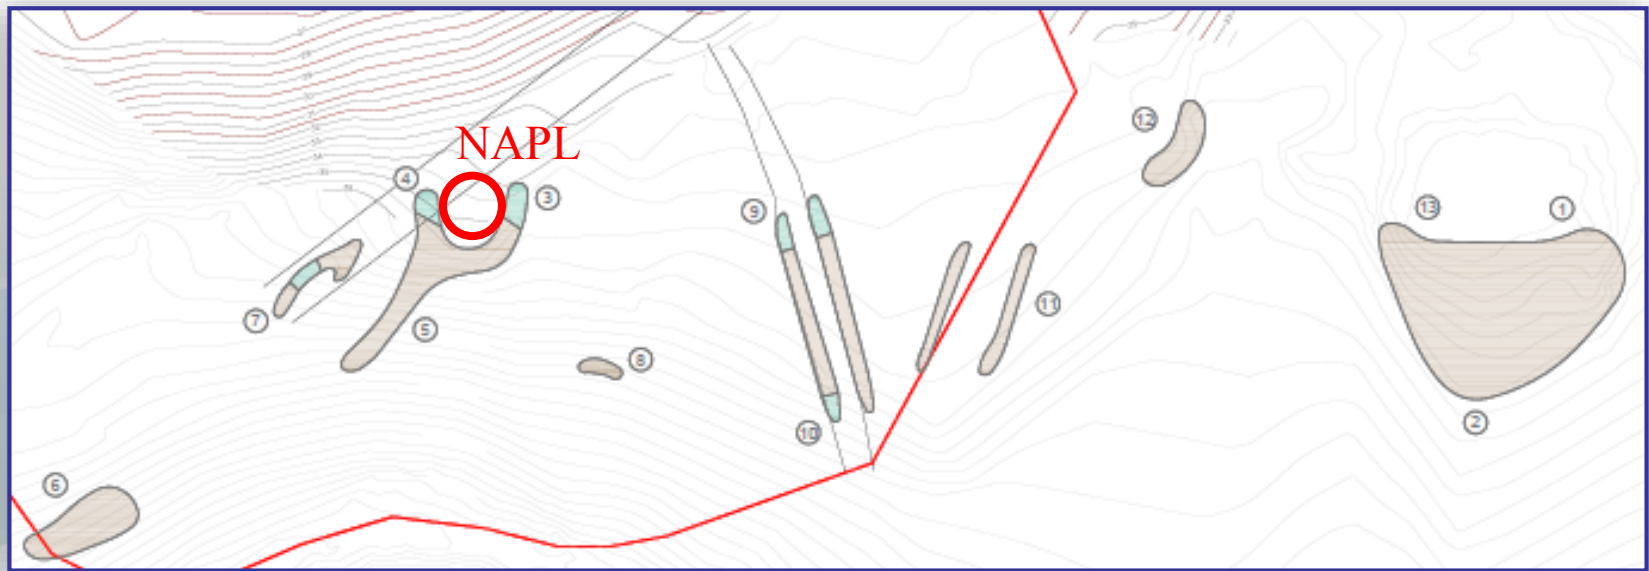
Significant number of bedrock outcrops on and off site

Recognized as an opportunity to gather cost-effective information on bedrock structures

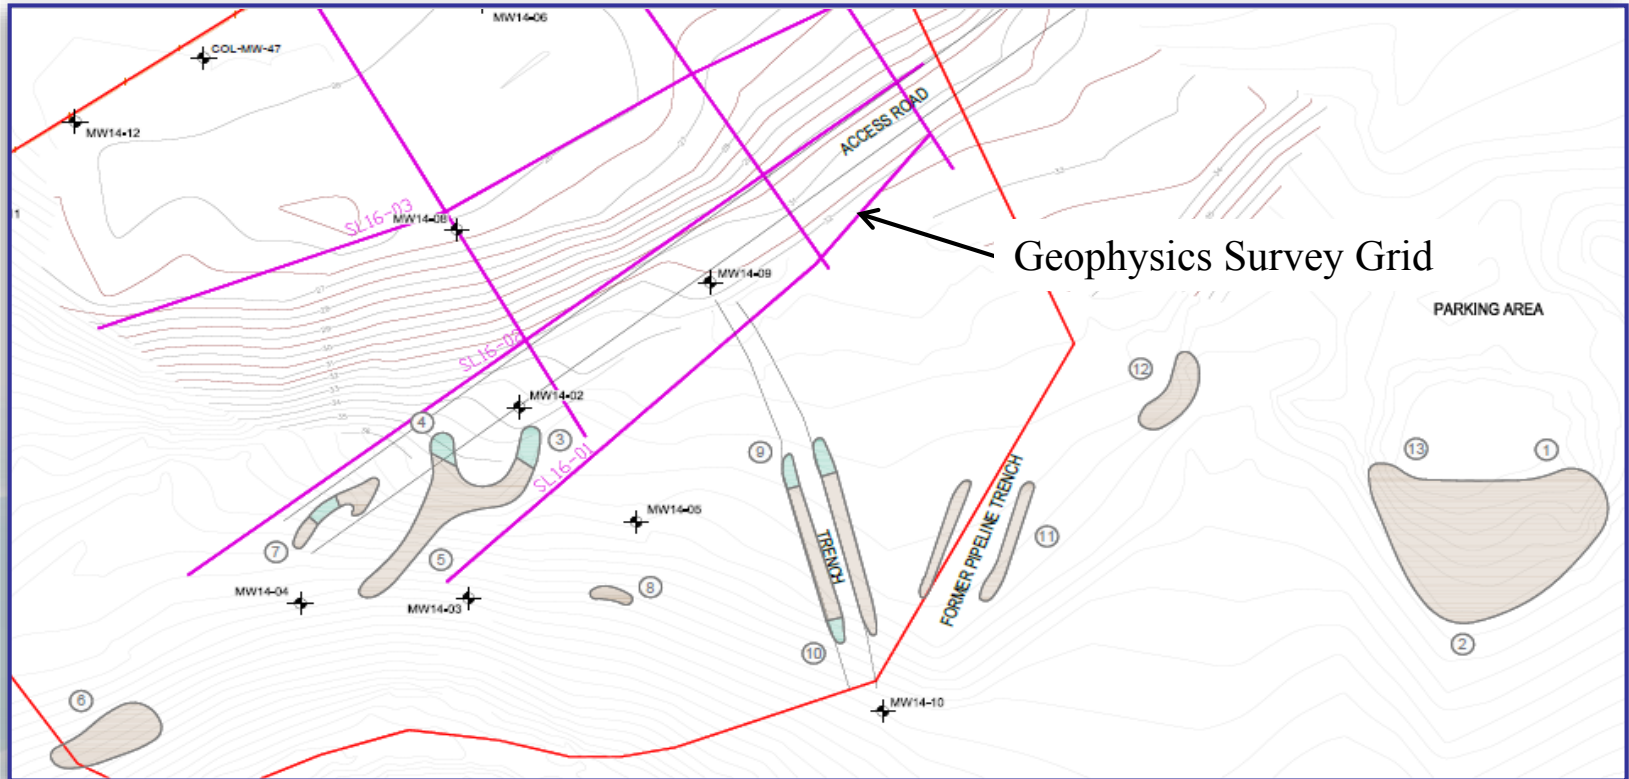
Bedrock outcrops catalogued and individually mapped for fracture orientations, unit contacts, other structural features

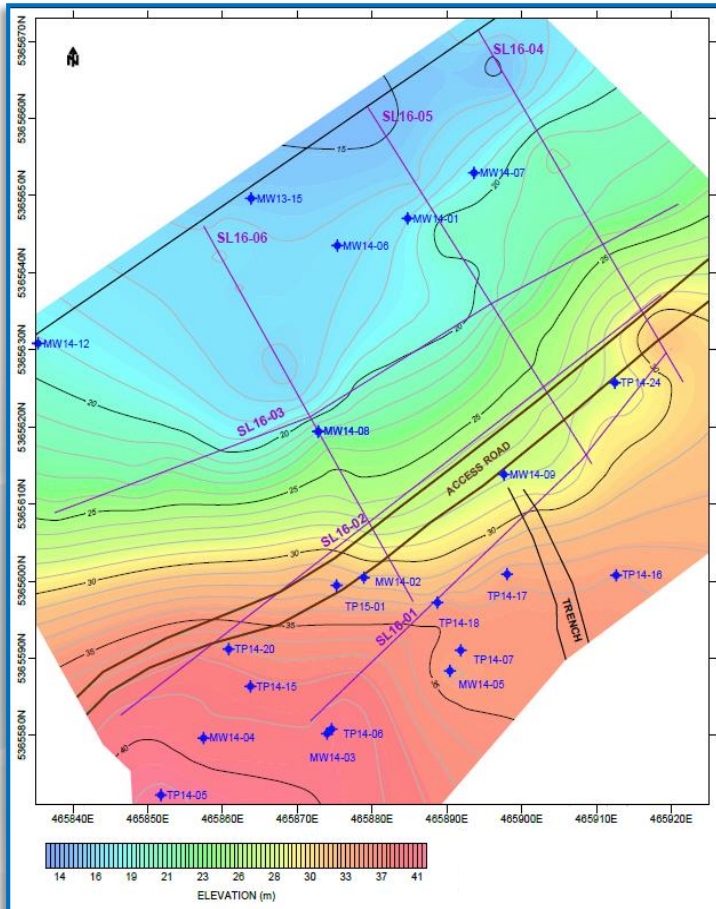
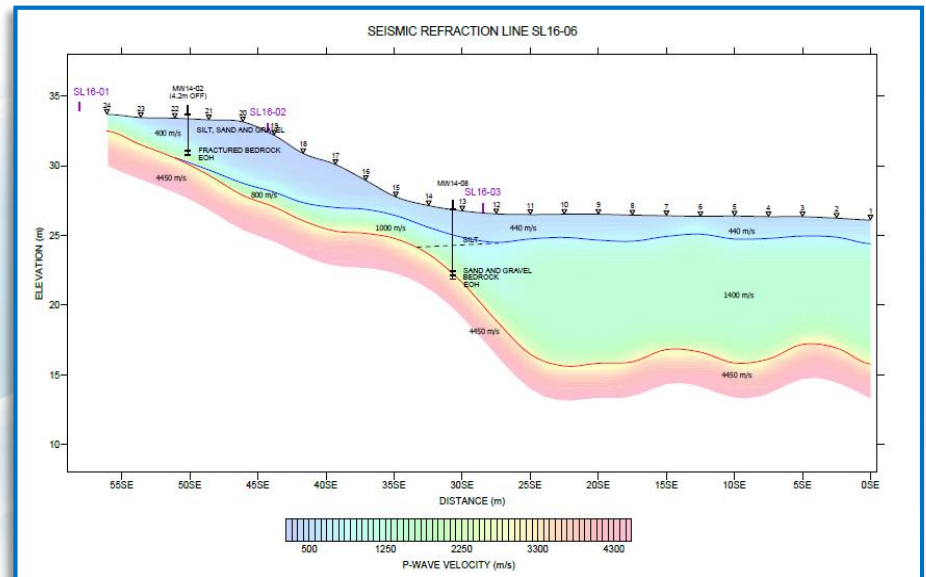
A seismic refraction survey was completed to determine subsurface bedrock topography to assist with delineation and remediation

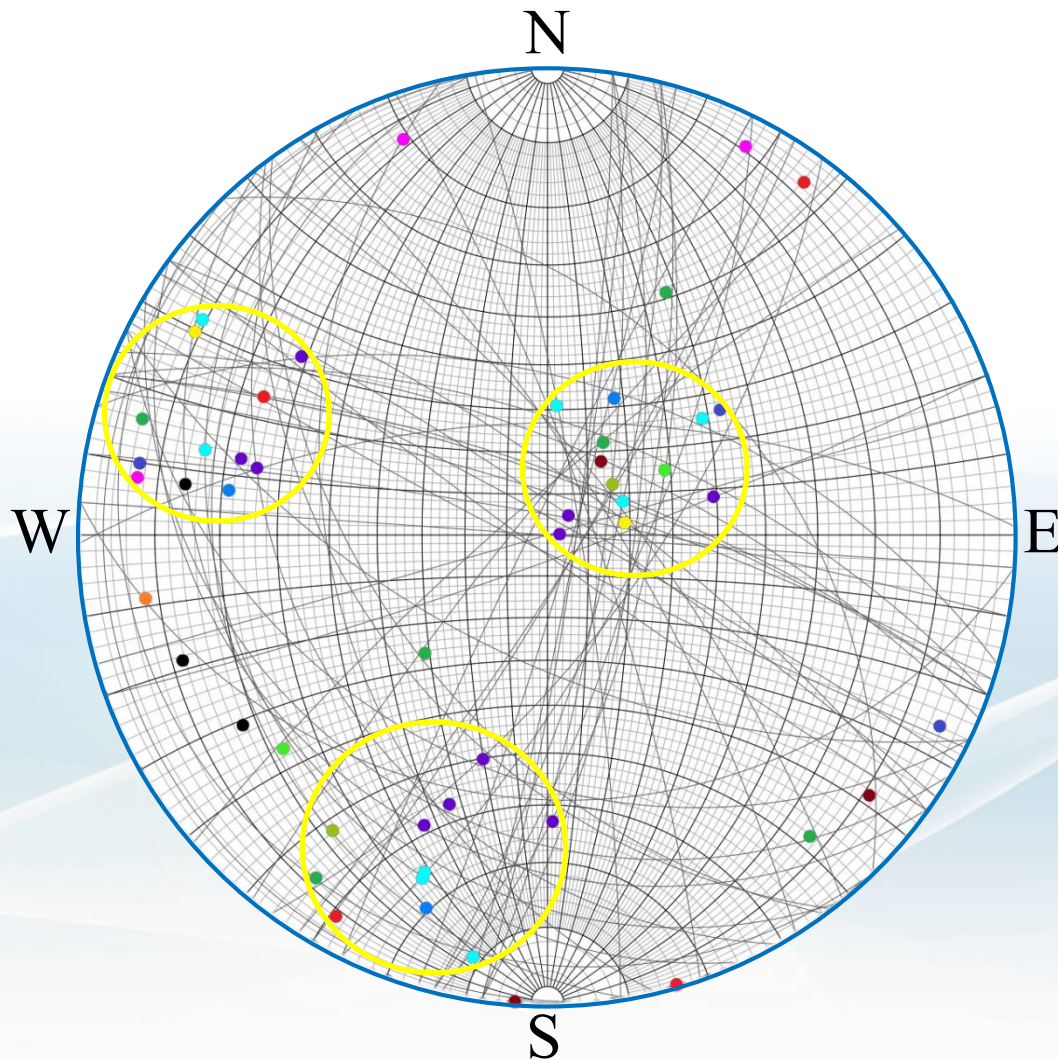
All Outcrop Areas

Predominant Fracture Orientations Across Site

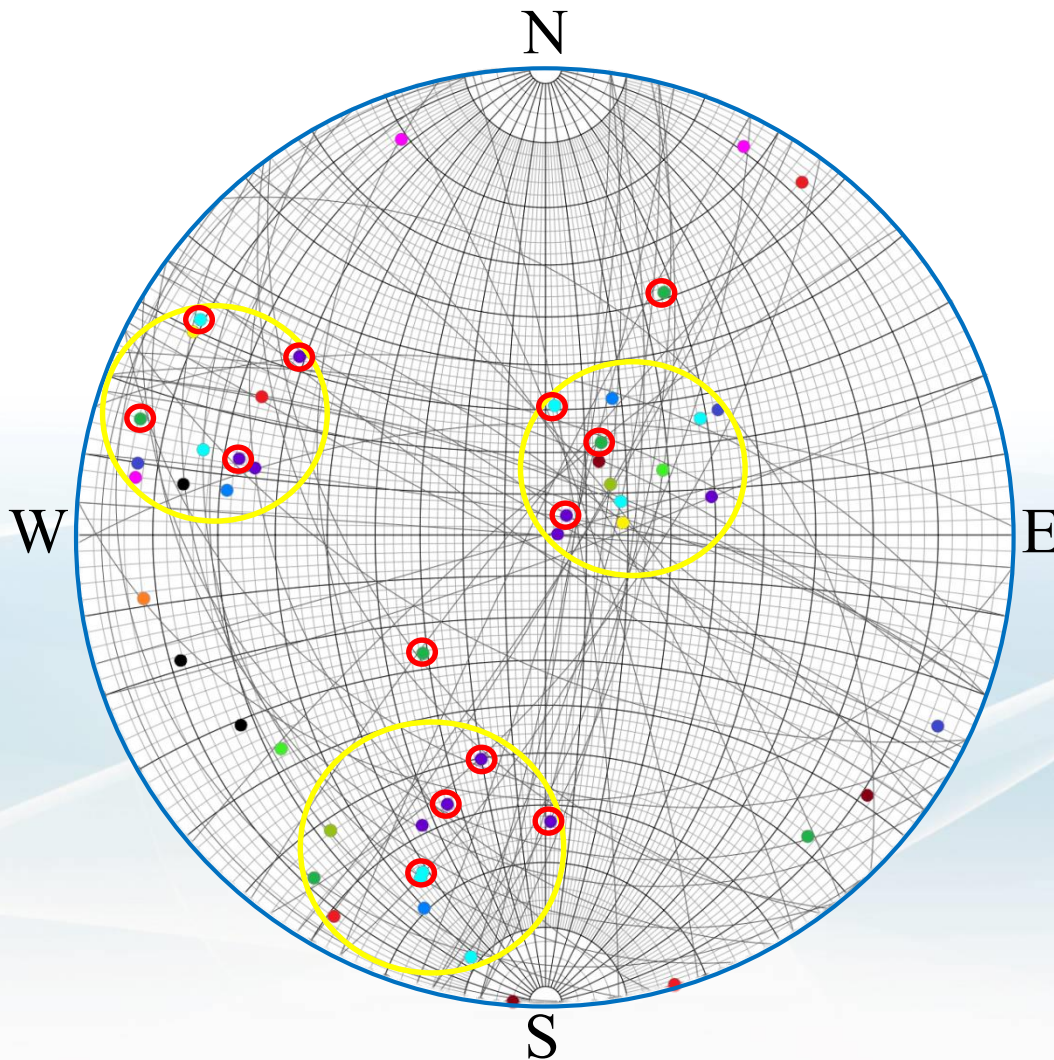
All Outcrop Areas

Predominant Fracture Orientations Across Site
-

Fractures with NAPL

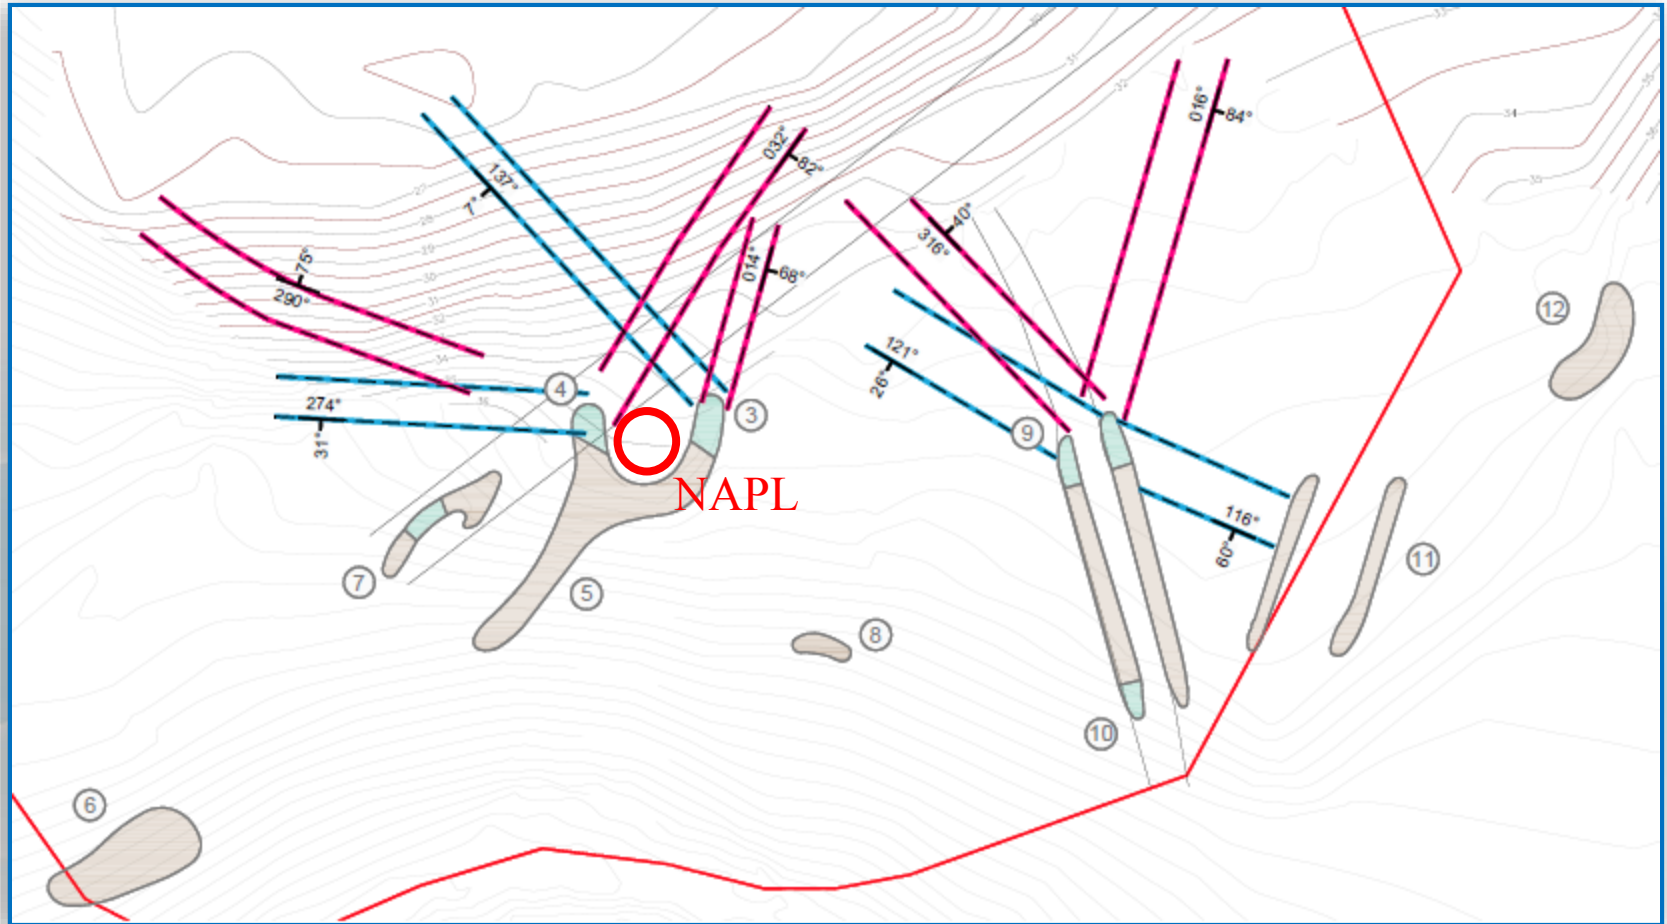
- Based on identification of the primary fractures linked to presence of NAPL, delineation targets were developed for drilling
- The orientation of these features was extrapolated from the area where NAPL was exposed; also from the former pipeline area below the tank farm, where minor staining was observed
- Extrapolated targets must be slope-corrected
- Important to drill perpendicular to targets

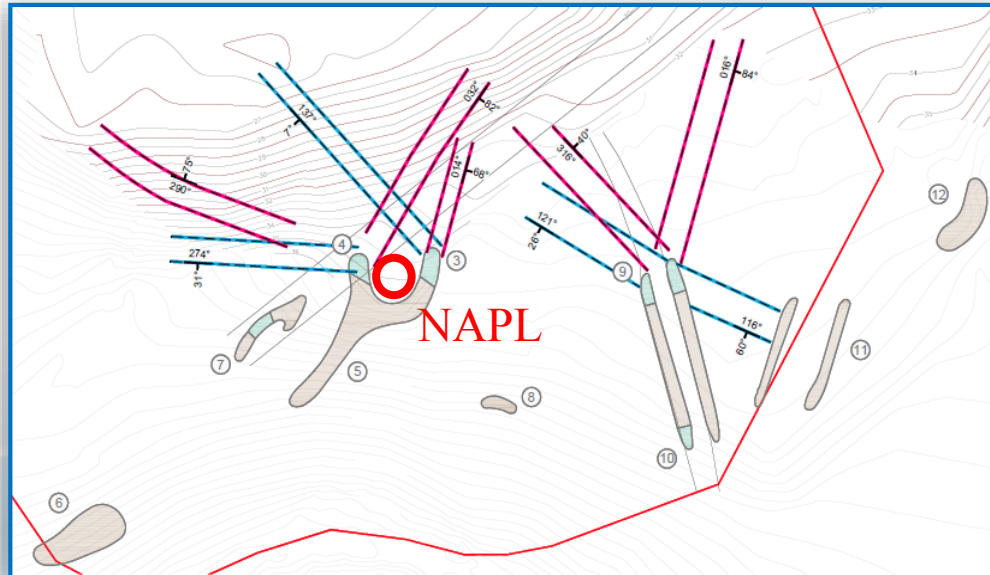
- Target zones were colour-coded by priority

- Red targets highest priority, greatest potential for down gradient migration of contamination
- Blue targets secondary priority, fractures dip back into the hill

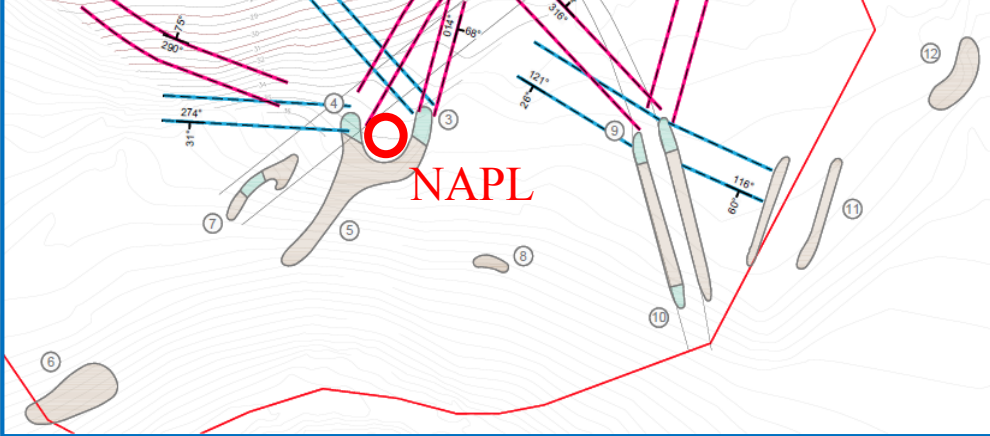
- Drilling conducted to evaluate all zones
 - Diamond coring to permit observation of fractures
- Required angle drilling, included several nested wells
 - Extrapolated target zones up gradient to evaluate most likely migration pathways between NAPL and former tank farm

- NAPL was not found at any locations drilled
- No evidence of staining or oxidation on fracture surfaces except in immediate vicinity of road side NAPL exposure
- Pressure transducers with data loggers were subsequently installed at multiple locations to monitor water table response to precipitation events
- Data corroborated hydraulic connection between the NAPL area and the target zones investigated

- Concluded that the NAPL was associated with historic asphalt manufacturing facility
- Structural analysis provided a high degree of confidence that the NAPL was localized and immobile
- Relatively low cost investment relative to other options
- Simply drilling up gradient or down gradient of the NAPL would not have provided the same level of confidence in a fractured bedrock environment
- Remedial options analysis determined that excavation and disposal was the preferred remediation strategy
