# Harrietsfield C&D Landfill

## Reclamation of a Former Construction Debris Facility

Presenter: Rob McCullough  
June 2022

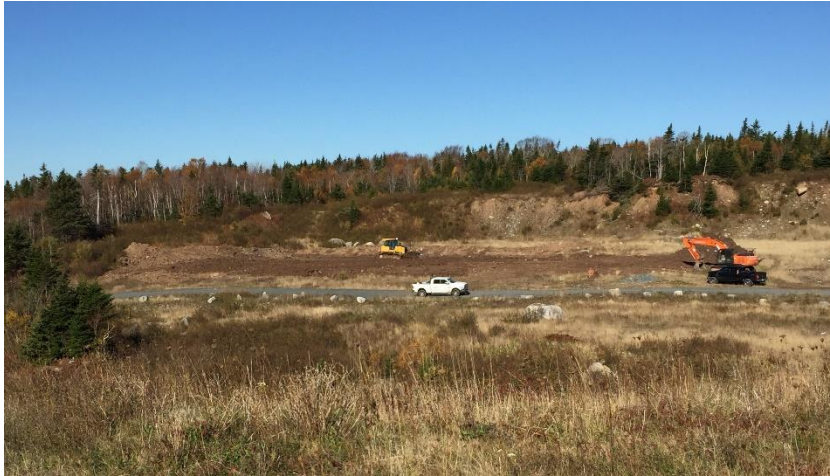
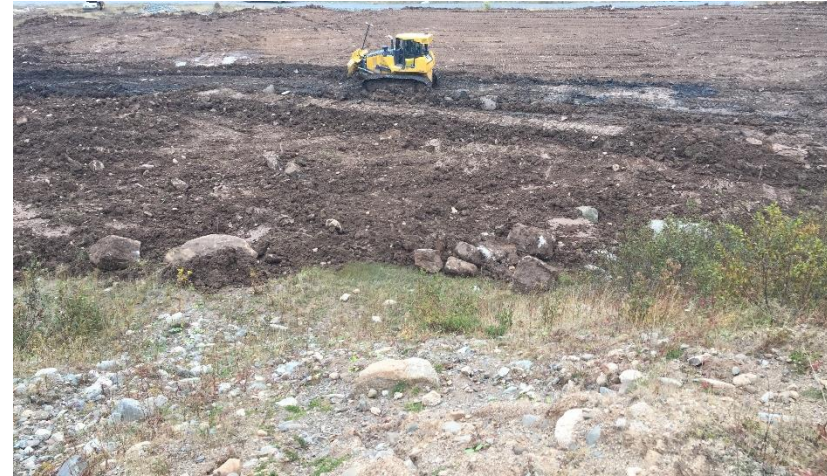
- Remediation of proposed Contact Water / Leachate treatment Pad Location

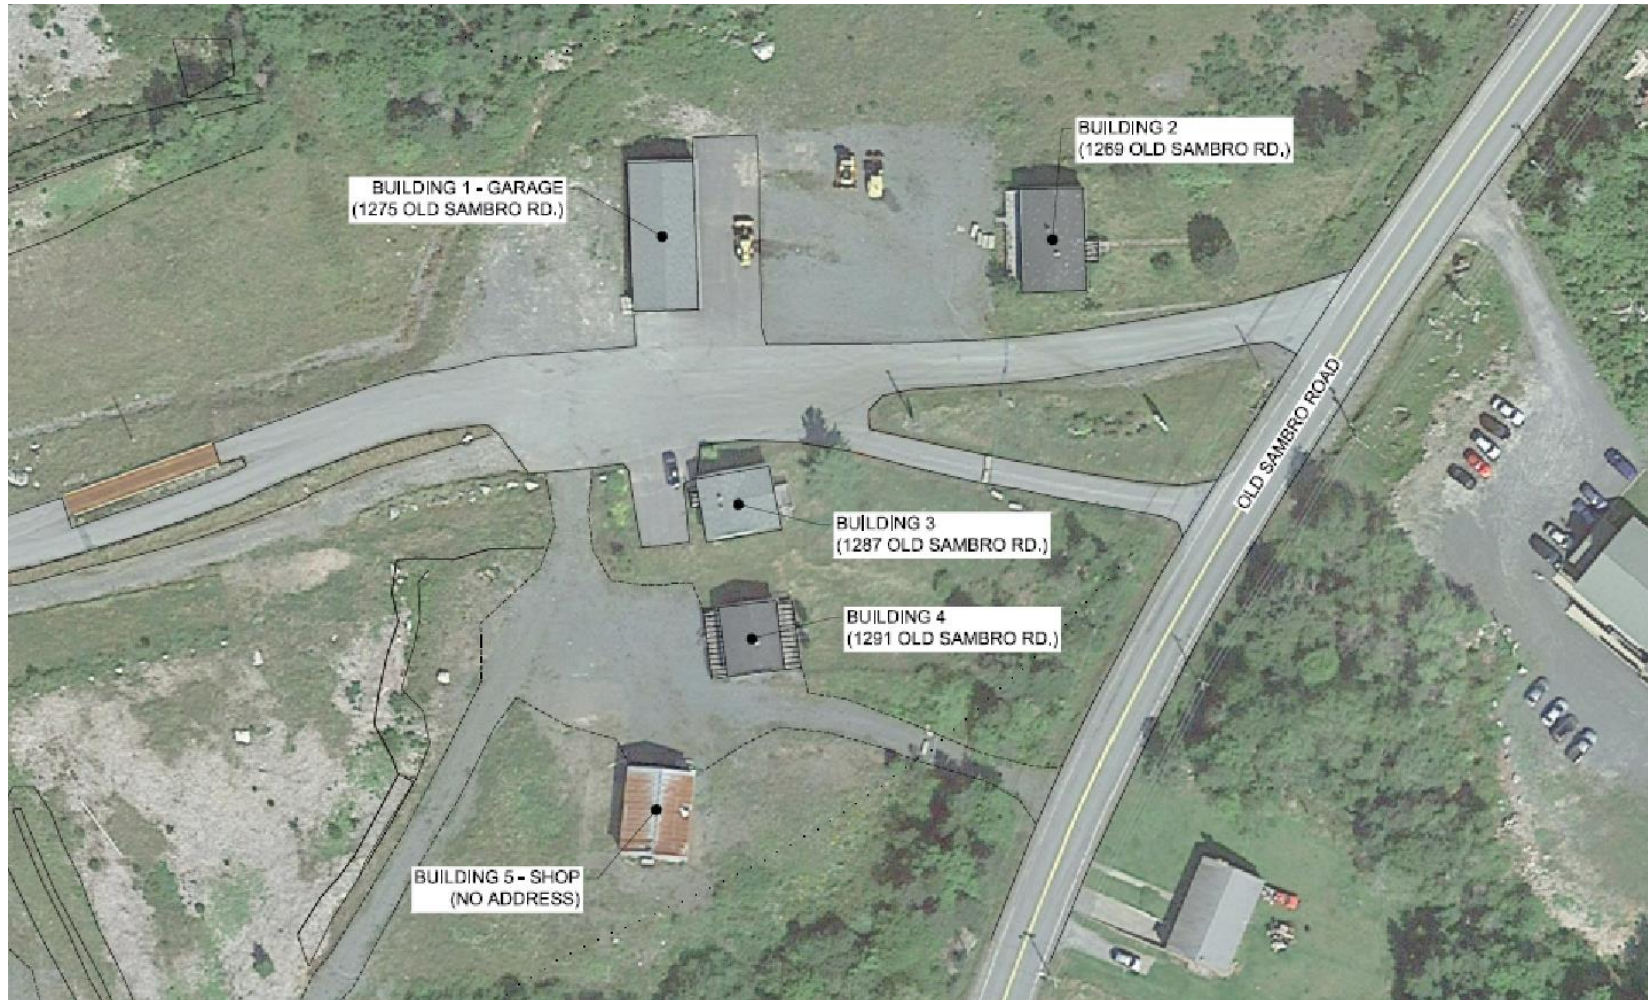
## Hazmat Assessment of on-site buildings and Sea Cans/Bins

Seacans and Waste Bins Hazmat: asbestos, paint, tires, compressed gas, tar, hydrocarbons

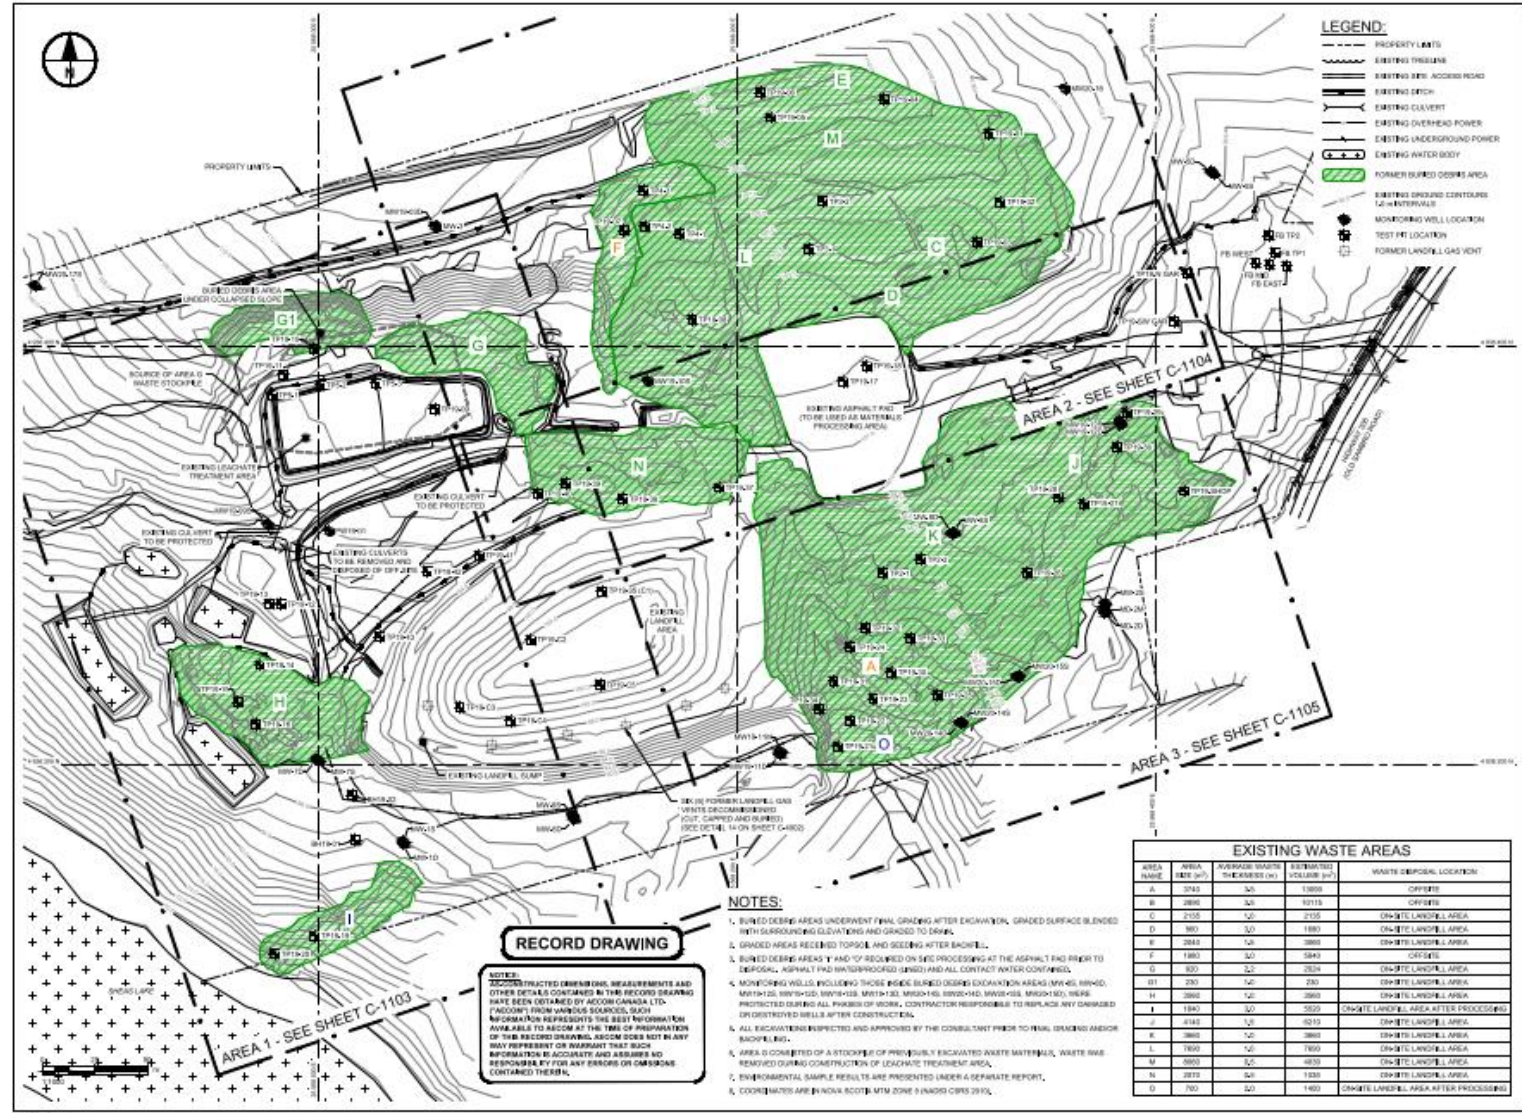
# Soil Remediation Areas

Waste Material Source	Disposal Facility	Approximate Truck Loads	Approximate Quantity (tonnes)
BDA A/B/O	Halifax C&D - Antrim	1,847	35,488
BDA A/B/O	Groundfix Remediation Services	659	16,271
BDA F	Groundfix Remediation Services	168	3,881
BDA A	Envirosoil	18	336
Building 1 Foot Print	Envirosoil	12	233
Area of Concern on Landfill Cap – PAH Contaminated Soil	Envirosoil	1	17
<b>Total</b>		2,705	56,225

- Originally estimate 40,900 tonnes to be disposed of off site.
- Additional 15,325 tonnes removed

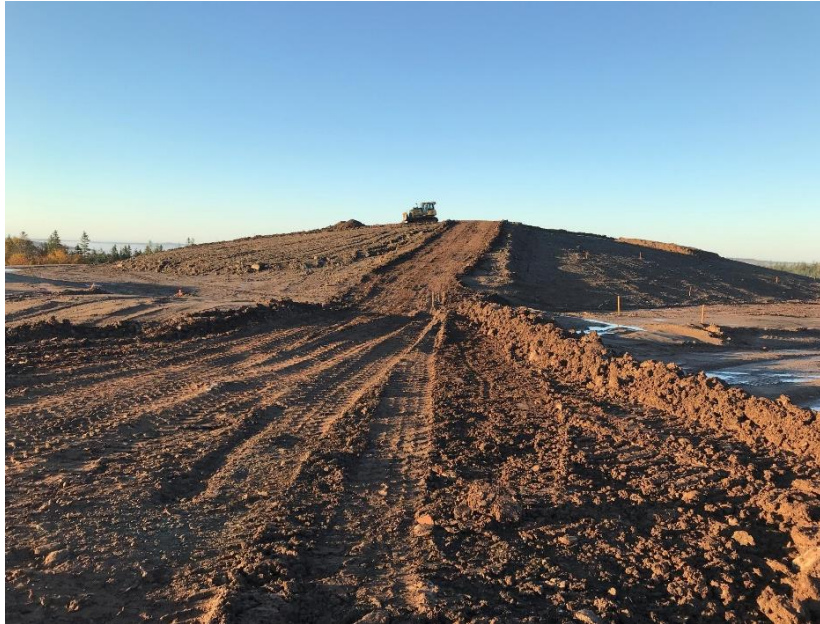
## Site Remediation – On Site Disposal

- Approximately 48,500 cubic meters of material
- Approximately 2,900 cubic meters required processing (bulky materials)

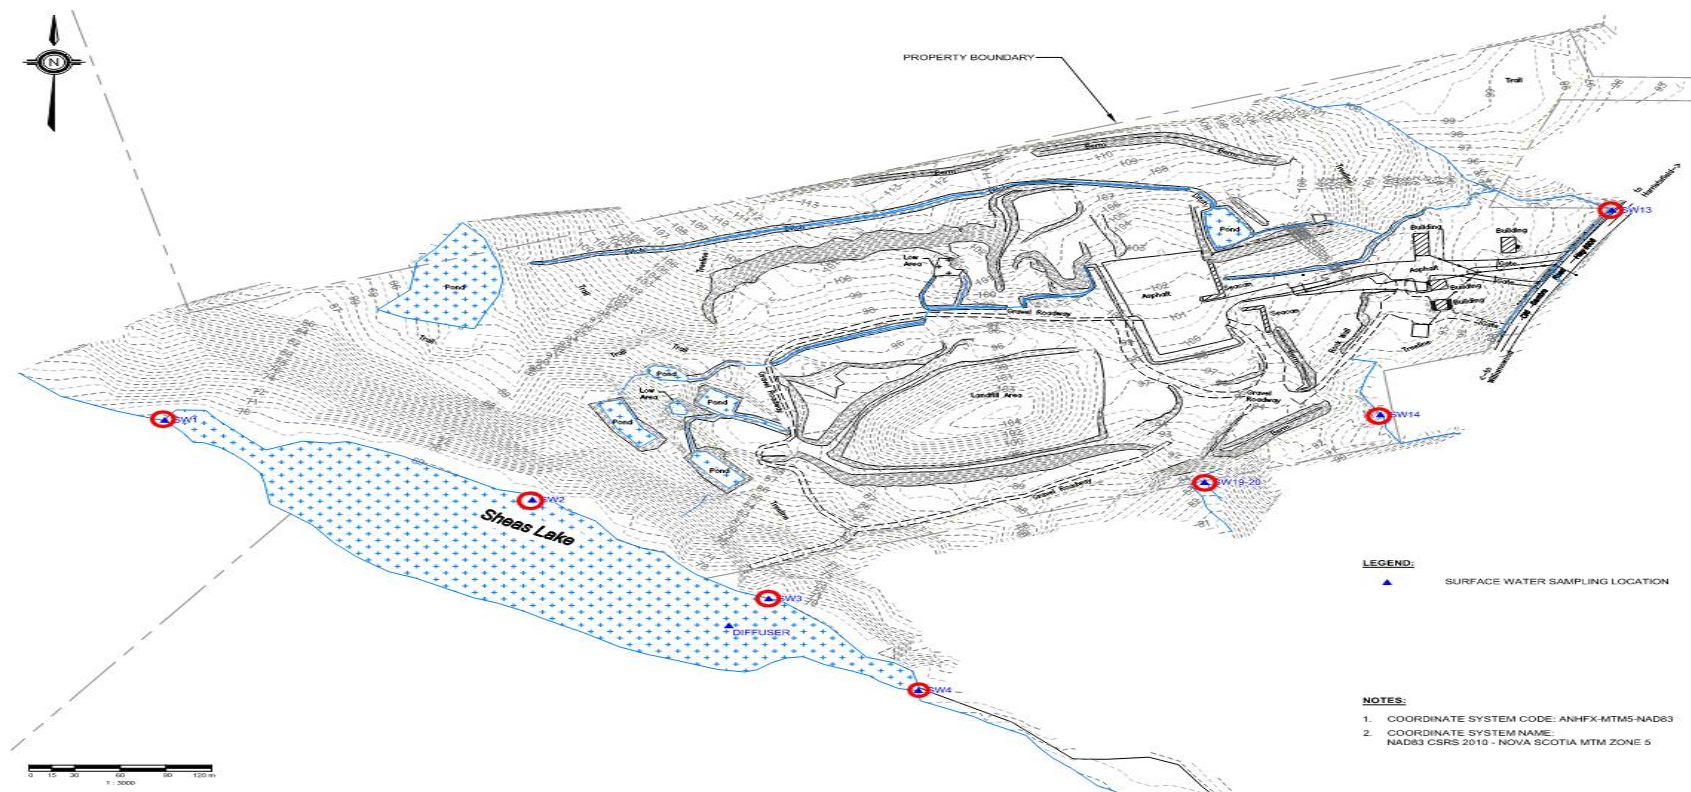
# Surface Water Sampling Locations

- Quarterly Groundwater Sampling Program
  - 31 on-site wells
- Bi-weekly surface water sampling program
  - 7 locations around site
- The annual report (October 2021) indicated upward trends in some parameters in surface water and groundwater
  - This was expected given the ongoing remedial construction.
- Quarterly reports since the end of construction have begun to suggest a downward or level trend, however, there has not been enough time since October 2021 to be able to confirm if this is part of a greater trend.
- More sampling data is required (1 year – 4 quarters, minimum) to assess conditions post construction
