# **Calgary Zoo Flood Mitigation**

Groundwater Management and Dewatering on an Island

# Introduction

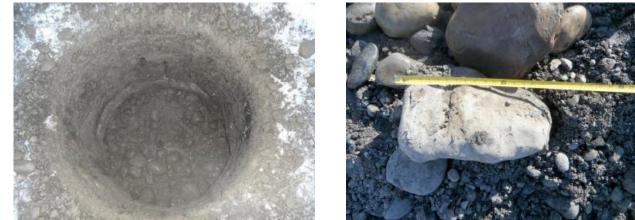
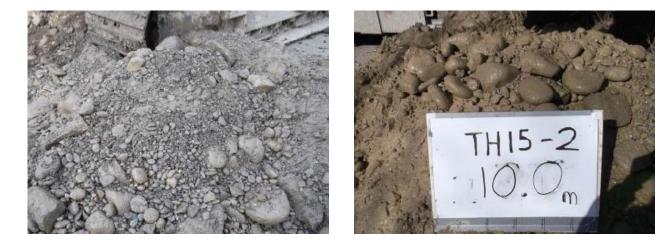
- St. George's Island consists of a thin clay/silt layer overlying sand, gravel, cobble and boulder deposits
- Paskapoo Formation bedrock consisting of fractured sandstone, shale and mudstone underlies the fluvial sediments
- The top of bedrock was interpreted to be higher at the downstream (eastern) end of the island
- Groundwater flow across the island follows the river from west to east
- The information available at the time suggested that the Bow River was the main source of the groundwater underlying the island

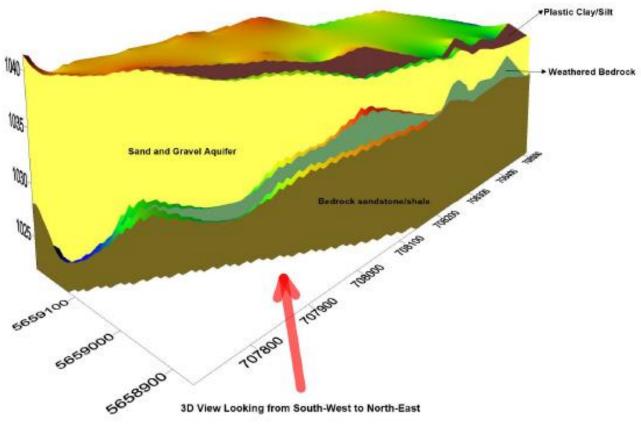
Figure 3-5 3D Conceptual Block Model

- A 3D numerical model was used to determine:
  - The leakage through the sheet piles
  - Duration of rise and fall of groundwater levels and volumes during a flood
  - The required pumping rates for dewatering wells
- The groundwater model was constructed by Associated Engineering prior to construction and was based on fairly limited information collected during initial investigations
- Various scenarios were considered, modelling both the passive and active system at leakage rates of 2%, 10% and 20%

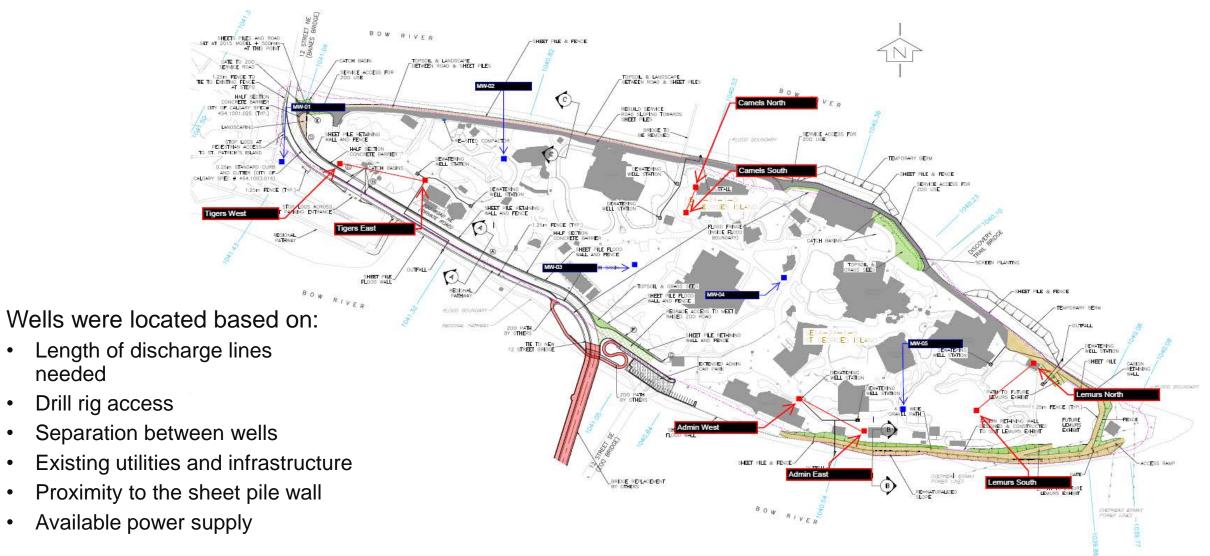
### **Dewatering and Monitoring Well Locations**

- Eight dewatering wells located across the island, each pumping at 15 L/s at least 11 days prior to a flood were determined to be needed
- Wells were to be located in vaults for ease of access and to not interrupt Zoo operations
- Dewatering wells were tied into existing or new stormwater outfalls to discharge water to the Bow River
- Dewatering wells were designed to be adaptive:
  - Well casings were oversized so that larger pumps could be installed
  - On/off switches could easily be adjusted
  - The system could be changed to an active system as long as power remained to the pumps
  - The discharge piping was oversized to be able to accommodate additional dewatering wells, if needed
- Five monitoring wells, one located outside the sheet piles, were also to be installed

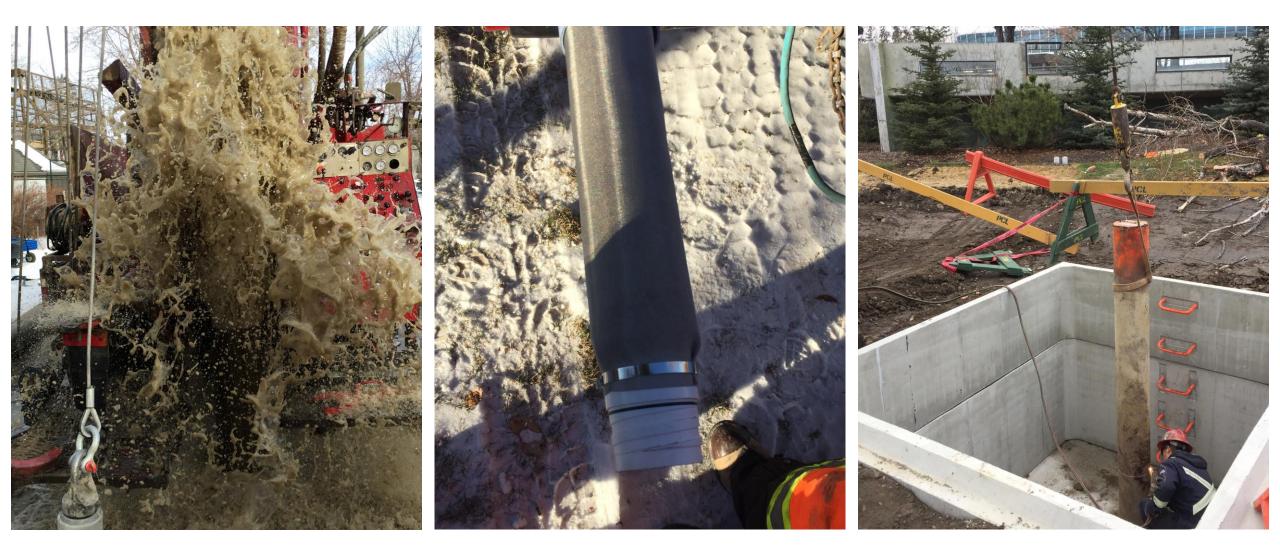
# Well Installation

- Upper 2.0 3.5 m was hydrovacced due to unknown utility locations throughout the Zoo
- Dewatering and monitoring wells were installed using dual rotary techniques, advancing casing as the borehole was drilled
- Boreholes were advanced to bedrock, which was found to be shallow in the east and a thick layer in portions of the west-southwest part of the island
- Dewatering wells had grain size analyses completed and a purpose-built stainless steel screen made for each well
- The steel casing was retracted after screen installation, creating a natural pack from the fluvial sands and gravels
- As much of the sands and gravels were screened as possible while considering the depth of the vaults to be installed around the wells
- Monitoring wells were installed with 2" PVC prepacked screens

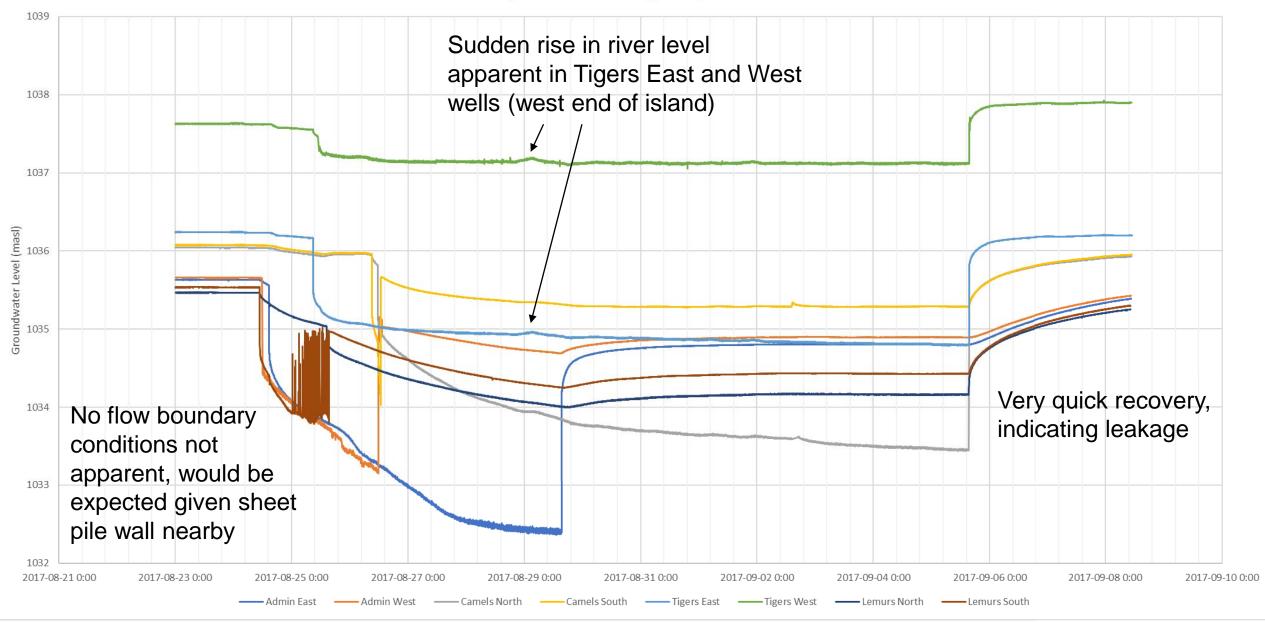
Dewatering Well Data from August-September 2017 Test

- Step and 8 hour constant rate pumping tests were conducted at each well to determine the individual well yields
- Permanent pumps were then installed at each well and connected to the discharge systems
- An initial entire system test was conducted for 4 to 5 days in June 2017, adjusting pumping rates and on/off switches to ensure water levels reached steady-state conditions and did not enter the pump intake
- A 14 day pumping test was conducted in August and September 2017 to determine the effectiveness of the dewatering system and to calculate the leakage rate

- Numerical model was updated and the leakage rate was calculated to be 8%, within the original design parameters
- Quick recovery in dewatering wells points to additional sources of water:
  - Sheet piles may not have reached bedrock in the west end of the island given the increased depth to bedrock
  - Fractured bedrock
- Drawdown across the island did not reach required values and most of the dewatering wells could not pump at the desired 15 L/s
- Only protected against a 1:20 to 1:40 year flood
- More dewatering wells determined to be needed along with upgrading the pump in the higher capacity Tigers West well and adjusting on/off sensors
- New well locations were chosen to be in areas with the greatest aquifer thickness

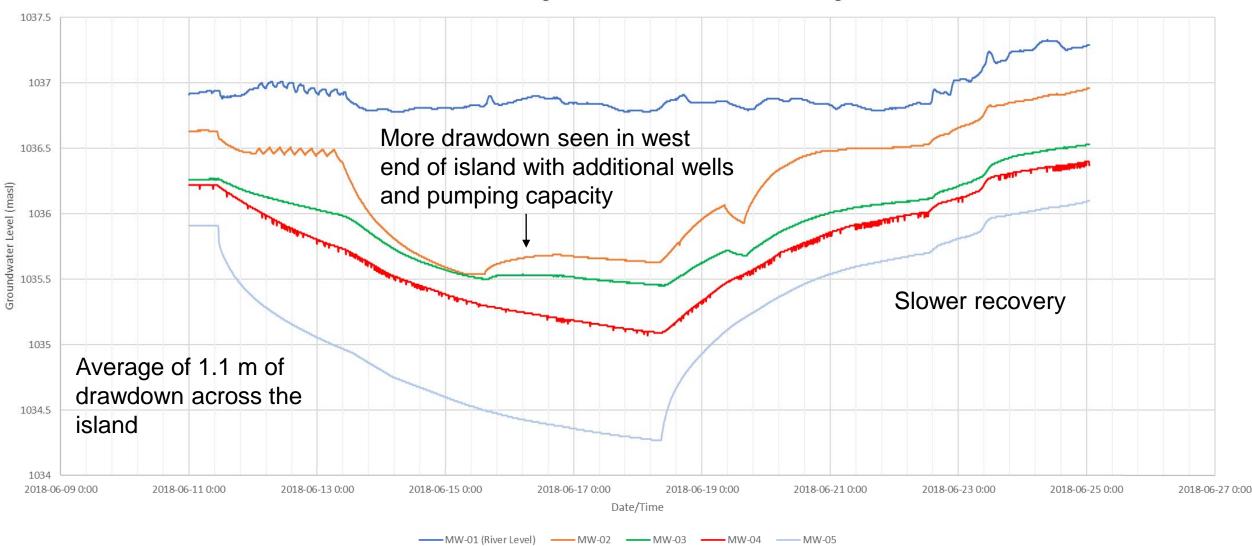
Groundwater Monitoring Well Data From June 2018 Commissioning Test

- After upgrading the pump in one well, the installation of two additional wells and the associated individual well pumping tests, sufficient dewatering capacity was gained
- All wells were installed, connected and operational prior to the flood season and Panda Passage opening in May 2018
- A final, full system test was conducted over a 7 day period in June 2018

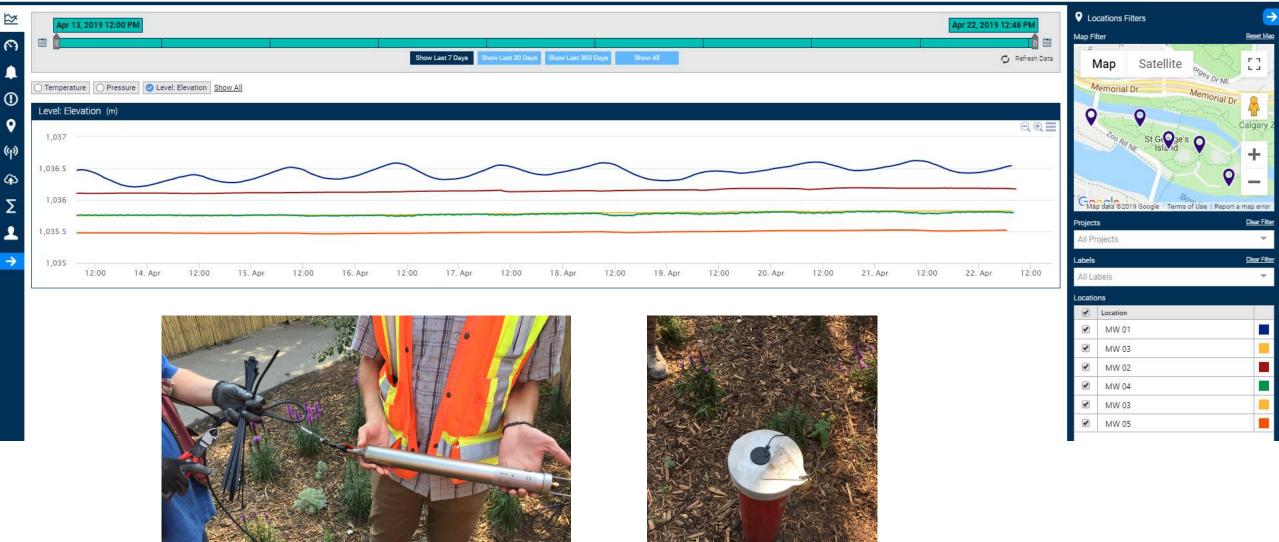
- Dewatering wells are operational from May to September every year and are winterized the remainder of the year
- On/off switches in the wells were optimized based on the pumping tests and numerical model to ensure adequate, sustainable drawdown across the island
- Dewatering wells operate automatically according to the on/off sensors and can be monitored from the Zoo's central control system
- Monitoring wells were fitted with telemetry systems that record groundwater levels and can be viewed via a website in near real time
- The dewatering system is integrated into the Zoo's flood response procedures

HydroVu

Notifications
