Remediation of a Coal Waste Pile in Union Bay, BC

Tara Siemens, MET and Ian Mitchell, MSc, PGeo
SEACOR Environmental Inc.

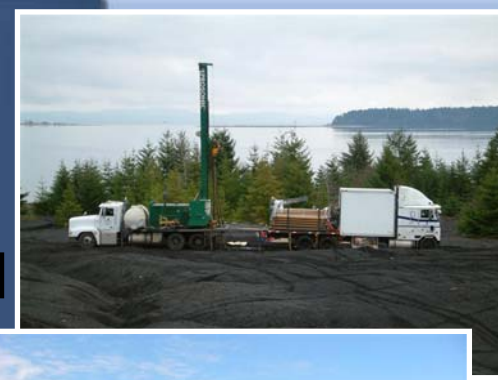
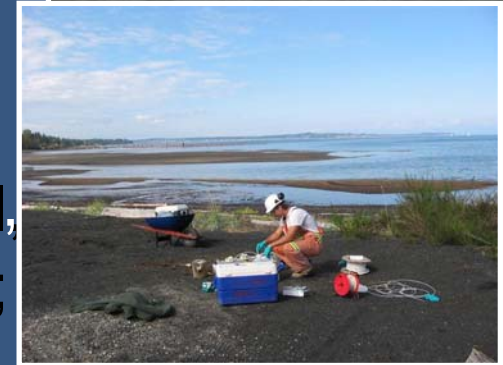
Waste Coal Pile - Results

- Waste Coal: arsenic, copper, naphthalene and phenanthrene > standards
- Native soils < standards
- Groundwater: cadmium, cobalt, copper, nickel, zinc and sulphate > standards for aquatic life; PAHs < standards

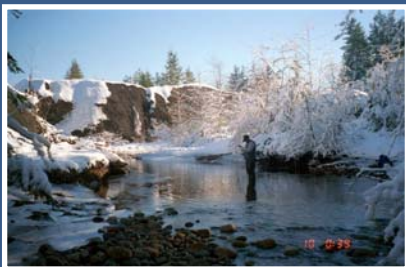
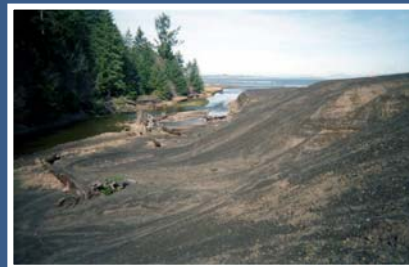
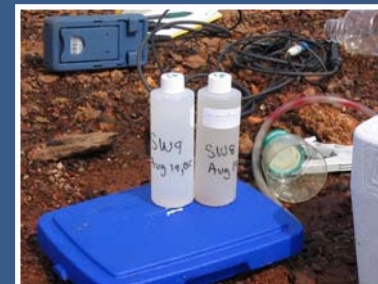
Hart Creek - Results

- Surface Water < criteria
- Sediment: PAHs and metals > criteria in 1 sample

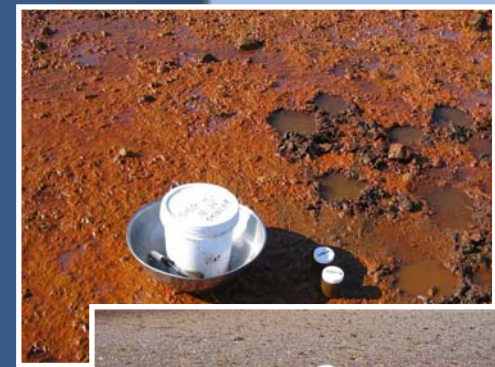
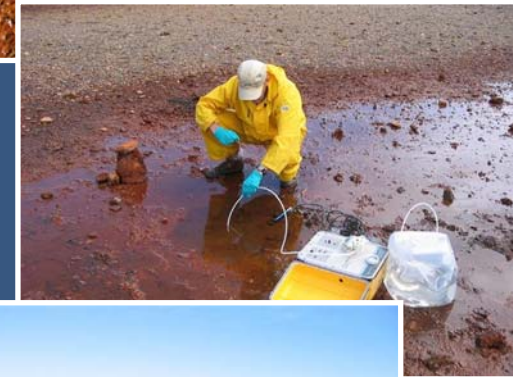
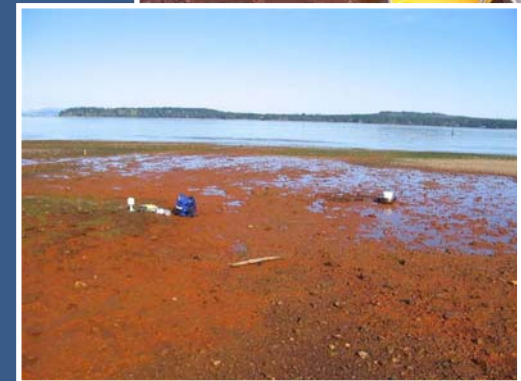
Baynes Sound - Results

- Waste coal present to > 30 m offshore
- Iron staining present in sediments north and east of coal pile in areas of groundwater discharge
- Sediment: PAHs and metals > criteria
 - 9 PAHs
 - Arsenic, copper and mercury
- Seep water: Metals > criteria
 - Aluminum, cadmium, cobalt, iron, manganese, nickel and zinc
 - ~ 10x's dilution of groundwater occurring during discharge to environment

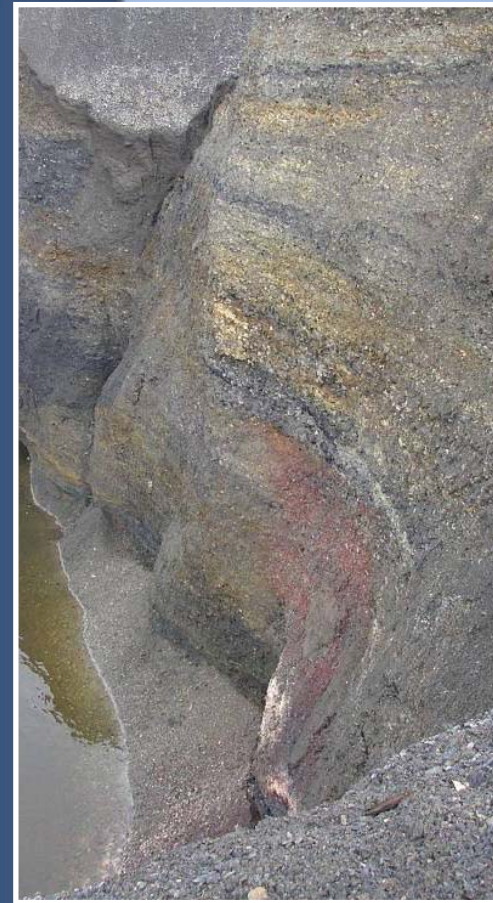
Geochemistry

- Geochemical characterization conducted by SRK Consulting (Canada) Inc.
- Static and kinetic testing conducted
- Testing indicated that all material is potentially acid generating or is already acidic
- Geochemical Profile
 - Sulphide sulphur present throughout
 - Accumulation of sulphate within top 2 m
 - Increasing pH and NP with depth
- Under existing conditions, acidification expected to continue for decades to a century

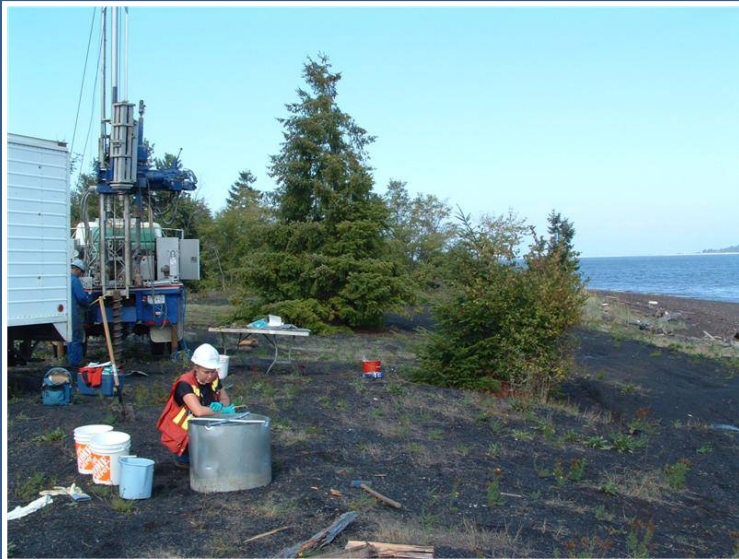
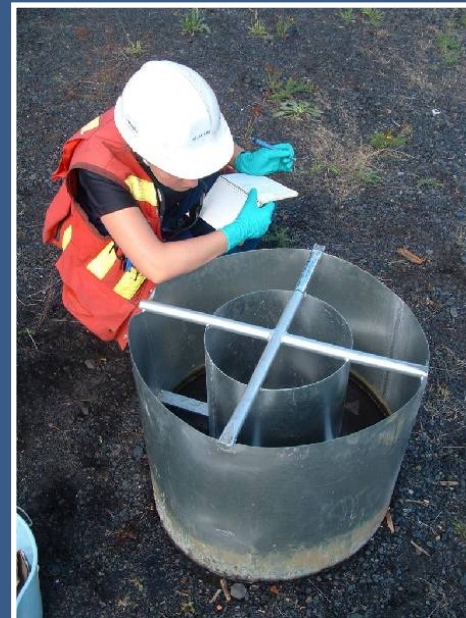
Infiltration Test Results

- Infiltration rate at 20cm depth is 5x greater than infiltration rate at typical surface locations
- Infiltration rate at typical surface locations is 10x greater than highly compacted surface areas

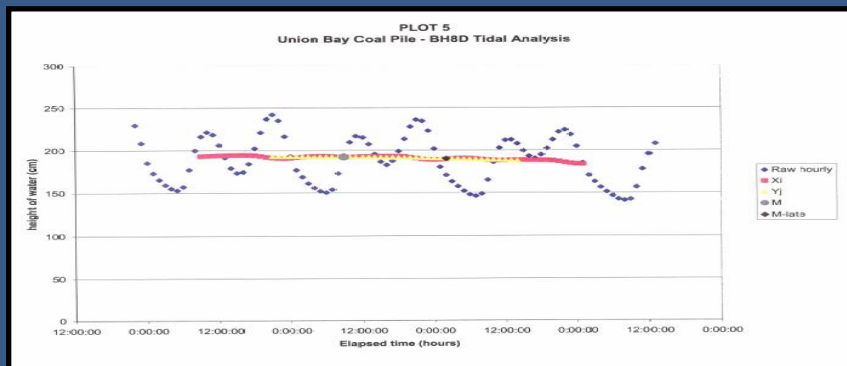
Tidal Analysis

- Tidally induced groundwater fluctuations 1.5m adjacent to foreshore; absent 400 metres inland
- Intrusion of saline groundwater observed to 75m inland
- Upgradient third of pile not exposed to tidal flushing

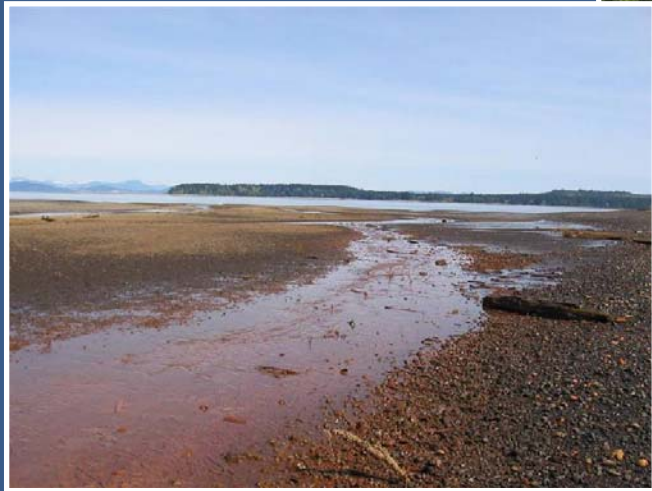
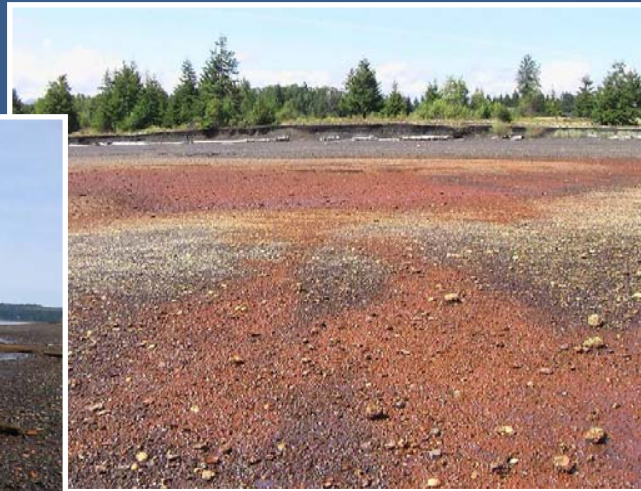
Summary of Groundwater Flow

- Estimated groundwater velocity in coal waste is 100-150 m/yr
- Estimated groundwater velocity in underlying native soil is 15-25 m/yr
- Net groundwater flow direction is towards the ocean

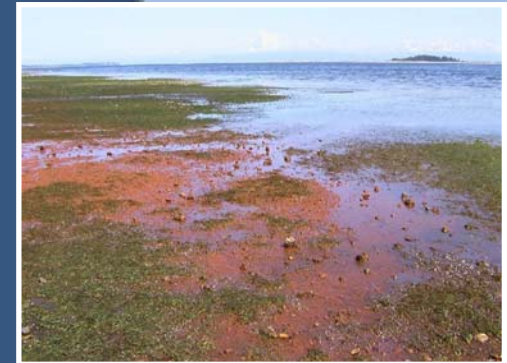
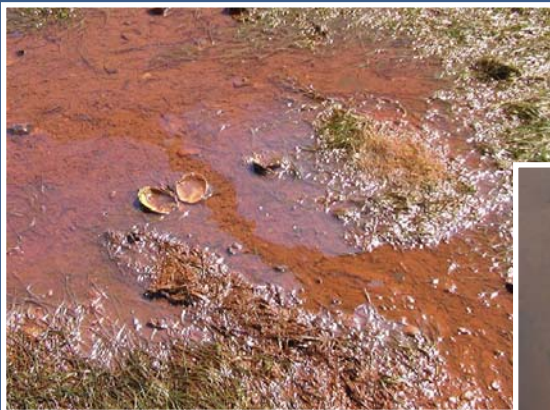
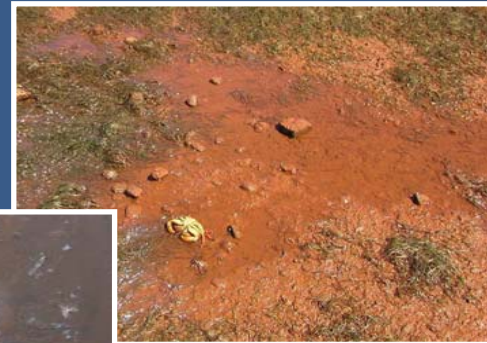
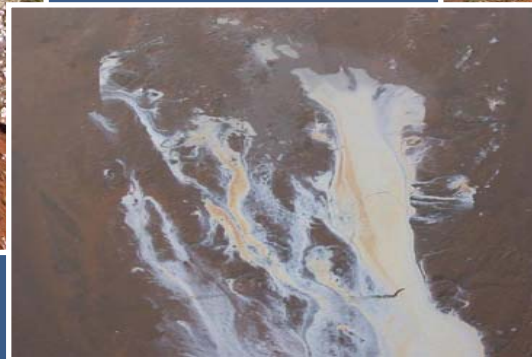
Important Conclusions

- Upgradient third of pile unsaturated at the base
- Upgradient side of pile not recharged by Hart Creek
- Contrast in conductivity promotes seepage along interface at base of pile
- Baseflow flushing through pile is relatively small component of overall discharge

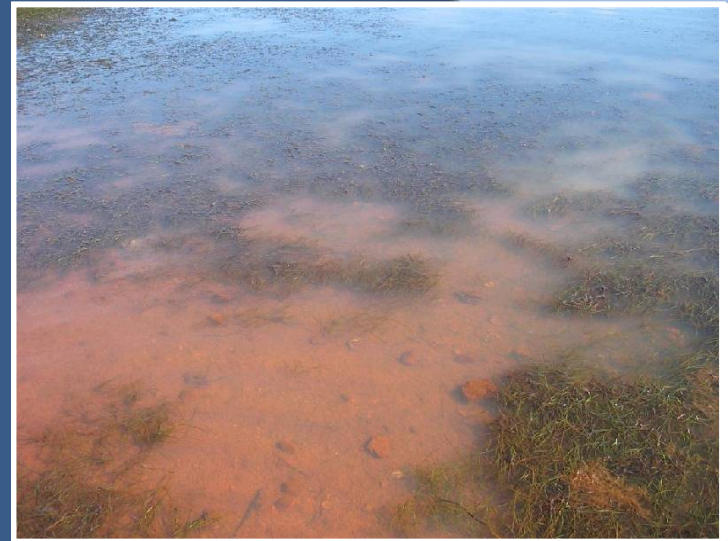
Remediation Plan

- Waste coal subdivided into 4 different zones:
 - Main pile (focus of presentation)
 - Hart Creek deposit
 - Tidal Zone deposit
 - Submarine deposit

Distinct characteristics indicate that different remedial strategies required for each zone

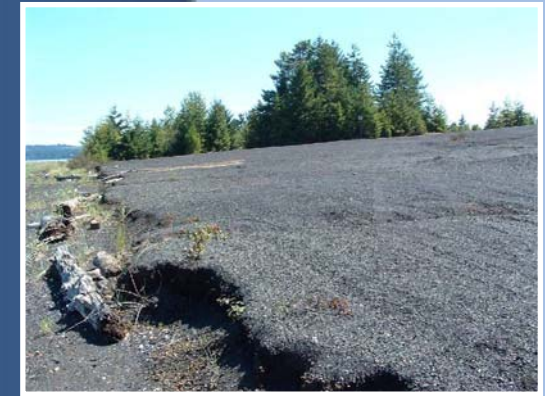
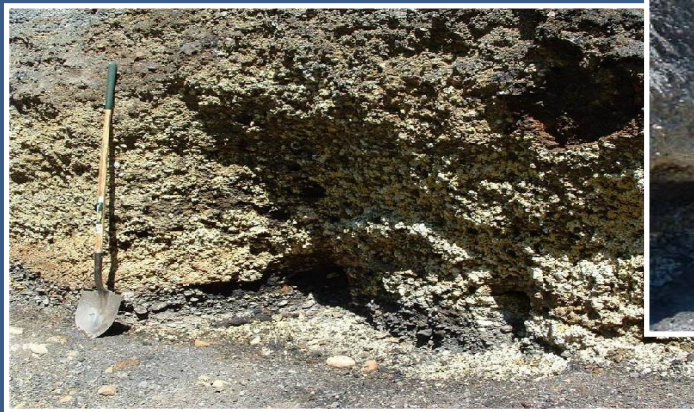
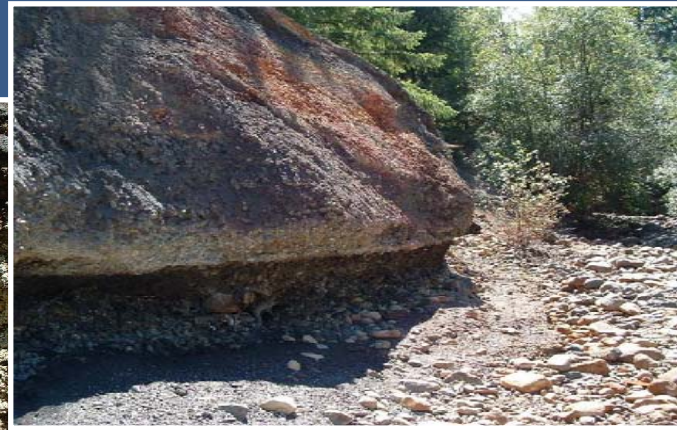
Remediation of Main Pile

- Pile forms a distinctly convex dome
- Coarse waste material results in a net downward flux of water
- Steep side slopes may destabilize over time as pile acidifies and cementation degrades
- Data indicates that direct revegetation is unlikely sustainable

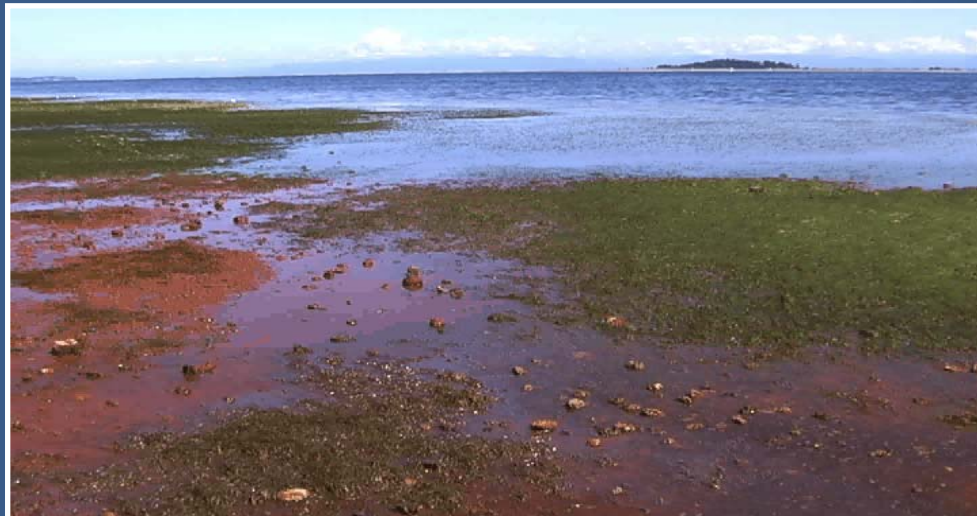
Potential Control Measures to Reduce Metal Loadings

- Alkaline amendment to offset excess acid potential
- Measures to control oxygen ingress to the pile
- Reduction or elimination of infiltration of water

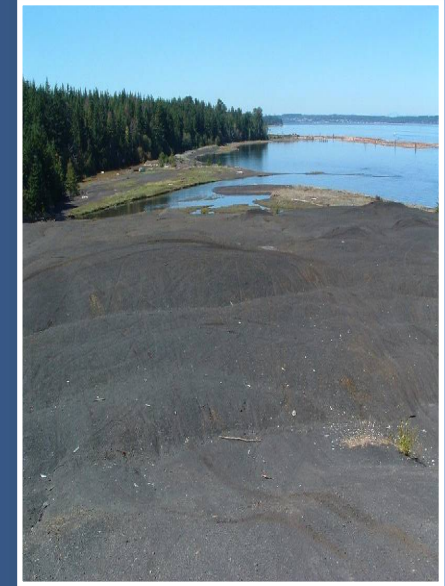
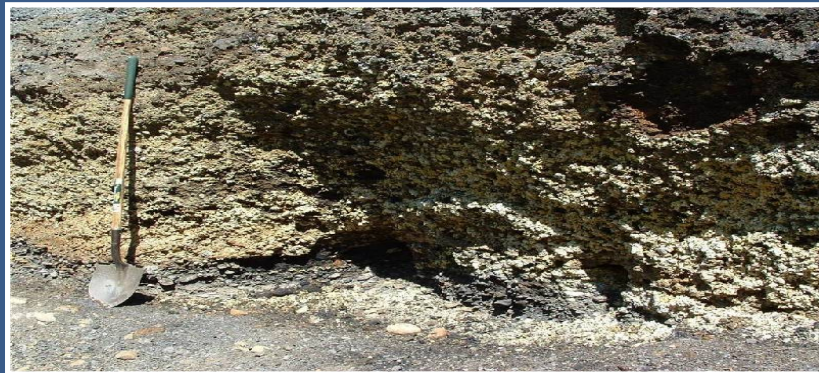
Cover Design Considerations

- Climatic water balance for the pile is net positive
- Main risk to low permeability cover is dessication due to wet/dry cycles
- Regrading of steep slopes required
- Special design considerations for contact areas with roadways, foundations

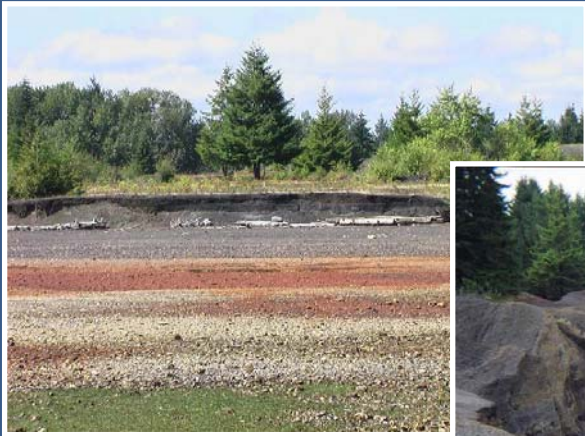
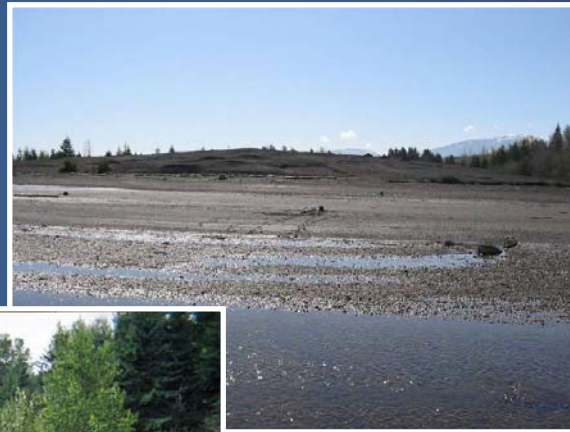
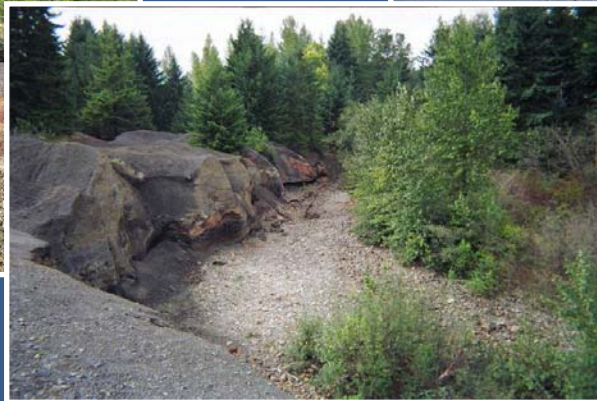
Path Forward

- Upper reaches of Hart Creek rechannelled in Sept 2005
- Risk based targets for groundwater currently being derived
- Slope regrading and capping of pile slated for summer 2006
