# Fracture Emplacement of a Micro-Iron/Carbon Amendment for TCE reduction in a Bedrock Aquifer

- What is Fracturing?
- Site Background and Objectives
- Pilot Program Design
- Emplacement of Treatment Amendment
- Initial Groundwater Quality Results
- Fracture Mapping Results
- Implications for Full Scale Remediation

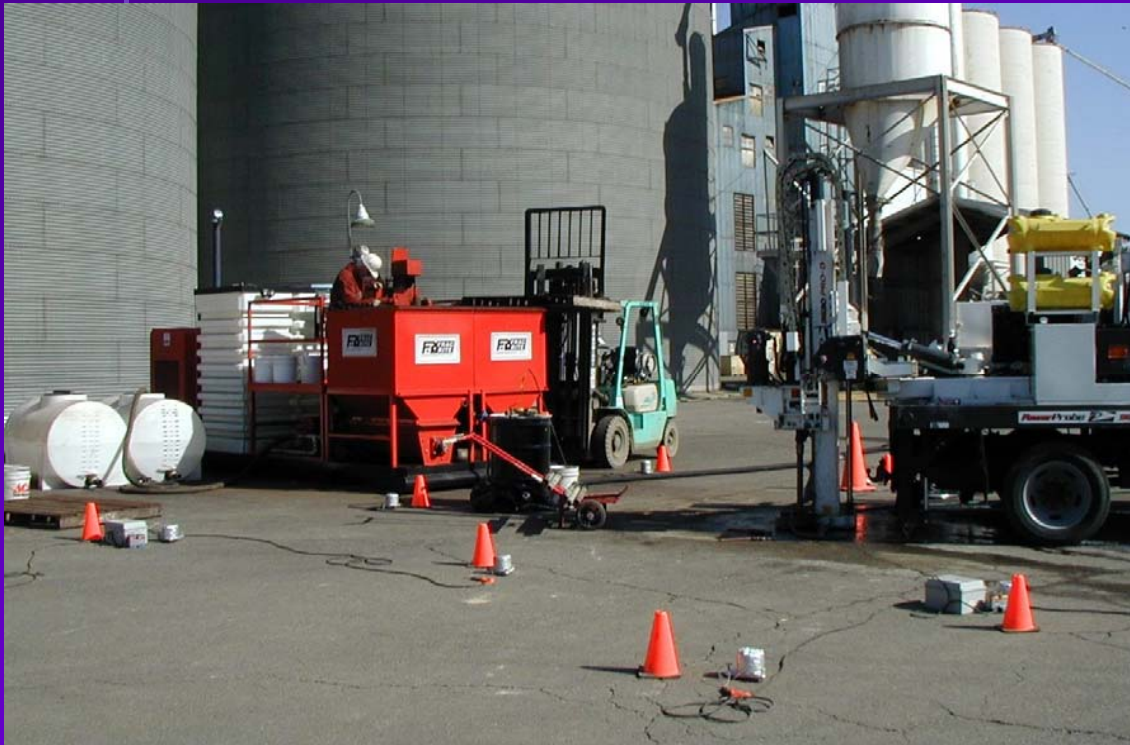
# Hydraulic Fracturing for Amendment Placement

- Mobile mixing tank and pumps
- Fluid Delivery System (gel)
- Drilling equipment
- Downhole Fracturing and Injection tools
- Real time pressure & flow data acquisition
- Fracture mapping equipment & modeling software

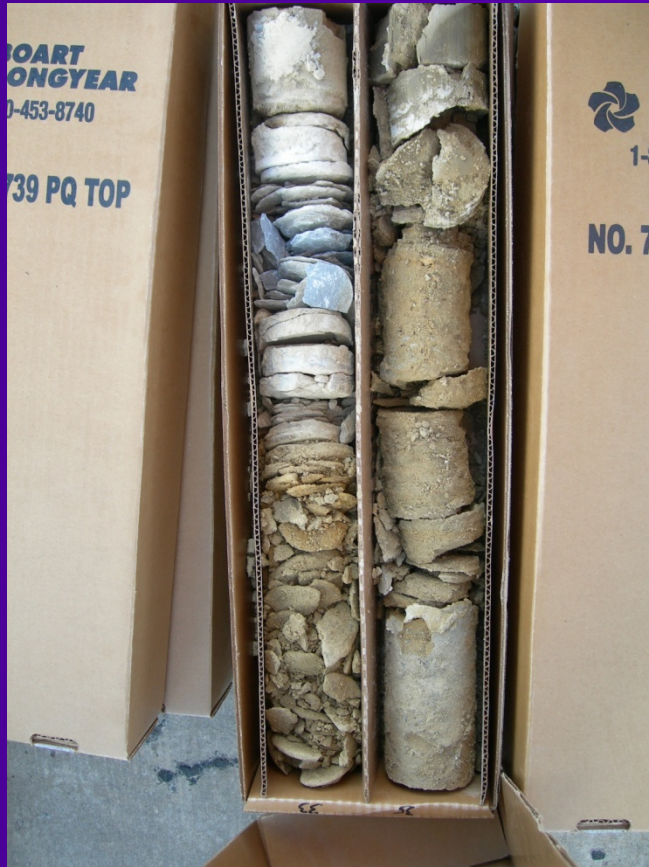
# Rock Testing Results

Sample tested from  
51 and 66 ft. depth  
– CIU Triaxial Tests

- Peak shear strength: 350 to 876 kPa
- Cohesive Strength: 45 to 75 kPa

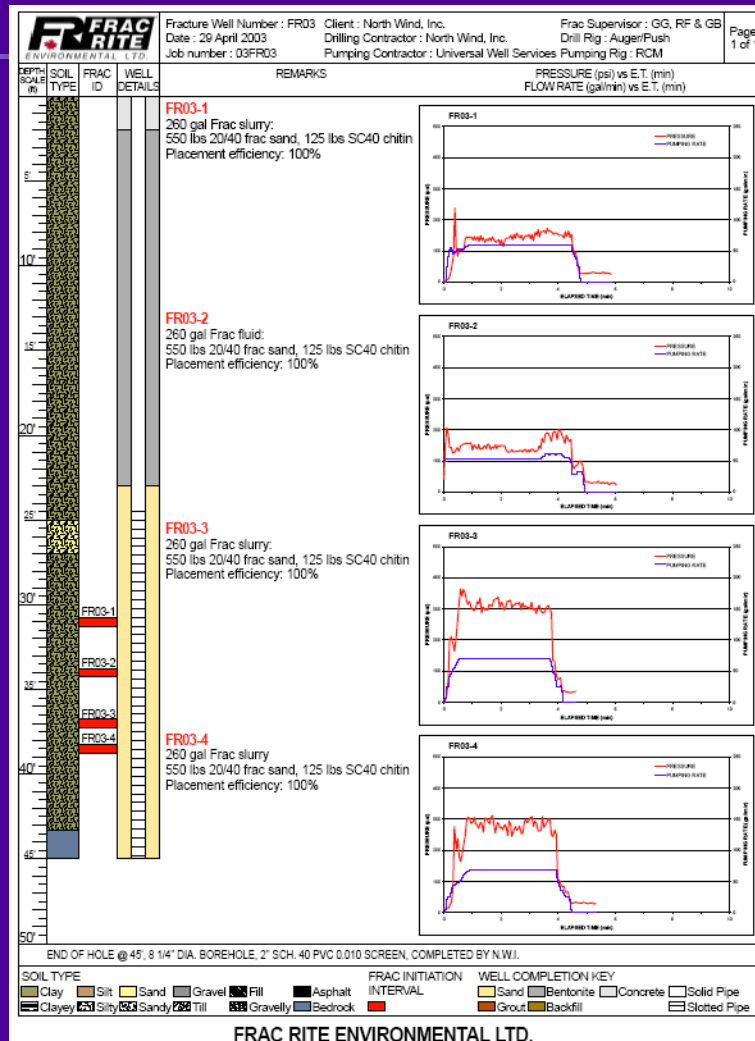
# Fracture Borehole Log

- Pressure vs. time characteristics indicate operational fracture pressures:
- “Break” Pressure – indicates pressure at which bedrock breaks (i.e. fractures)
- “Propagation” Pressure – indicates pressure required to radiate fracture outward from borehole

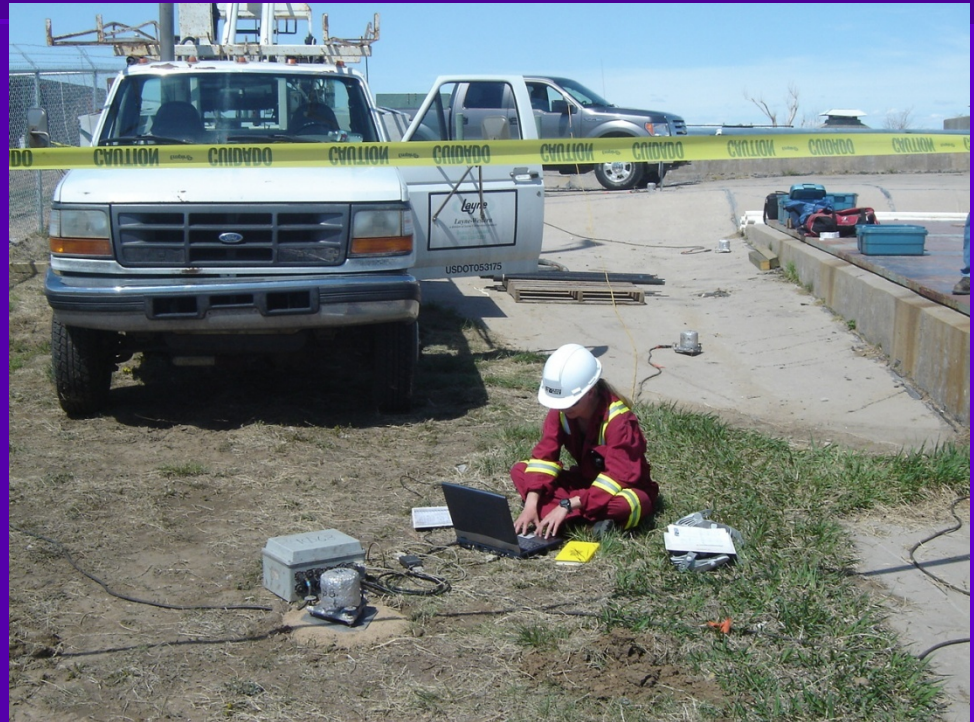
# Fracture Mapping using Tiltmeter Geophysics

- Tiltmeters are ground surface sensors that detect tilt angle and tilt direction in response to a fracturing or injection event in the subsurface

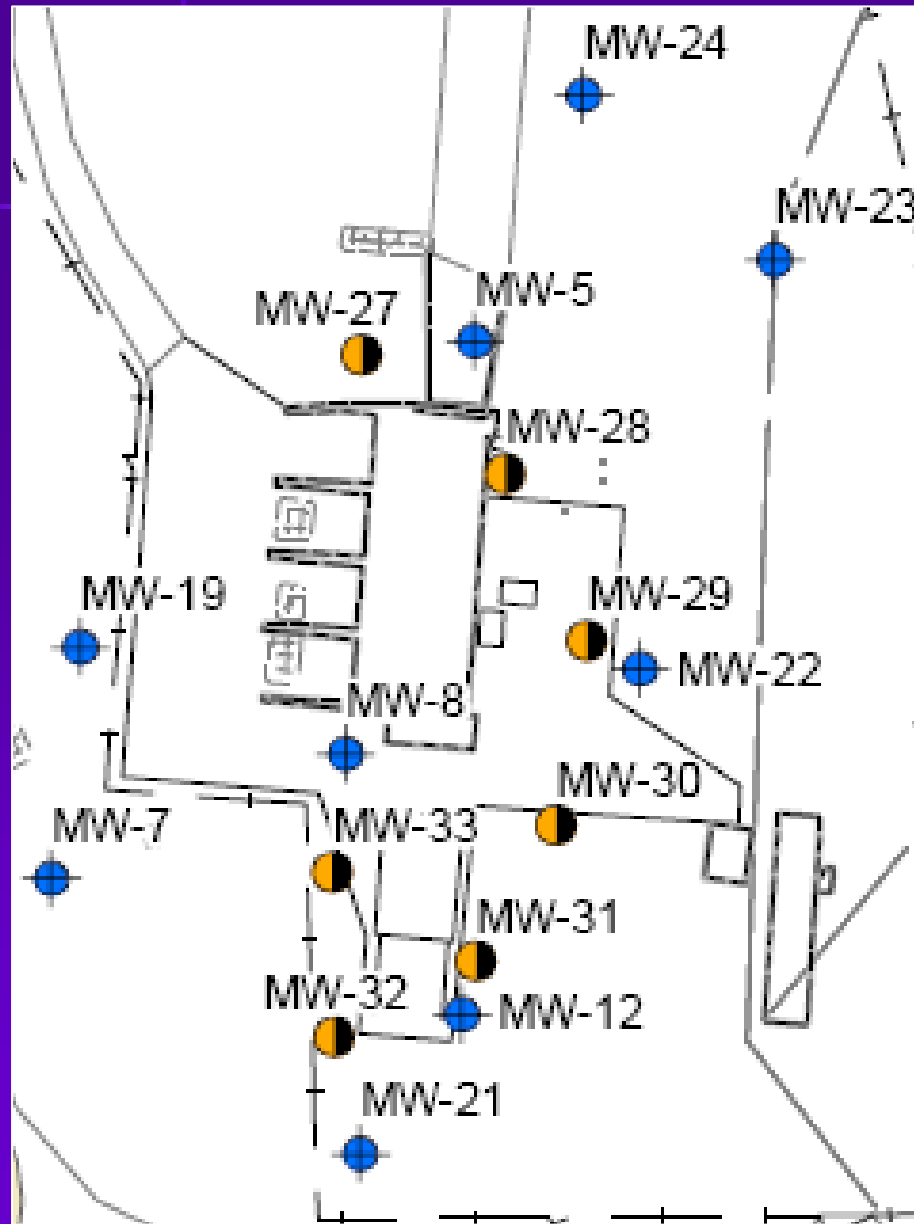
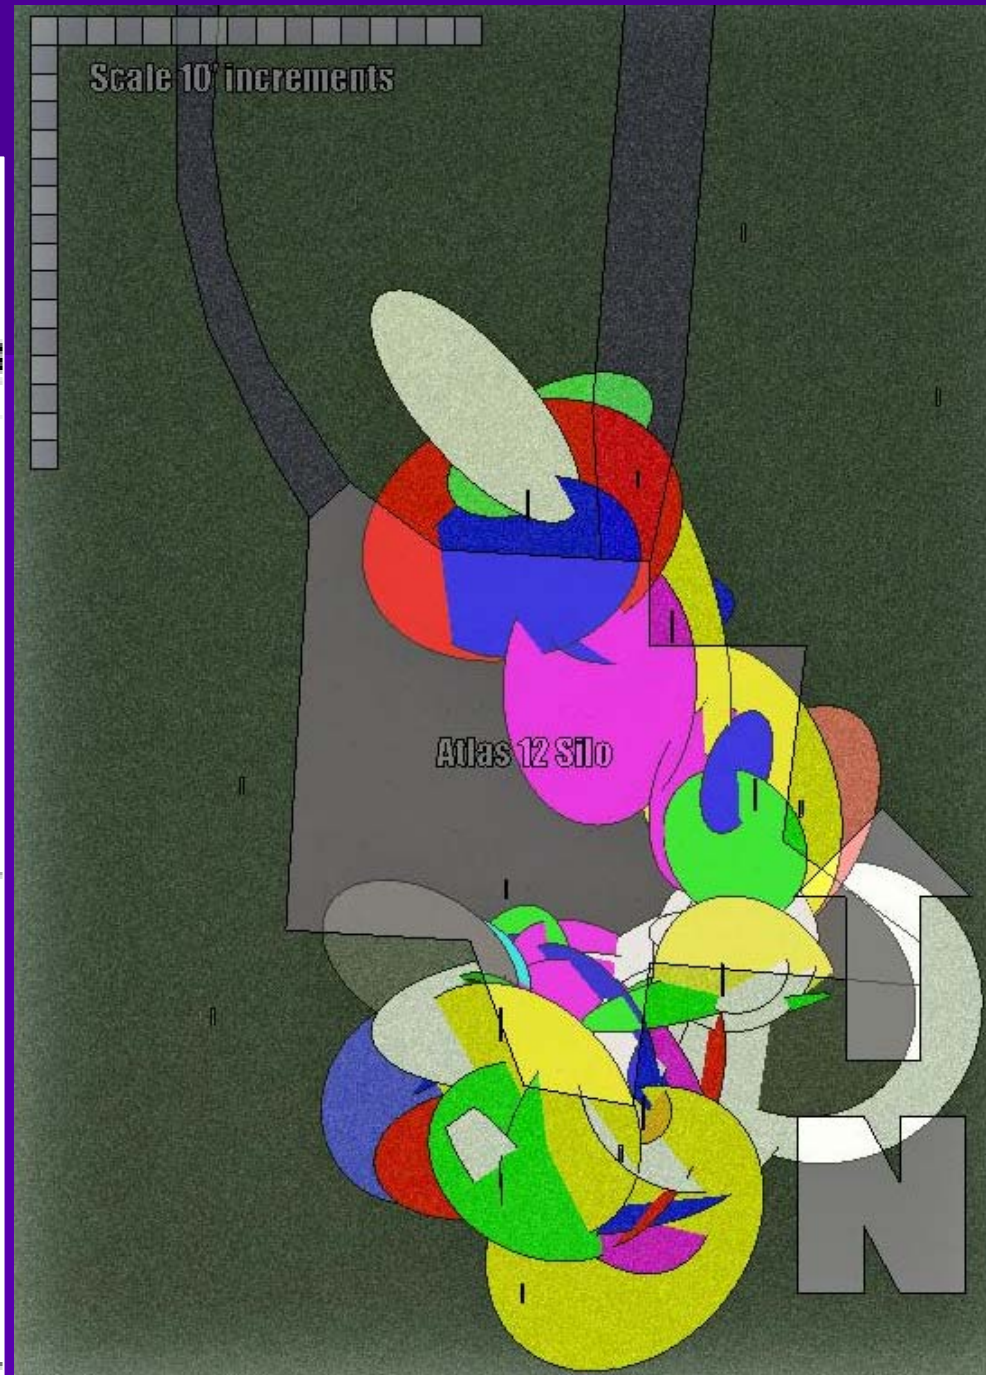
# Fracture Mapping

Conducted for 7 boreholes in source area

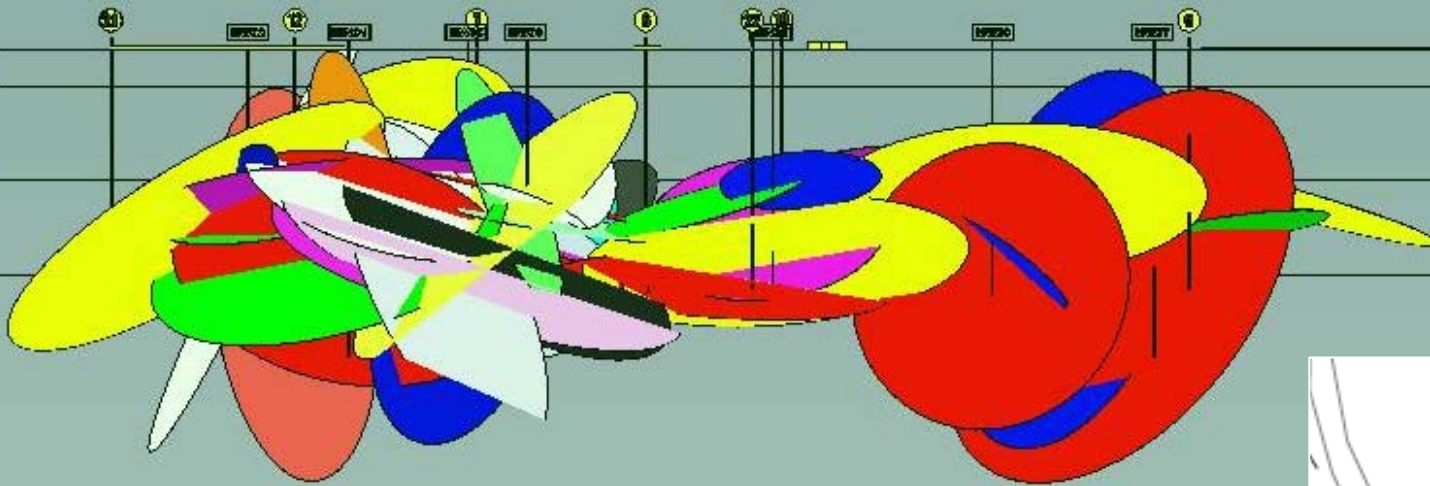
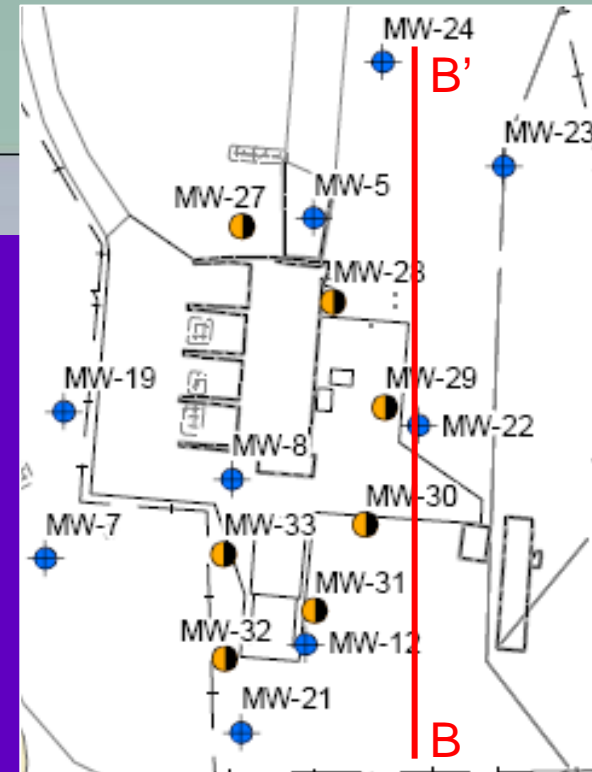
# Fracture Mapping

From MW-22 looking west

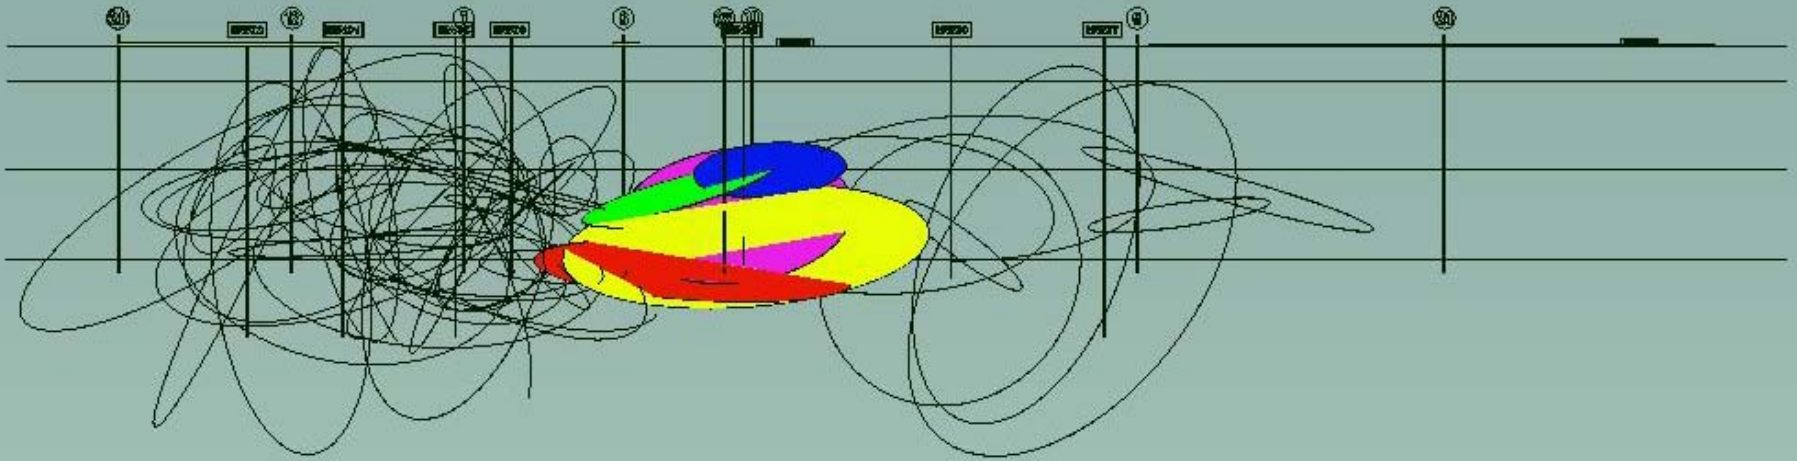
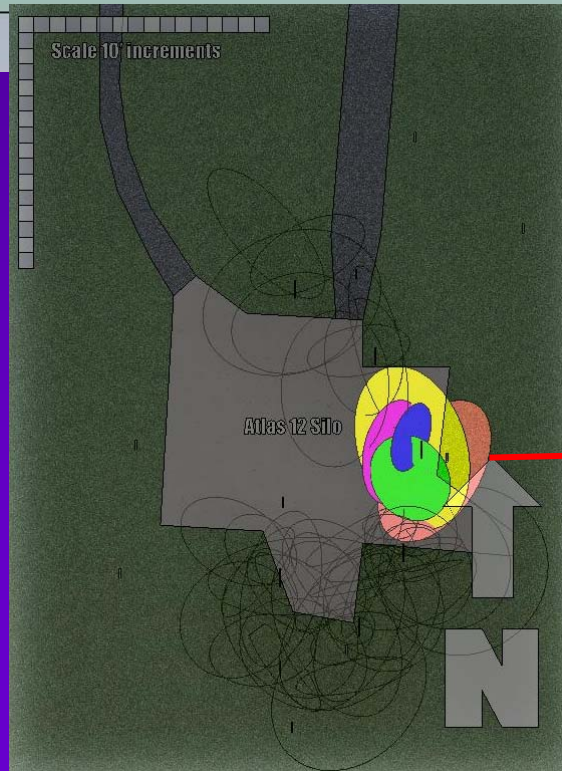
# Fracture Mapping- MW-29

Scale 10' increments

Atlas 12 Silo

32,000 lbs;  
5 depths
