Giant Mine Remediation Project

RemTech,
Banff, AB Oct 2009

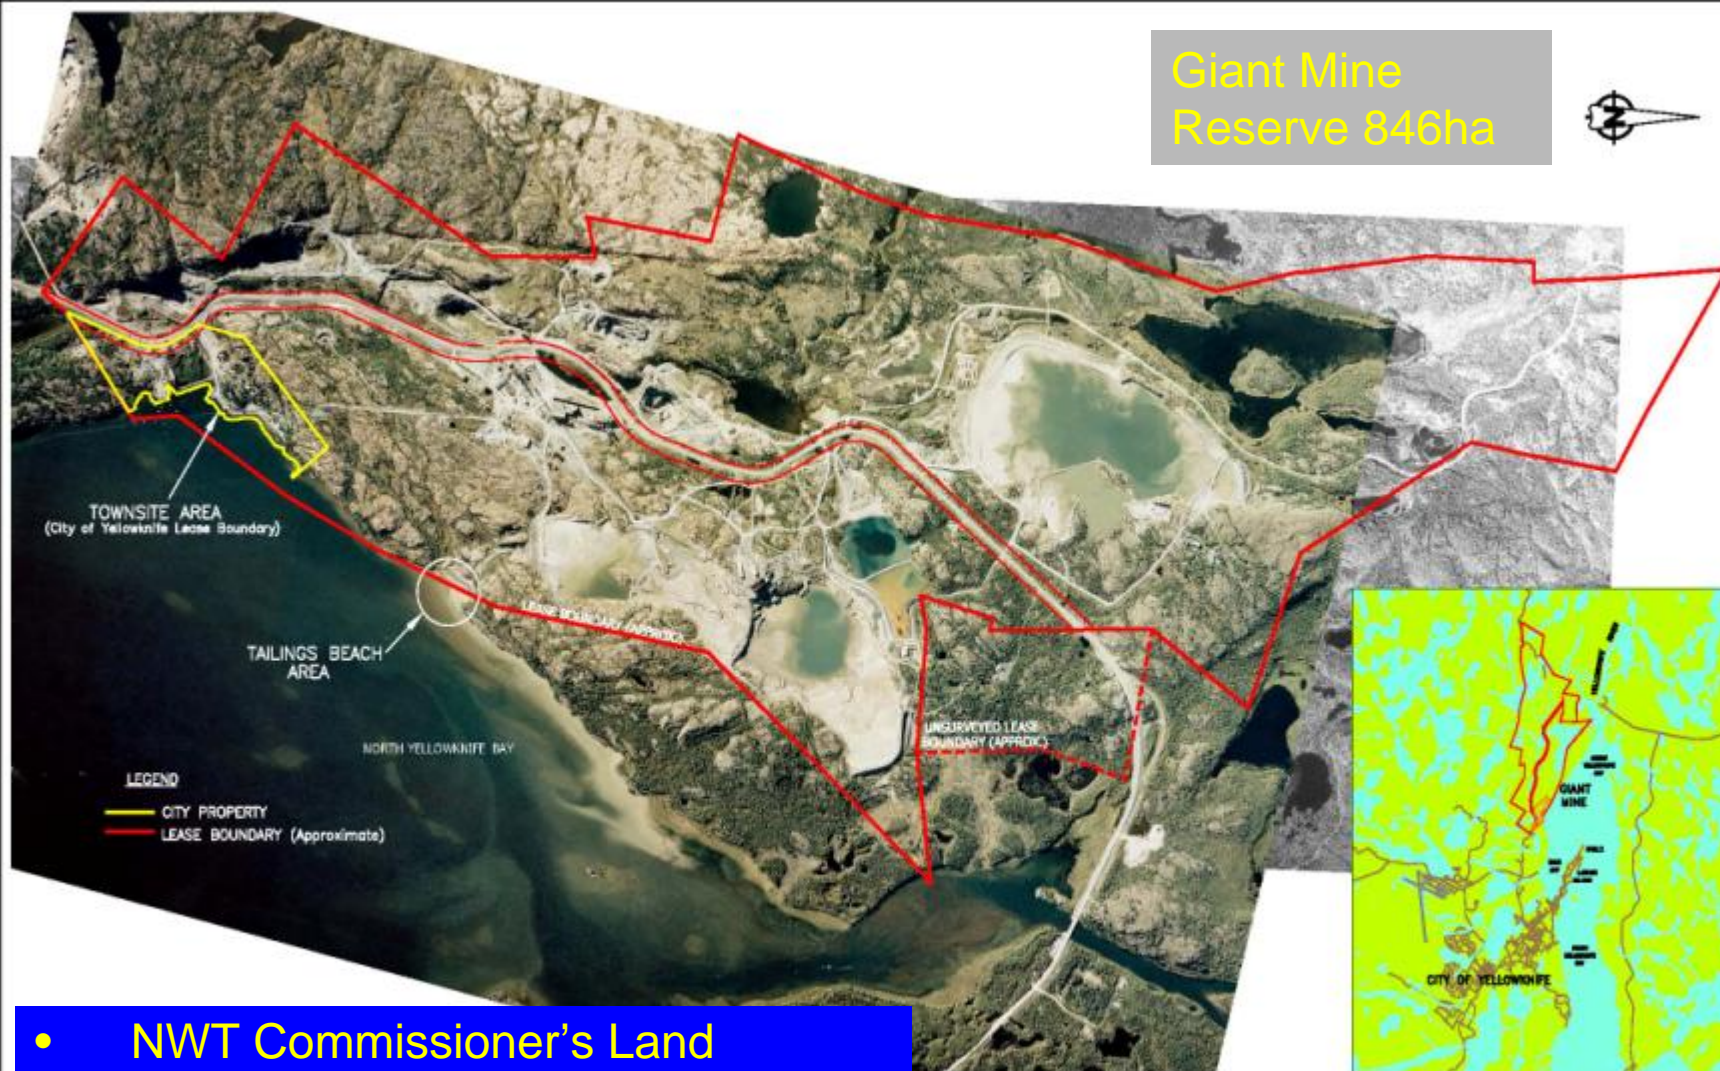
Giant Mine Reserve 846ha

- NWT Commissioner's Land
- Within Yellowknife City Limits
- Includes Town Site

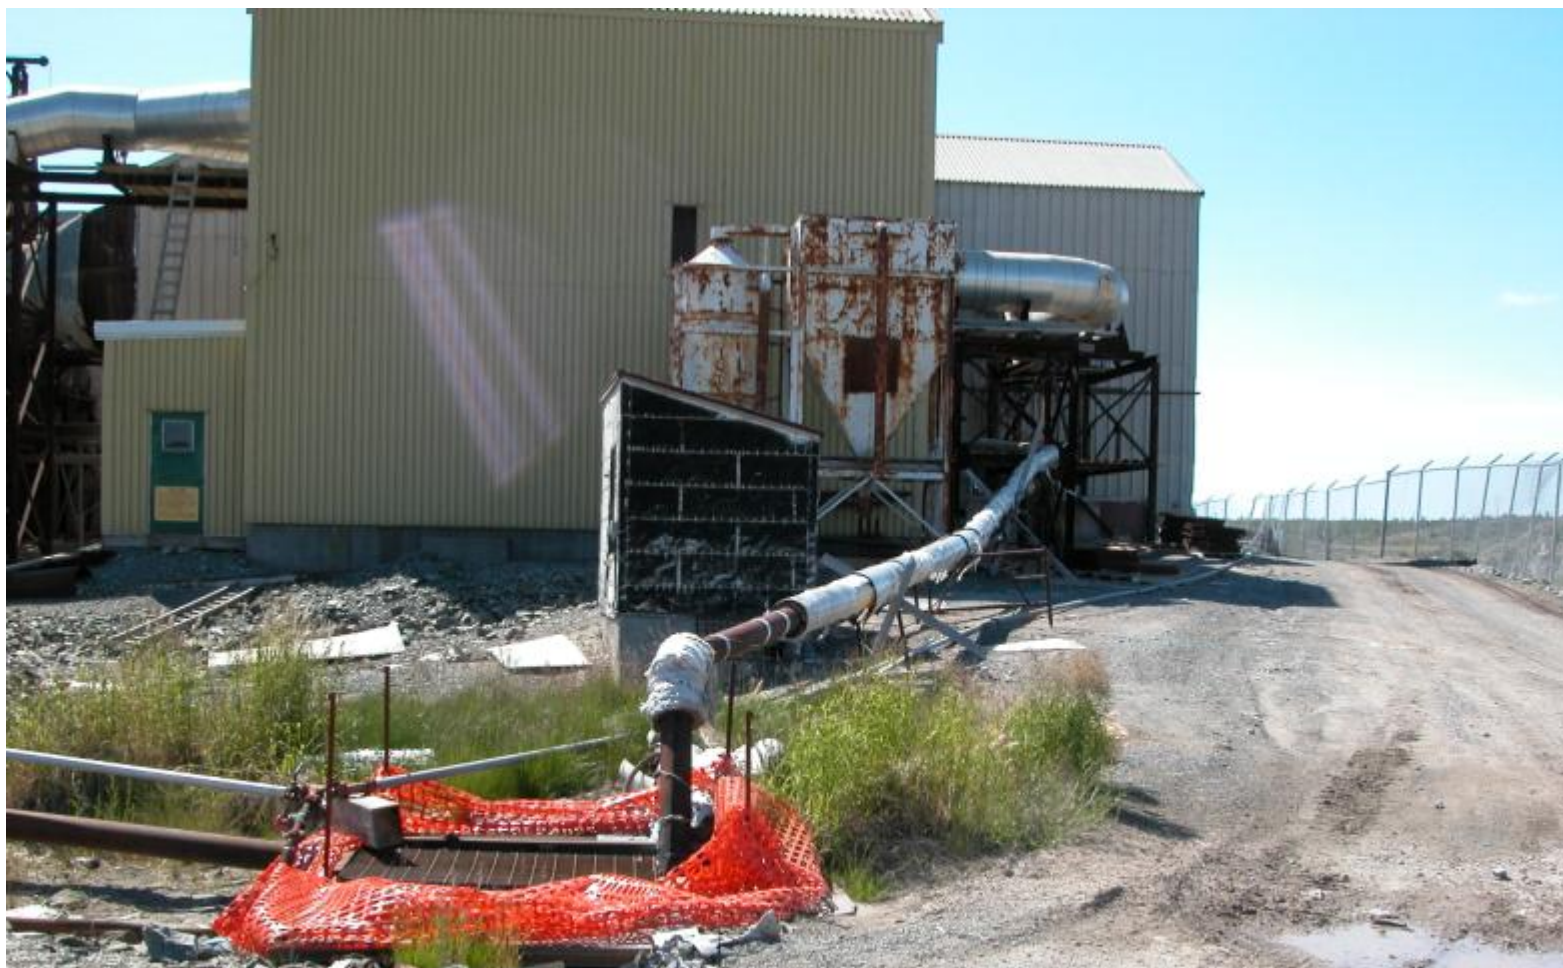
■ Roasting process to extract gold produced 237,000 tonnes of arsenic dust as byproduct – now in underground storage

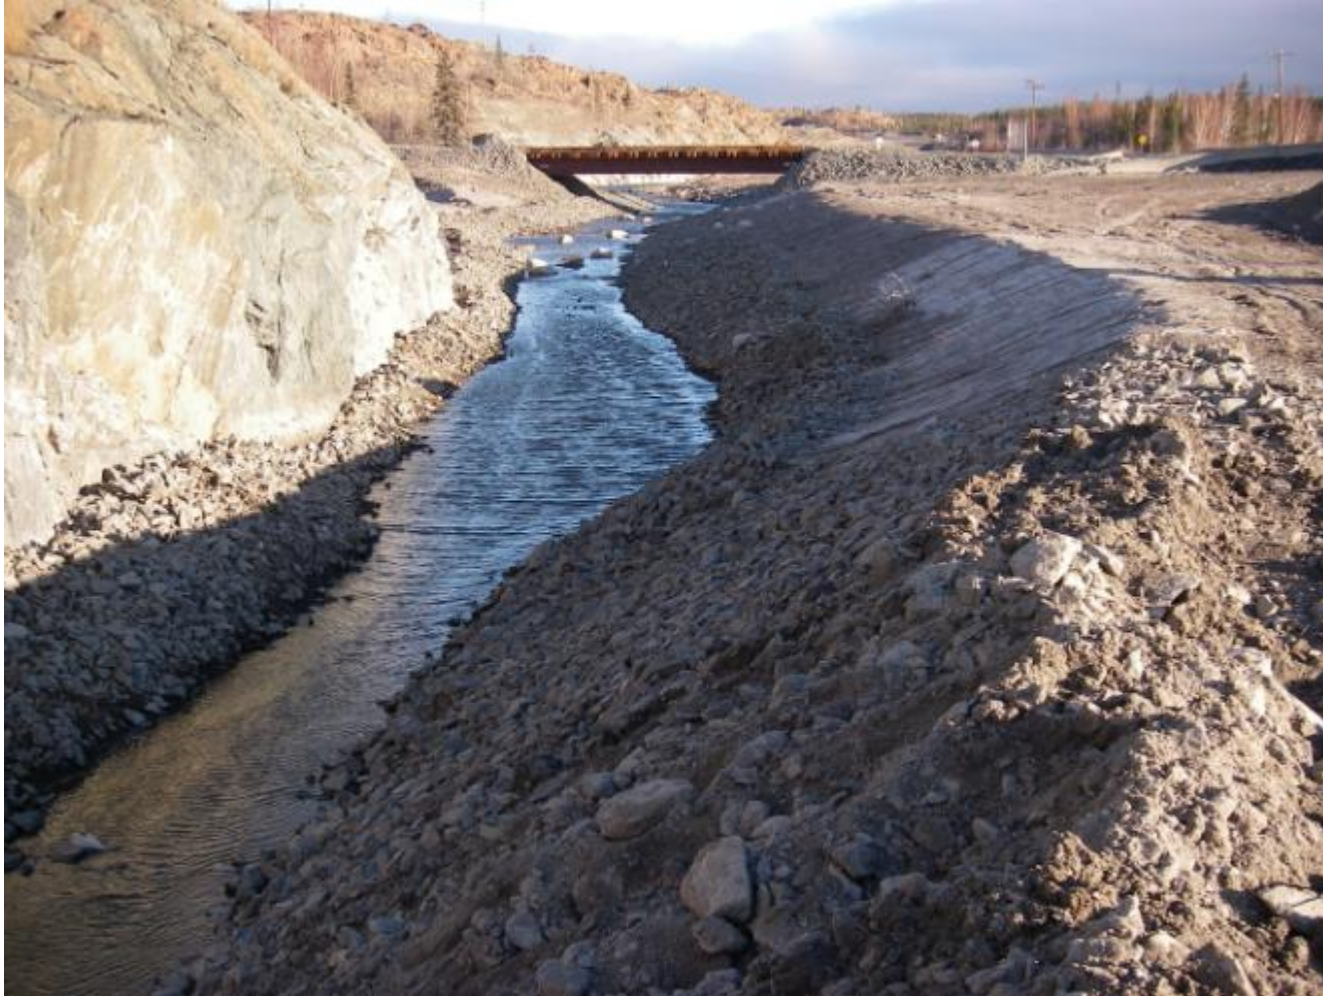
Baker Creek Reach 4 - Complete

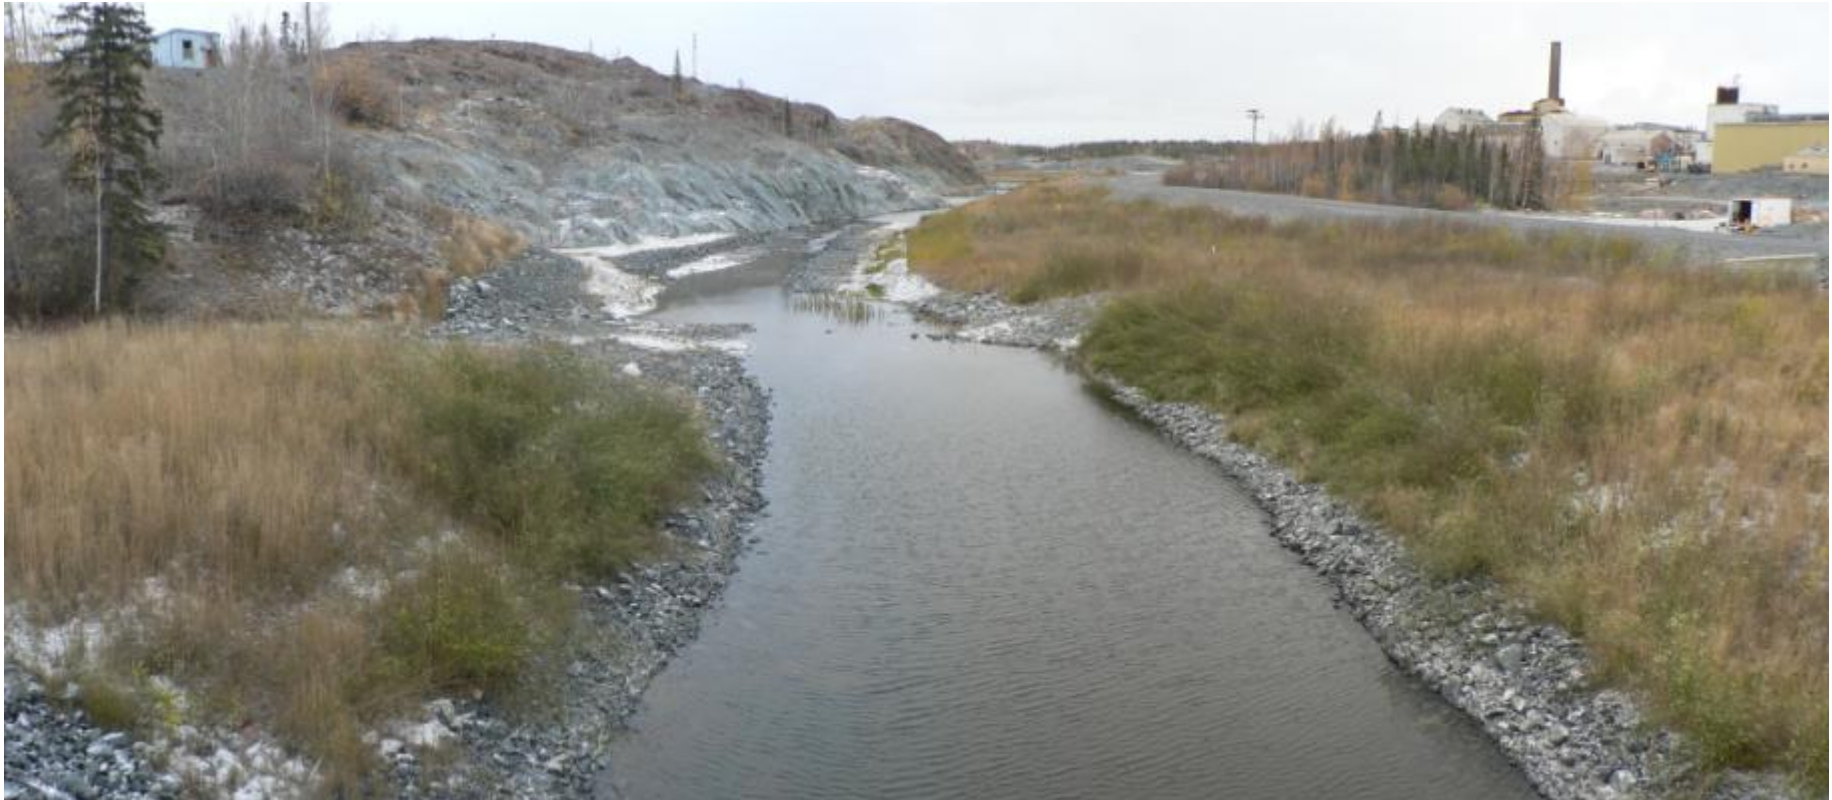
Baker Creek Reach 4 – 2009

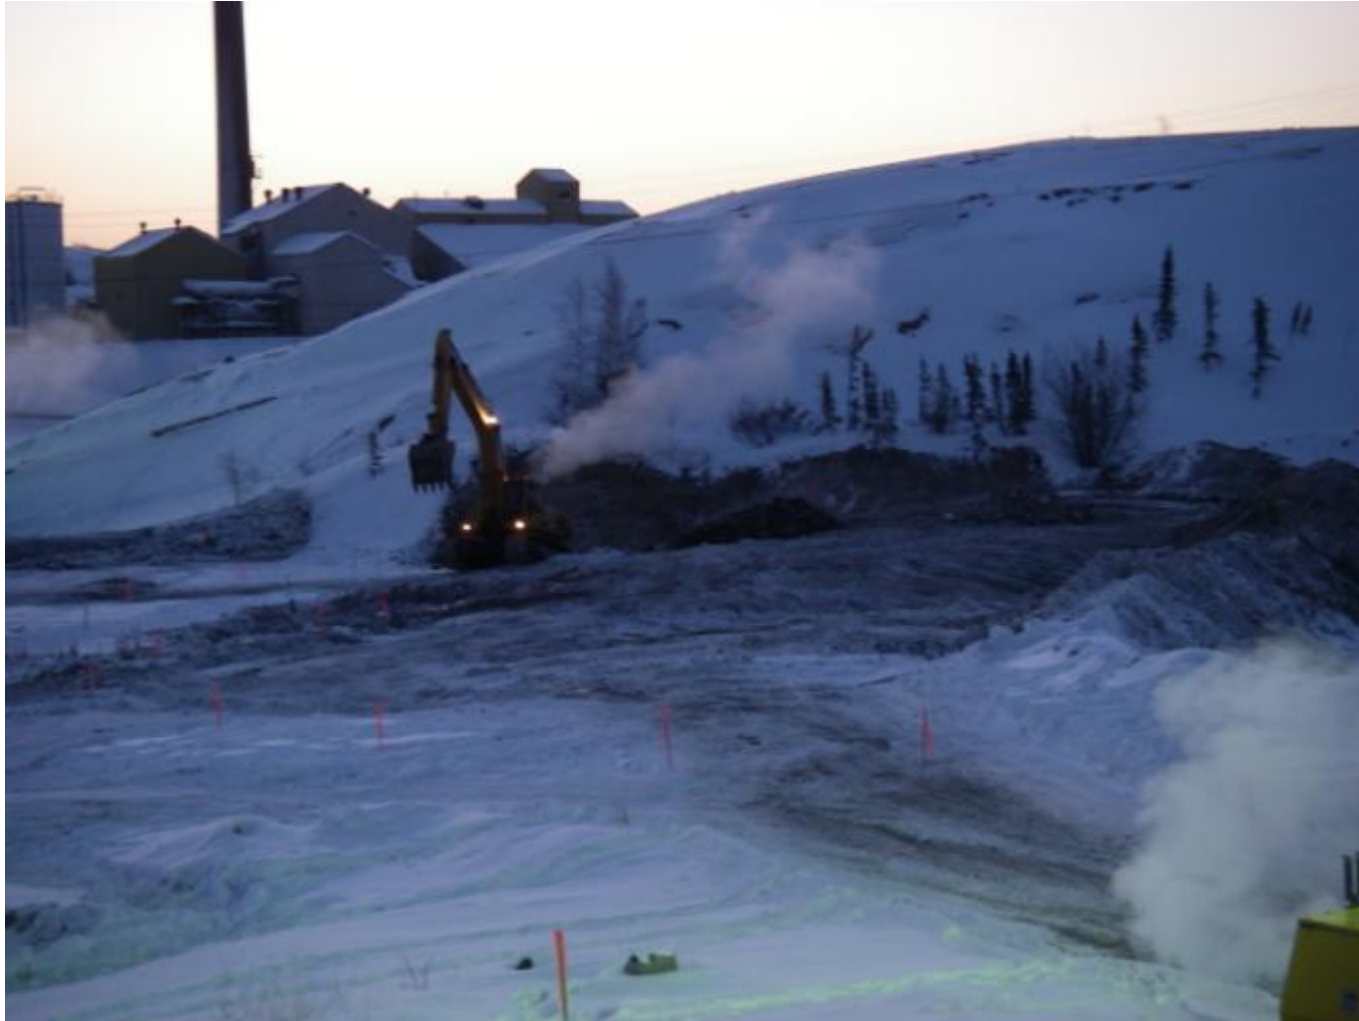
B2 Dam Reconstruction

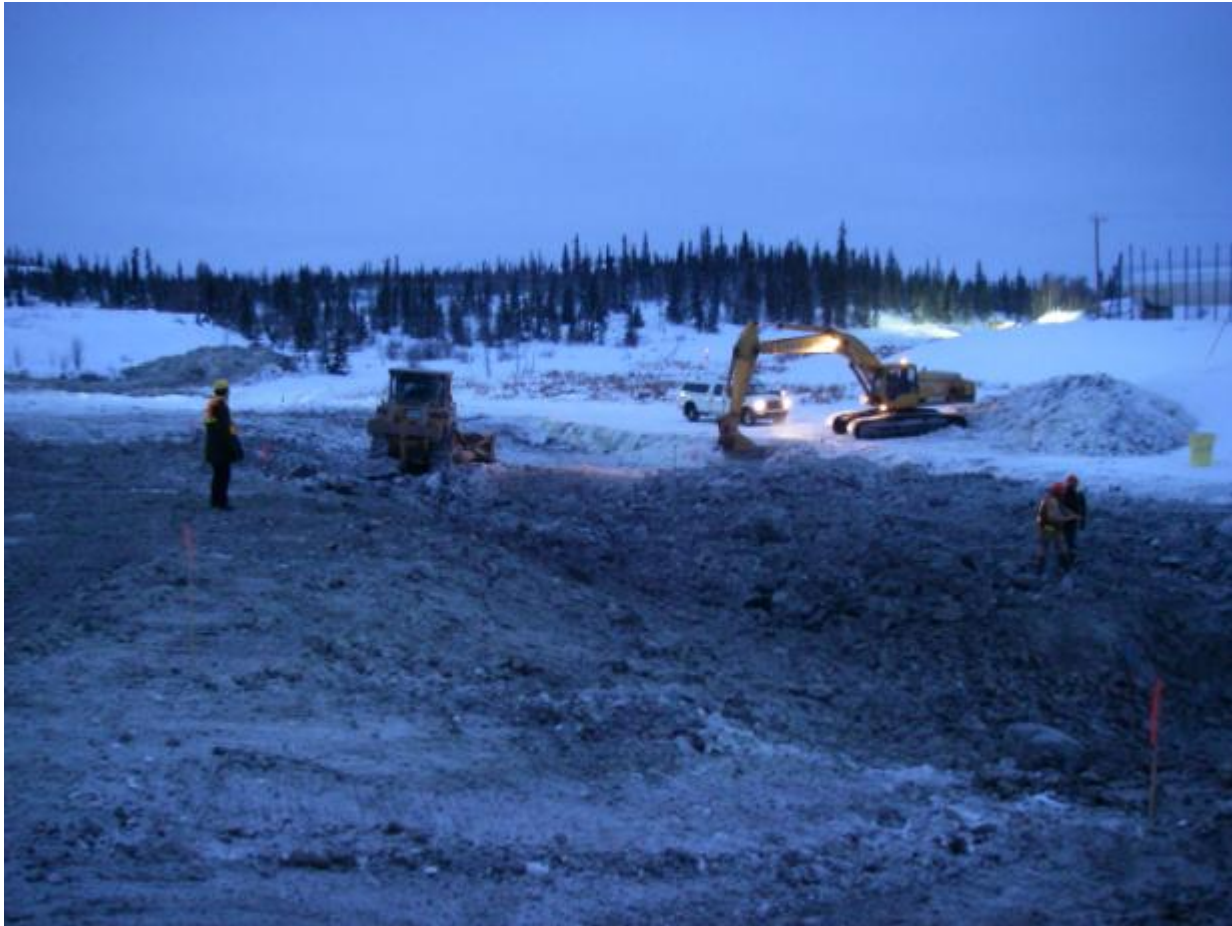
B2 Dam – All clay excavations had to be ripped

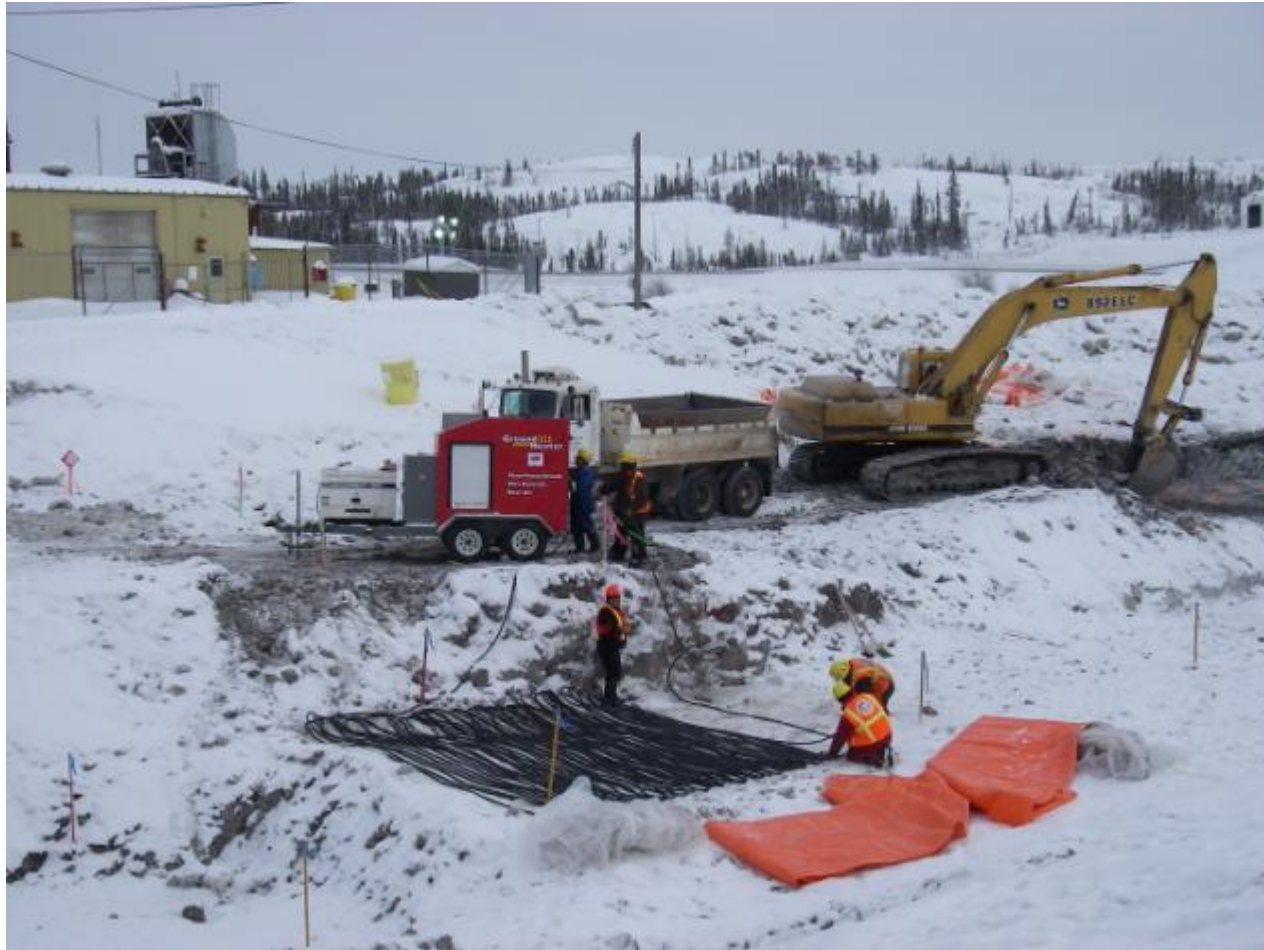
B2 Dam – Clay had to be heated for shaping

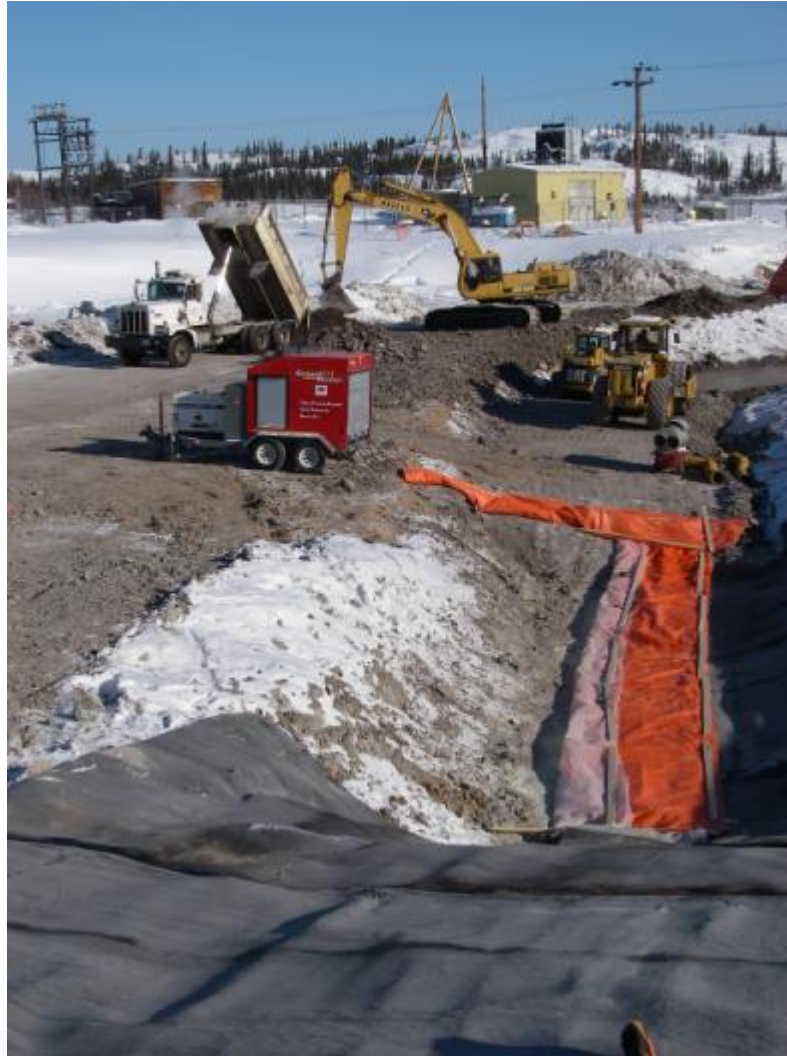
B2 Dam – Heating Clay at -35C

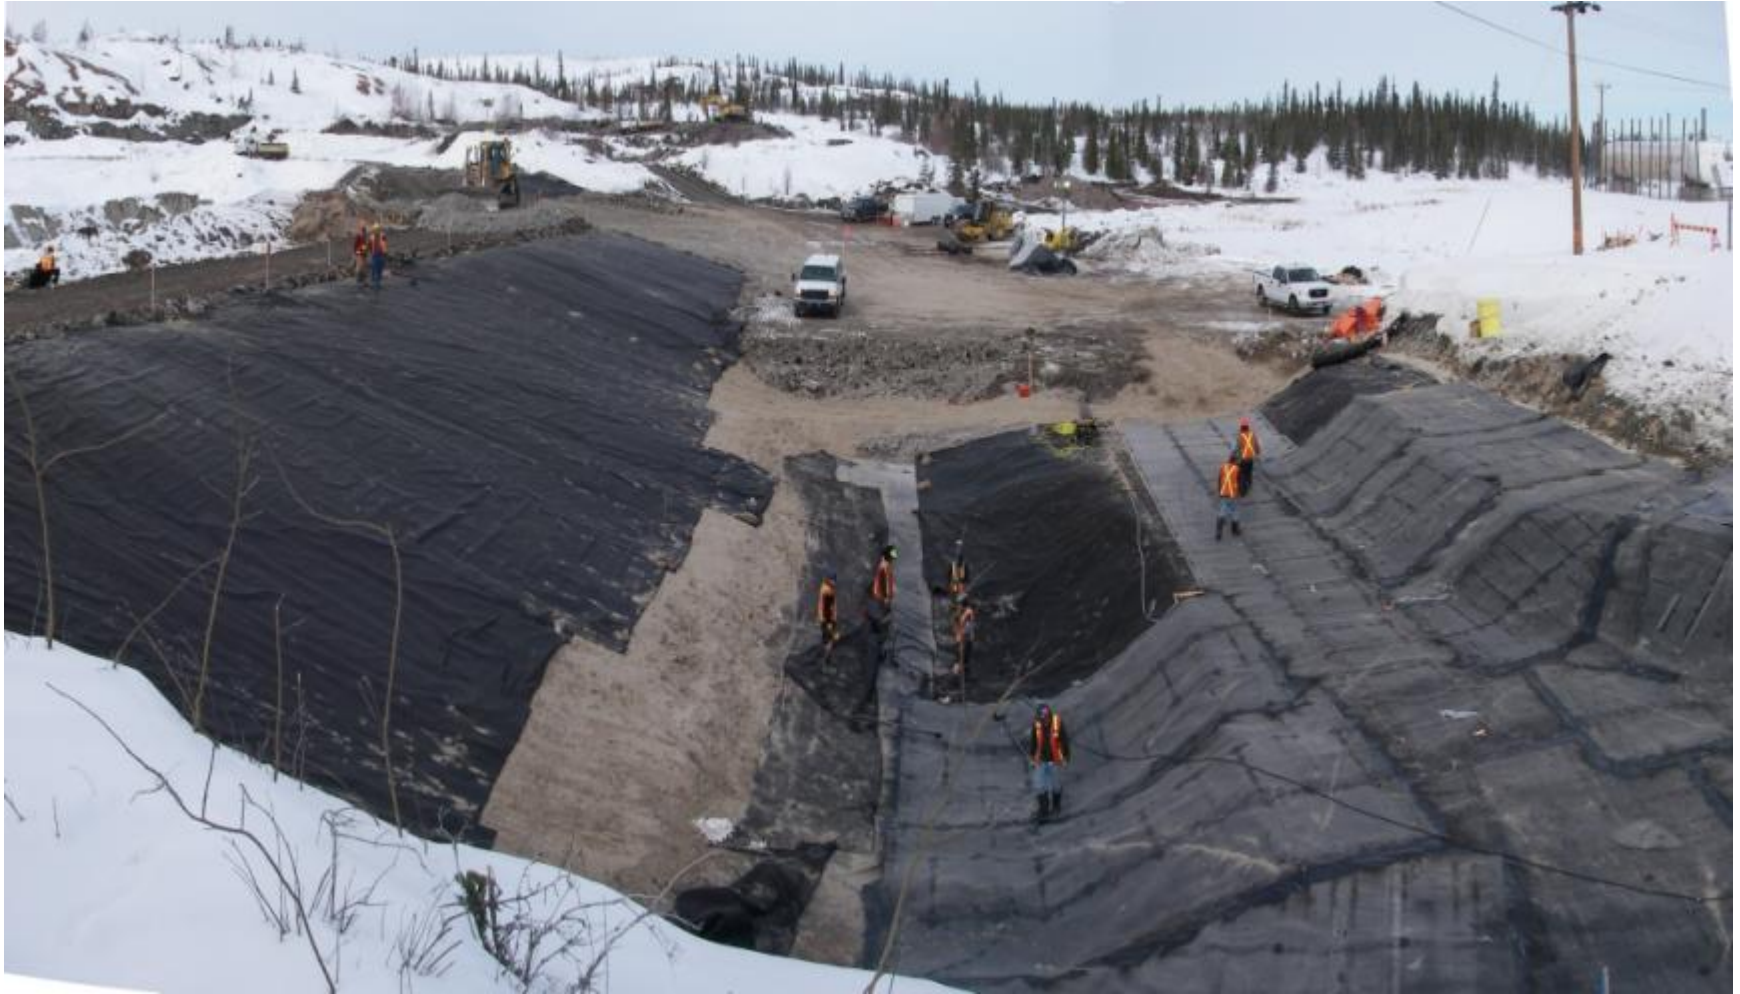
B2 Dam – Field Engineering & Challenging Geometry

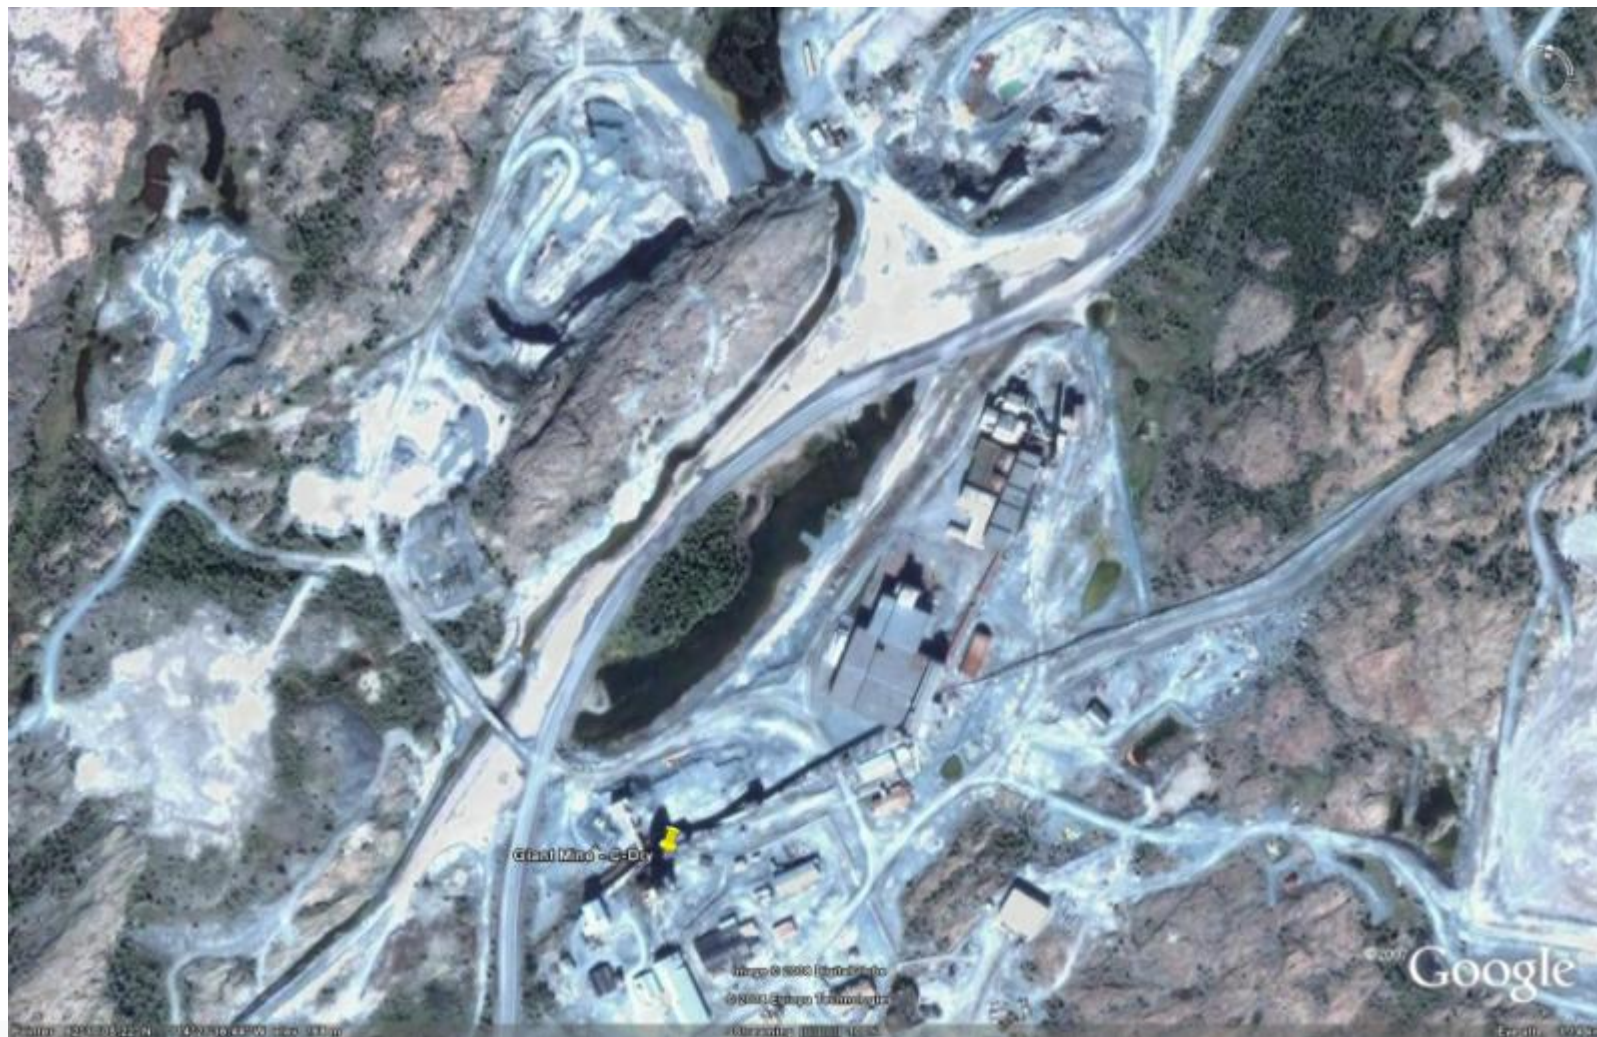
Completed Baker Creek & B2 Dam
