# Difficult Access & Difficult Drilling Conditions

Stage 2 Preliminary Site Investigation  
and Detailed Site Investigation

# 1 Introduction to Case Study

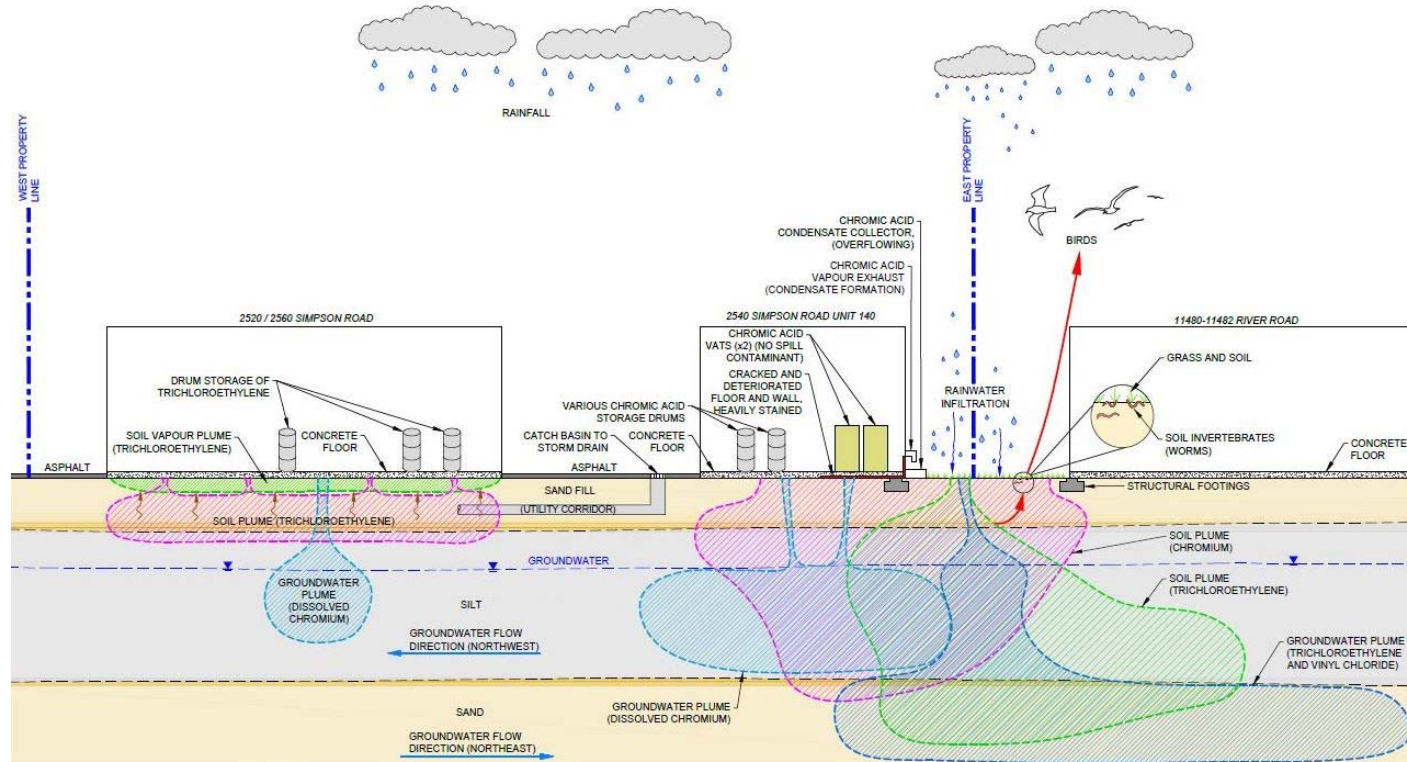
## Stage 2 PSI and Detailed Site Investigation Conceptual Site Model

- Geology encountered included Fraser River Delta sands overlain by silt with trace amounts of peat
- Two distinct hydrogeologic zones
- Complex groundwater flow regime encountered during investigation

- Tidally influenced groundwater system
- Completed a complex hydrogeology monitoring program
- Groundwater flow direction determined to be northwest towards Fraser River in silt
- Groundwater flow direction determined to be northeast towards Fraser River in sand

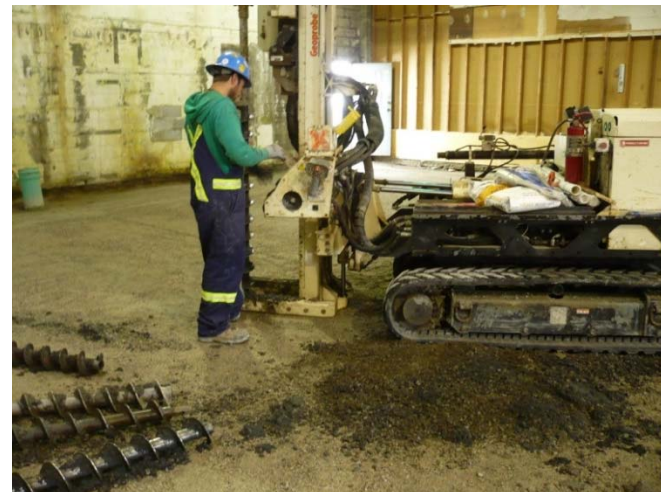
# Fraser River Sands

- The investigation required delineation of contaminants into the Fraser River Sands
- Groundwater location at approximately 2.2 – 2.6 metres below ground in overburden silts
- Upward hydraulic gradient causing heaving sand phenomena

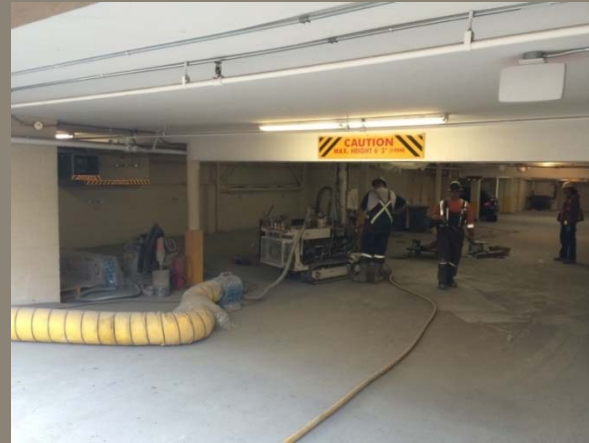
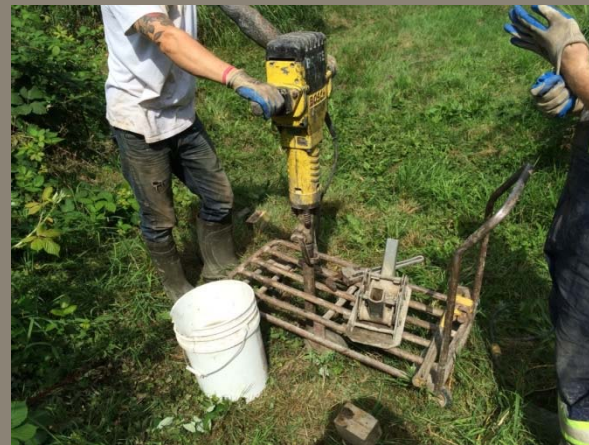
# Overcoming Limited Access

- Employed the use of the track mounted auger drill rig & Pionjar
- Installation of 1" monitoring wells

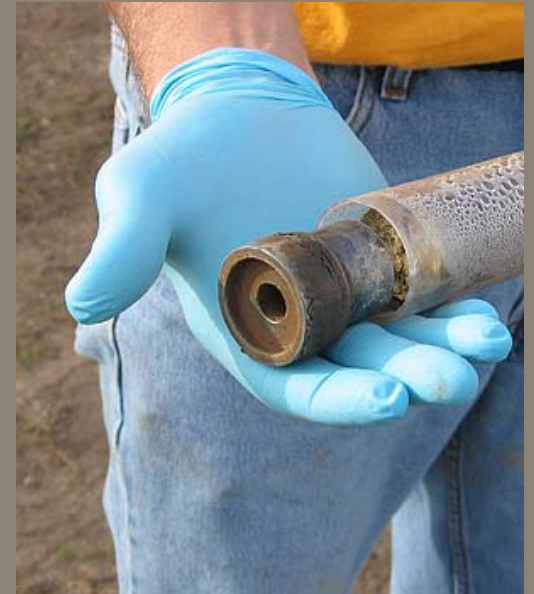
# Direct Push – Macro Coring

- Clay, silt, sand
- **Saturated, heaving sands**
- Undisturbed soil sample
- Target sample depths
- Excellent monitoring well installation

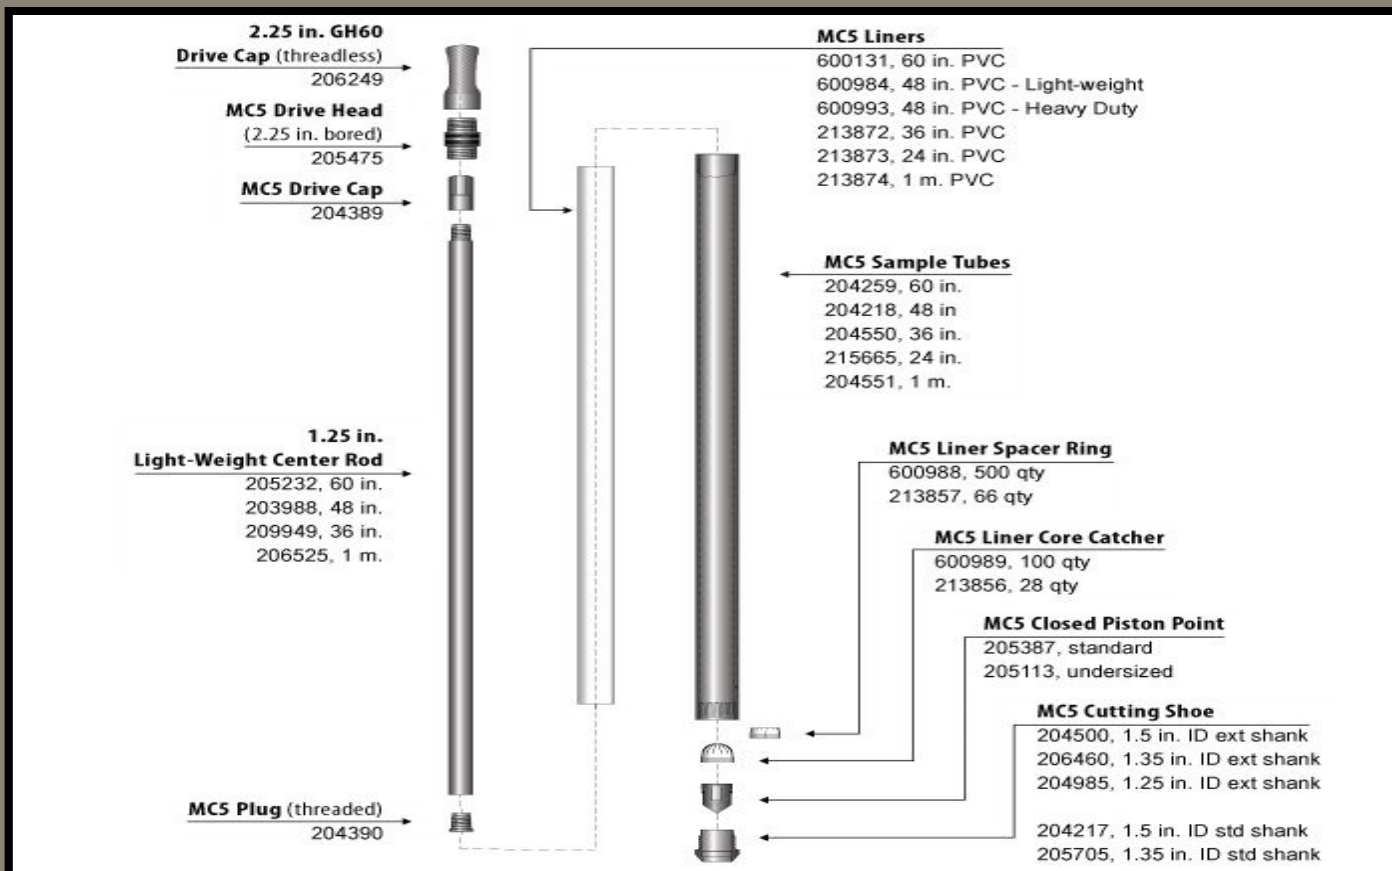
# How it Works

- Internal rod holds a closed piston point in place while advancing through soil

Steel Centre Rod

Closed Piston Point  
Cutting Shoe

Add drive cap to top of steel  
Insert plastic sample tube liner  
Add drive cap to top of steel  
closed piston point in place  
sample tube  
while advancing borehole

Steel Sample Tube

Insert plastic piston and cutting  
shoe into bottom of steel  
sample tube
