The Biggest Environmental Risk You Missed

REMTECH
October 2016

Types of Elevators

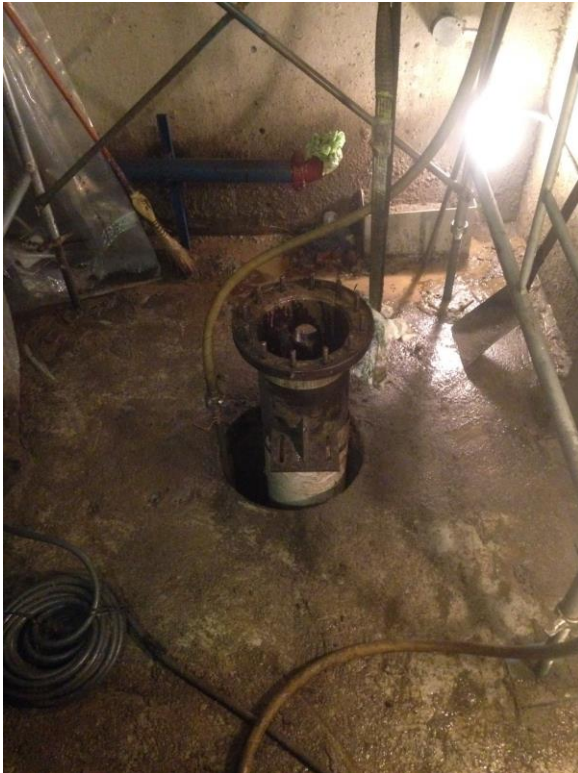
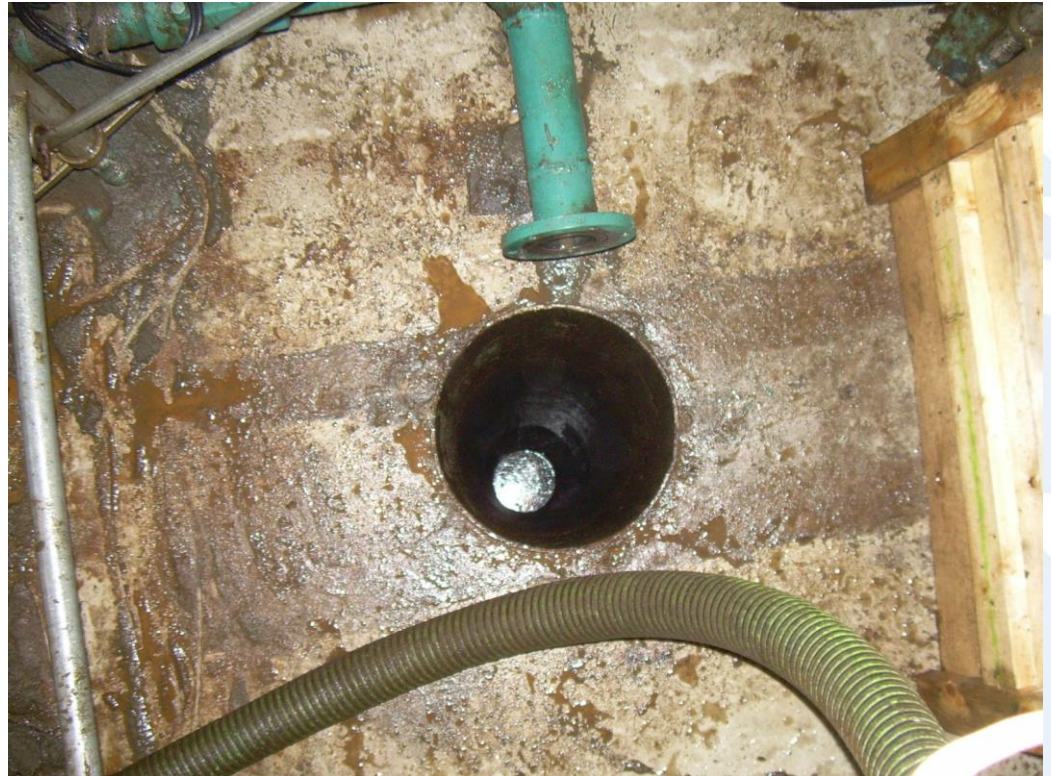
- Hydraulic elevator leak investigation and remediation conducted at time of elevator repair.
- Piston removed from cylinder.

- Cylinder vacuumed out to remove oil over water.
- Cylinder removed (>70 feet deep).

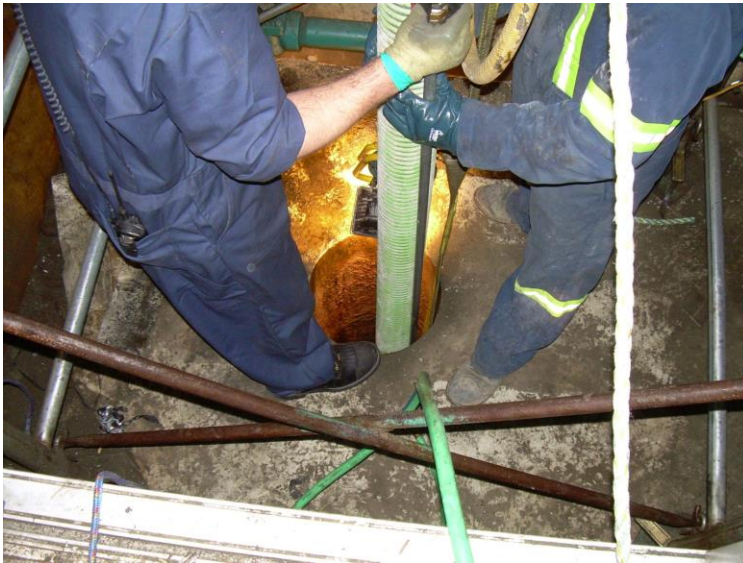
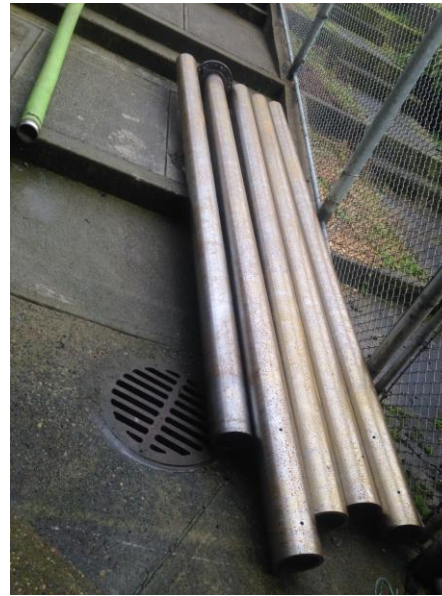
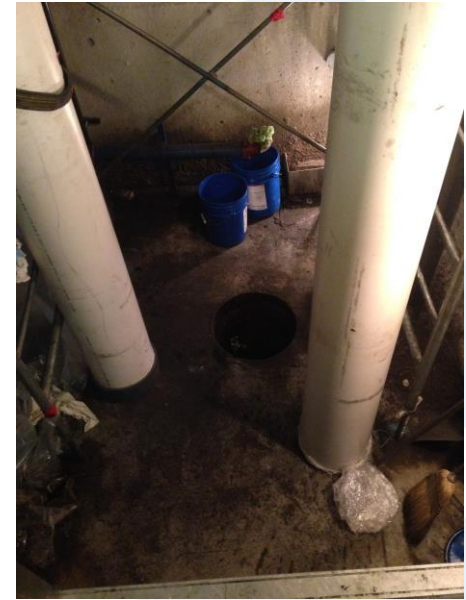
- Casing (caisson), which had no seal on bottom, vacuumed out to remove water and oil, including groundwater recharging into casing. When water appeared clean, samples collected and vacuuming stopped. Remaining impacts were risk managed in-place.

- PVC sleeve, with bottom capped placed inside casing to reduce potential for future loss.
- New cylinder installed and elevator systems re-instated.
