Remediating Bedrock: What Once Was Impossible Is Now Routine. Three Case Studies

RemTech – Banff, AB. October 13, 2022 Kevin E. French, P.Eng.

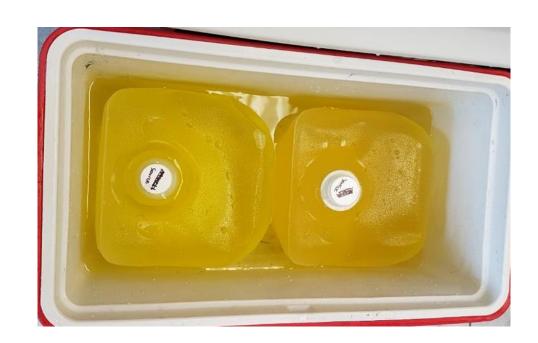
Hex Chrome – Bench-Scale Testing

Remediation Amendments Tested

- Molasses
- FerroBlack®
- Zero Valent Iron (ZVI)
- Trap & Treat® BOS 100®

Method

- 1 L containers
- Silica sand and remedial amendment
- Groundwater added
- Placed in dark, let sit one week, sampled
