Remediation of Petroleum Hydrocarbon-impacted Peat Within a Wetland and Adjacent to an Operating Pipeline

Jason Hampson, B.Sc., P.Ag. – Principal Scientist, Trace Associates Zoe Churchill, B.Sc., P. Eng. – Environmental Specialist, Trans Mountain Pipeline

Date: October 14, 2023 File: Trans Mountain Remediation RemTech 2023

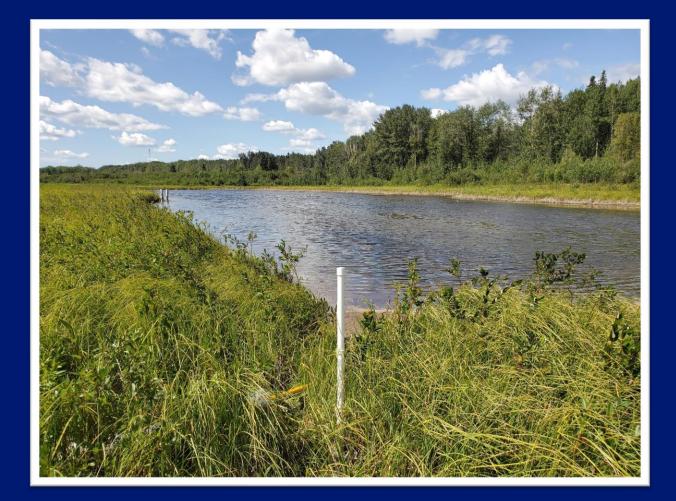
Site Characterization

- Impact depth is ~2.0 metres (m) to 3.0 m
- Pond adjacent to the north
- Water level at surface of peat most of the year
- Fish-bearing waterbody
- Forested and steep slope to the north
- South is an industrial site
- Sentinel monitoring wells consistently below guidelines
- Water quality in pond is good

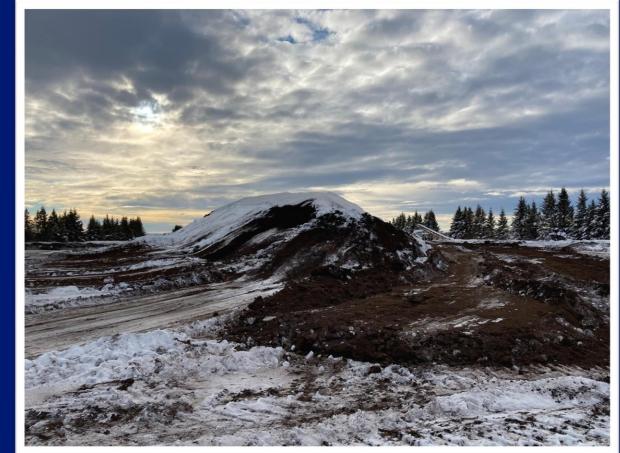
Fill Material Planning

- Large volume of peat required
- Peat known to contain natural elevated petroleum hydrocarbons (PHCs), polycyclic aromatic hydrocarbons (PAHs), and boron
- Harvested peat brings challenges for reuse
- Peat material requires donor moss or salvaged peat for re-establishment
- Laboratory tests and forensics confirmed suitable fill
- Aimed to salvage peat

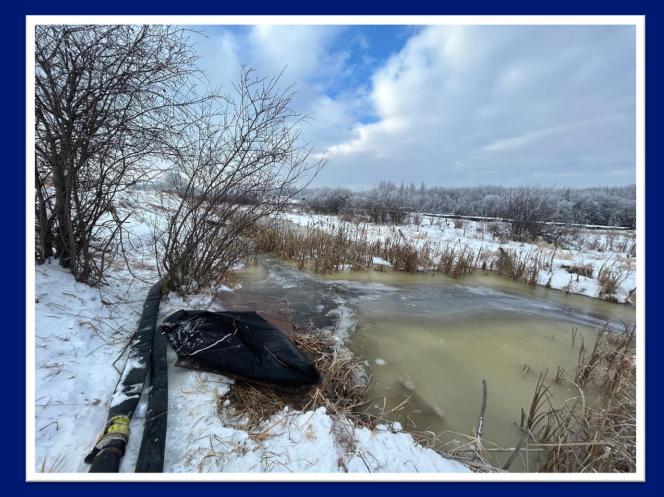
Dewatering Methods

- Laboratory testing of pre- and post-discharge waters
- Constant pre- and post-discharge monitoring for sheen
- Pre-discharge oil field screening
- Laboratory chromatogram interpretation used
- Forensic scientist utilized to provide interpretation of suspected biogenic toluene
- Filtration used to prevent breakthrough

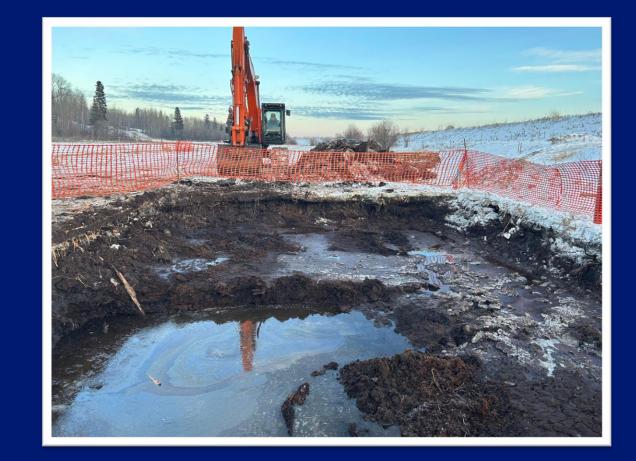
Laboratory Results Forensics

- Natural occurring PHCs, PAHs in surrounding peat
- Approved Remedial Action Plan conditions – allowed for exceedances if justified
- Utilized a combination of methods to confirm/justify biogenic material
 - Biogenic Interference Calculation Scale analyses
 - Biogenic/petrogenic laboratory forensics
 - Third-party forensic interpretation

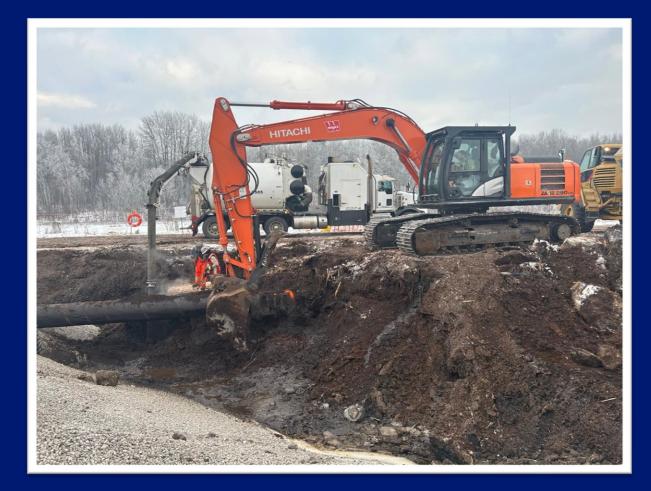
2022 and 2023 Excavation Results

- Salvaged 250 cubic metres (m³) of surficial material
- Remediated approximately 16,000 m³ of impacted peat/soil
- Backfilled with washed rock; approximately 0.5 m upper surface is peat

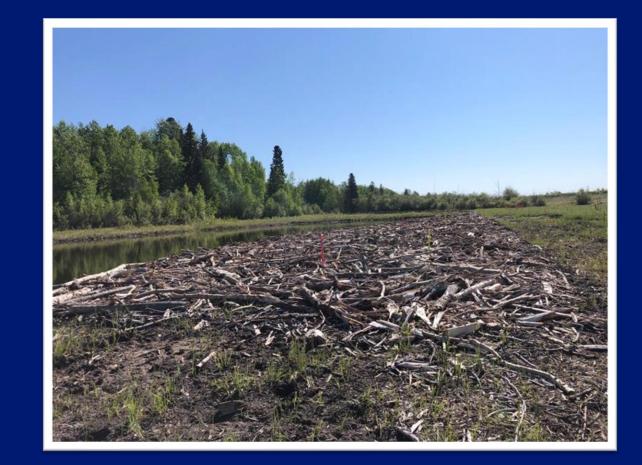
Backfilling

- Wash rock / peat used
- Peat material is hydrophobic
- Utilized salvaged surface material for revegetation
- Approximately 250 m³ of salvaged peat and 3,000 m³ of harvested peat used

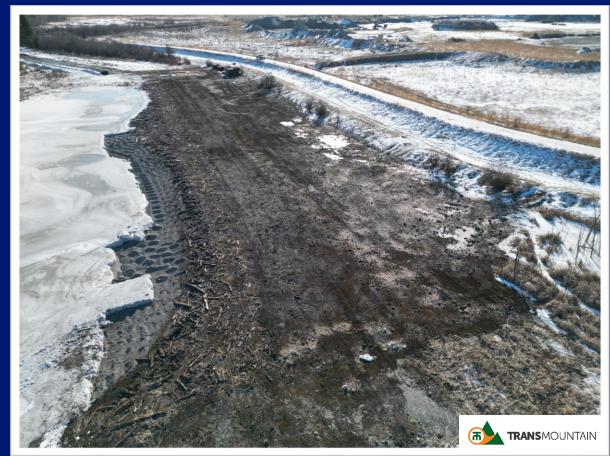
Ongoing Risk Assessment

- RMP prepared in fall 2023 to address areas which could not be remediated
 - Below industrial dyke
 - Surficial material on steep slope, with healthy mature vegetation
 - Hand auger delineation in fall 2023 to confirm impacts remaining in place
