### Field Pilot Testing for Chemical Oxidation at the Former Nitchequon Meteorological Station DECONTAMINATION PROJECT IN ISOLATED NORTHERN AREAS

Adriana Peisajovich<sup>1</sup>, Éric Bergeron et coll<sup>2</sup>, Mathieu Barbeau et coll<sup>3</sup>, and Ginette Lajoie<sup>4</sup>

<sup>1</sup>Transport Canada, Quebec Region, <sup>2</sup> Golder Associates Ltée,

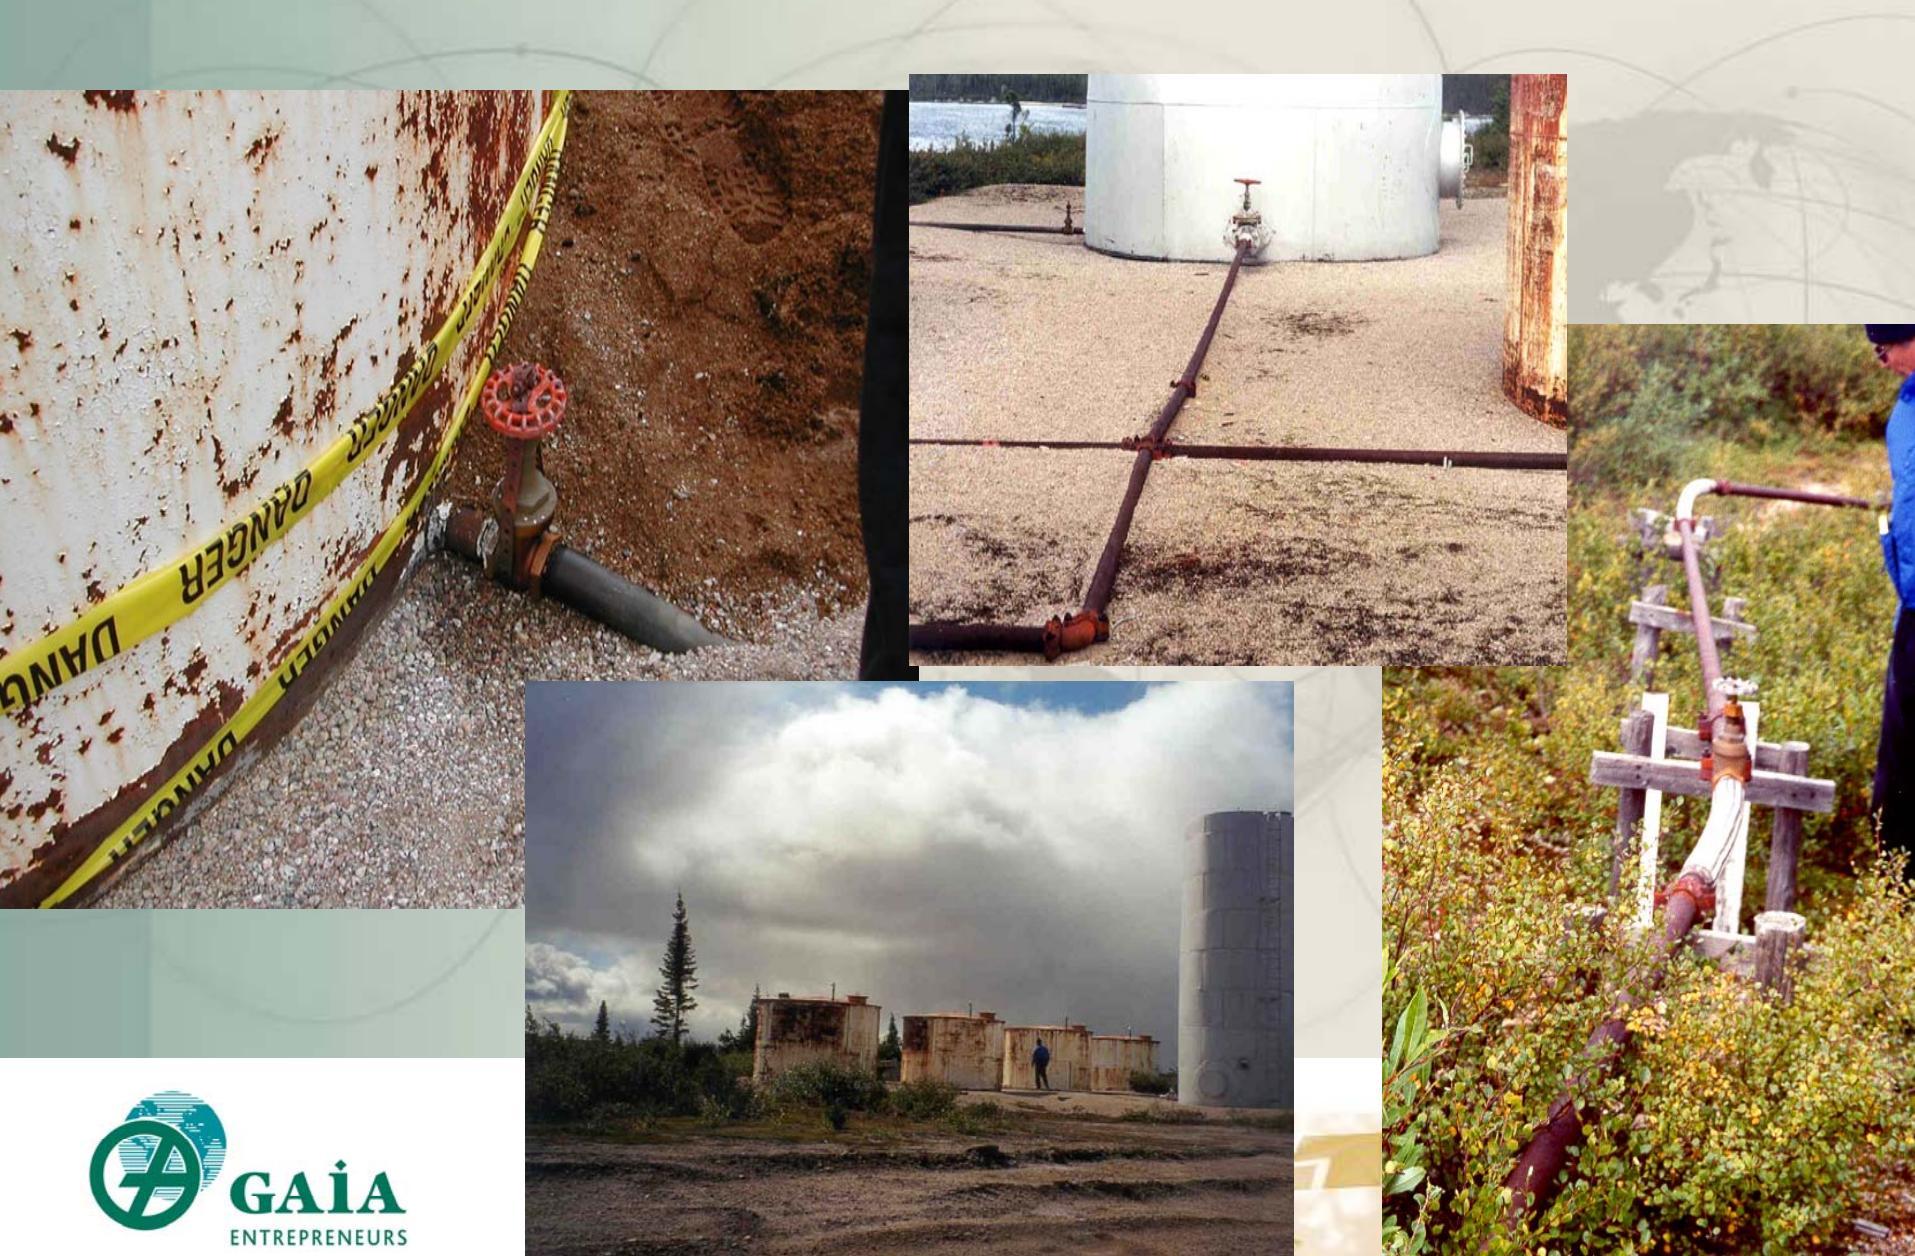
# SOURCE OF THE PROBLEM

#### IST OF FACILITIES:

- LOCATION OF CONTAMINATED SOILS
- Q-13 Hydrogen Generator / Balloon and Helium Building
- Q-16 E.P.U. Building

4 000 m<sup>2</sup>

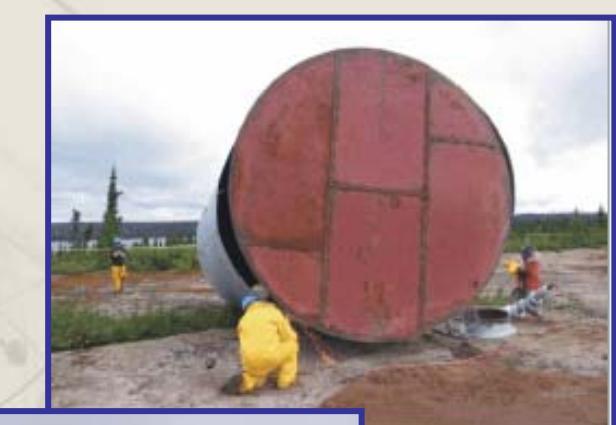
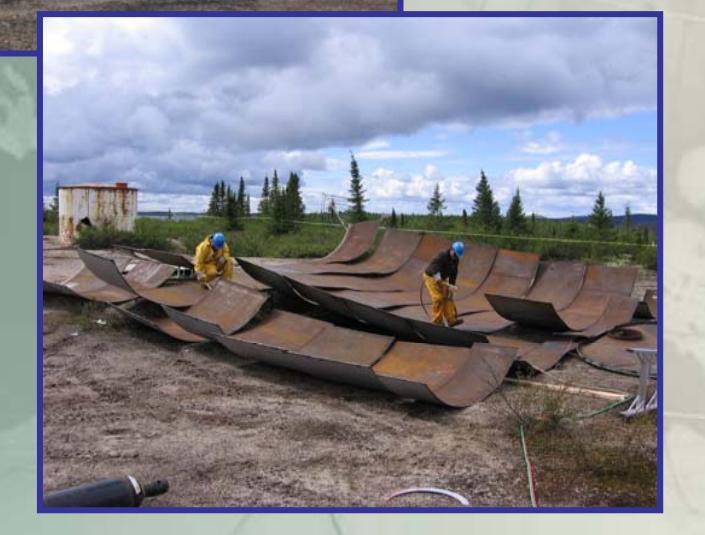
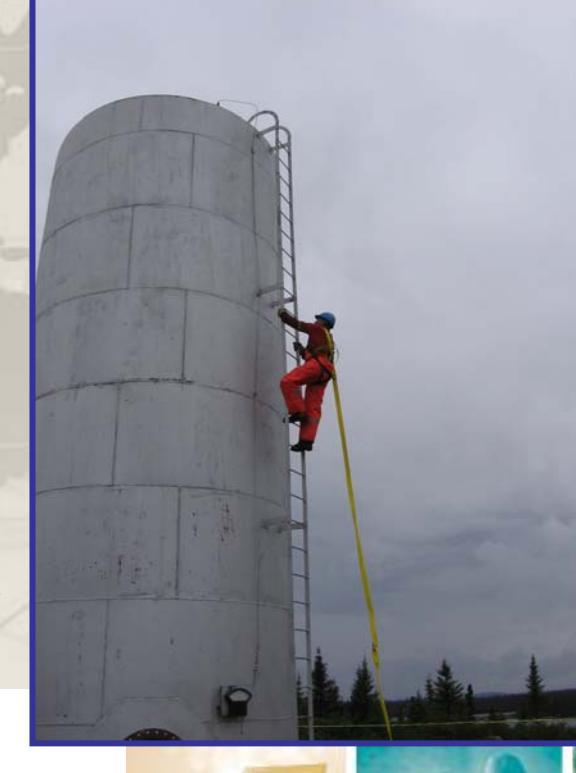
### **DISMANTLING OF TANKS**

Cutting of metal in plate of 0,6 meter by 1,2 meter to facilitate transport

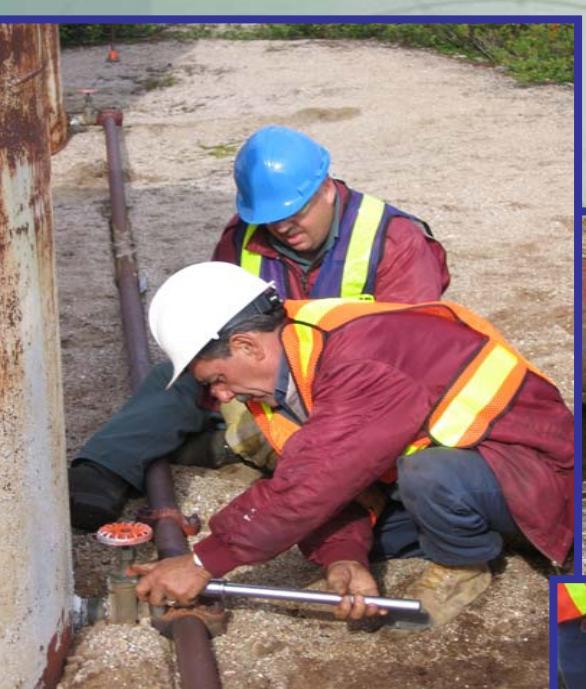
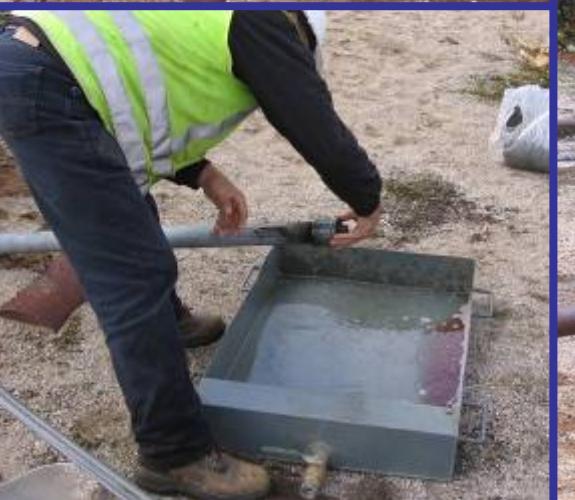
### **PIPELINE DISMANTLEMENT**

- > 0,075 m Pipes
- Total length of 1 230 meters
- Residual products pumping

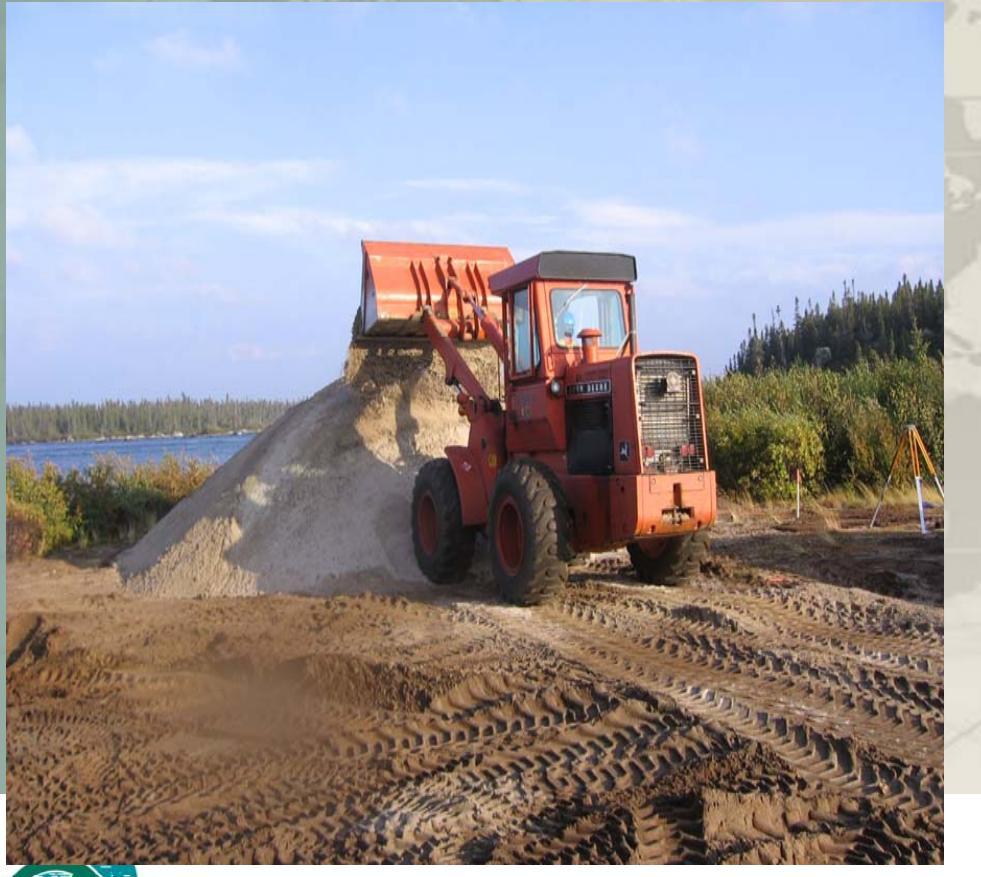
- 1- Vegetation removal
- 2- Excavation of the first 2 feet of soil
- 3- Contaminated soil is transferred on HDPE lining prior treatment

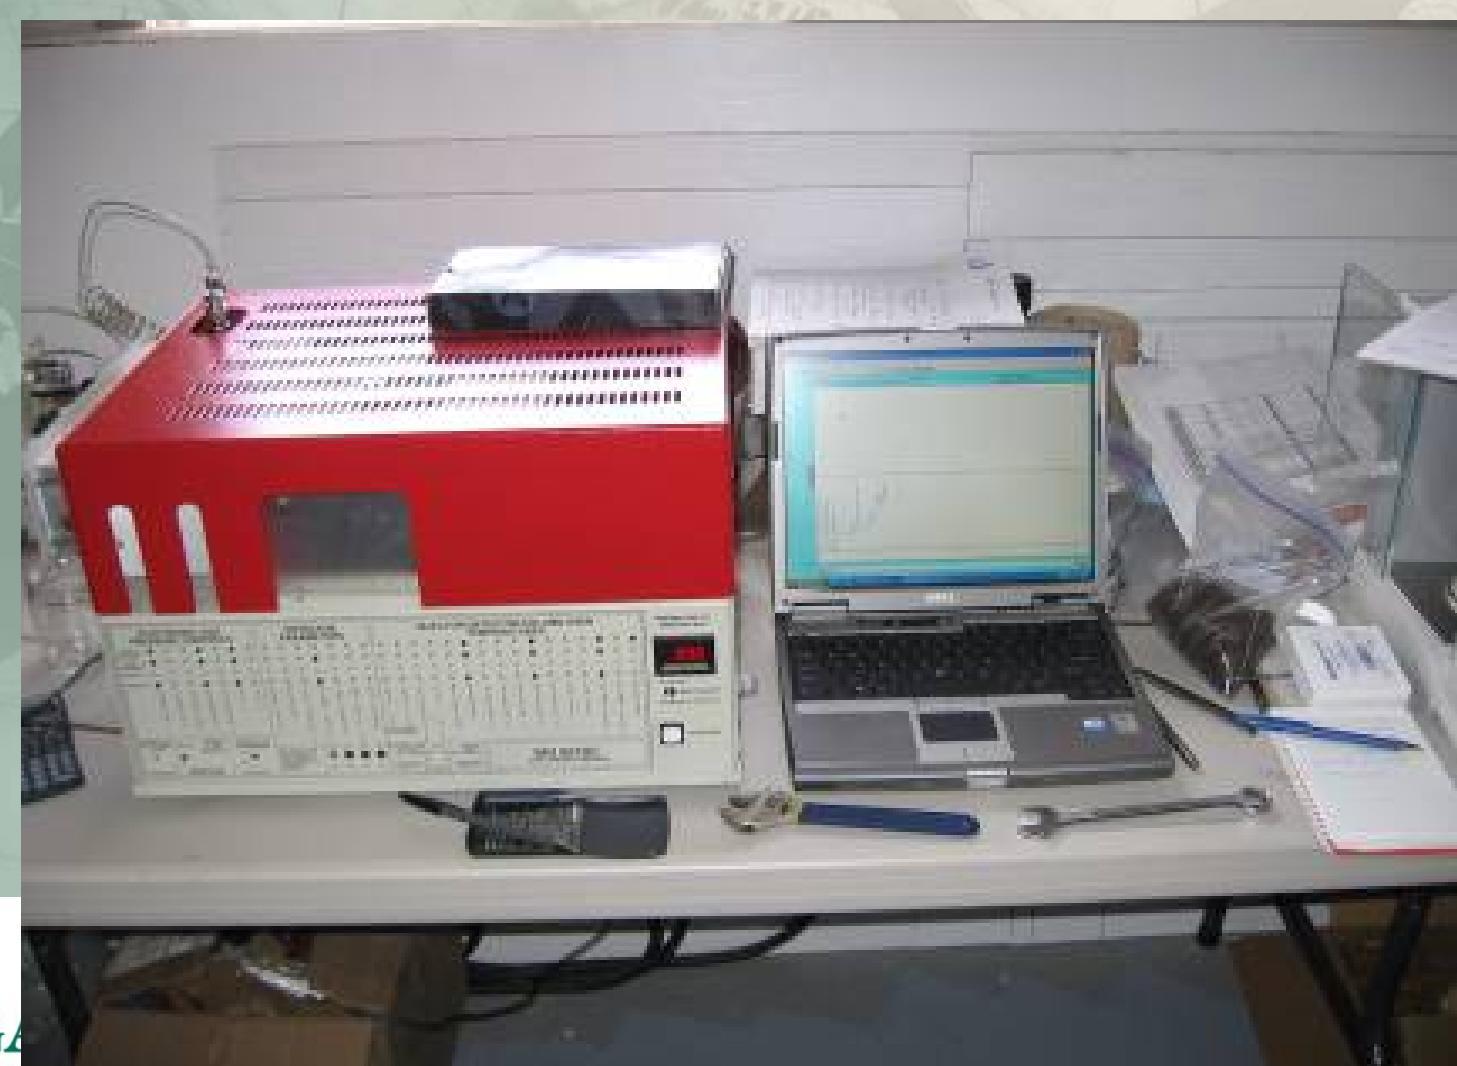
- 4- On-site analysis of the C<sub>10</sub>C<sub>50</sub>
- 5- Dosing based on the GC analysis : g KMnO<sub>4</sub> / g  $C_{10}C_{50}$

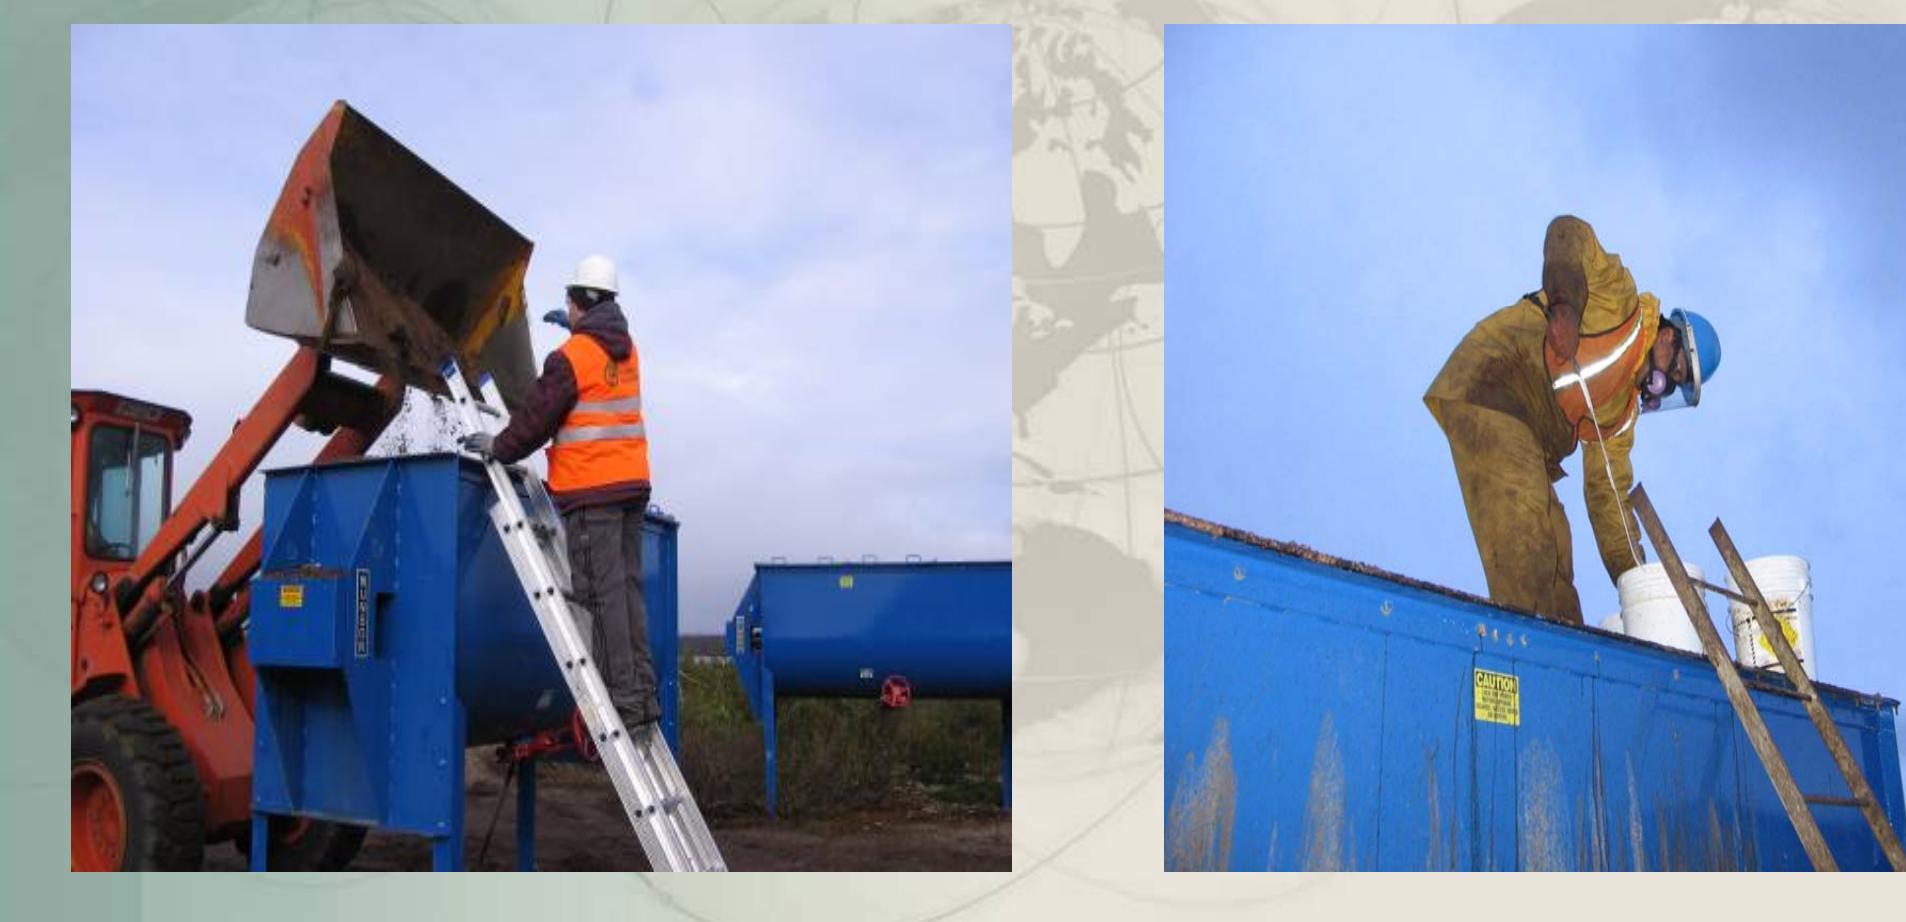
8- Soils is transferred into the mixers (10)

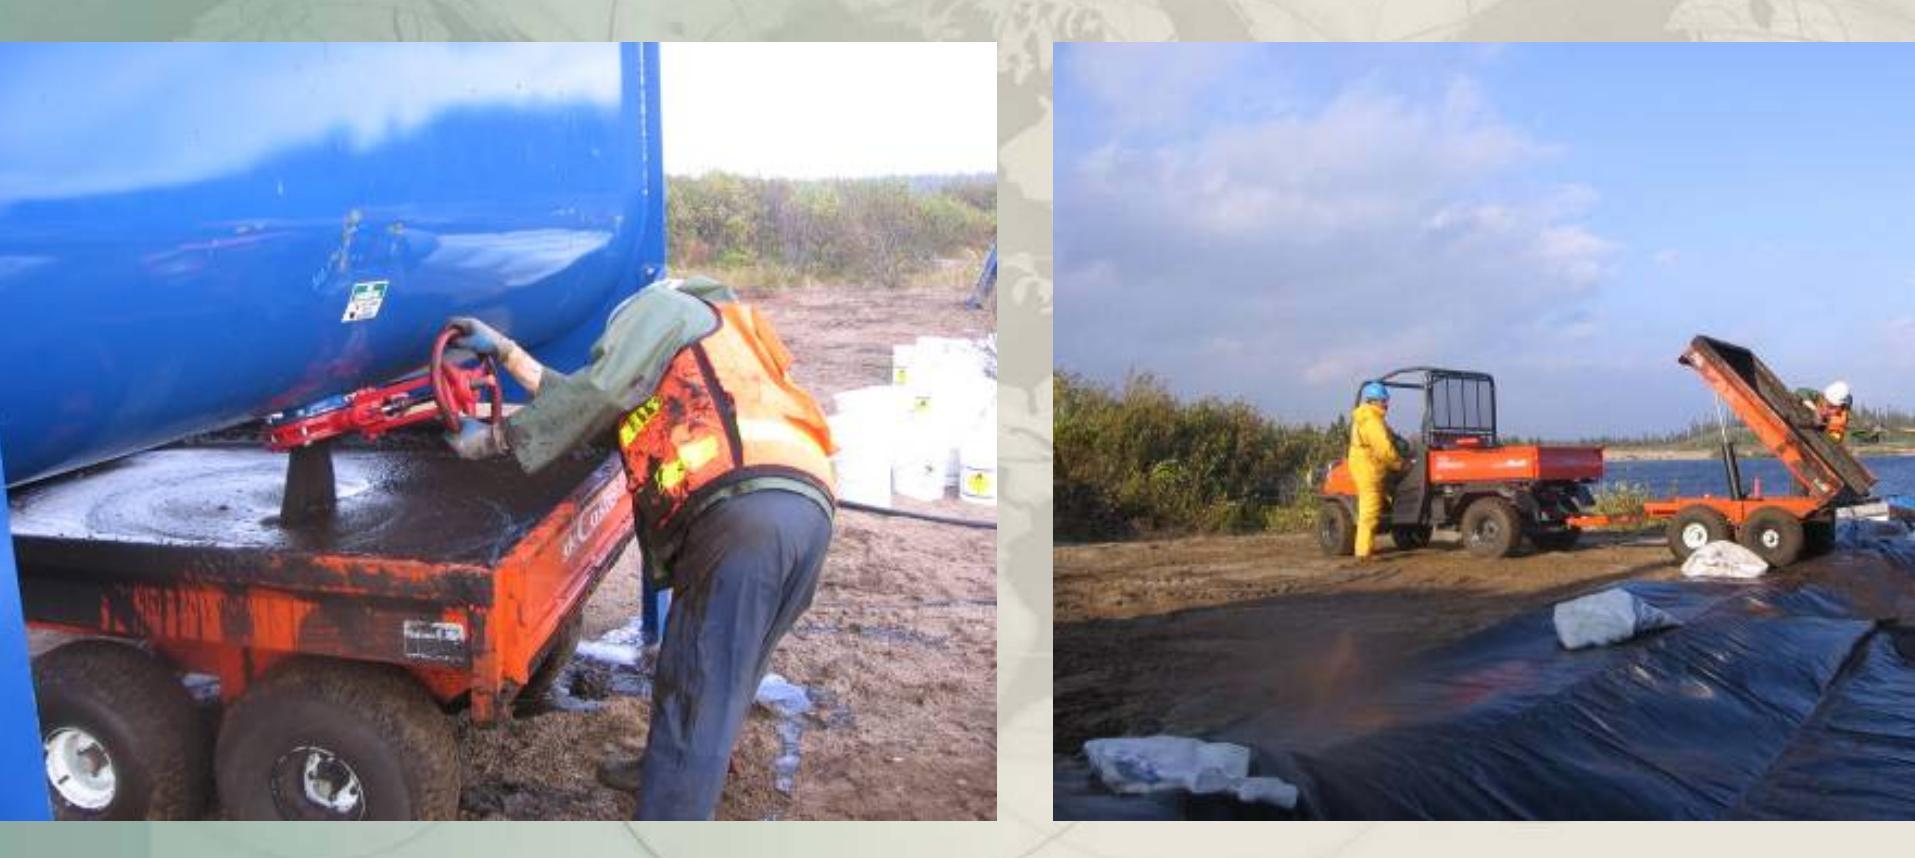
9- Treated soil is transferred from the mixers to the curing cells

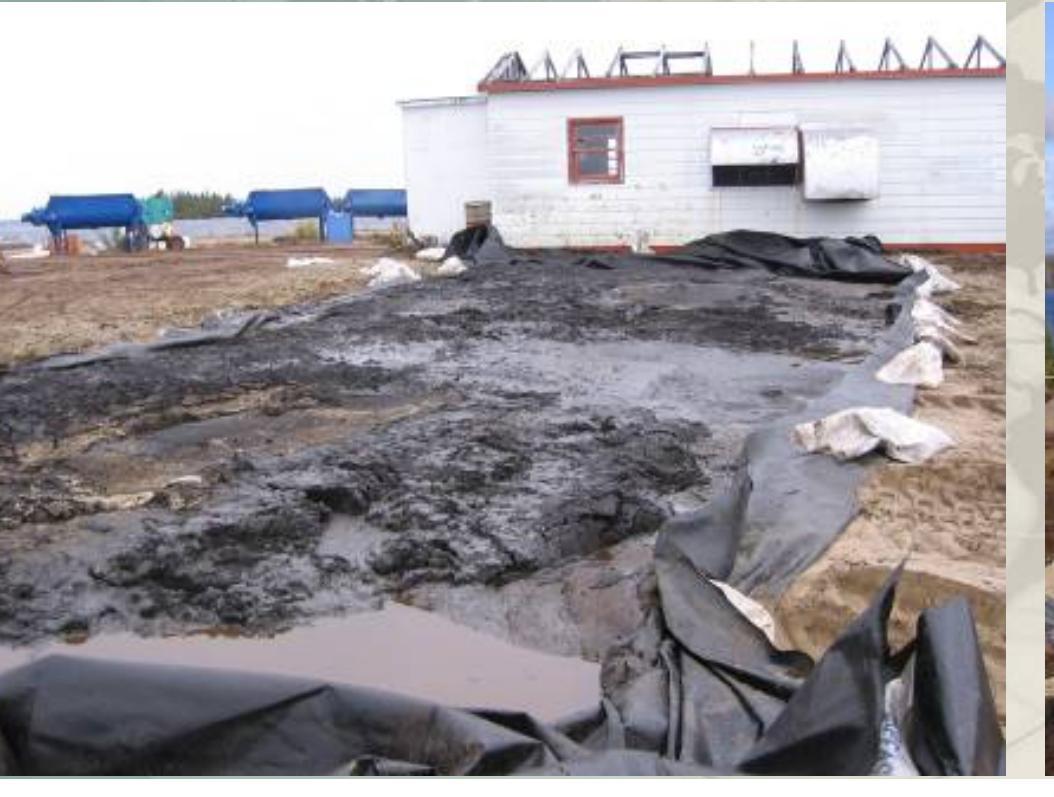
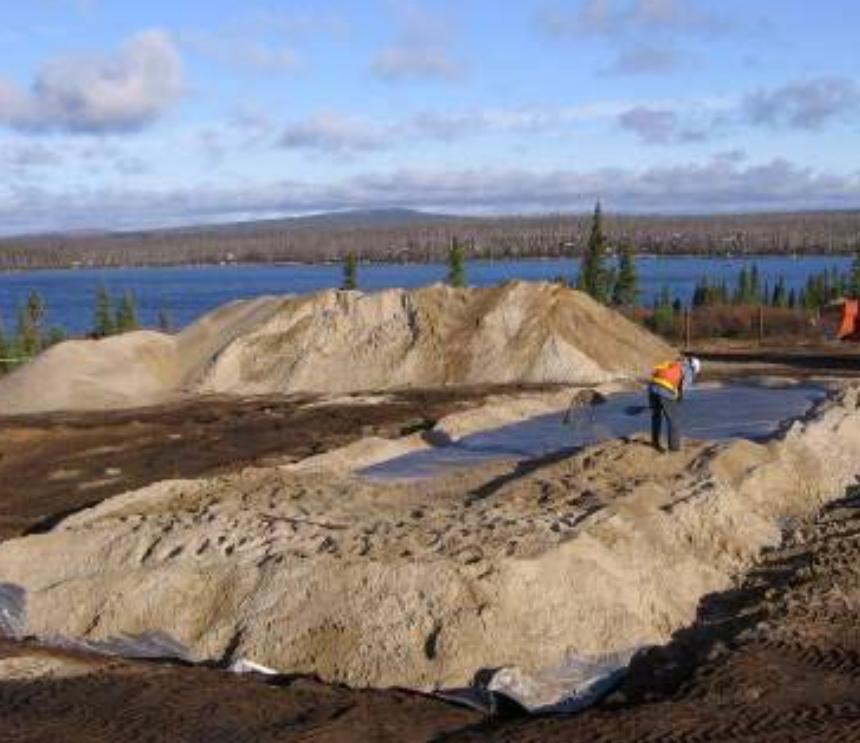
10- HDPE top cover lining is installed over the treated soil 11- 12 inch of clean soil is added over the top cover lining
