#### **REMEDIATION OF A FORMER TANK FARM SAVIKTOK POINT, NWT**

#### Philippe Gingras Biogénie S.R.D.C. Inc.

### Saviktok Point Tank Farm

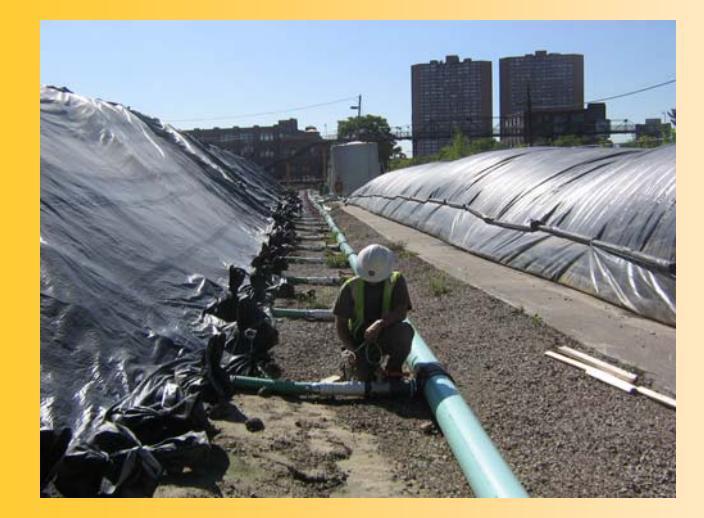
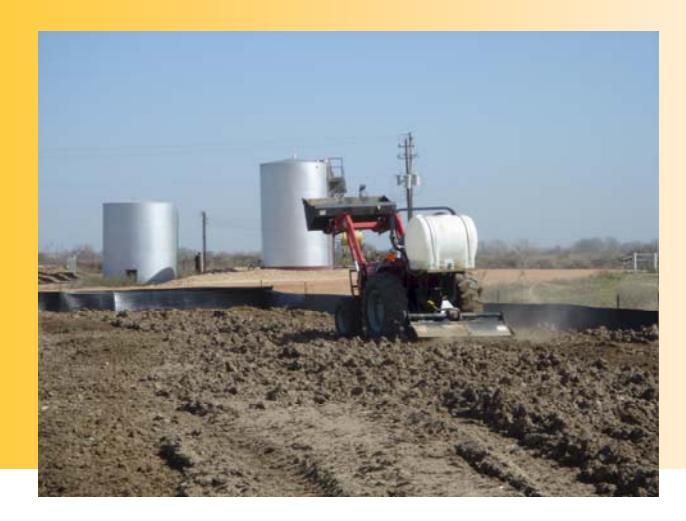
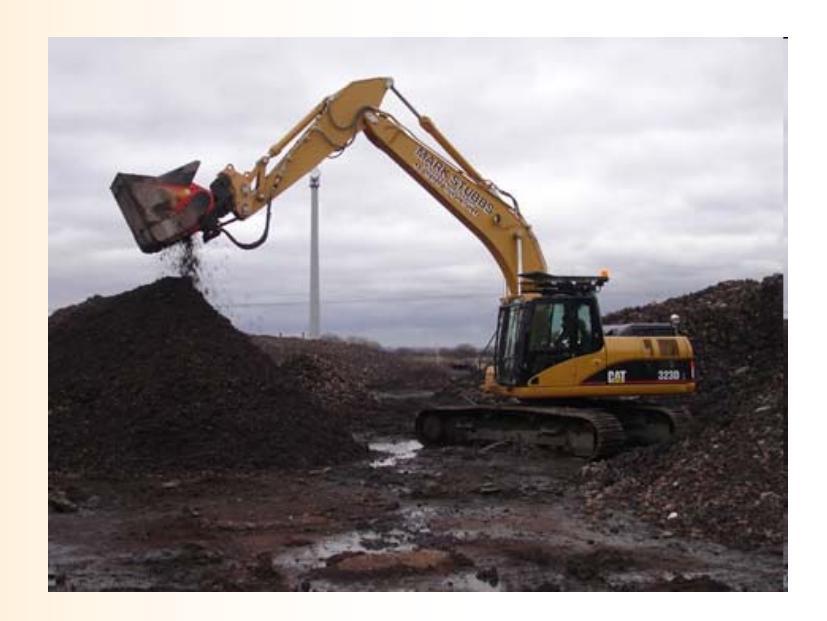
## **Treatment Technologies**

- $O_2$  is required to maximise the degradation of contaminants
- Heat is required to sustain microbial activity
- Nitrogen and Phosphorous
- Neutral pH, loose structure and moisture content

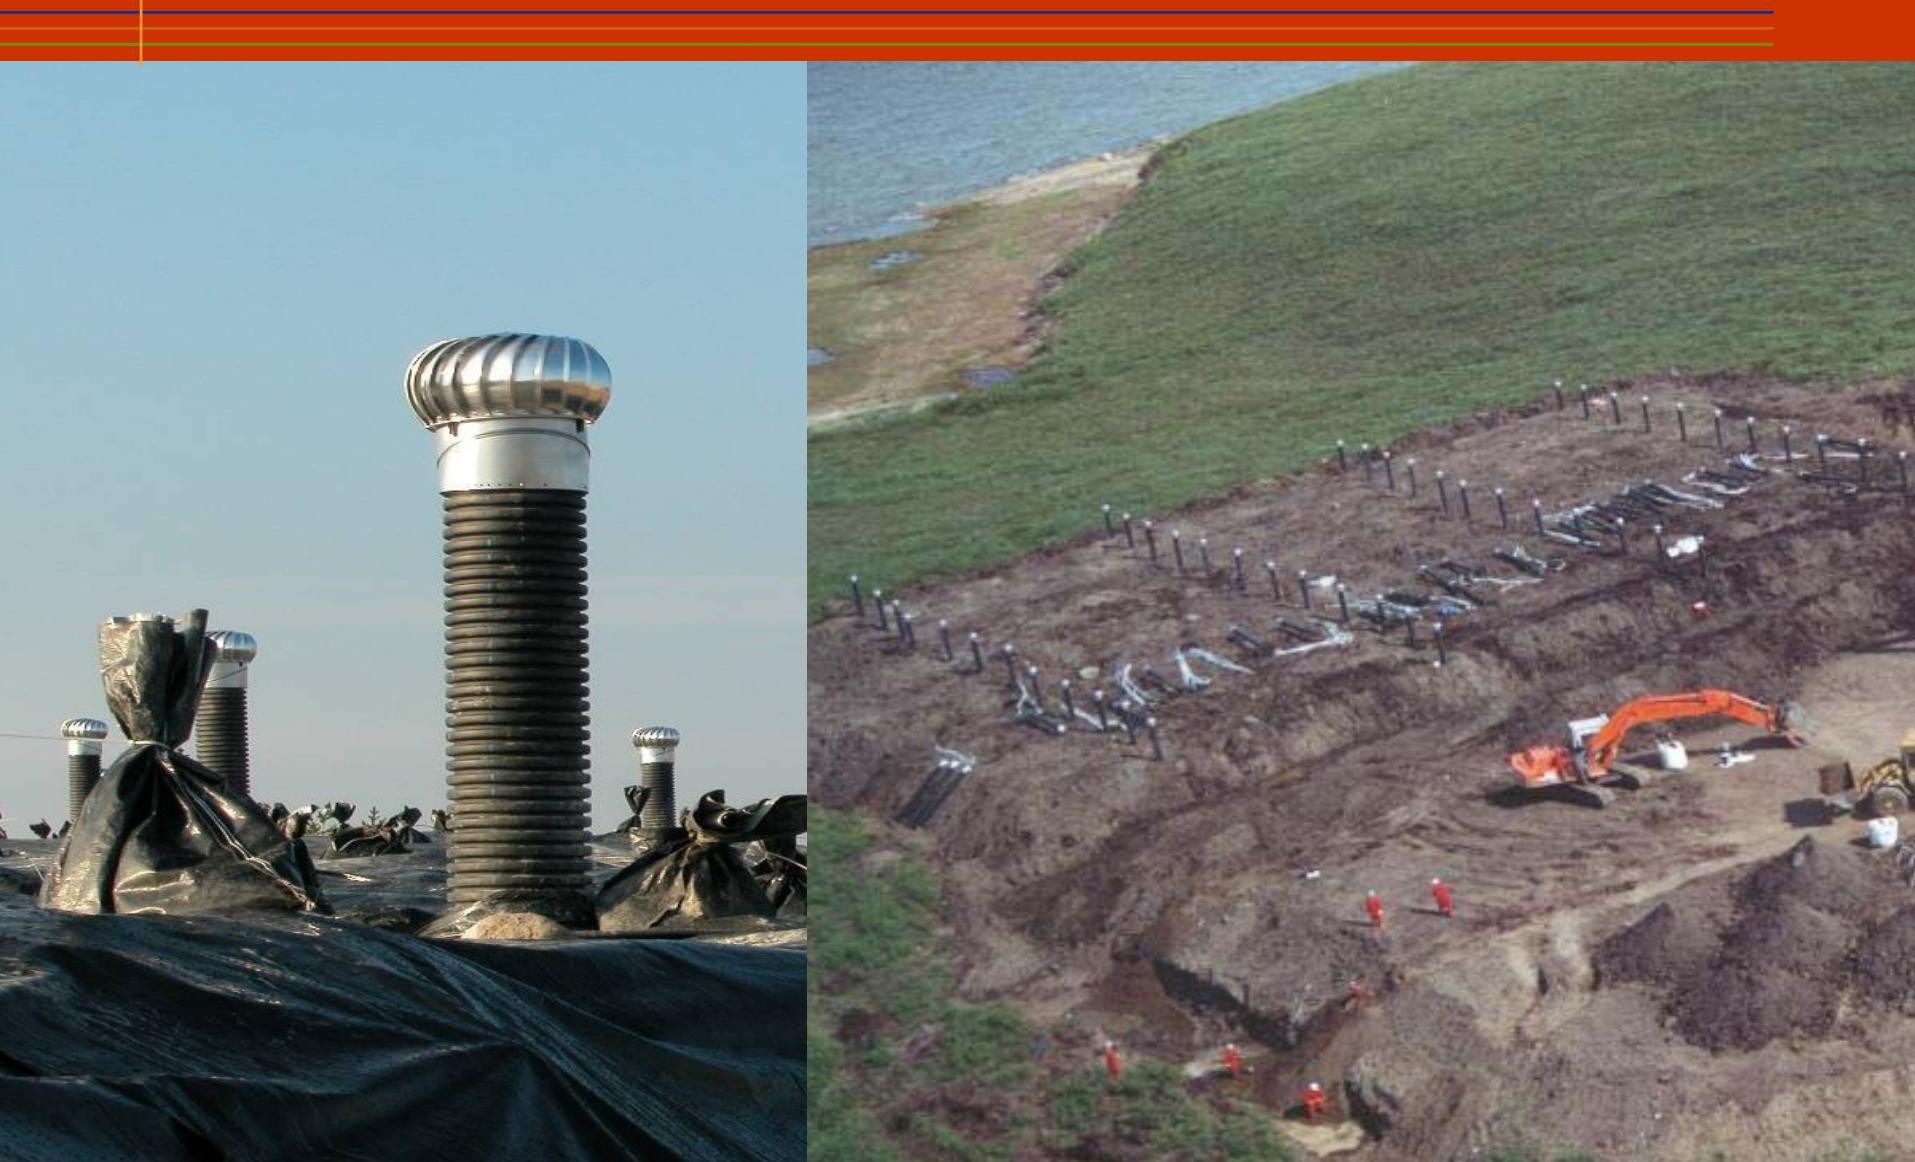
# Wind Turbines

- Minimization of soil handling
- Utilization of a windpowered aeration system
- Adapted design of the biological treatment to site-specific conditions
- Maximum use of local resources

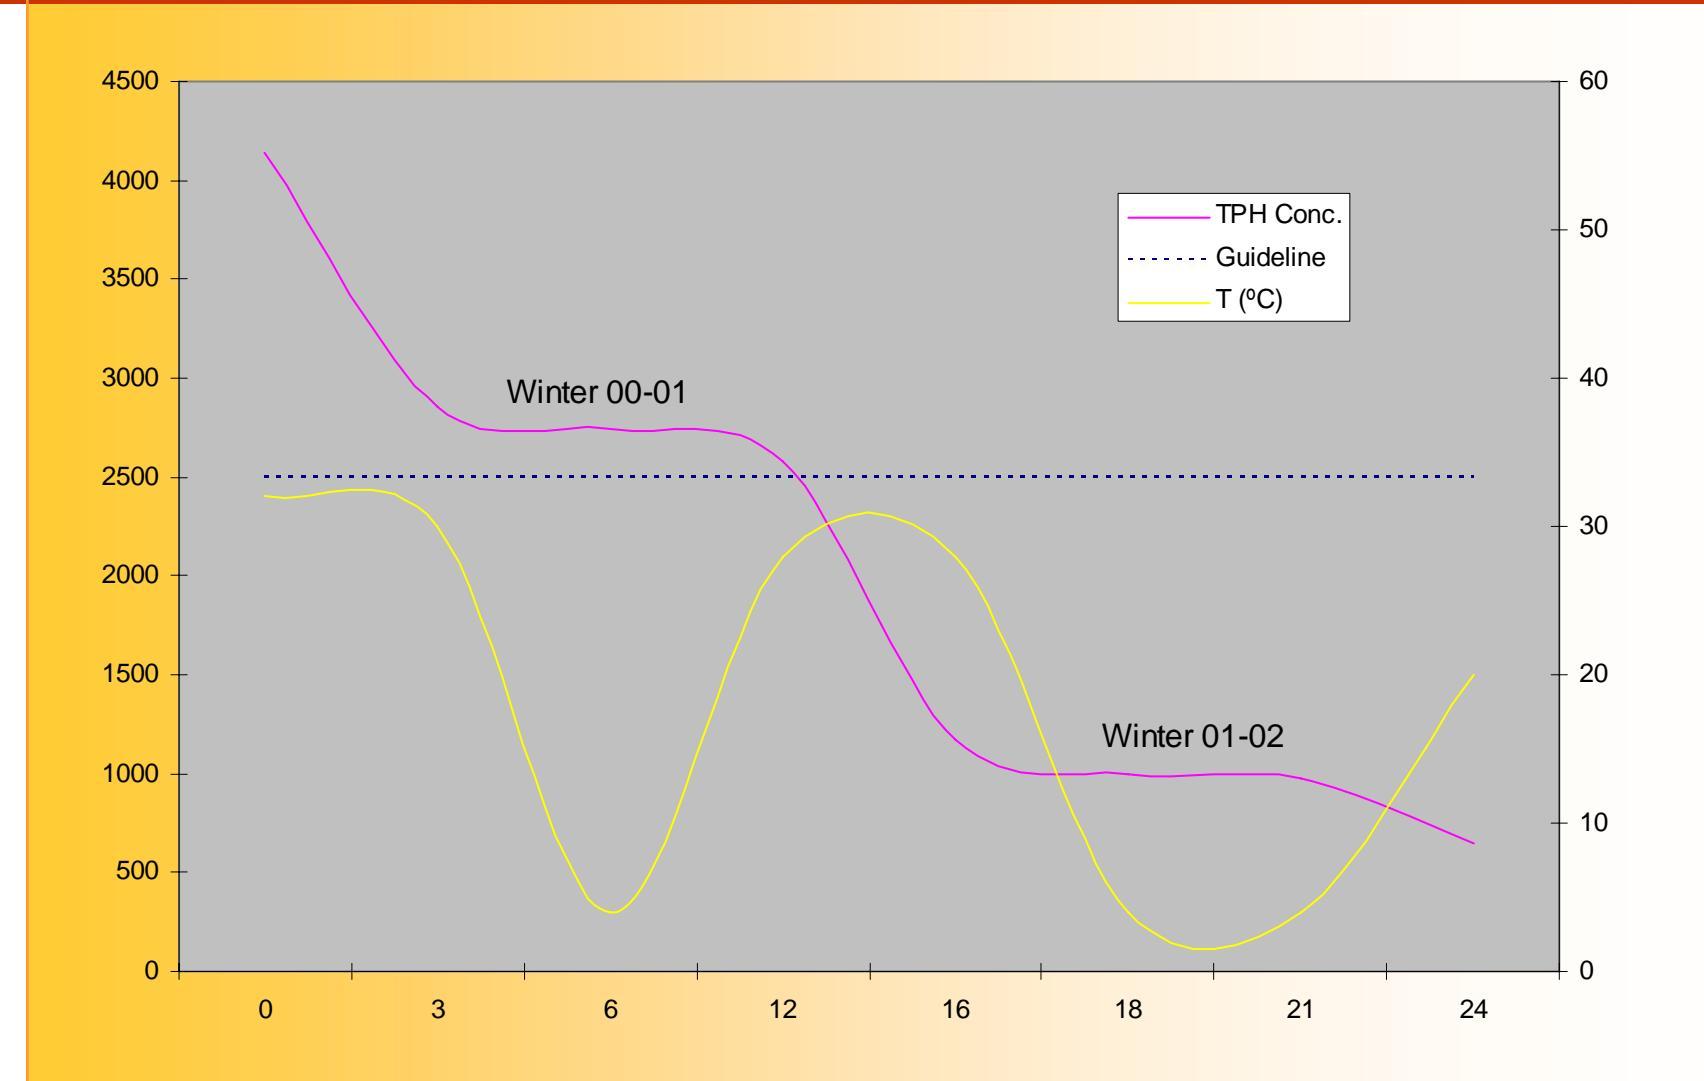
#### Saviktok Point Bioremediation Efficiency

- 17,000 m<sup>3</sup> treated to NWT Industrial Standard (2,500 mg/kg)
- 85% Average reduction of concentrations 4,136 mg/kg to 649 mg/kg
- Three seasons of treatment
- Average temperatures of 30 °C during treatment
- Soils were recycled as landfill cover material
