Case Study: Response and Cleanup of a Gas Well Blowout

Devin Allibone, Canadian Natural Brent Albrecht, Marquis Alliance

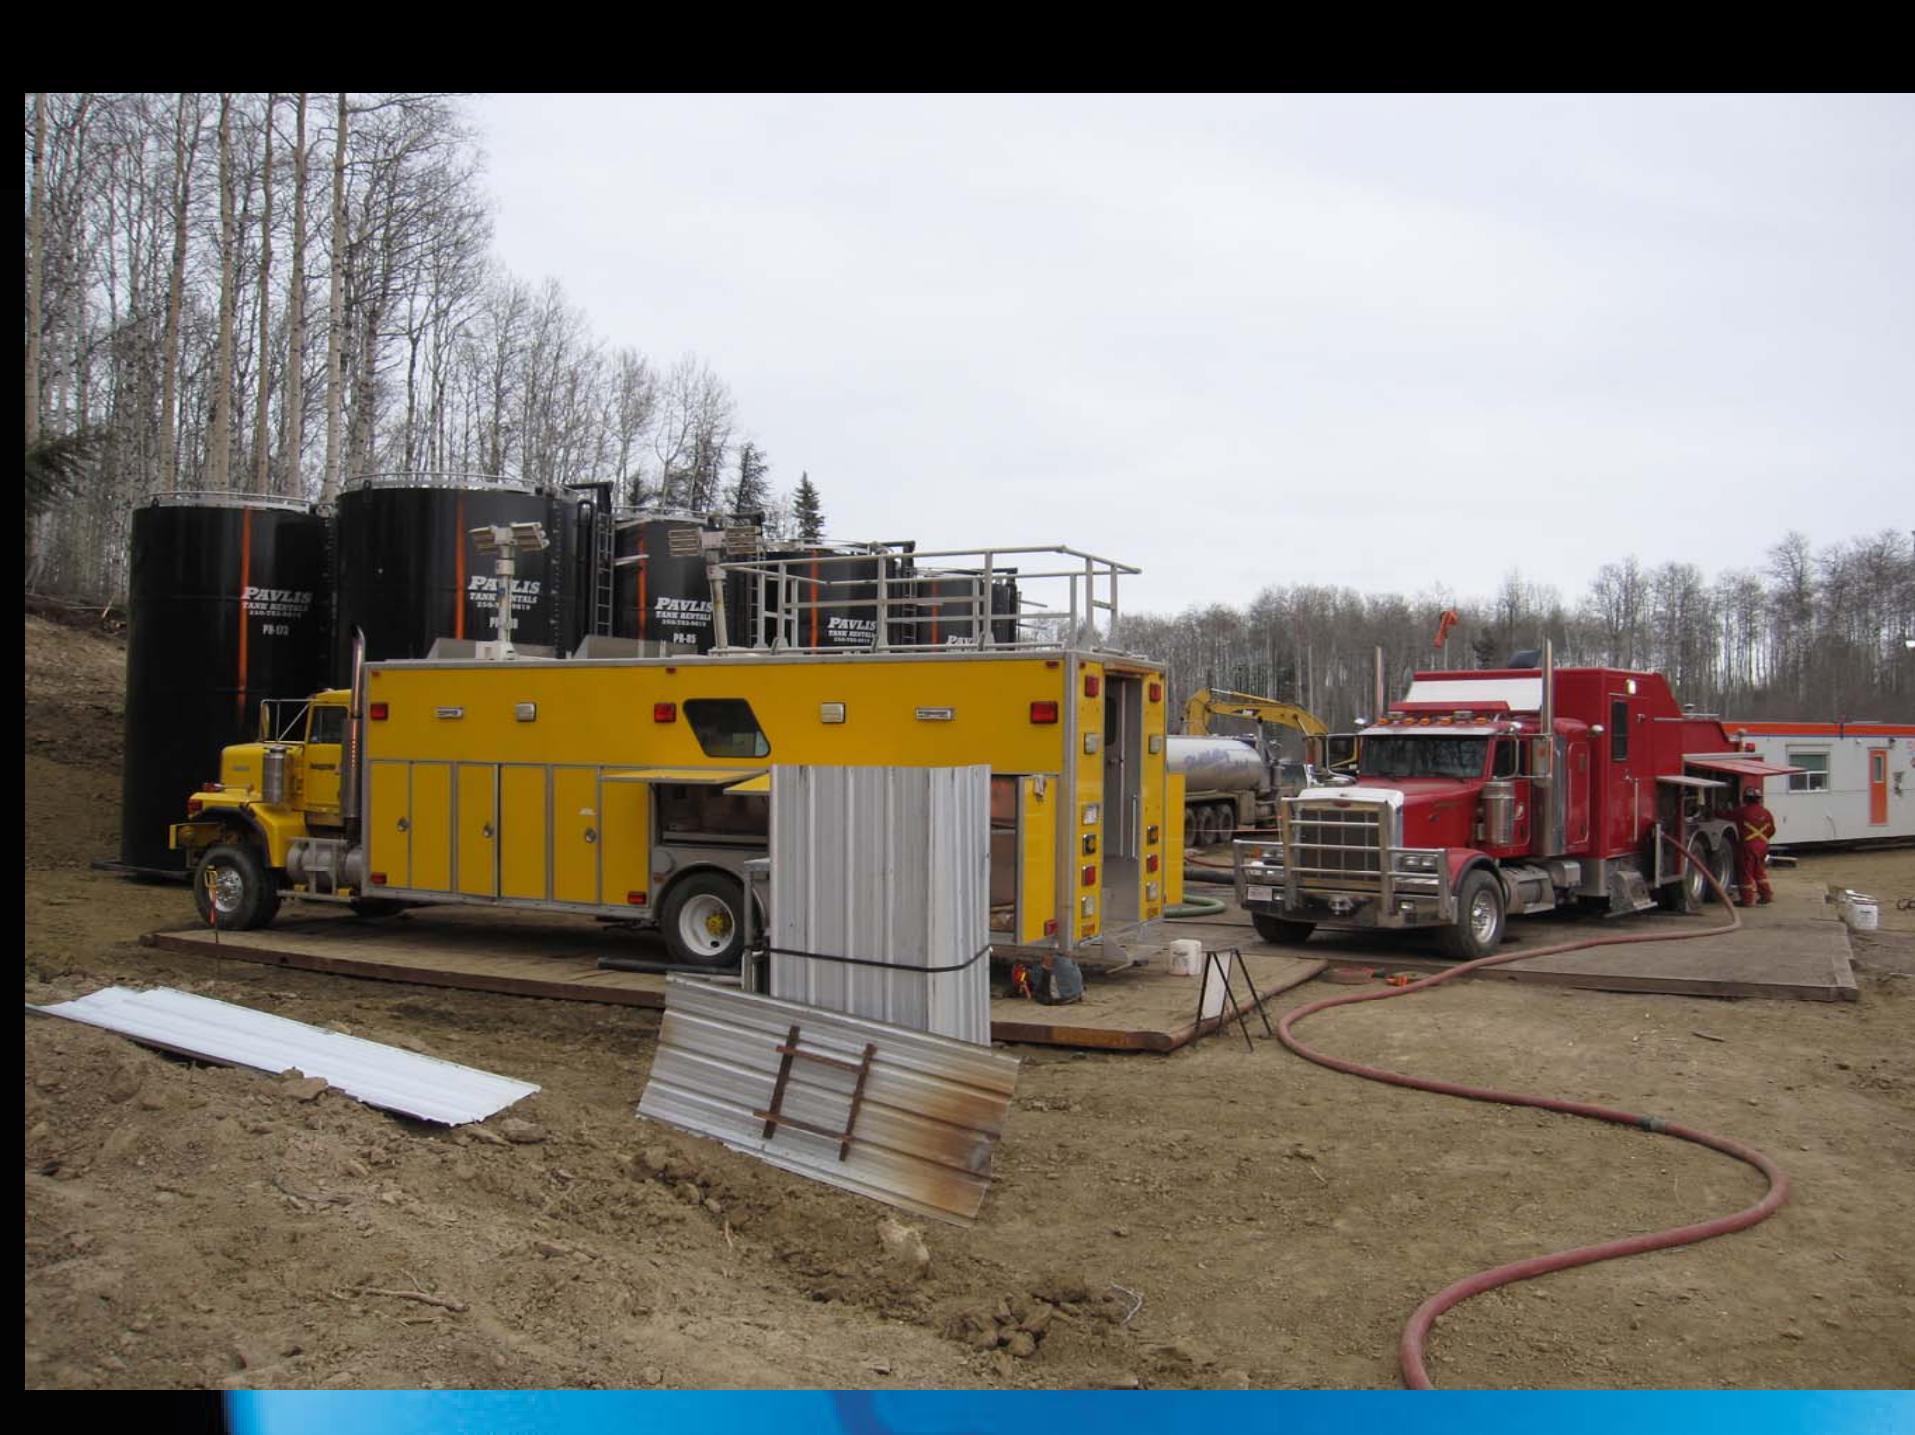
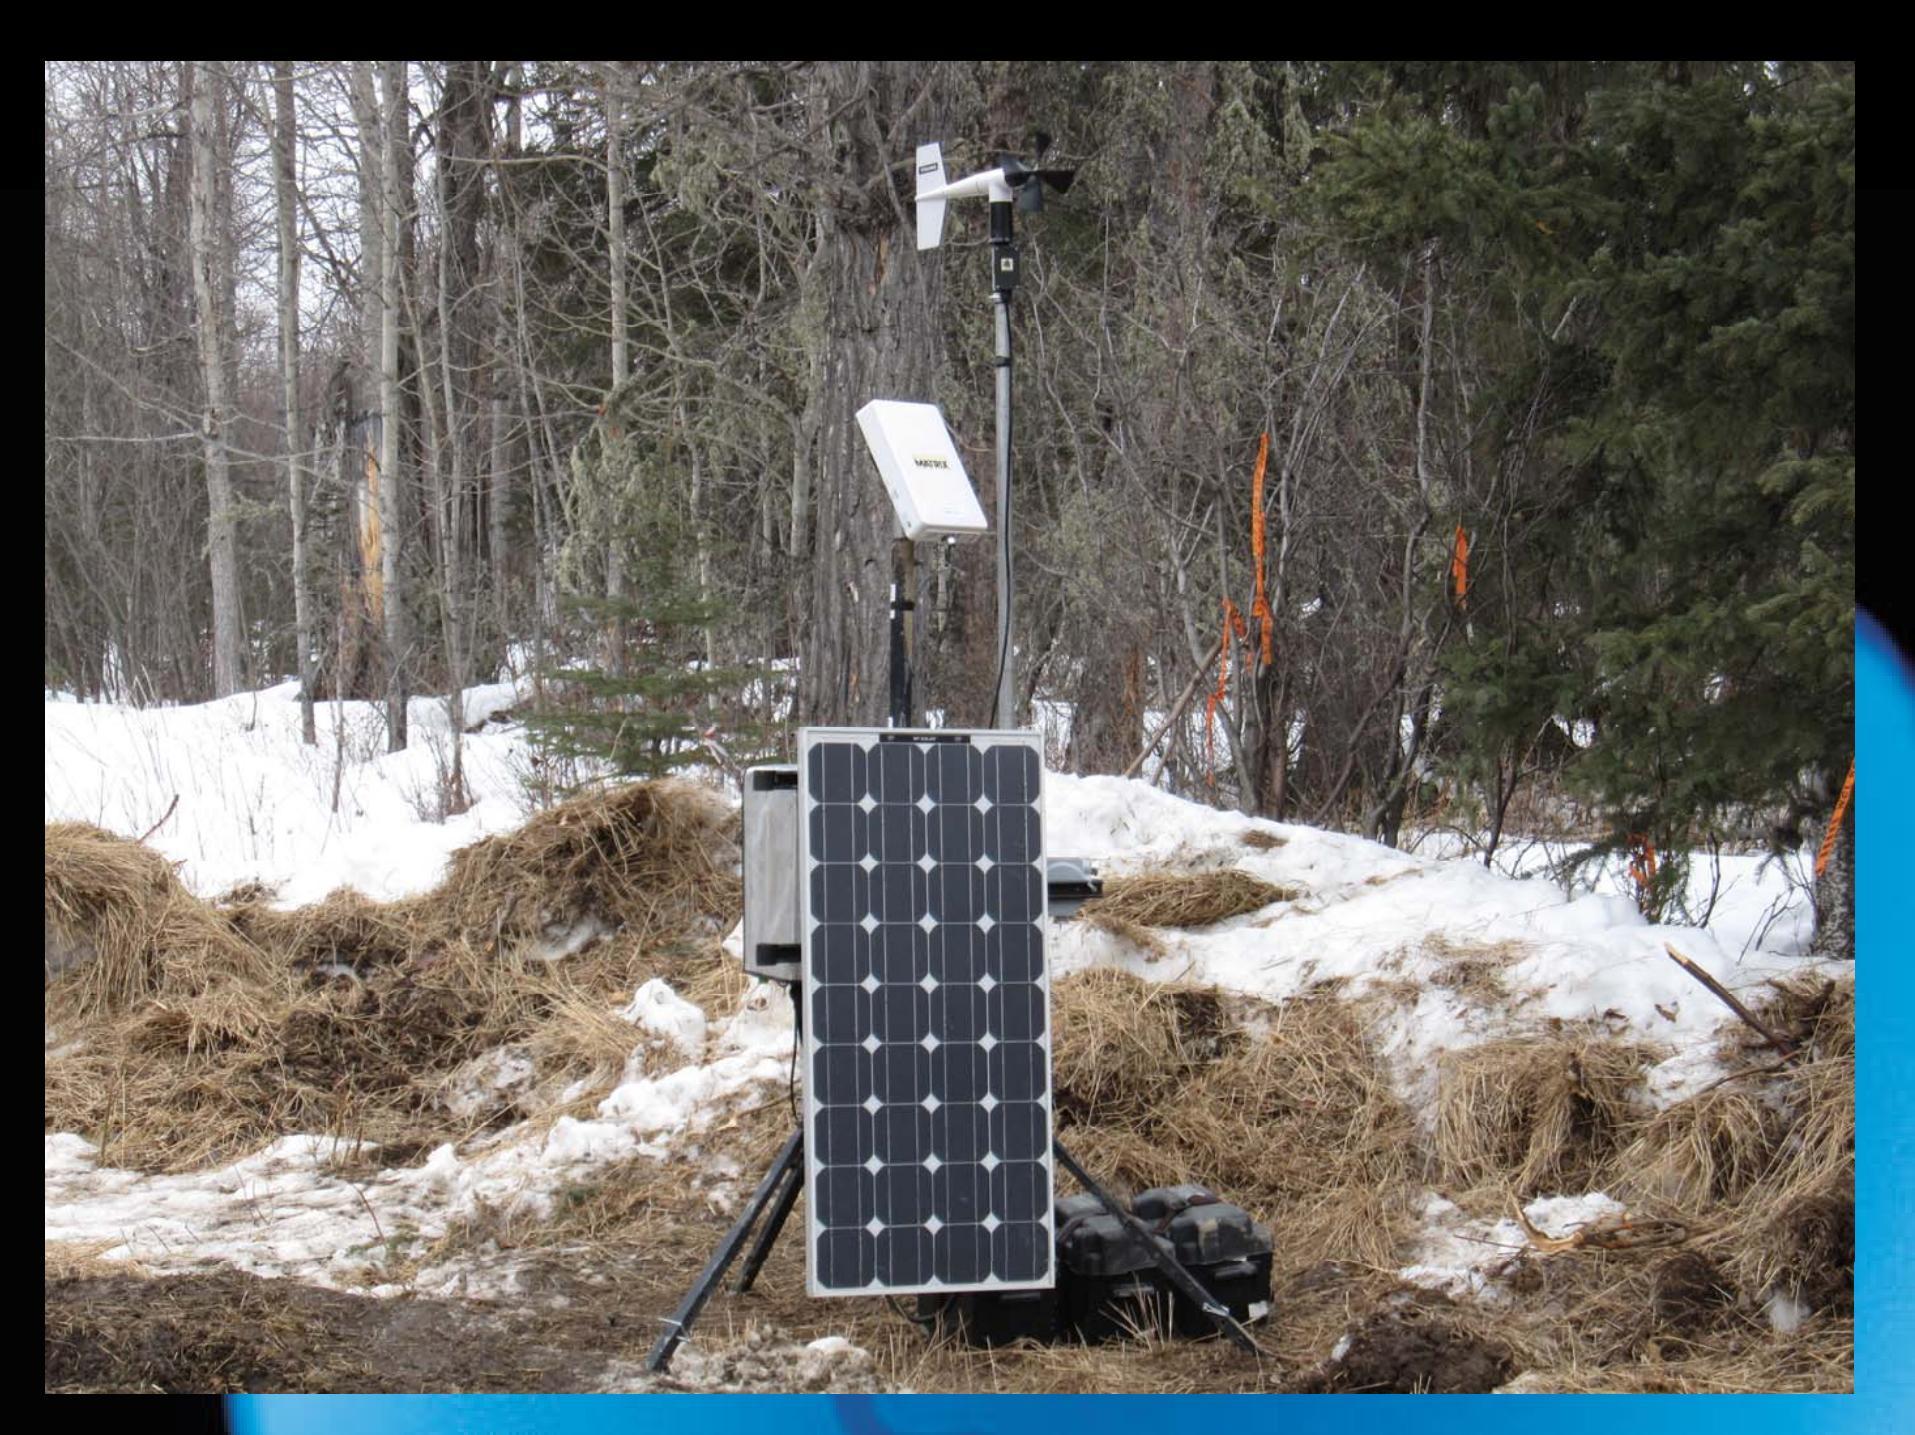
Wind speed and direction monitoring equipment

Air monitoring equipment powered by its own system

3-D topographical mapping software

A vast array of communications equipment

Notebook computers that contain all relevant data on all Alberta's energy facilities, and full high-speed Internet access

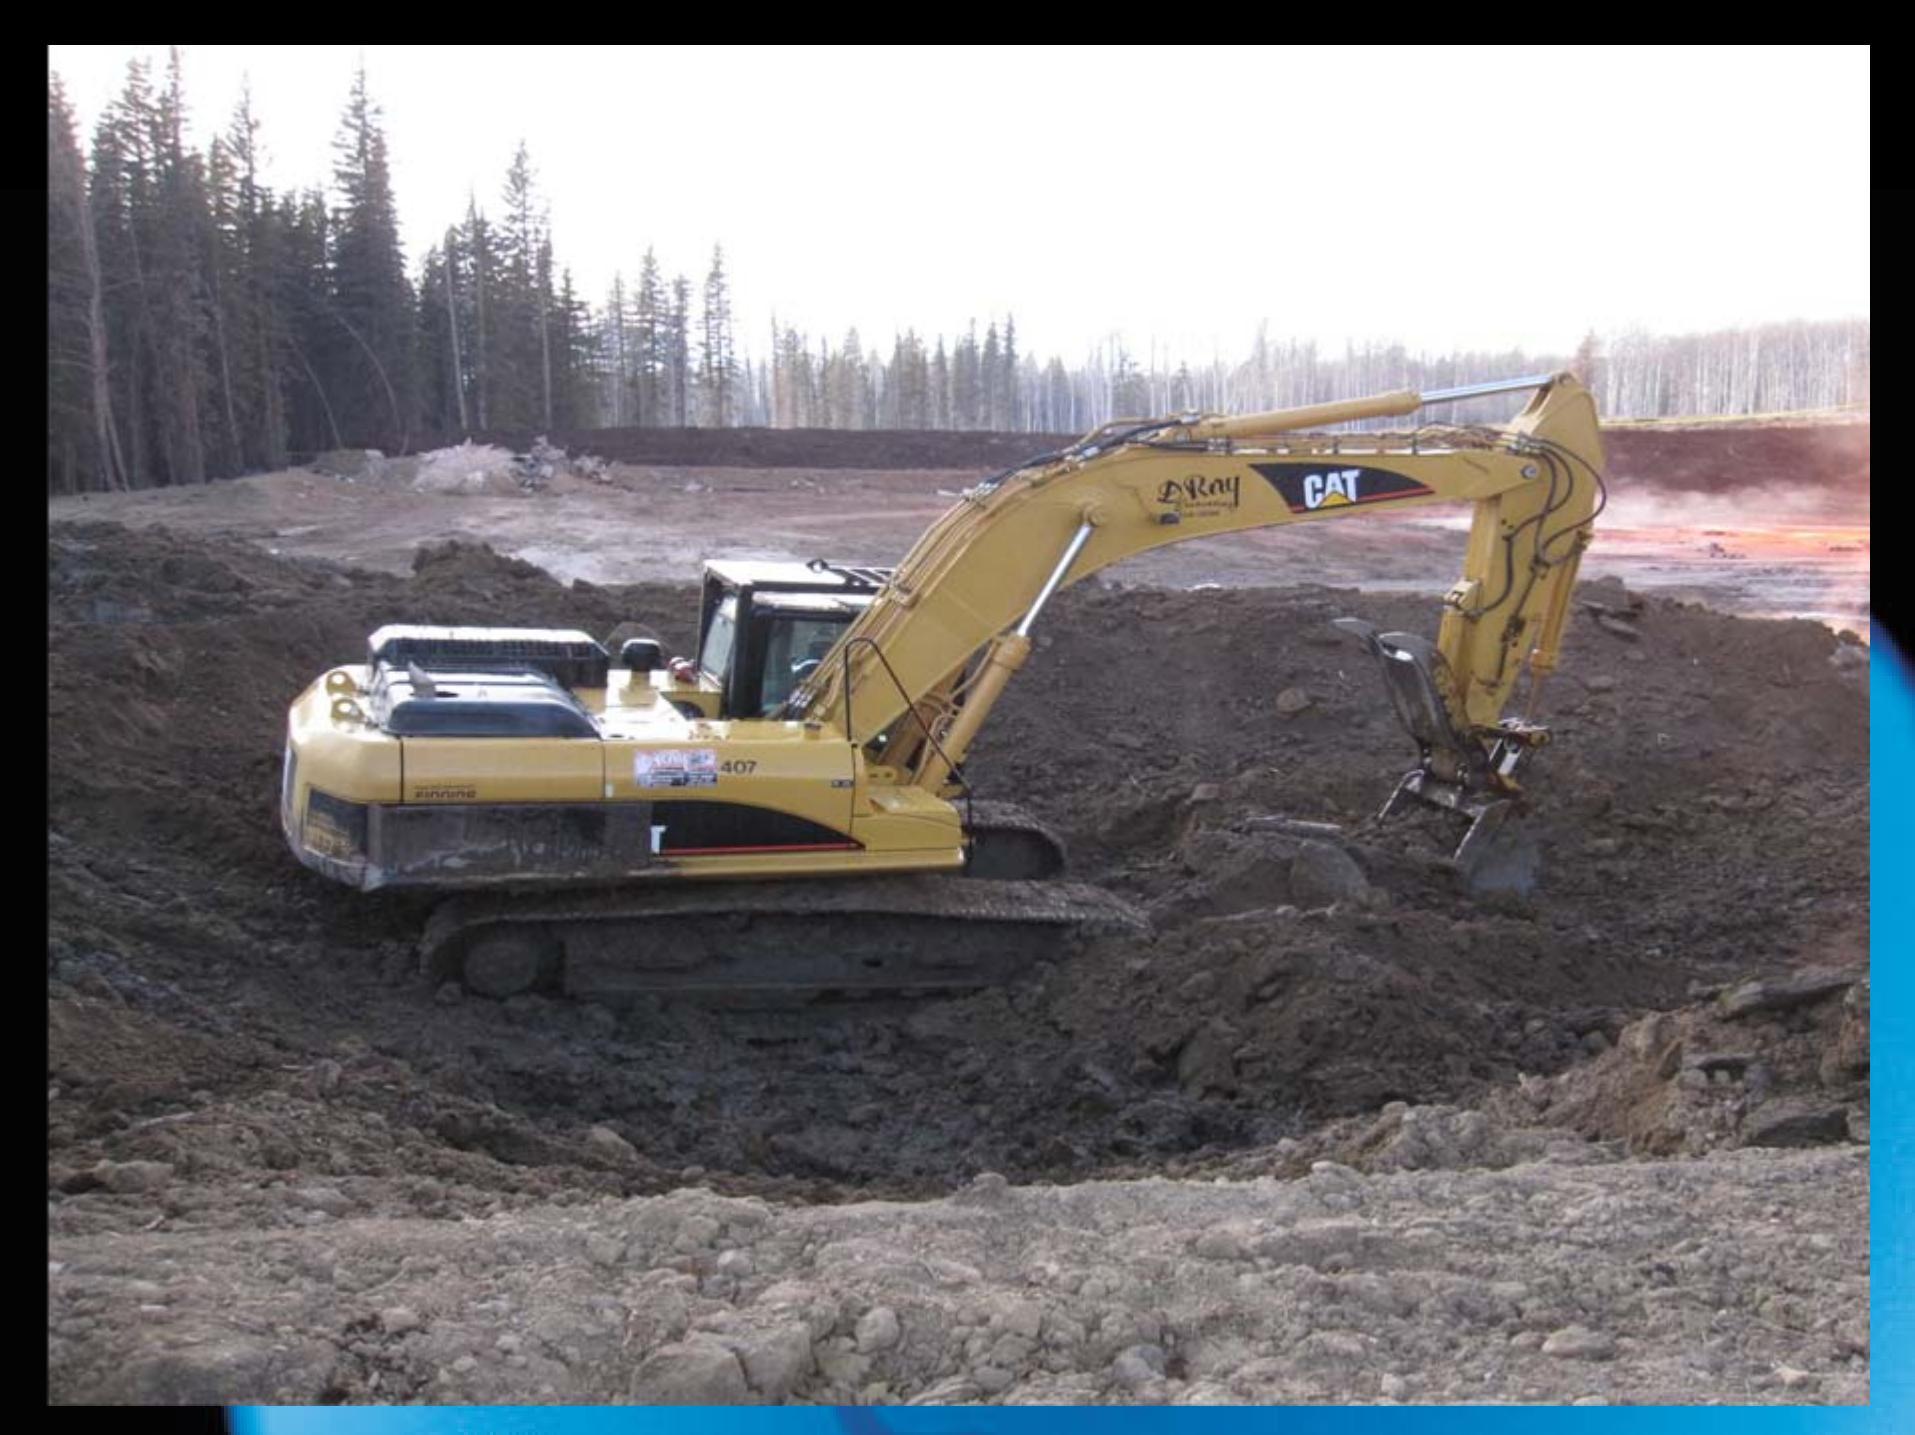
- Poly liners were brought to site as a possible containment aide.
- Drainage area was constructed to contain any well fluids in an area that would be safe to access frequently.
- Off site pits were excavated to contain any fresh water that may be produced.
- Pumps were brought to the location and hoses inserted into drainage area to allow for continuous removal, if required.

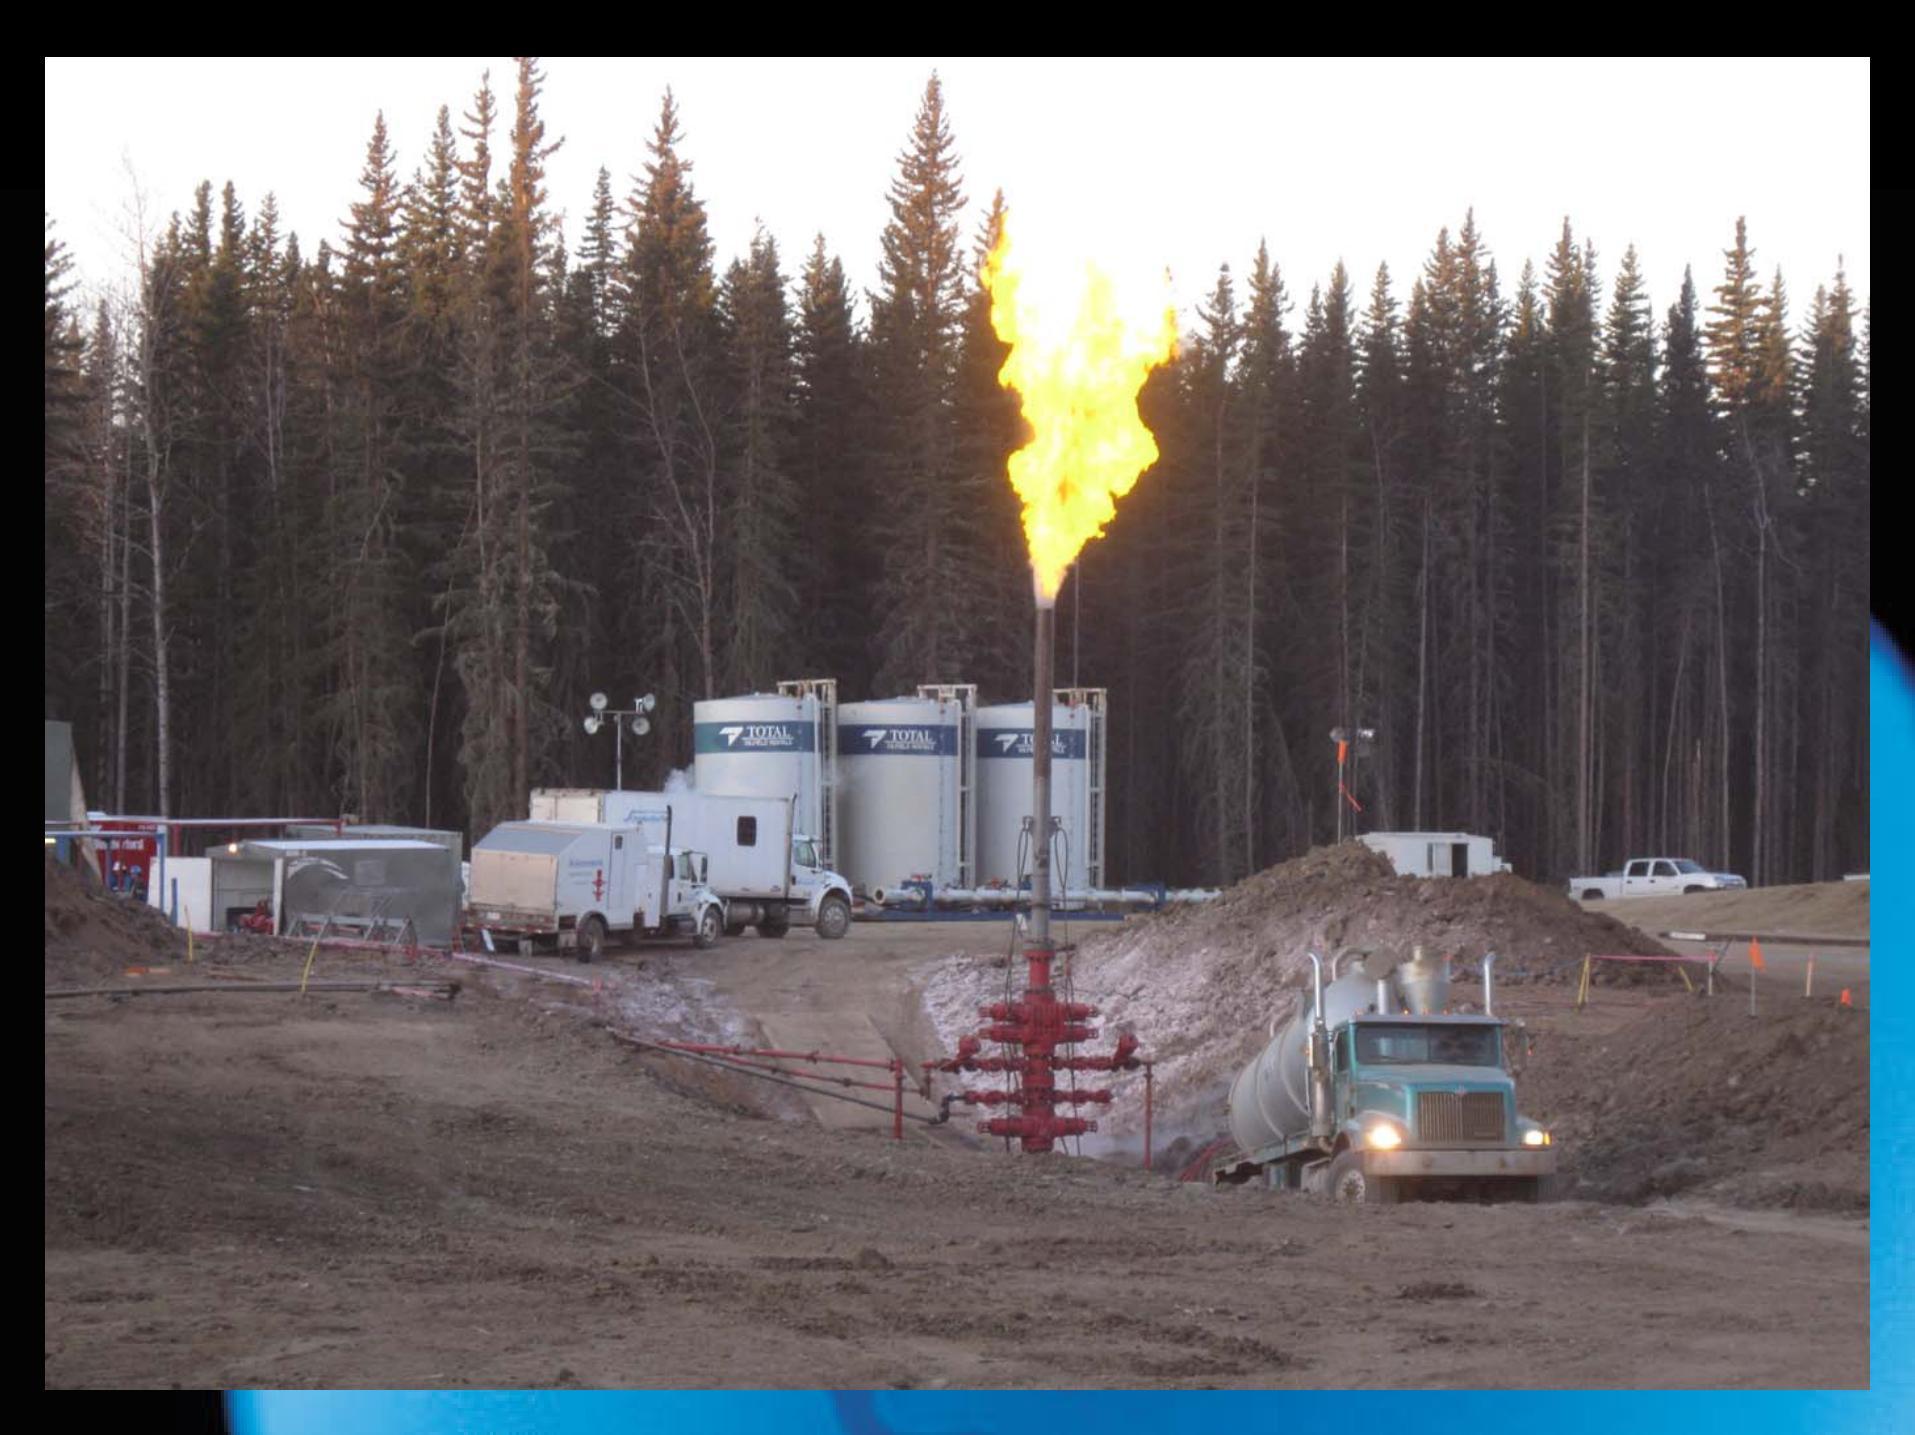
- Spill trailer was mobilized to the site in the event it would be needed.
- All hazardous waste was removed as soon as it was safe to do so.
- Large three sided shale bin was used to contain any non-DOW wastes before they were hauled to a Class II landfill.
- Tree Hugger moment, all metal that could be saved was sent to a recycling facility. This meant picking through the "garbage"!

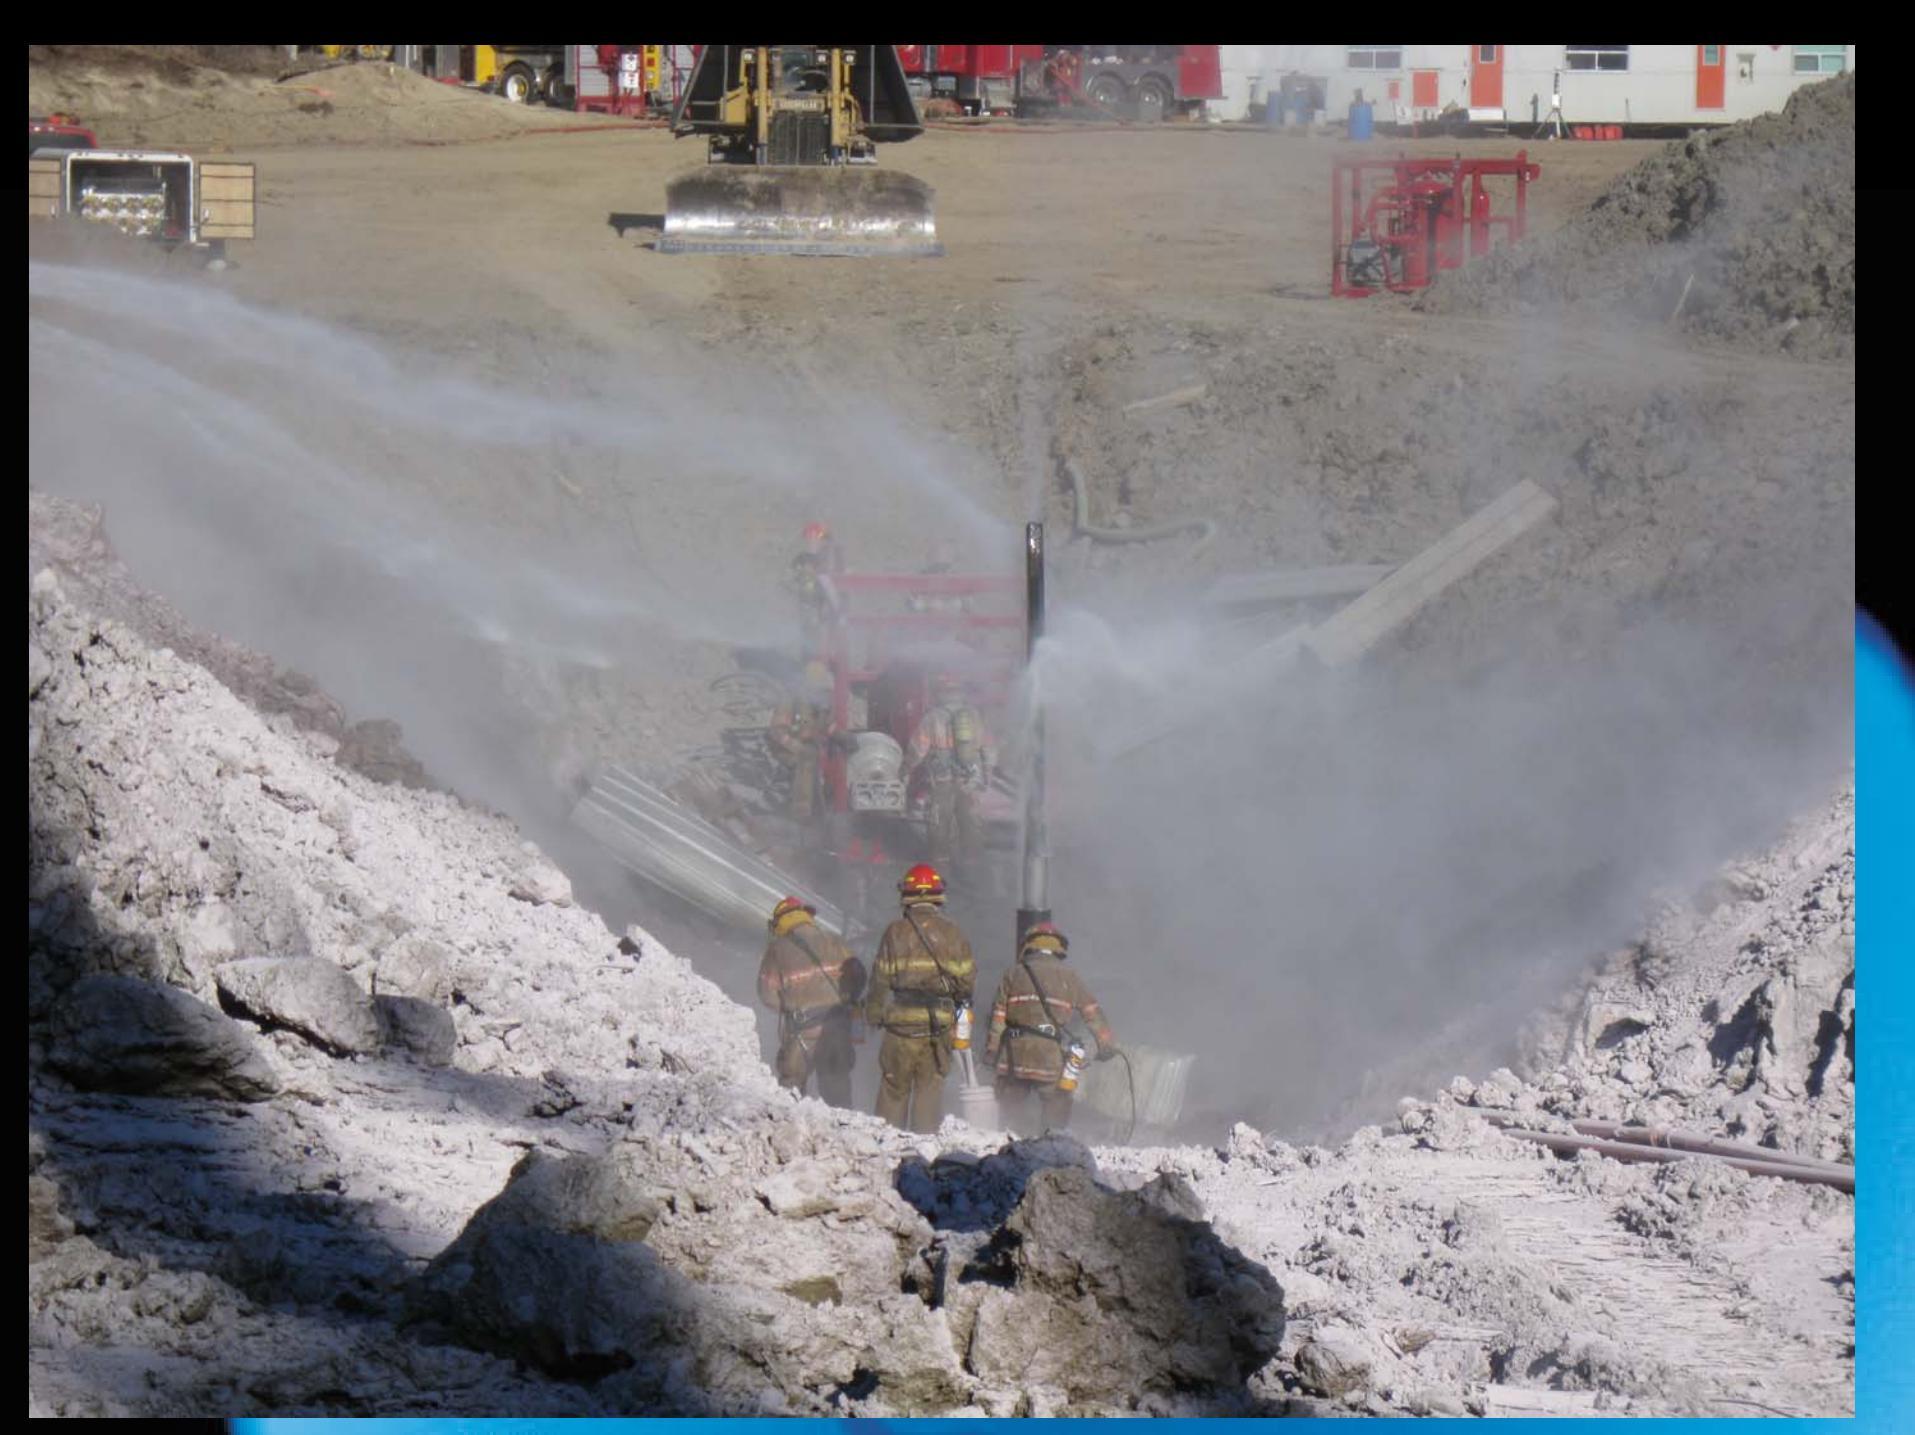
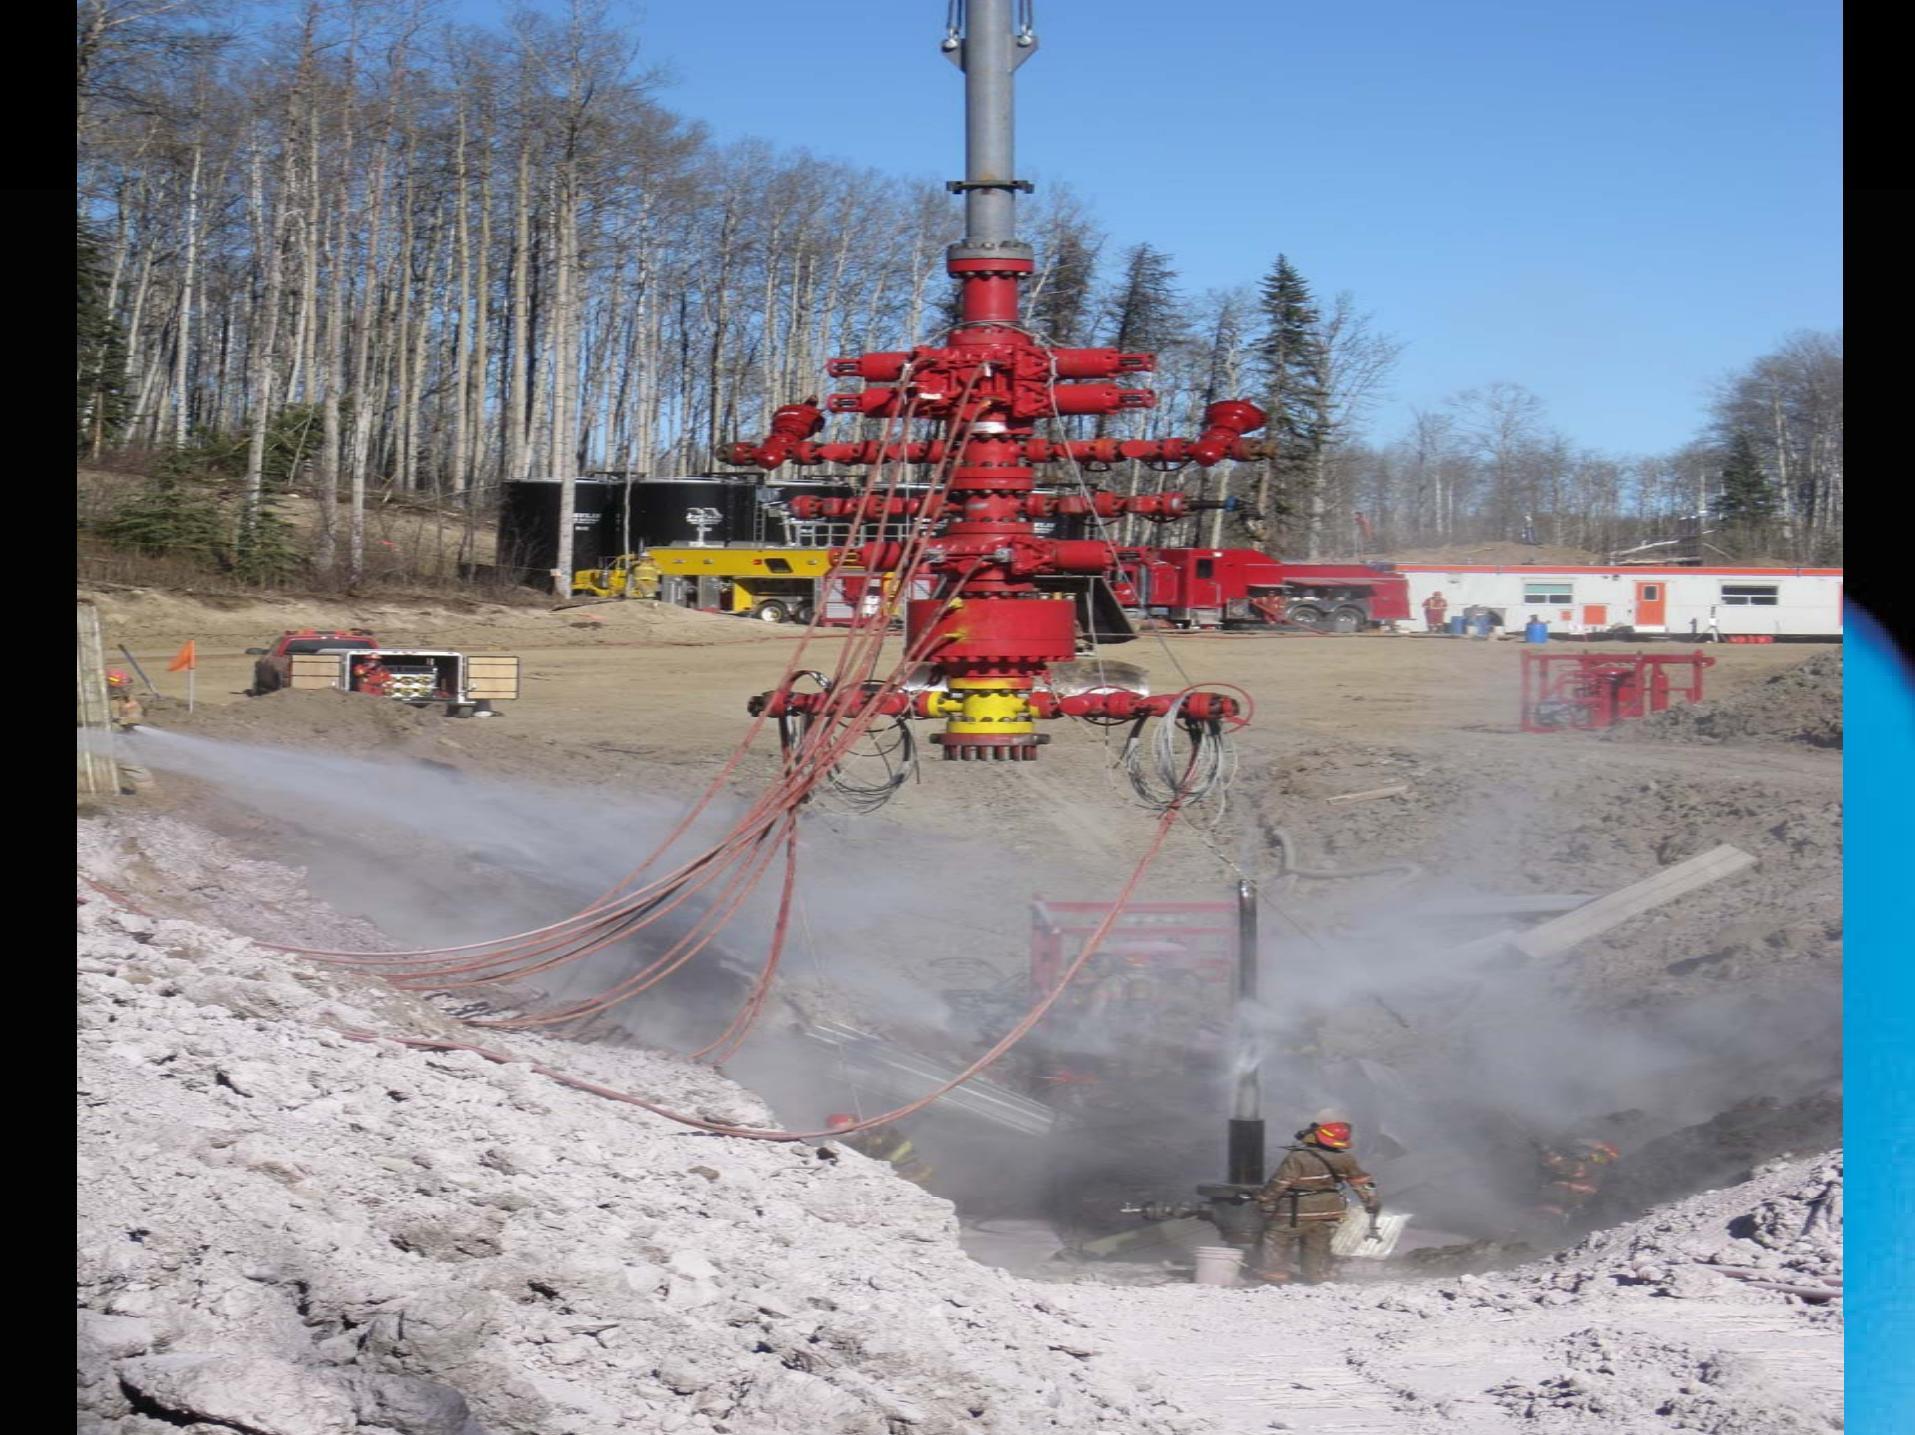
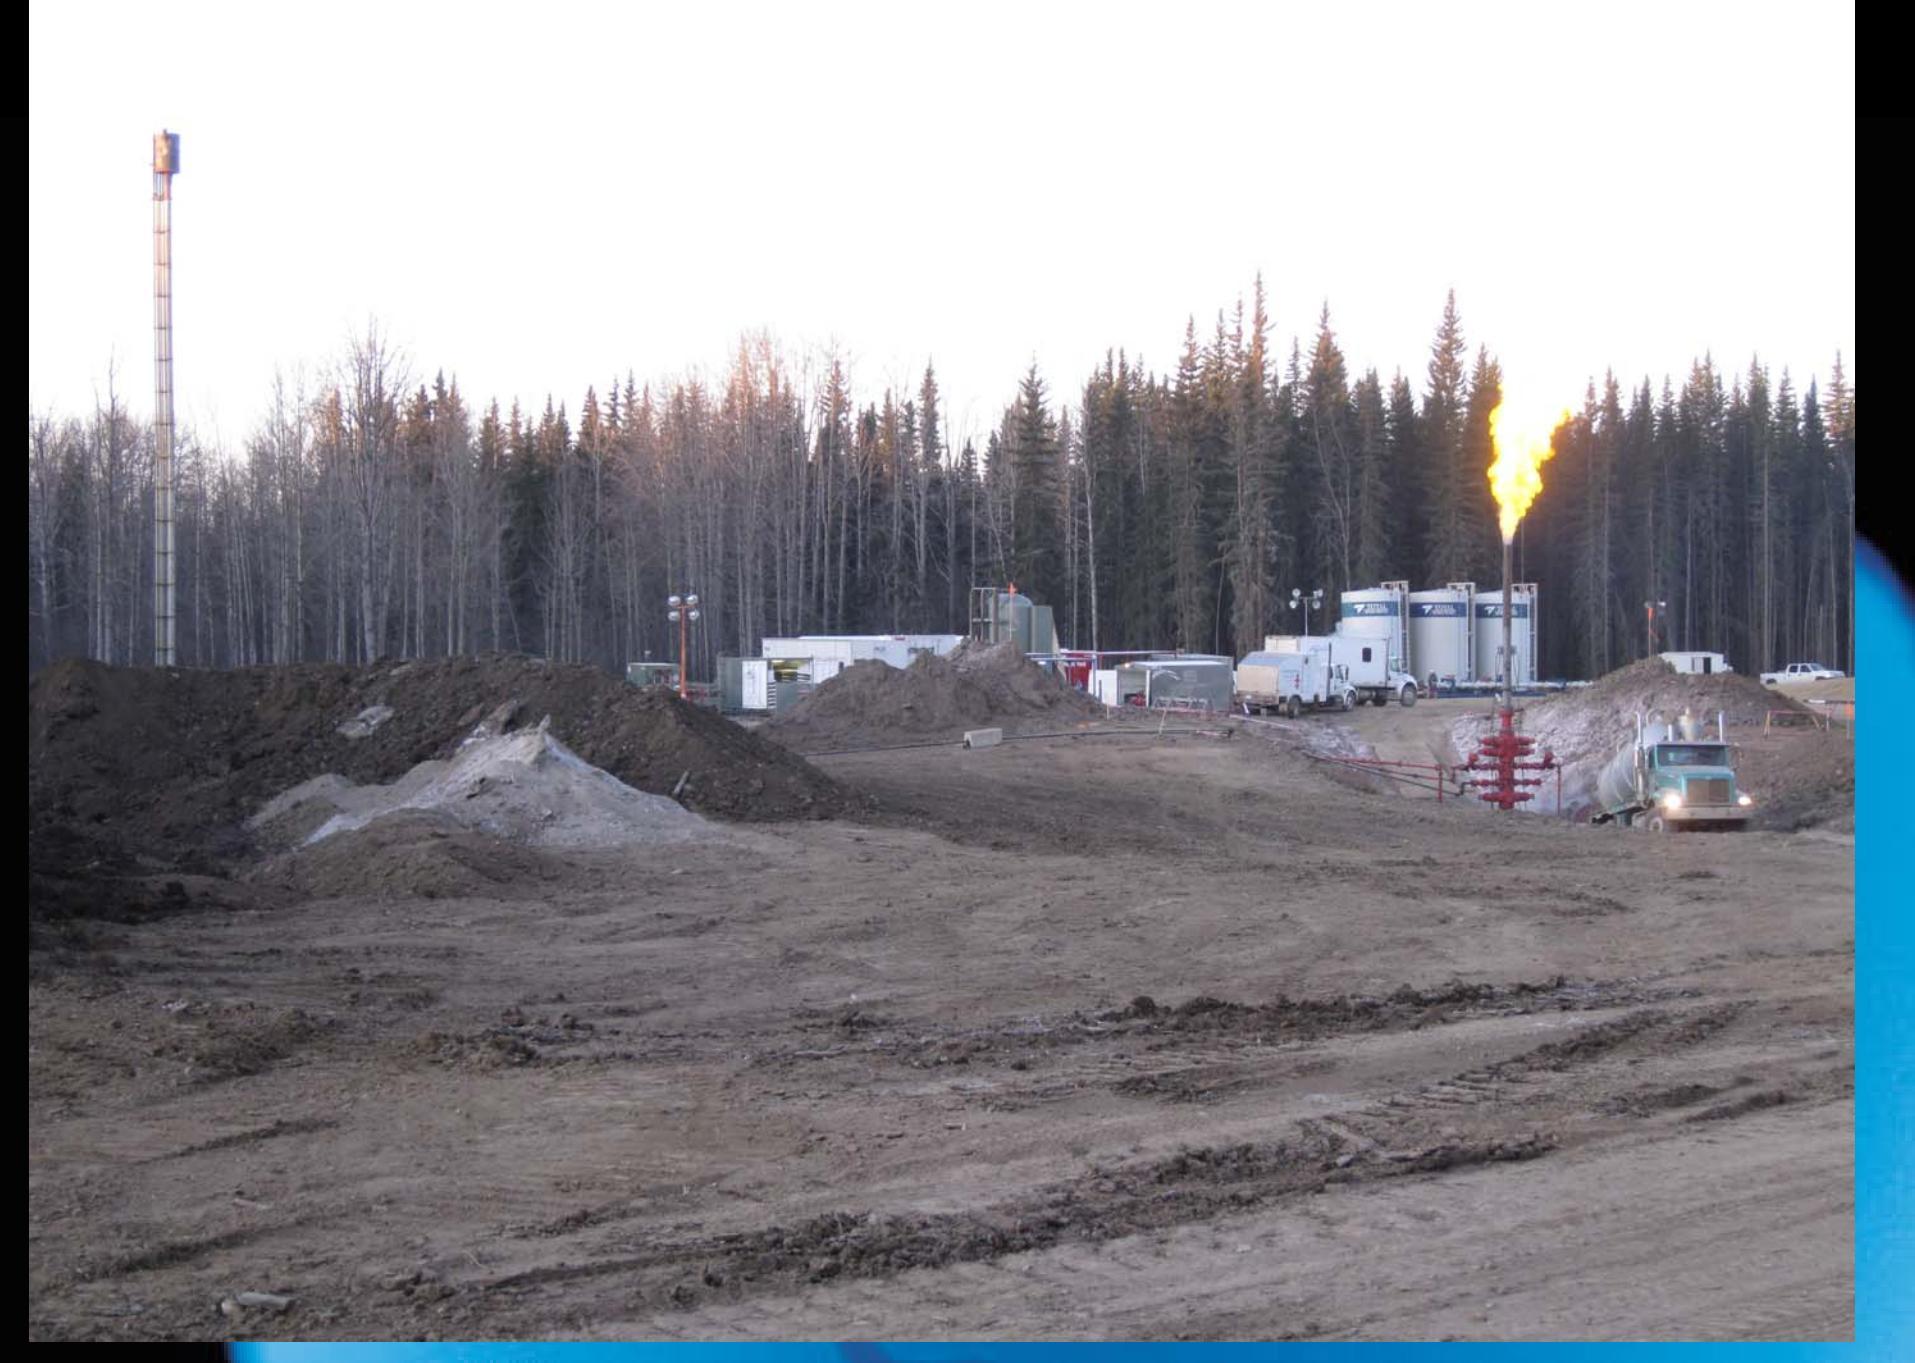
- Excavated area around well centre down to competent surface casing.
- Installed a casing extension and a new casing bowl.
- Snuffed the flame to install the new BOP and re-ignited the flame.
- Snuffed the flame to divert the flow to a well test package.
- Gas flow rate and pressure were monitored to determine the optimum well kill program.

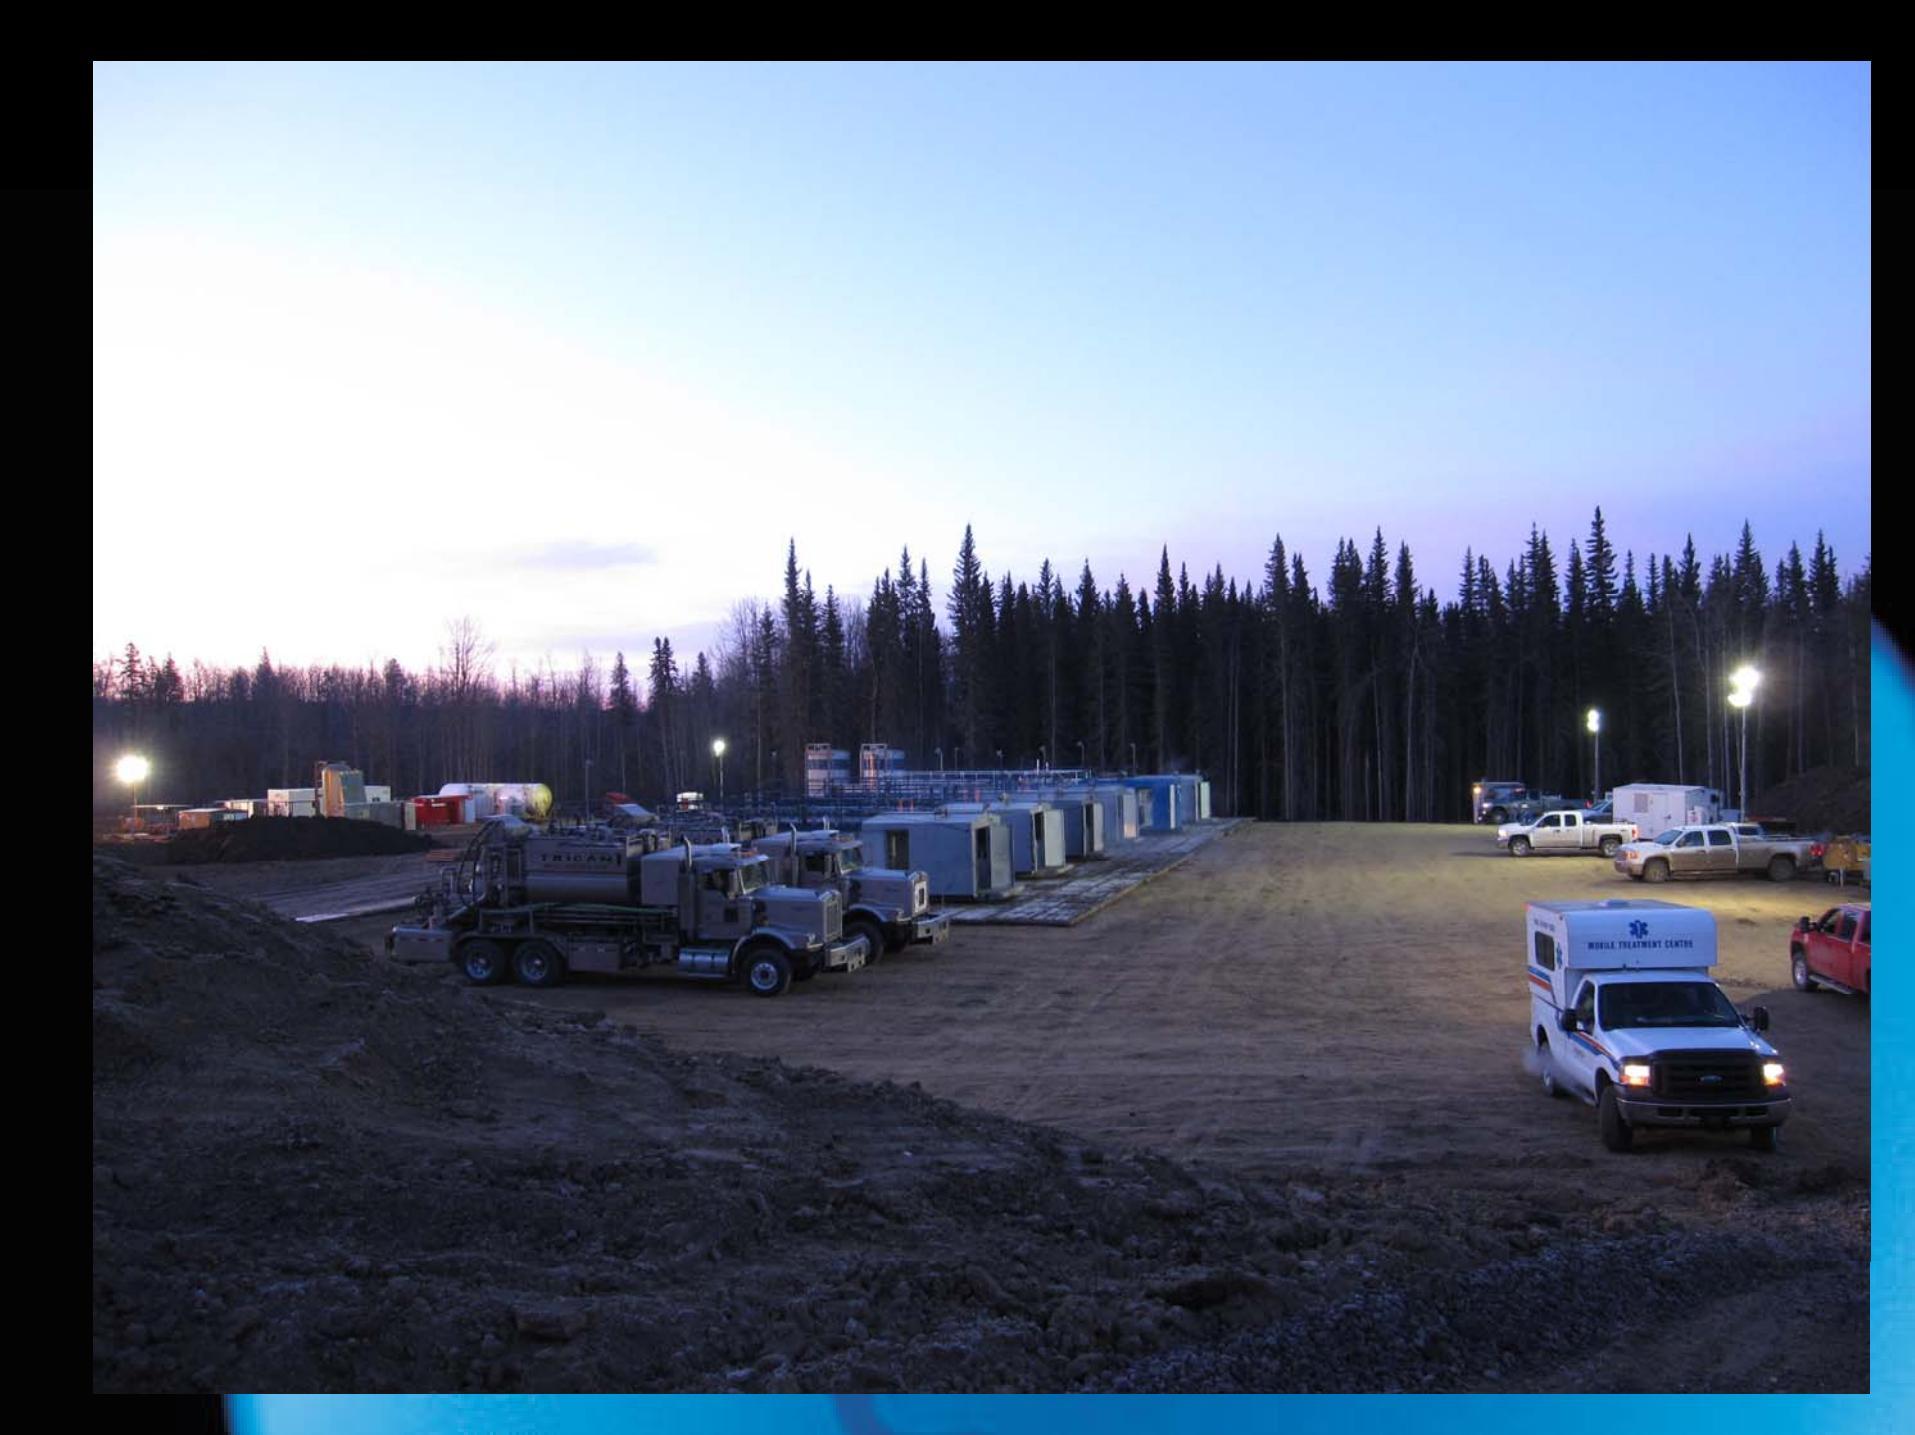
- Annulus killed utilizing a volumetric (lubricate) kill procedure with 1700 kg/m3 water based kill mud. The weighting agent was Barite. The Barite was suspended with Bentonite Gel and caustic soda to activate the gel.
- Drill pipe was killed using a bullhead kill procedure with water, 2400 kg/m3 water based kill mud, followed by 1950 kg/m3 Class 'G' cement.
