Case Study: Response and Cleanup of a Gas Well Blowout

Devin Allibone, Canadian Natural Brent Albrecht, Marquis Alliance

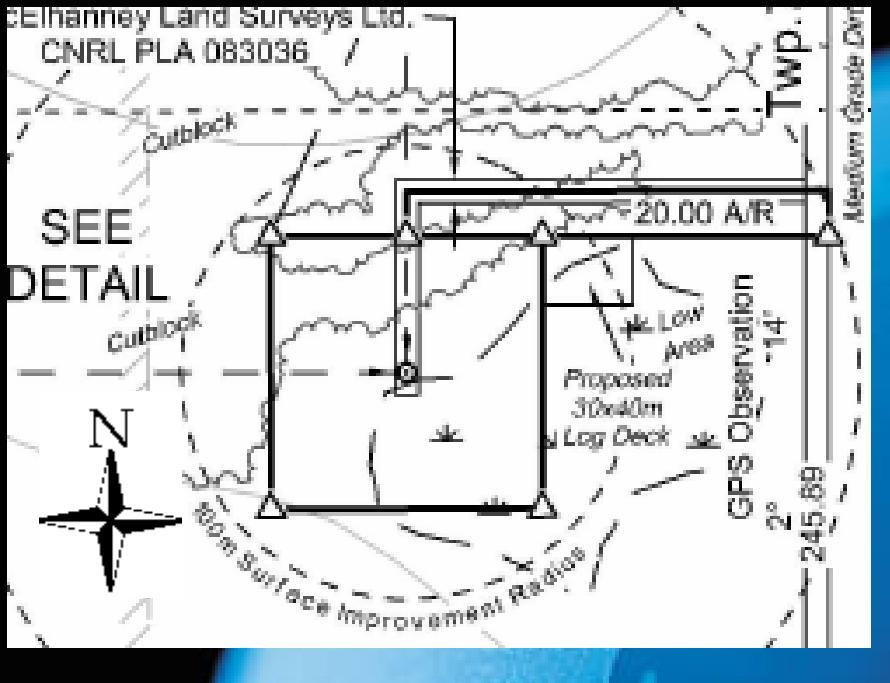
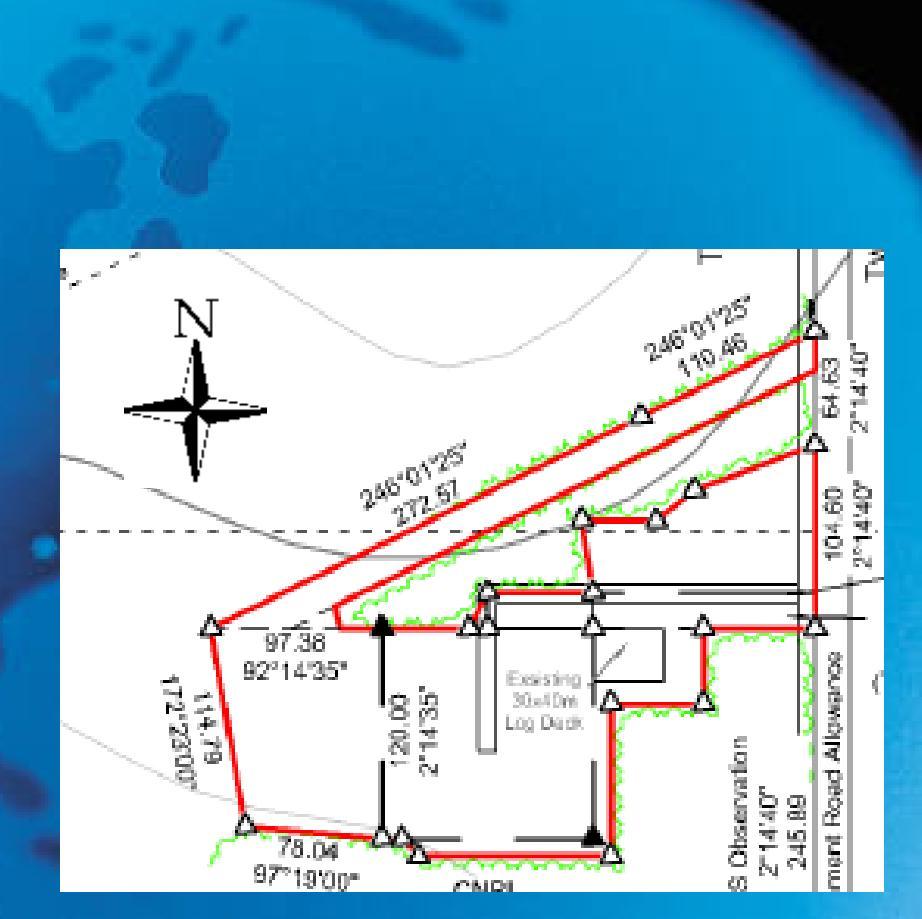
Initial Assessment Locations

1. Well Centre

- Area of most activity due to well kill operations and the event itself.
- 2. Shale Pit Area
 - Initial well shale storage area and onsite drainage area to manage fluids flowing from the well.

3. Flare Tank Area

- Potential area of concern based on drilling fluid used to drill the well.
- 4. Invert Tank Area
 - Obvious area of potential impact!

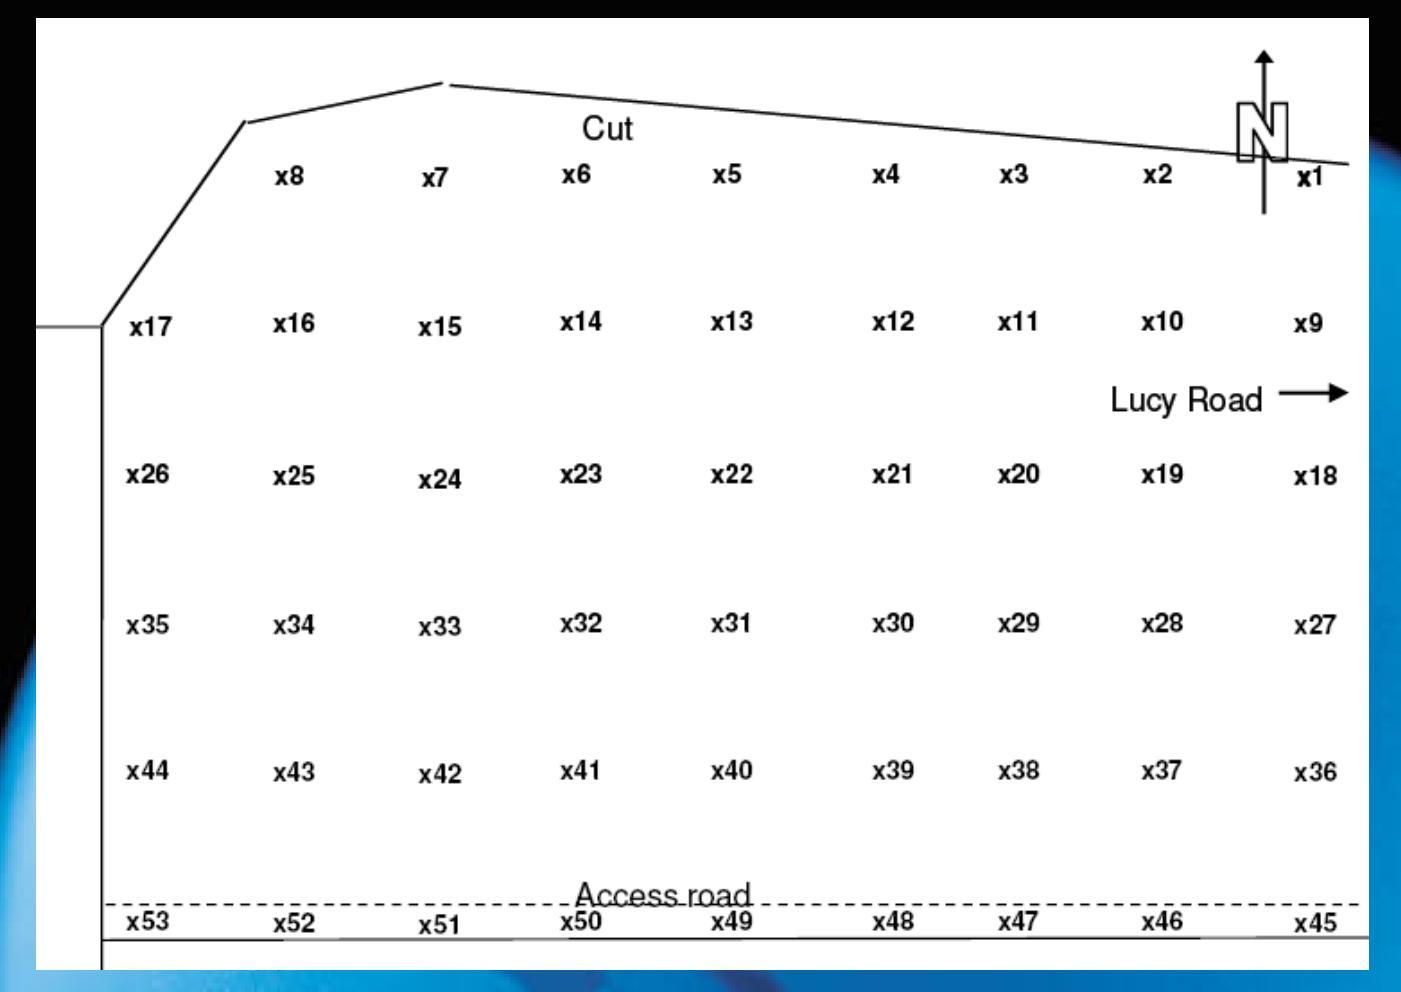
Example - Staging Area Sampling

- Target sampling was completed in areas with known or suspected impacts (well centre, shale pit etc.)
- Areas where impacts were not known or were suspected, samples were collected using a grid pattern (east/west expansion areas, staging areas etc.)
- Field screening and a EM31 survey were used to guide which samples were submitted for laboratory analysis.

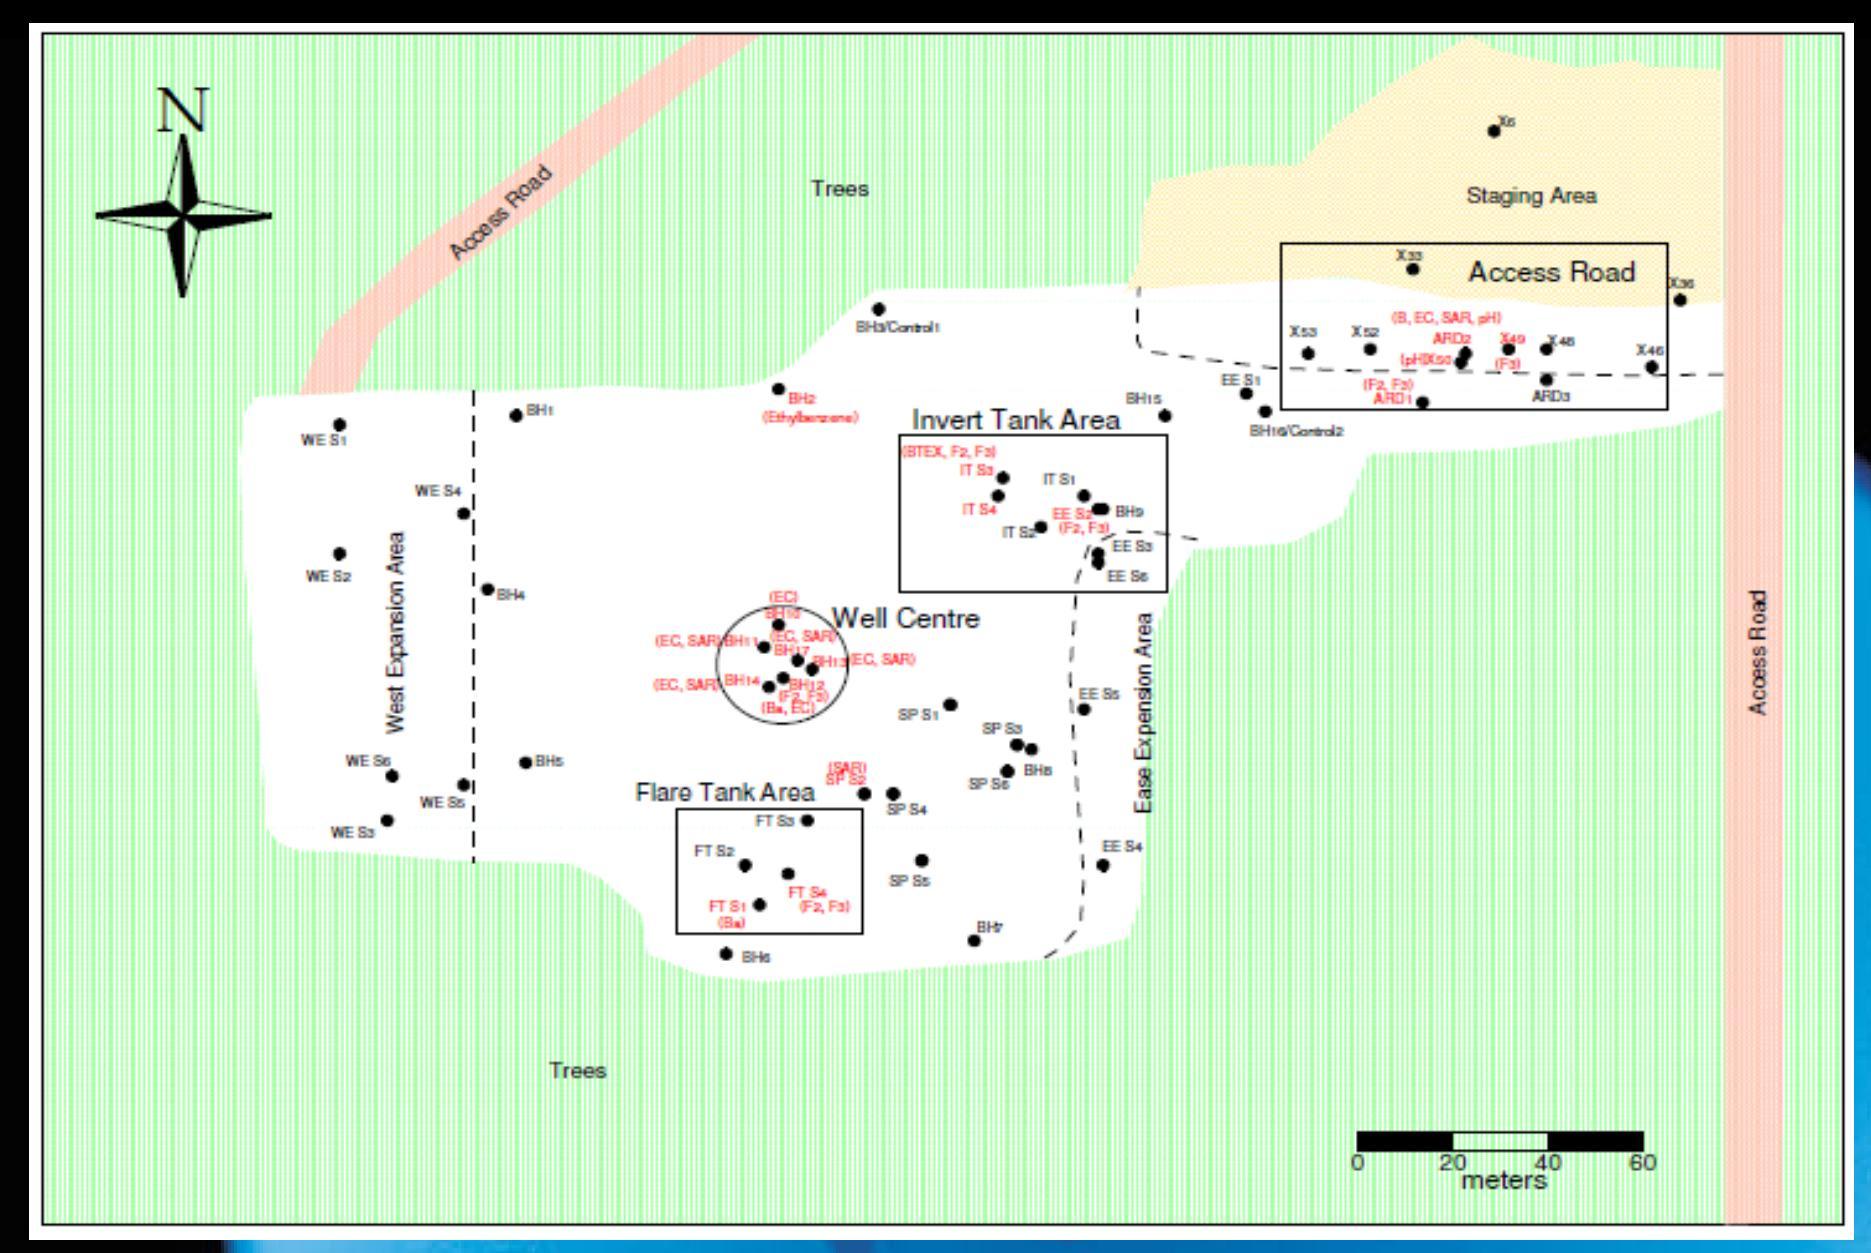
Initial Sampling Summary

- Some initial salinity exceedances (SCARG).
- Hydrocarbon and barite exceedances were noted.
- No groundwater impacts noted at anytime.

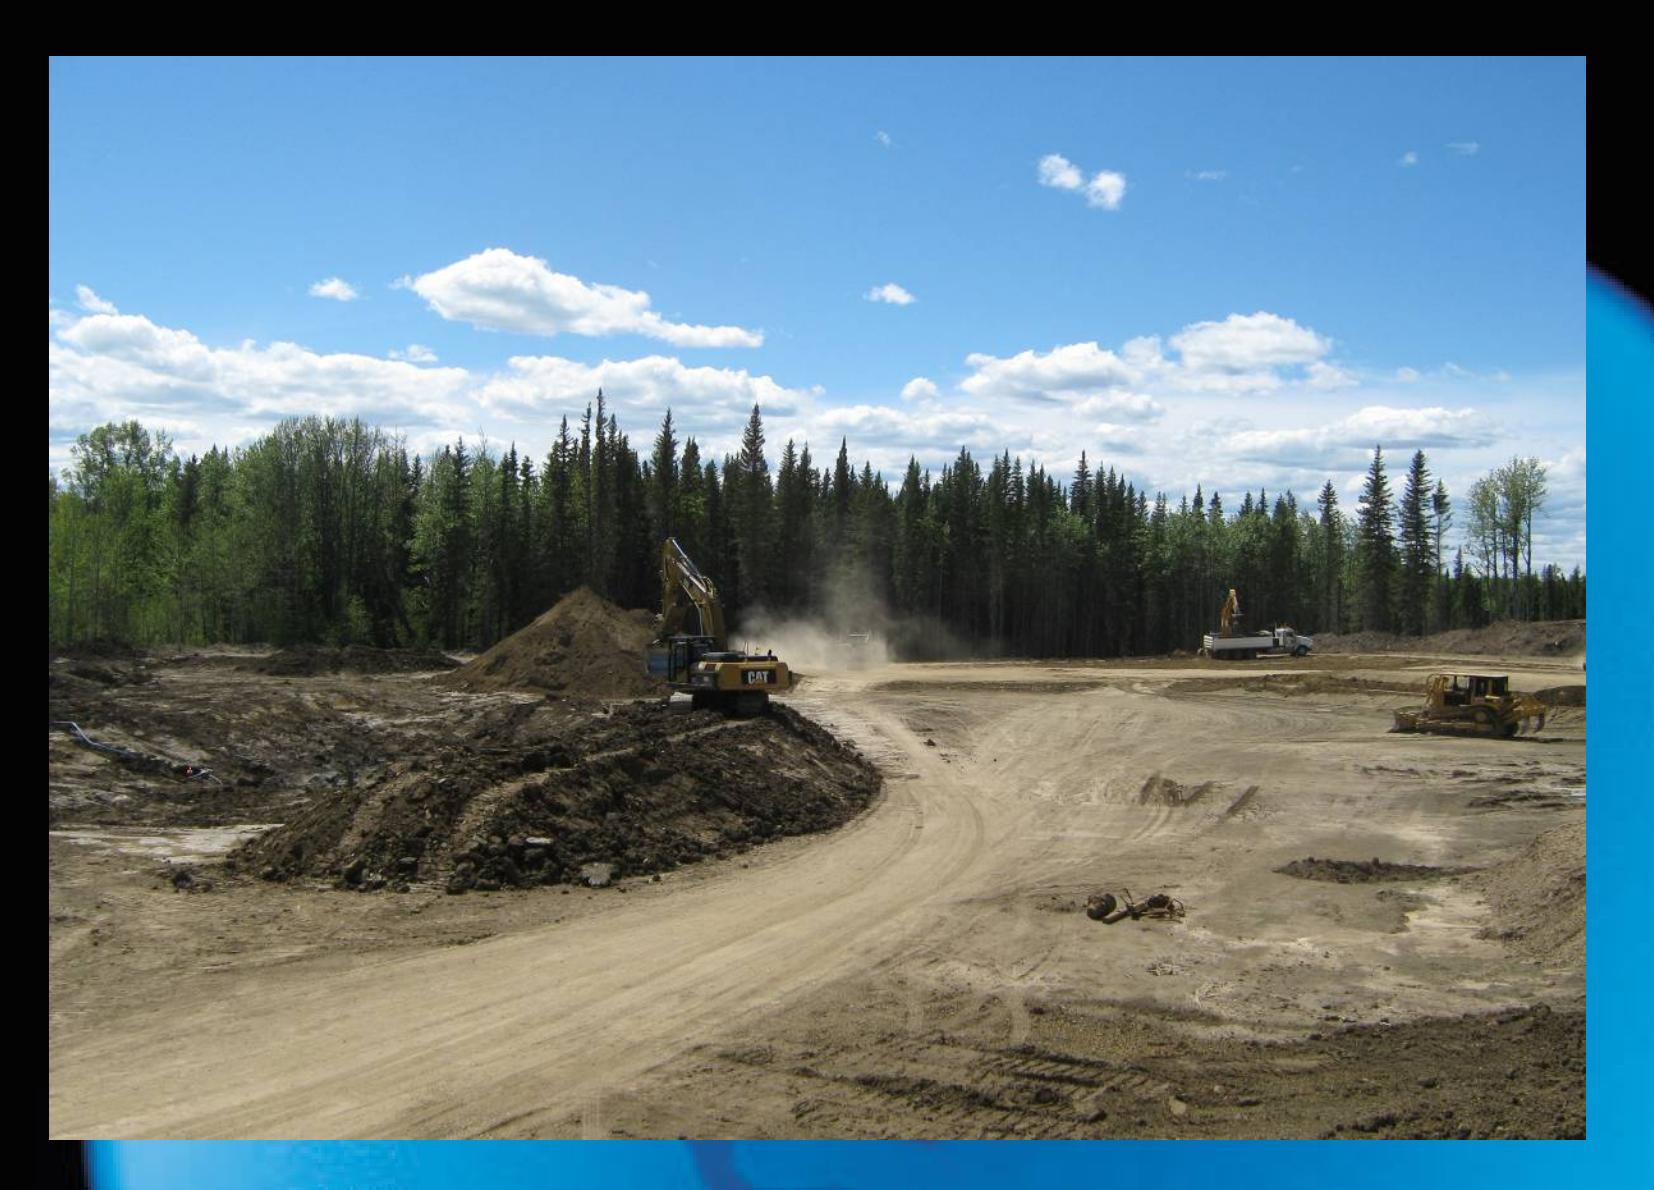
Site Cleanup

Obviously impacted material was excavated and stored for eventual facility disposal.

- All impacted material was hauled to an approved Class II landfill.
 - Site assessed, remediated and closure achieved within 3.5 months of initial incident (including break-up).
- Tier I and SCARG End points were achieved.

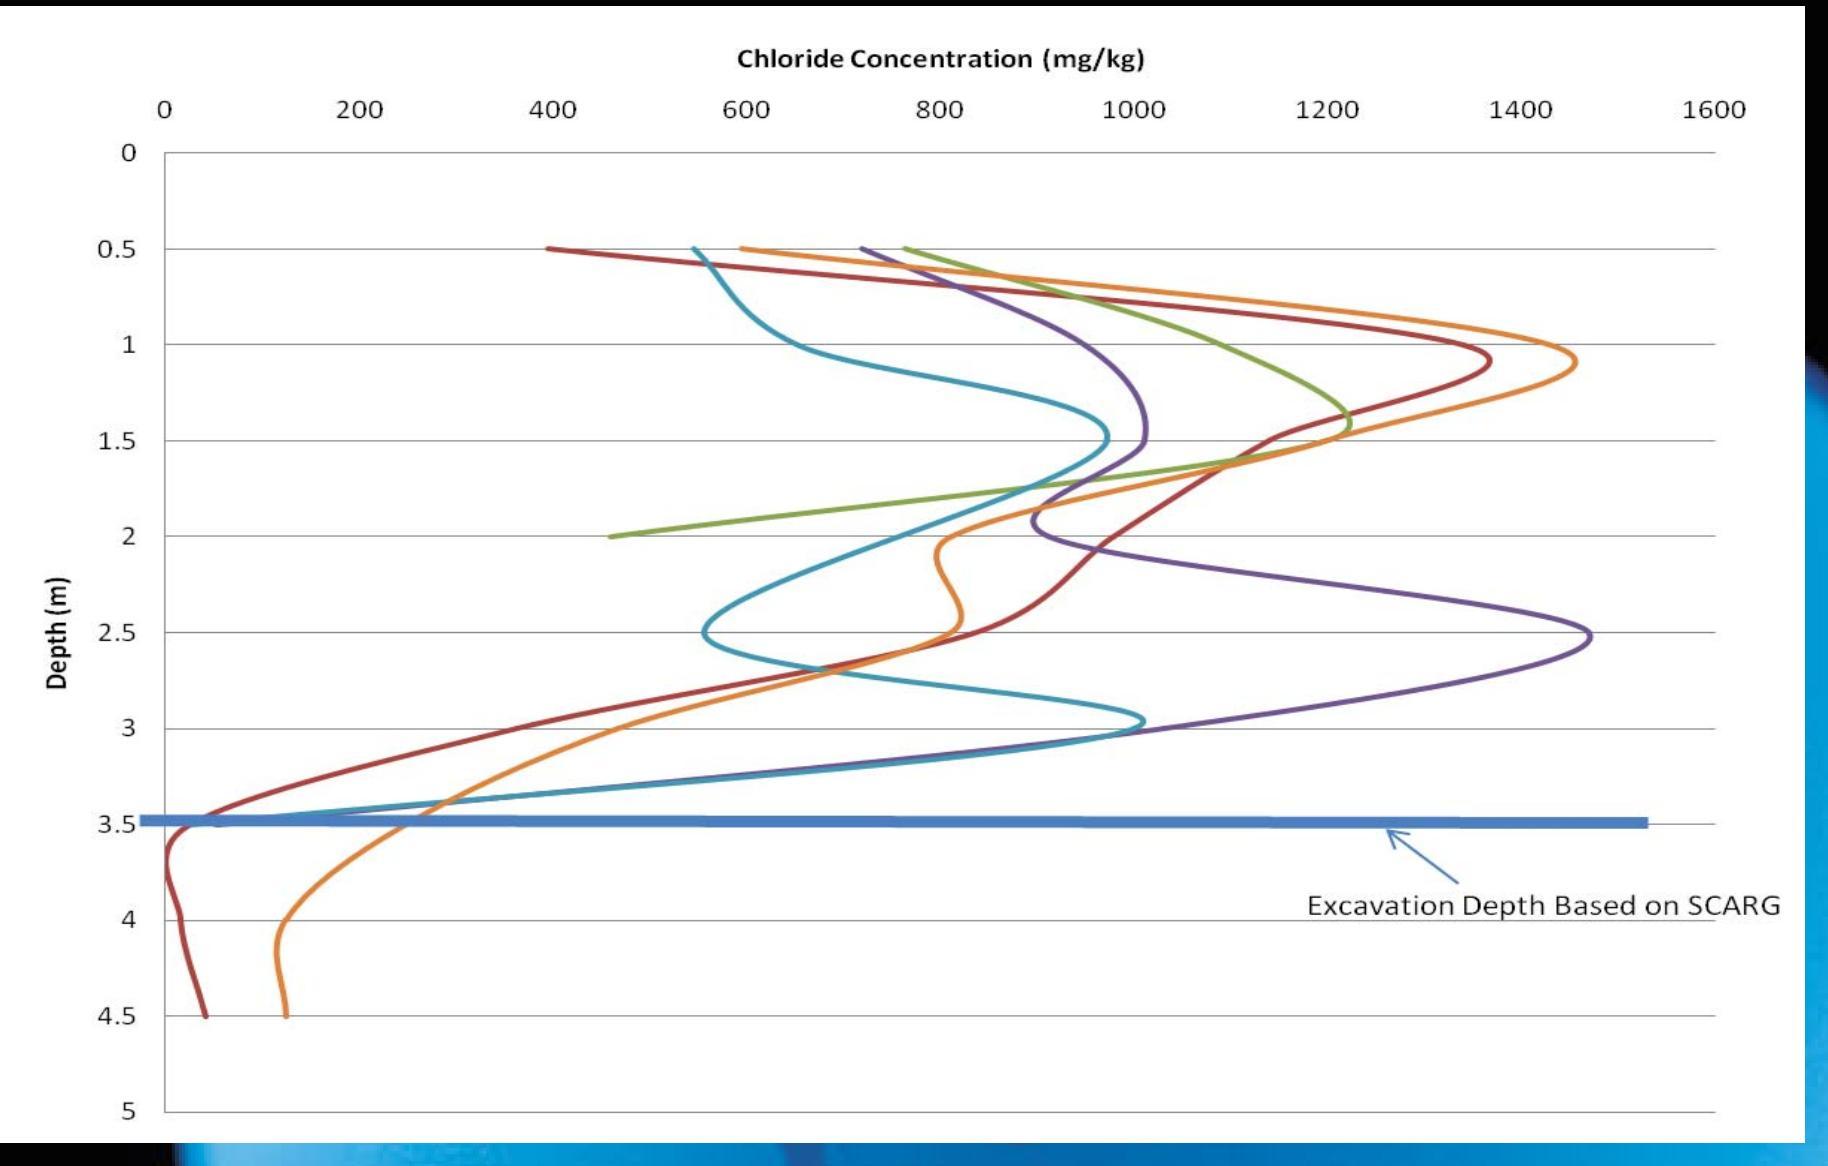
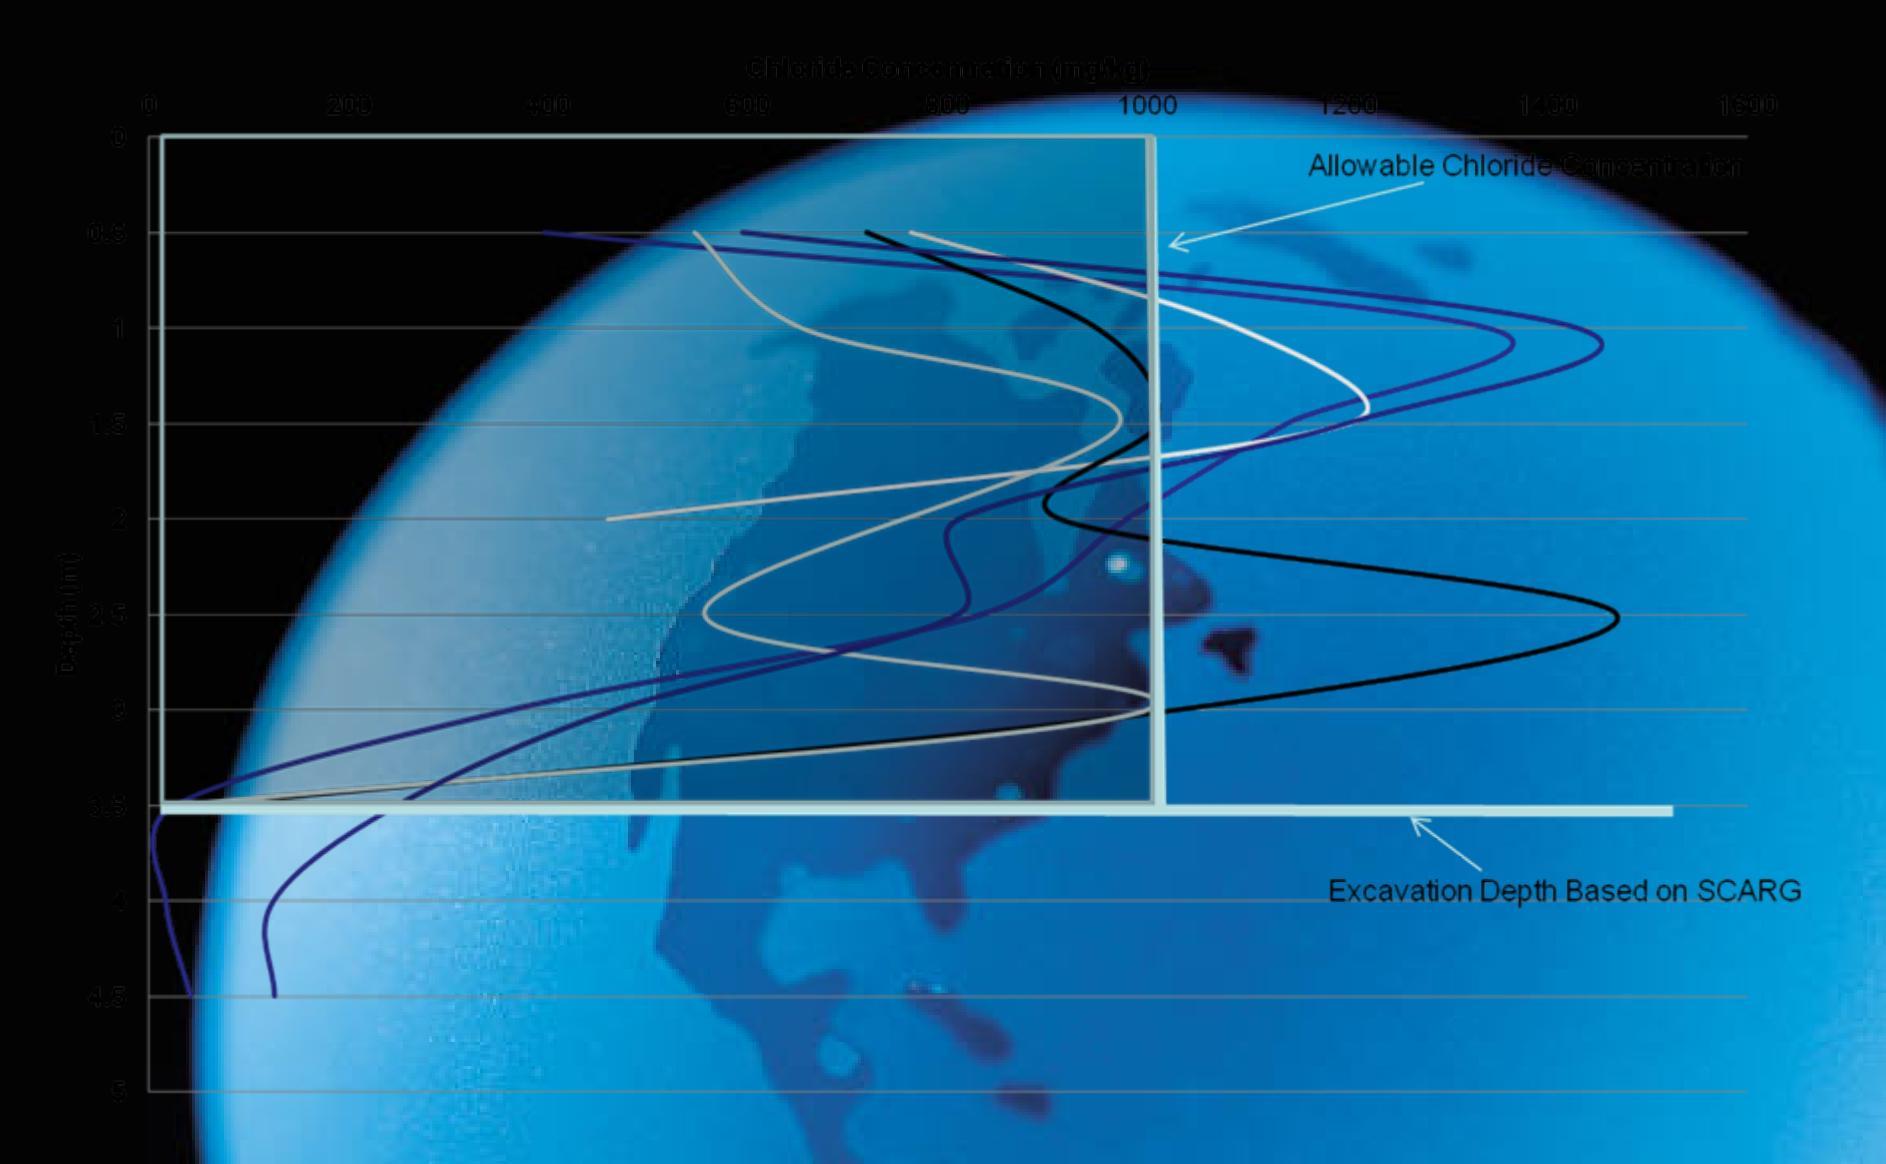
Why not SST?

- Total Barite ranged from 10,000 20,000 mg/kg by ICP Fusion
 - Barite One initial borehole, during conf. sampling 2 walls failed (this material was hauled for disposal).
- F2 and F3 exceedances

Hydrocarbon - One initial borehole, during conf. sampling 4 walls failed (this material was hauled for disposal).
