Remediation Technologies Symposium October 21<sup>st</sup>, 2010

# ADDRESSING ENVIRONMENTAL CONCERNS DURING THE EAST VILLAGE BROWNFIELD REDEVELOPMENT PROJECT

Stantec Consulting Ltd.Garry Chan, P.Geol.Margarida Santos, EIT

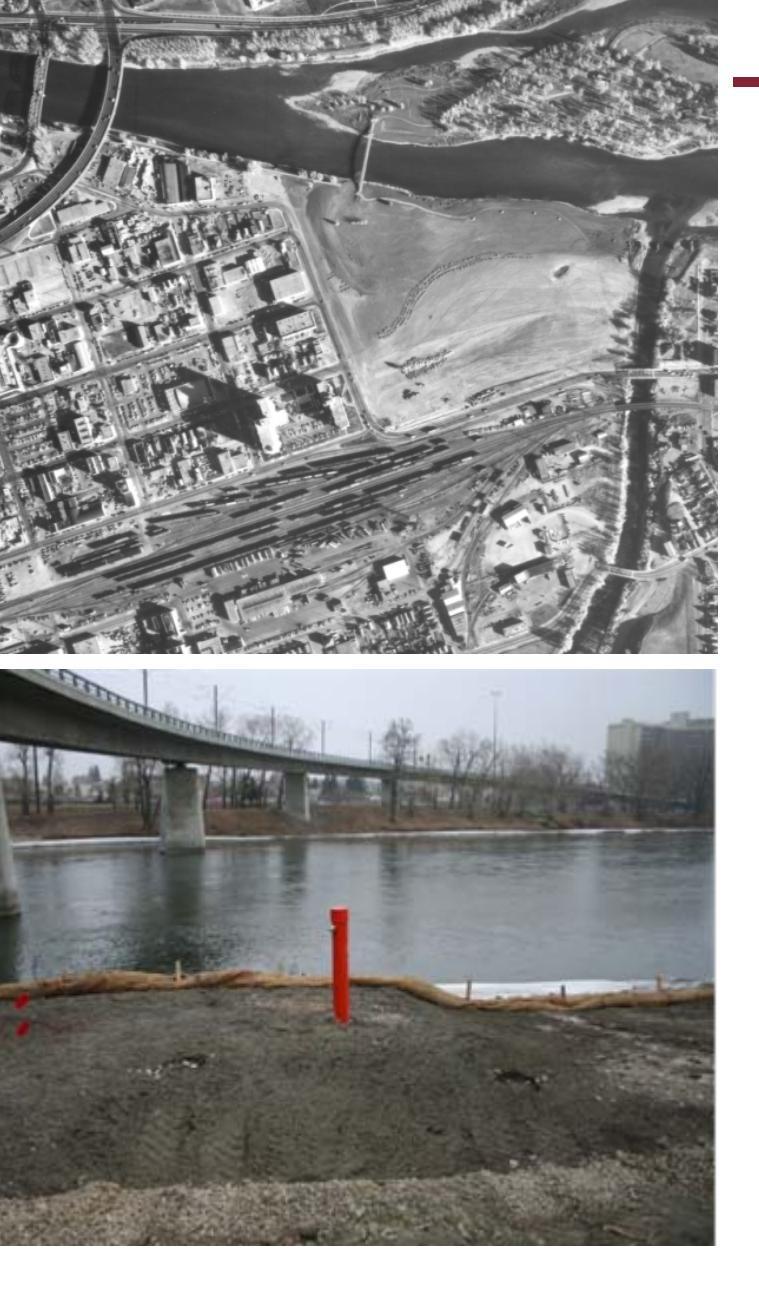
Top: 1976 East Village/Fort Calgary. Source: Government of Alberta, SRD Bottom: Groundwater monitoring well on RiverWalk, 2010. Source: Stantec

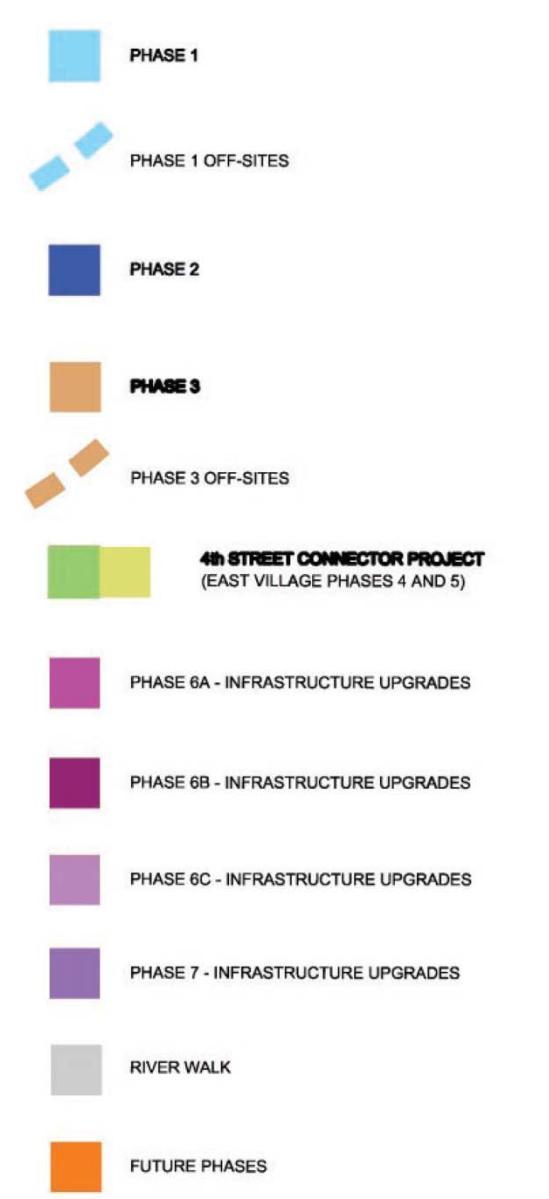
#### Infrastructure Construction Phasing Plan

#### Original Drawing by Progressive Engineering for CMLC, Nov. 25, 2009

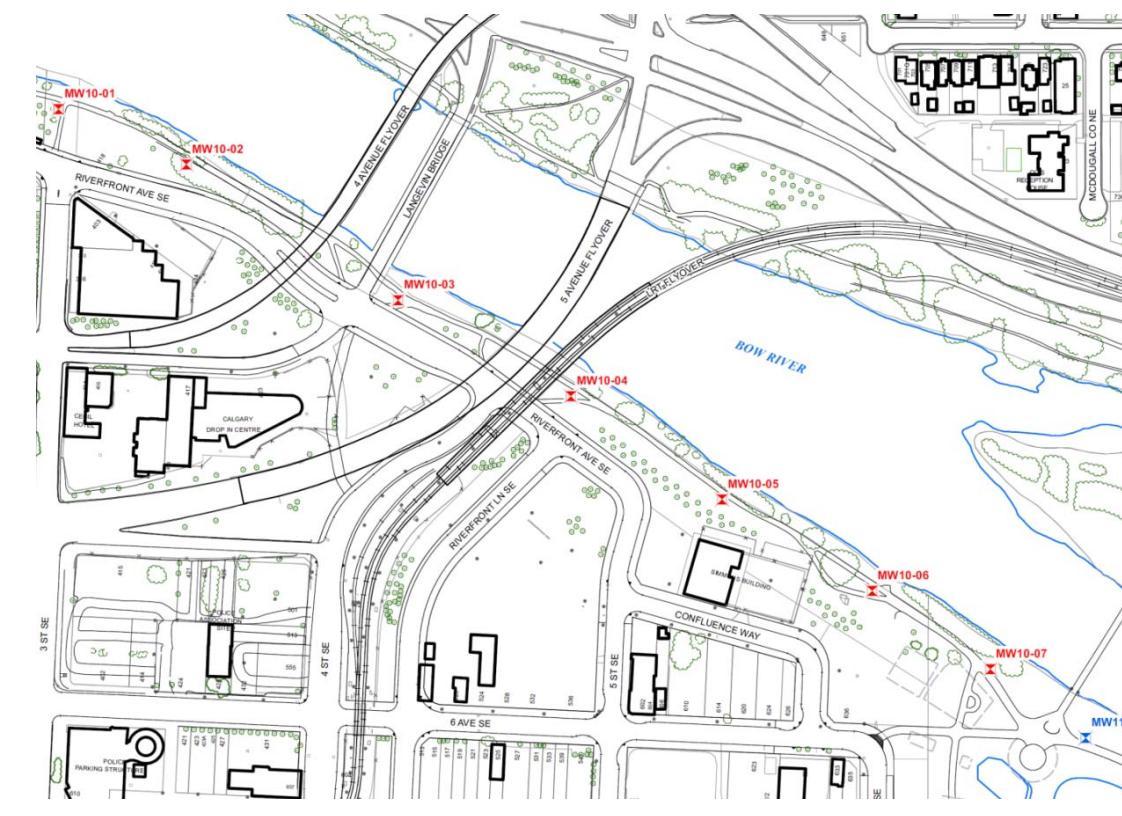
- Disposal of groundwater from utility trenches to sanitary sewer.
- Installation of groundwater monitoring wells along perimeter of East Village for post-development monitoring/sampling.
