## Installation and Start-Up of In-Situ Air Sparge / Soil Vapour Extraction (Biosparging/Bioventing) Remediation System Beneath Mall

Takako Matsueda, P.Eng.

SLR Consulting (Canada) Ltd.

Prepared for RemTech 2010

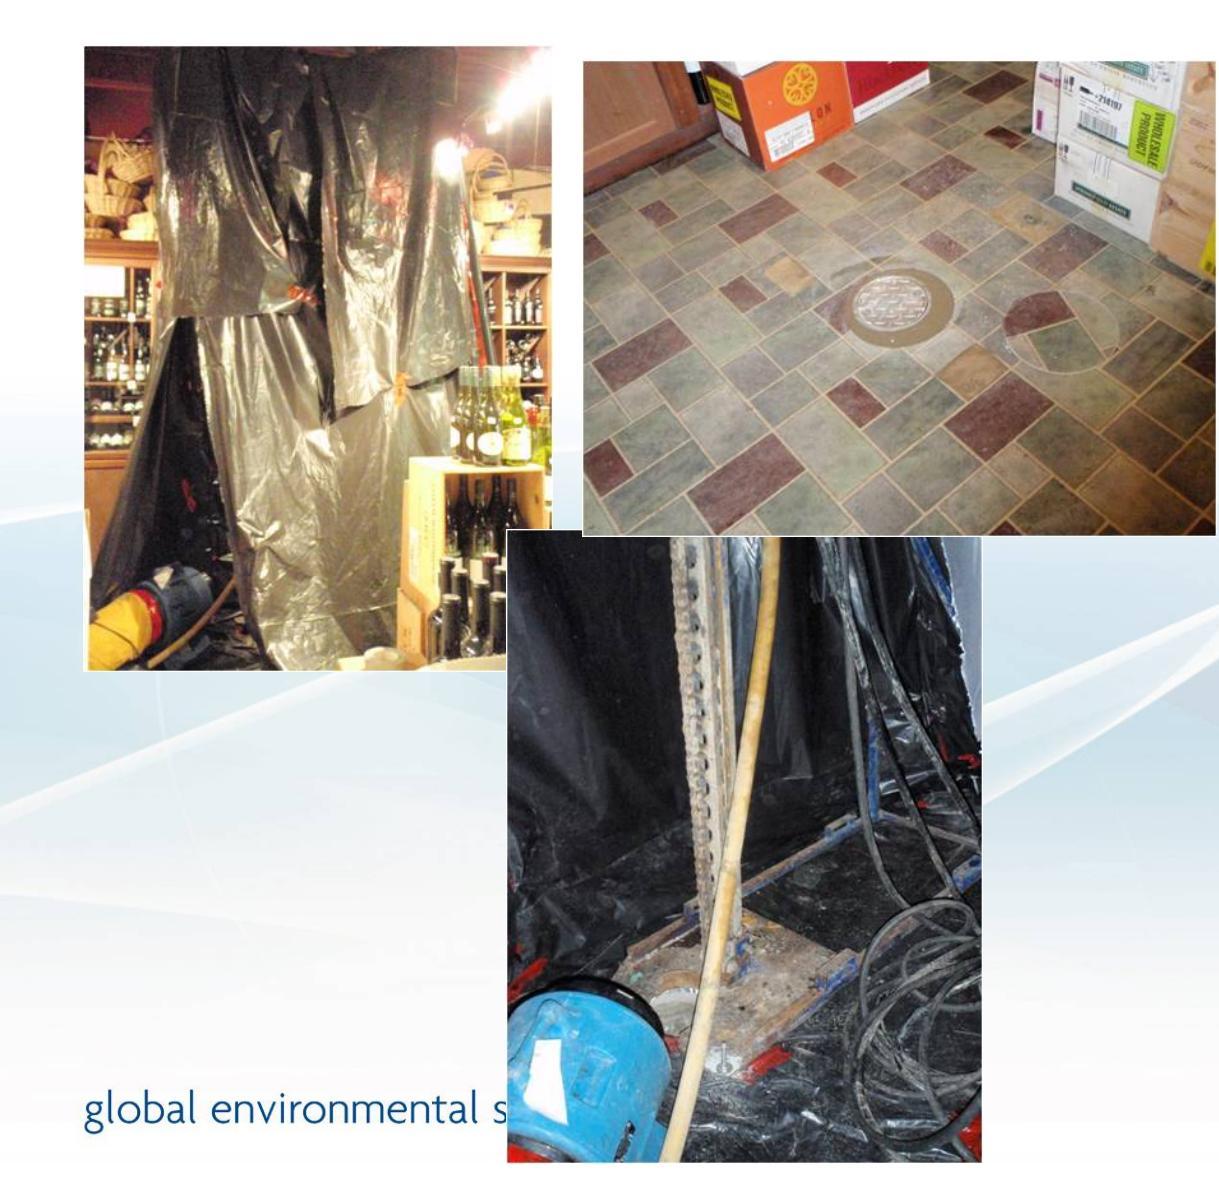
## Delineation Drilling - challenges/logistics

For north end of plume beneath building used a mini odex rig (inside wine shop)

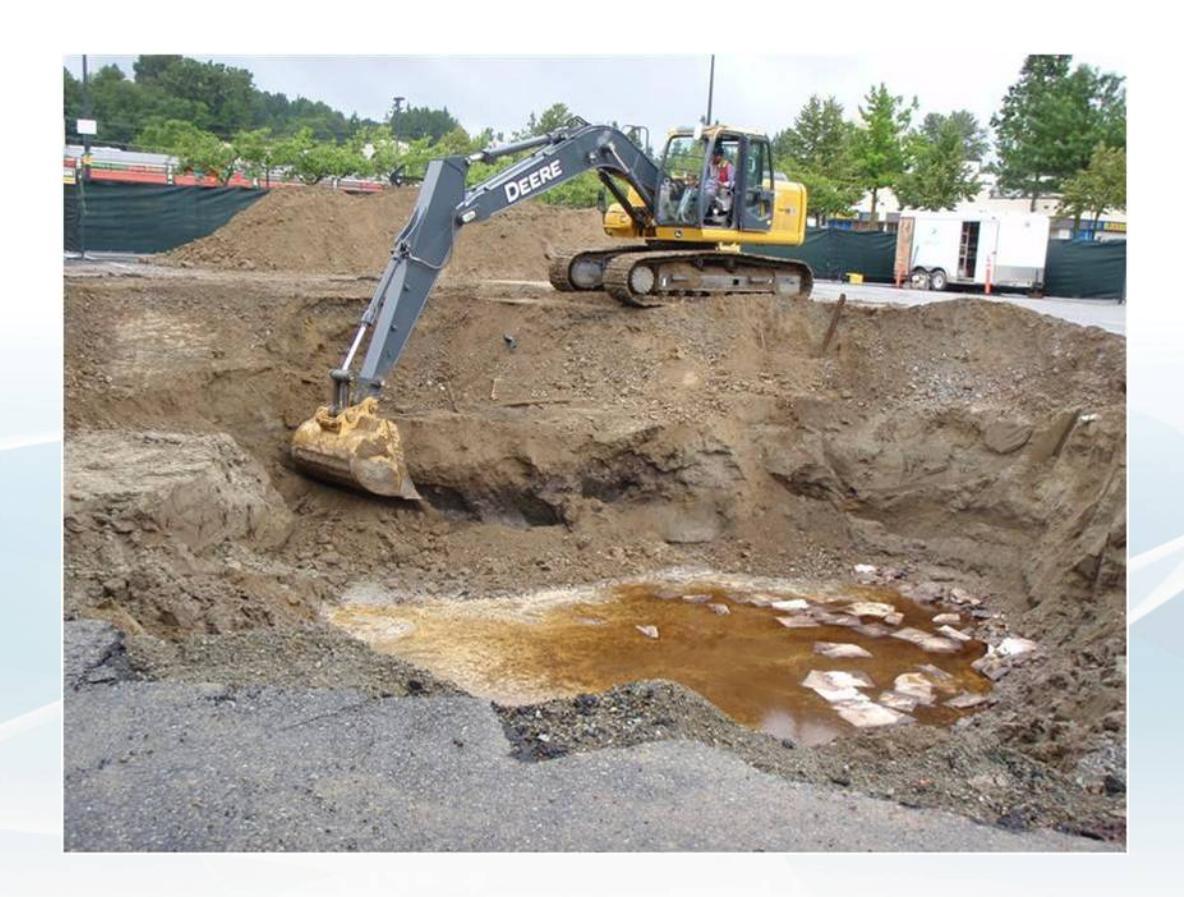
## Parking Lot - Excavation

Excavated approximately 1,000 tonnes of soil, dewatered excavation, collected confirmatory samples

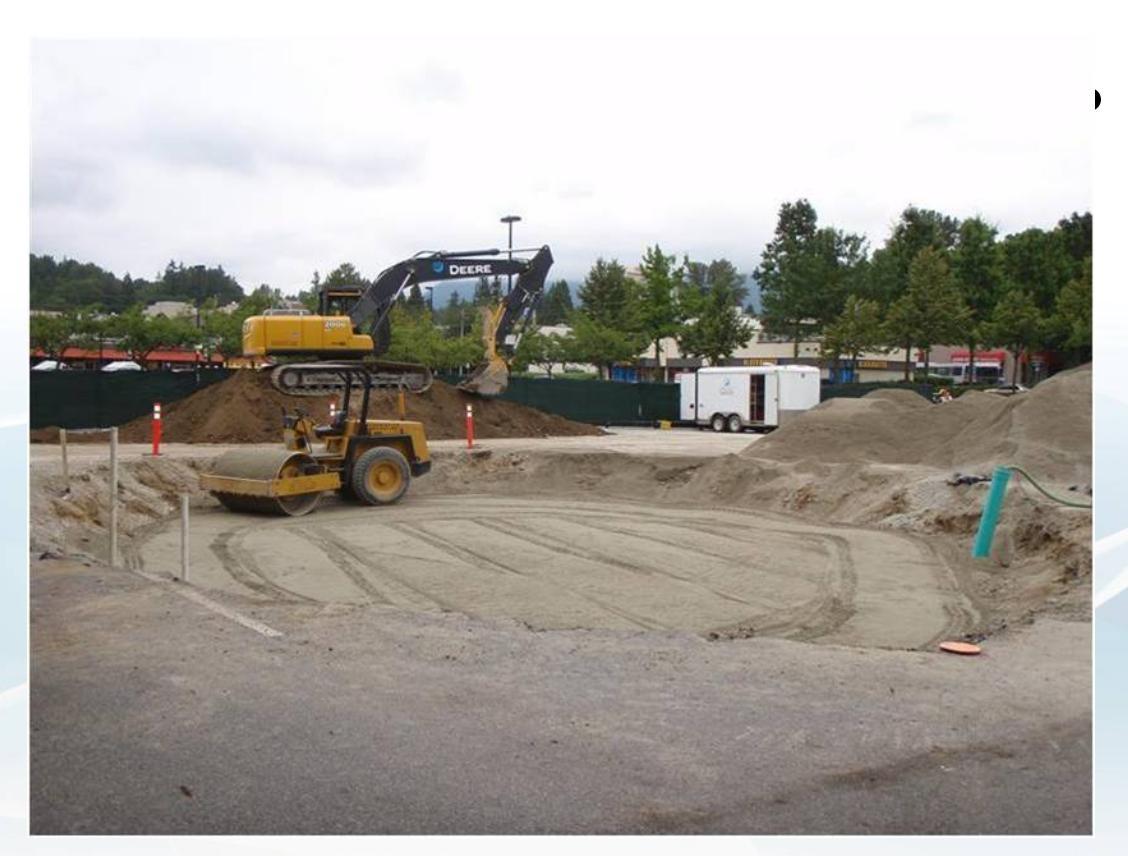
## Parking Lot - Excavation

- Backfilled, paved, painted parking stall lines
- Installed and sampled post remedial groundwater and soil vapour wells
- Confirmed this area remediated

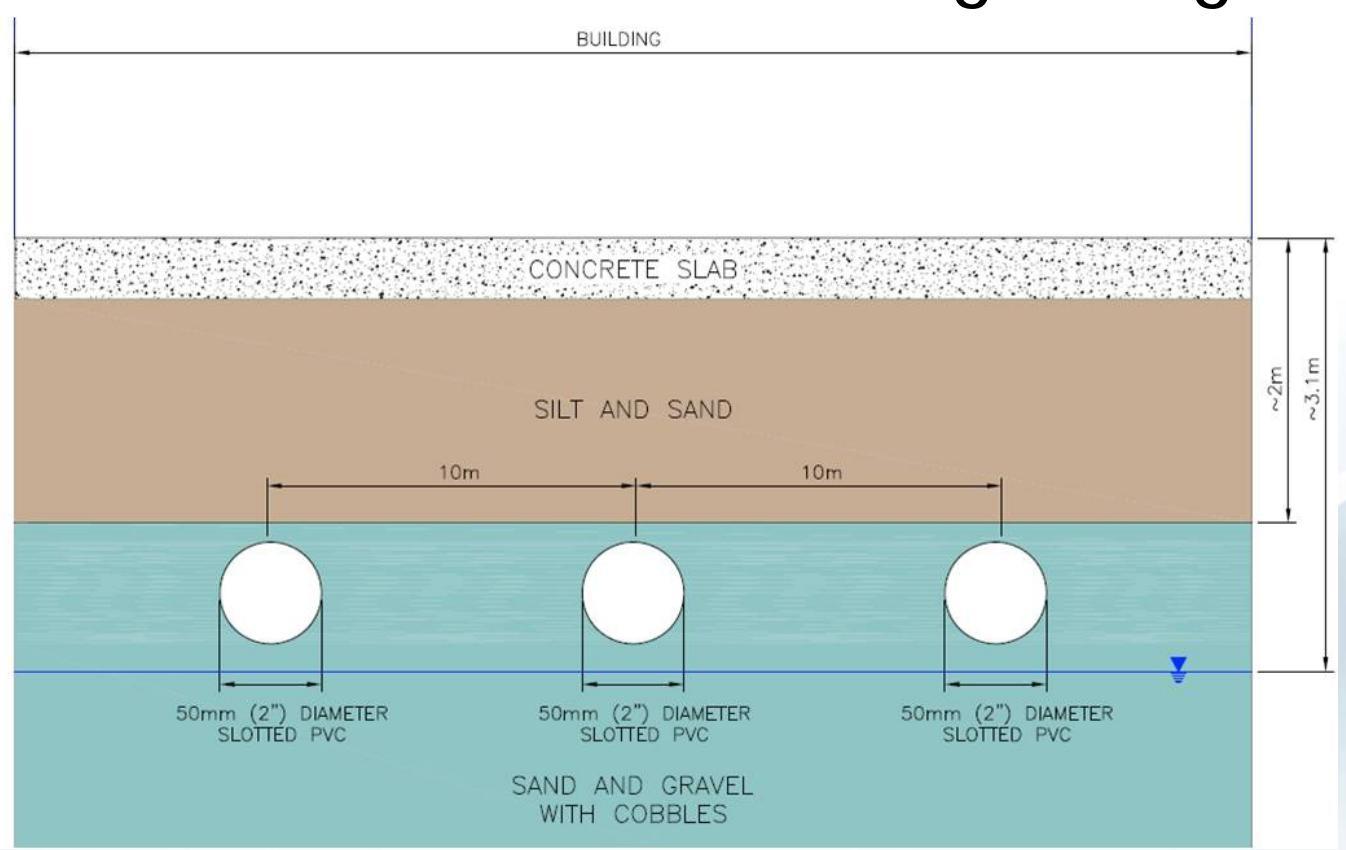
## Soil Vapour Extraction/Bioventing Line Installation - challenges/logistics

- Directional drilling to install 4 horizontal lines under building
- Depth critical (above the water table but still in sand and gravel below a silt and sand layer)

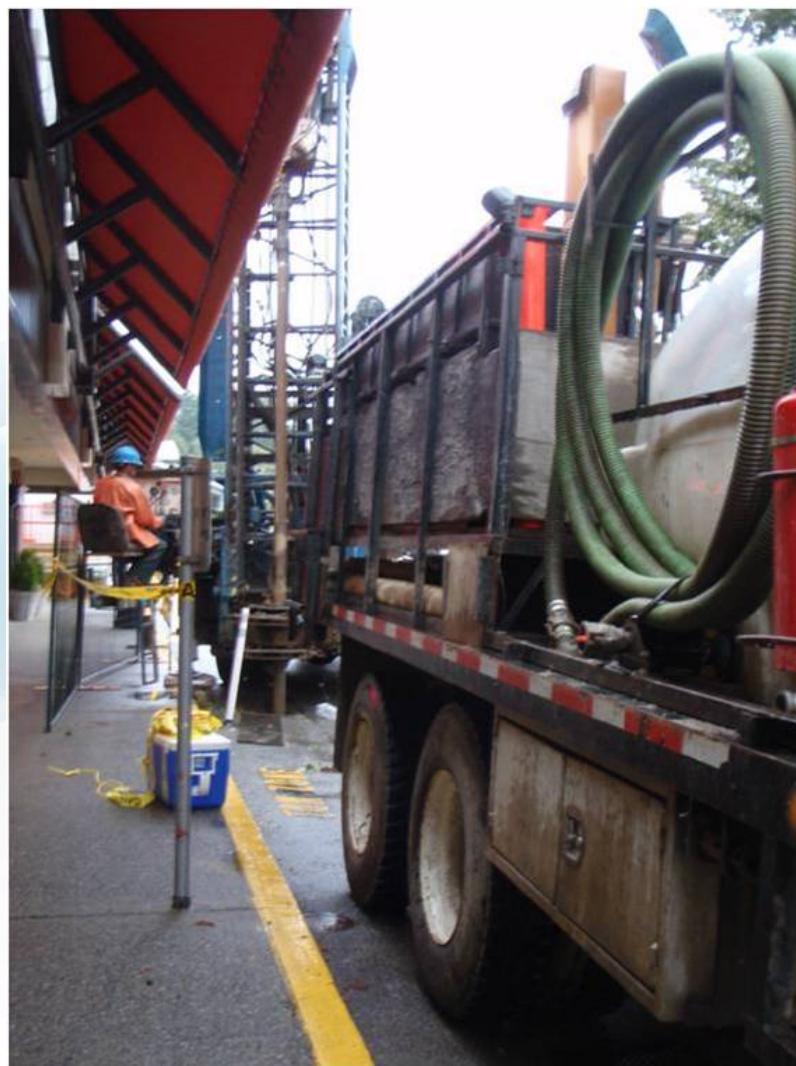
# Sparge Well Installation - challenges/logistics

- 10 new sparge wells installed:
  - 7 vertical
  - 3 angled under building (approximately 35 degrees from vertical)
- 9 of existing sparge wells also reused for new system

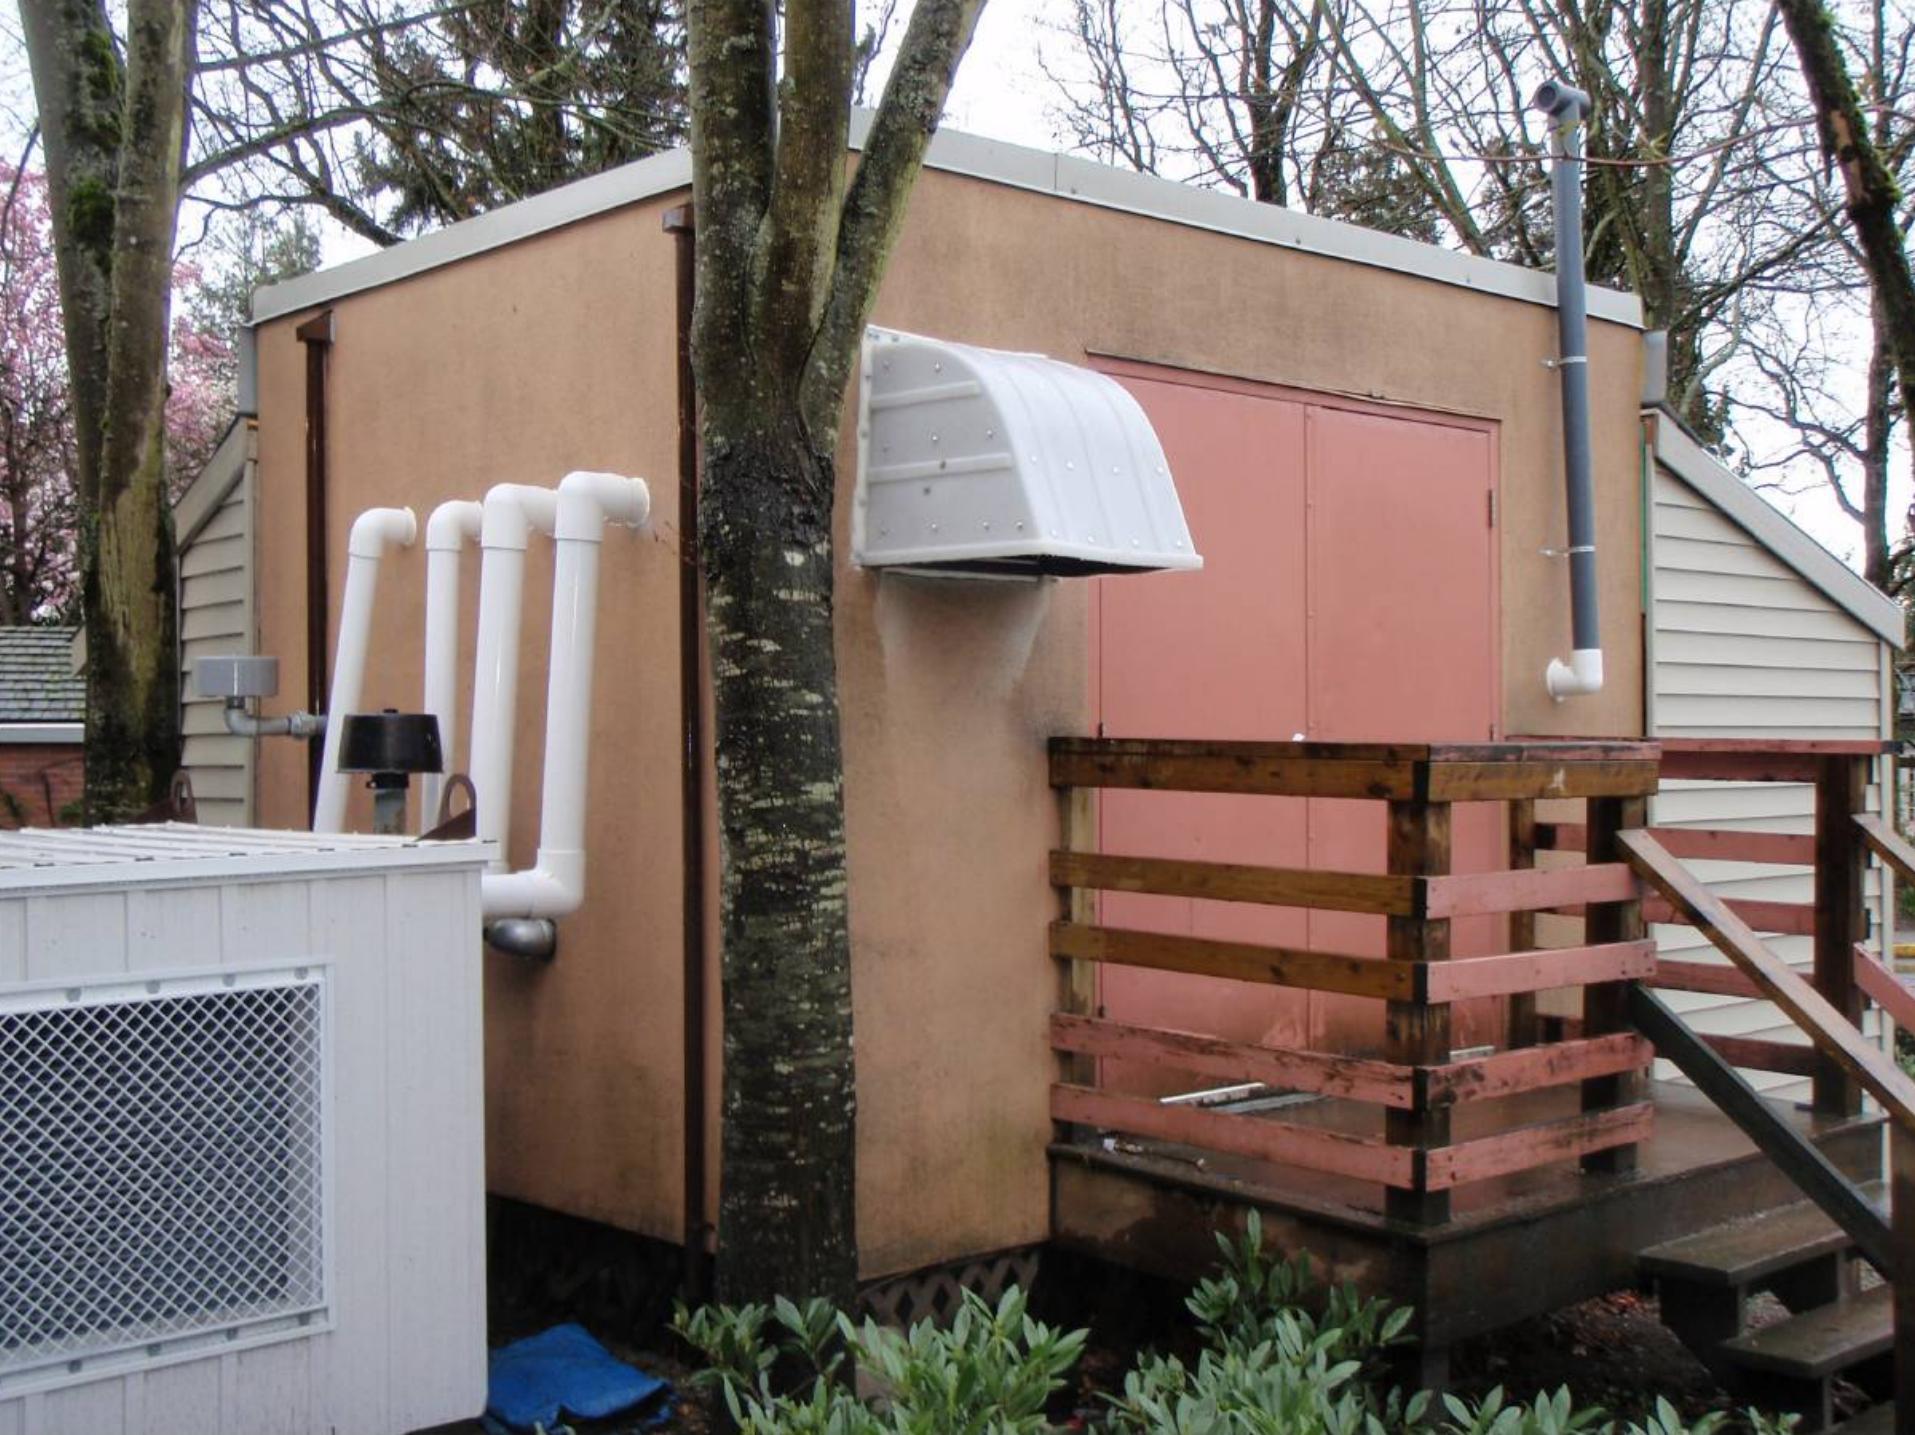
- sparge compressor (rotary claw compressor with 40 HP, 208-230/460 V/3P motor) = 300 scfm at 28 psig
- SVE/biovent blower (5L rotary lobe blower with 15 HP, 230/460V/3P motor) = 400 scfm at 80 inches H<sub>2</sub>O
- heat exchanger
- liquid / vapour separator
- water holding tank
- carbon vessels
- fans, instrumentation, gauges etc.
- control panel, telemetry

#### SPARGE COMPRESSOR

SVE BLOWER

CARBON VESSELS

HOLDING TANK

#### LIQUID / VAPOUR SEPARATOR

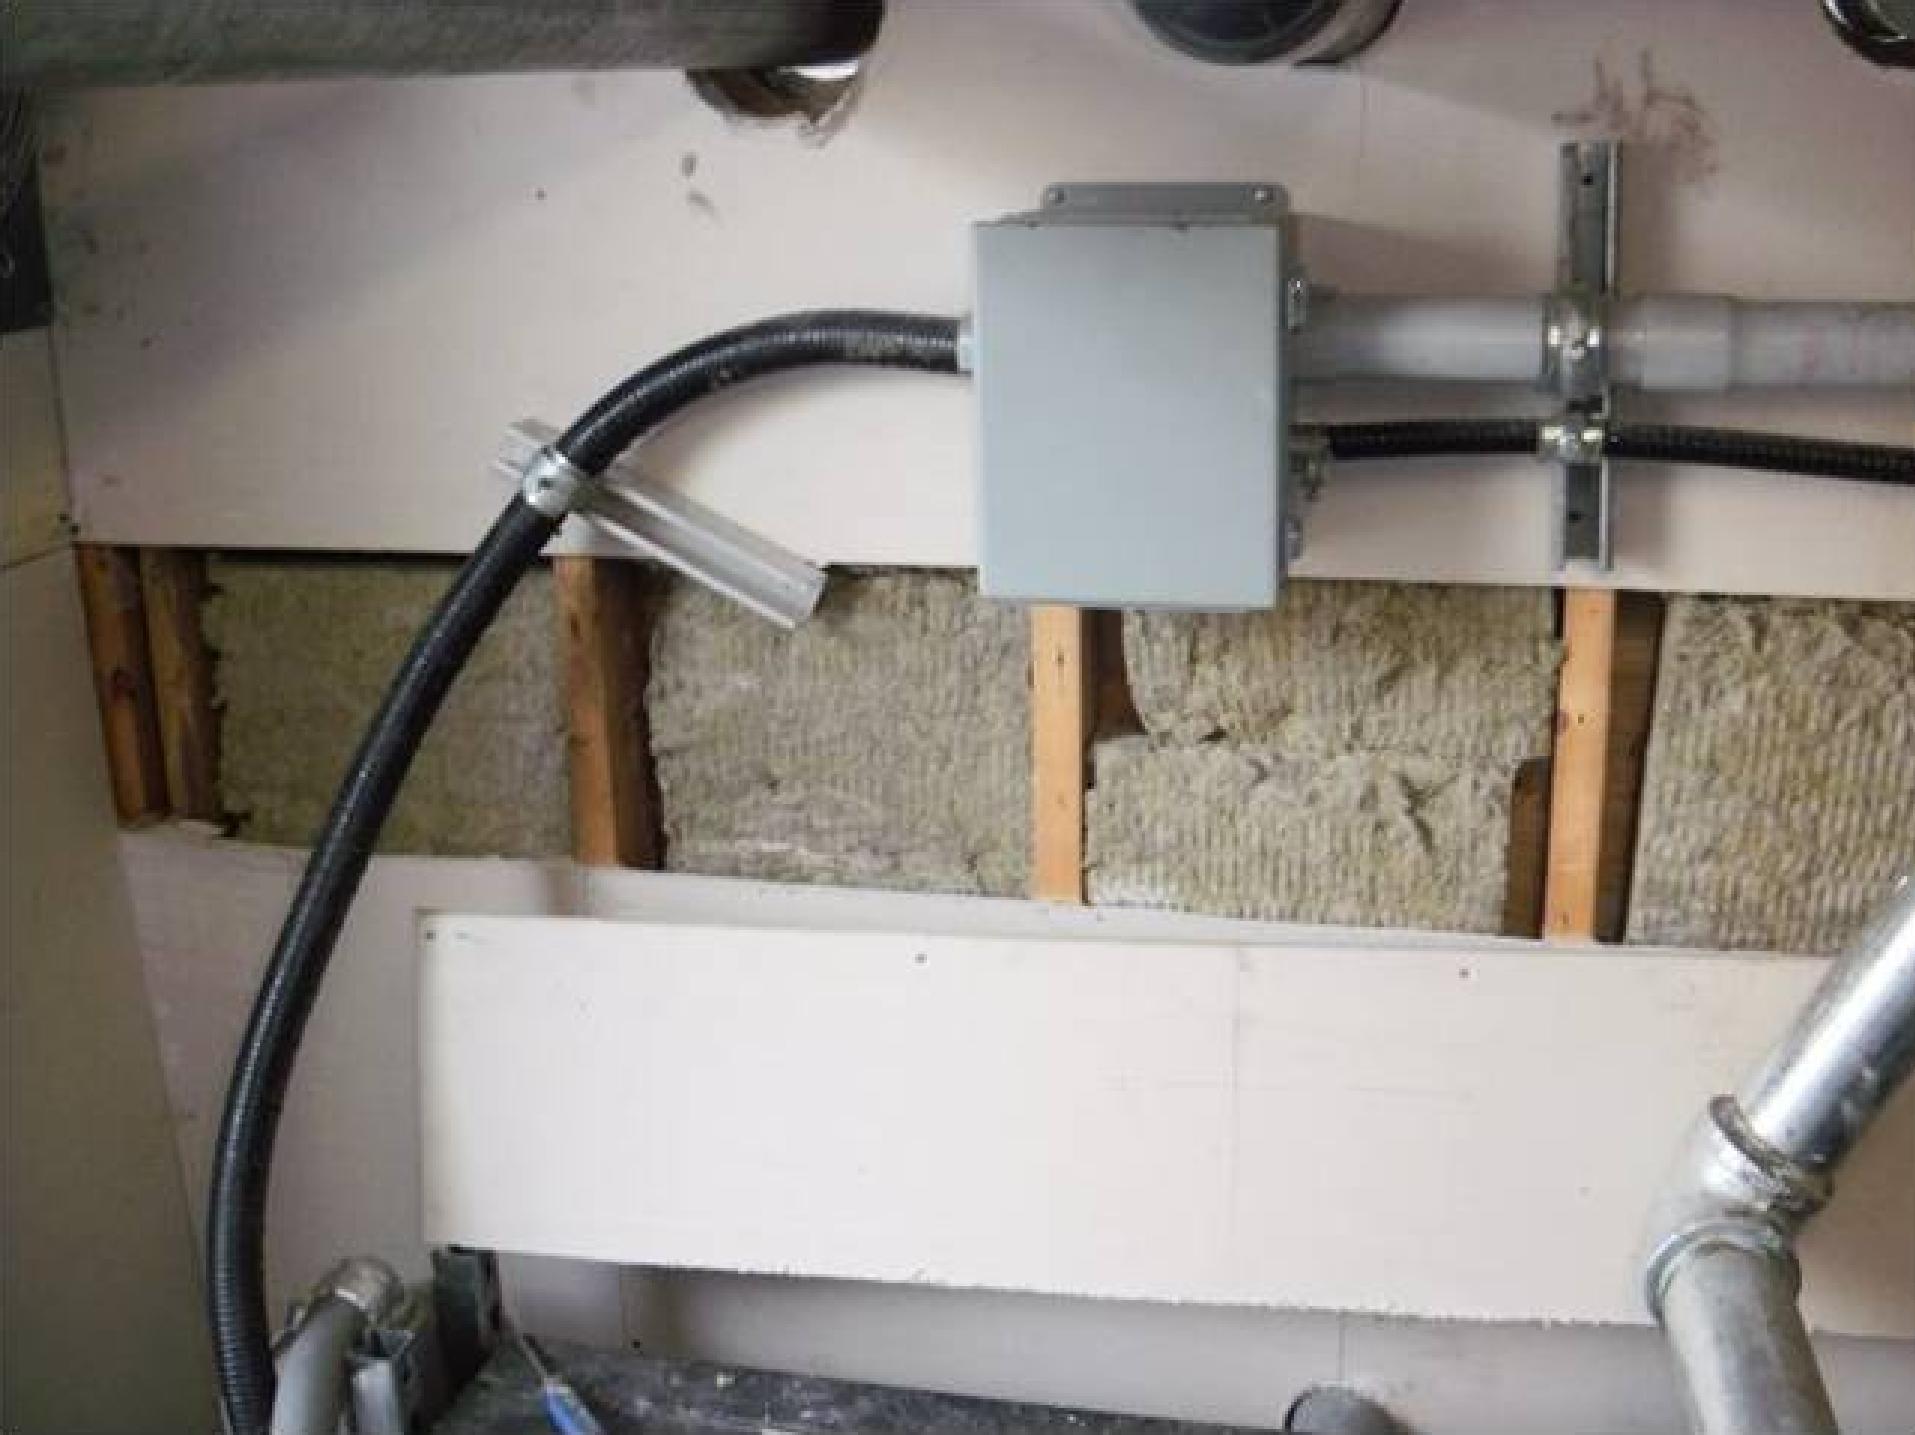
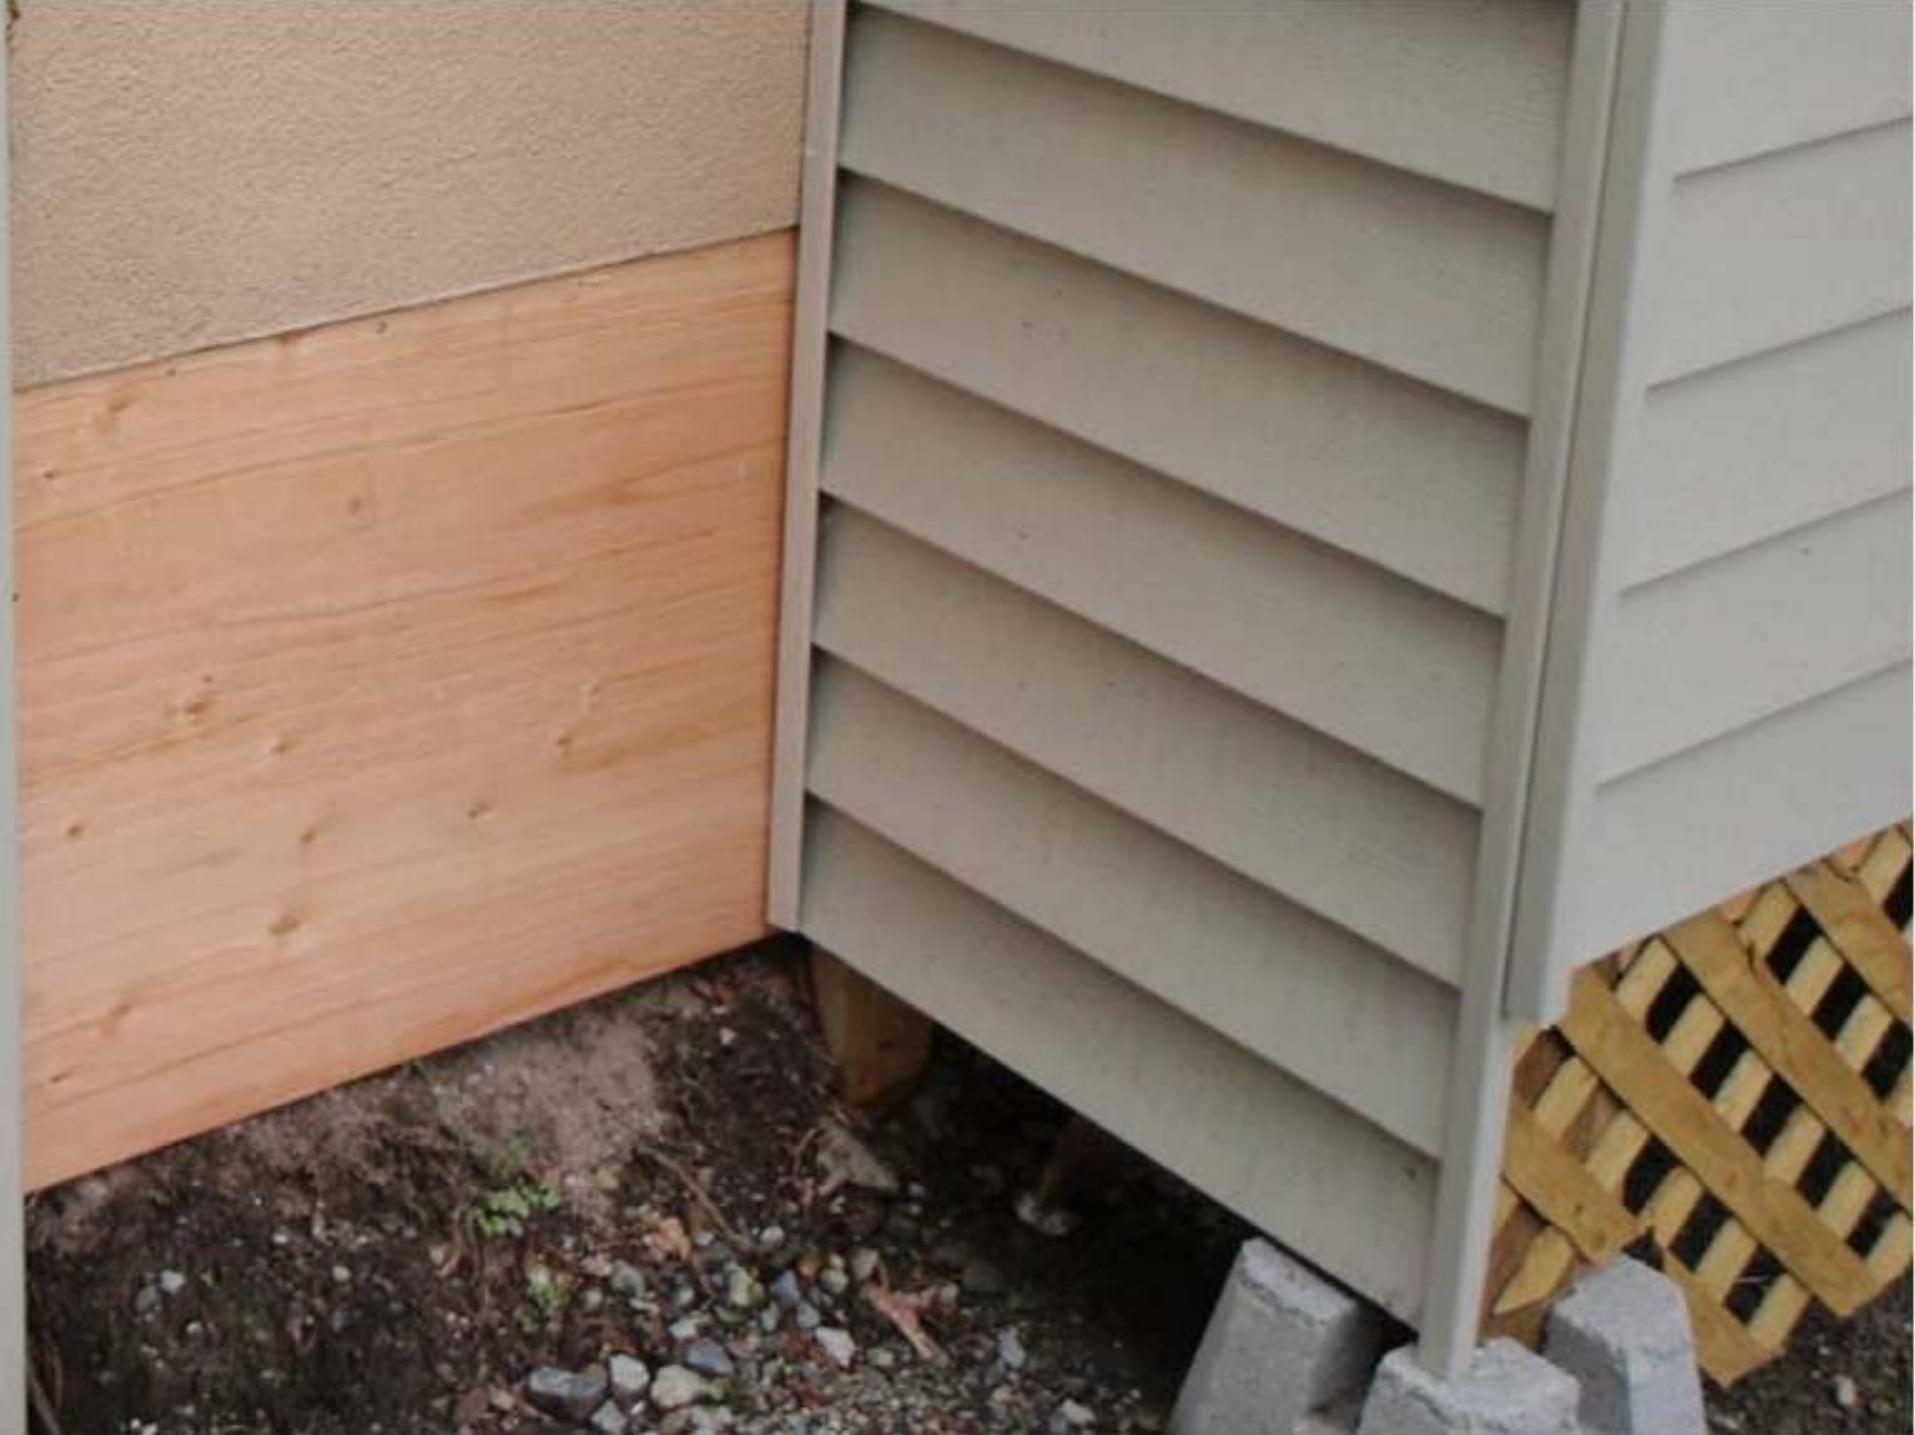
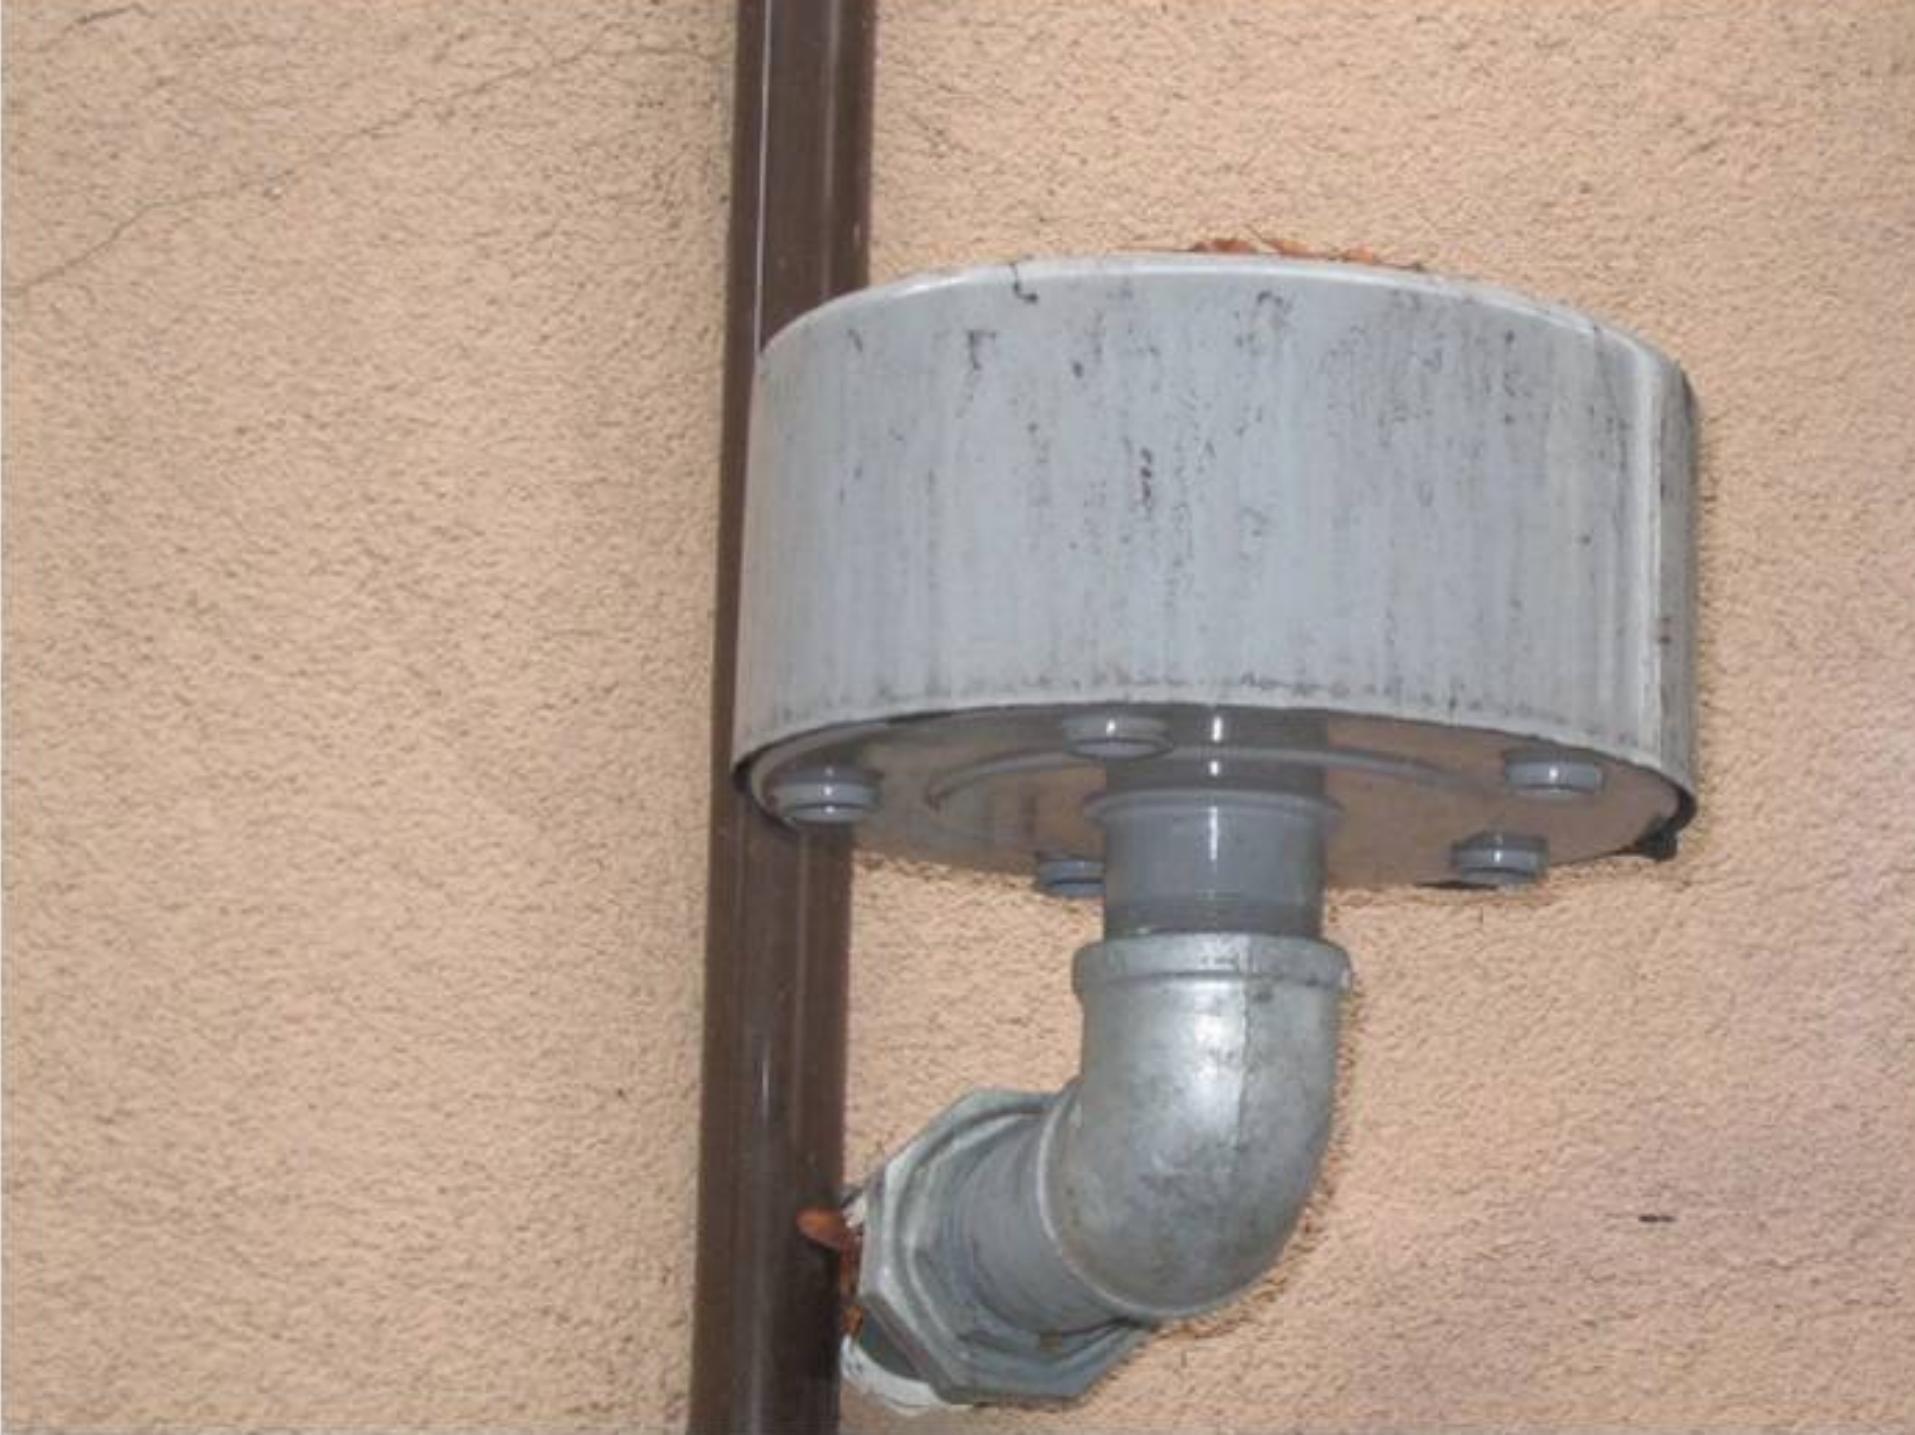
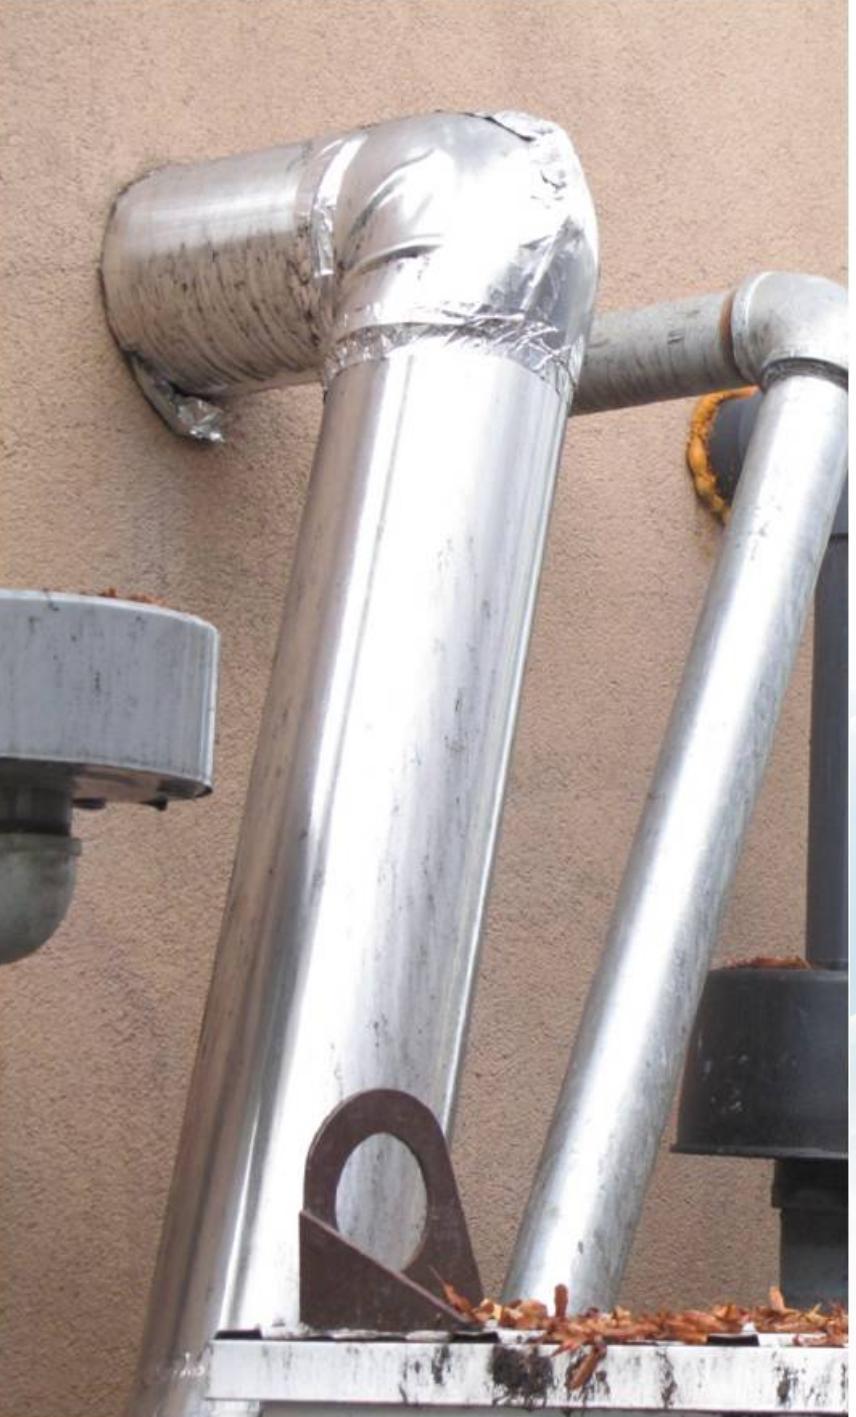
## Managing and Reducing Sound Levels

- lined the inside of the heat exchanger and equipment enclosure with liner board/insulation
- replaced latticed area with solid plywood
- placed rubber foam on stack covers
- wrapped piping with insulation/added foam
- covered inlet and outlet of heat exchanger with custom made downward facing covers
- added a silencer and dampener at the outlet of compressor (~15 db reduction each)
