BC Hydro – Working Area 1 (Stage 1) Remediation History

- Assessment (1990-2003)
- Stage 1 Remediation (2004/05)
- Post Remediation
 Assessment (2007-15)
- Heritage Revitalization Agreement (2012)
- WA1 Supplementary Remediation and Tar Well Removal (2013)
- BC Certificate of Compliance (2016)

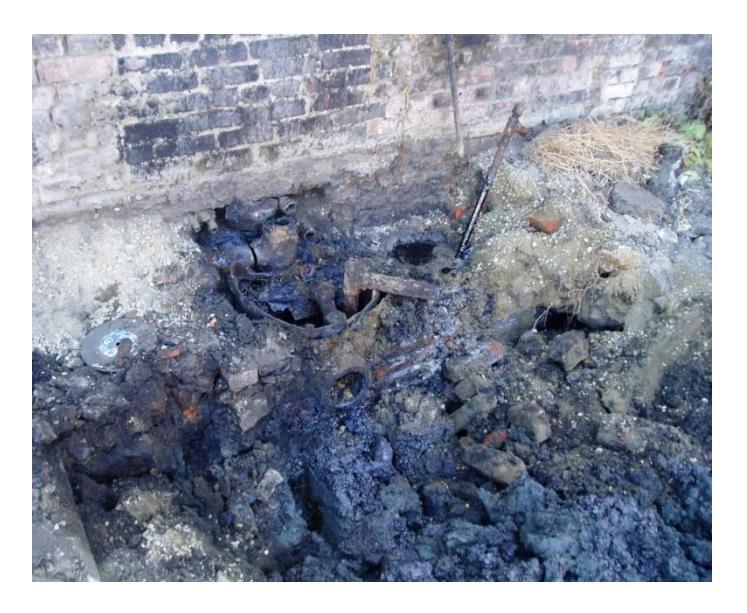
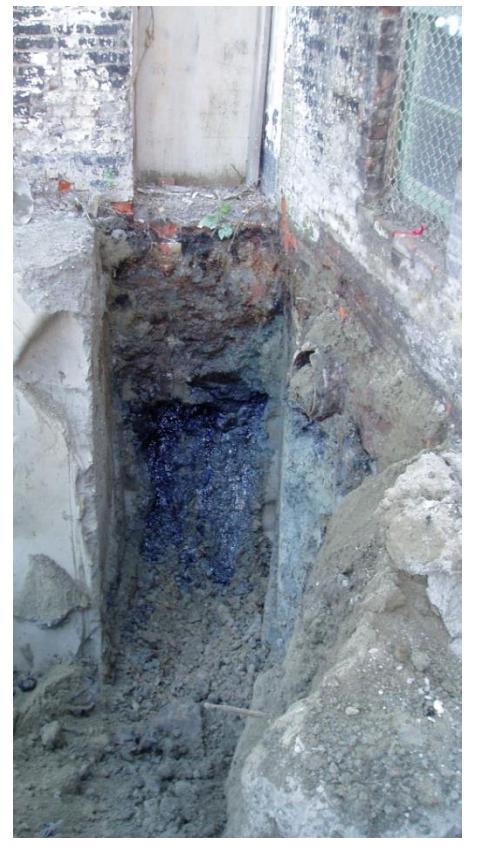
- Excavation and off-site disposal of over 110,000 tonnes of contaminated material from BC Hydro and Transport Canada Lands
- Minimal contamination identified beneath the Admin Building and the Rock Bay Building

- Significant volume of Waste and Hazardous Waste contamination remained beneath the Former Instrumentation Building (FIB) (estimated at ~2,000 tonnes)
- > Source of ongoing groundwater contamination for the property

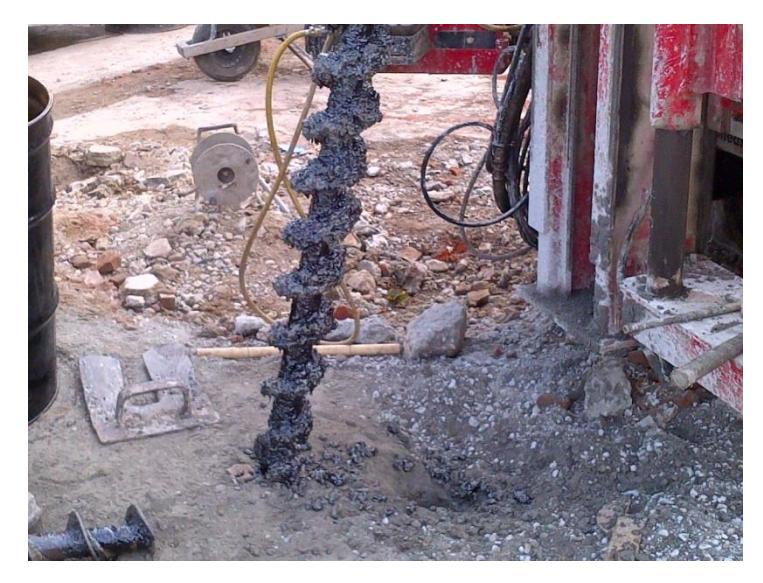
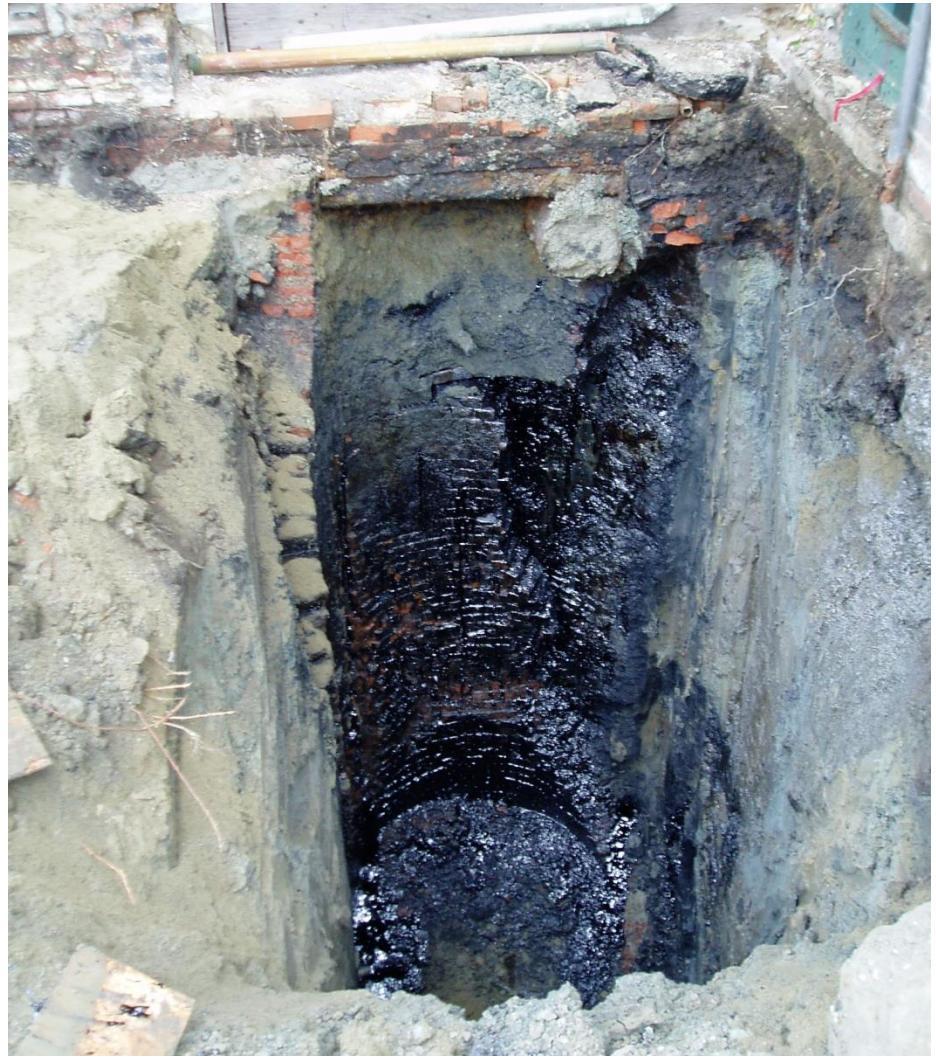
Tar Well

- Identified during the excavation around the perimeter of the Former Instrumentation Building
- > 1.9 m diameter / 14 m depth
- Estimated to contain 26,000 litres of coal tar NAPL

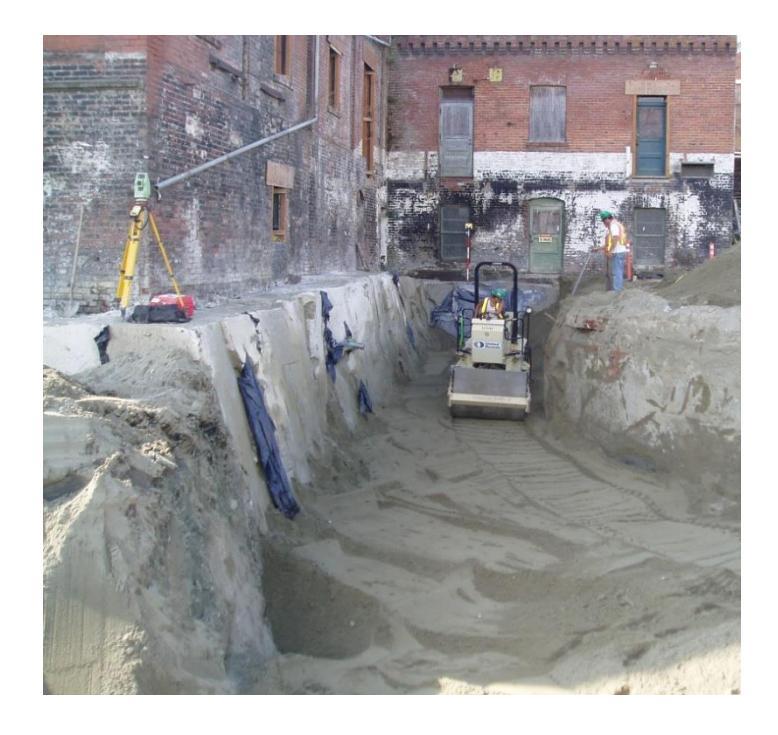
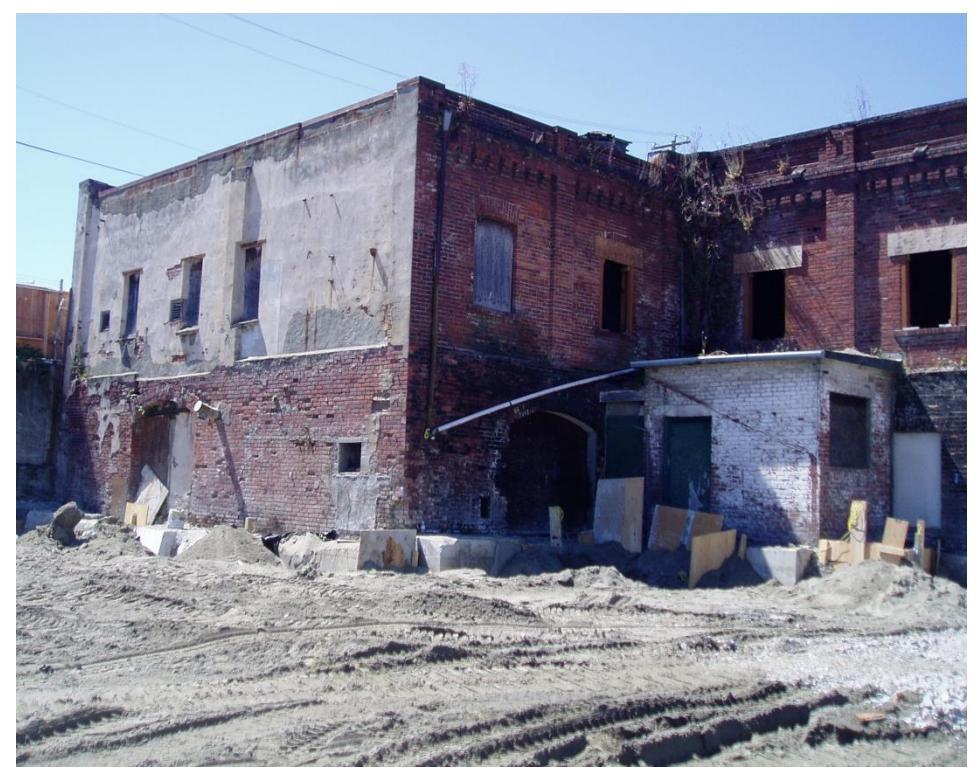
Instrumentation Building

Waste and Hazardous Waste isolated with CDF until a resolution on how to address the material could be reached (2004)

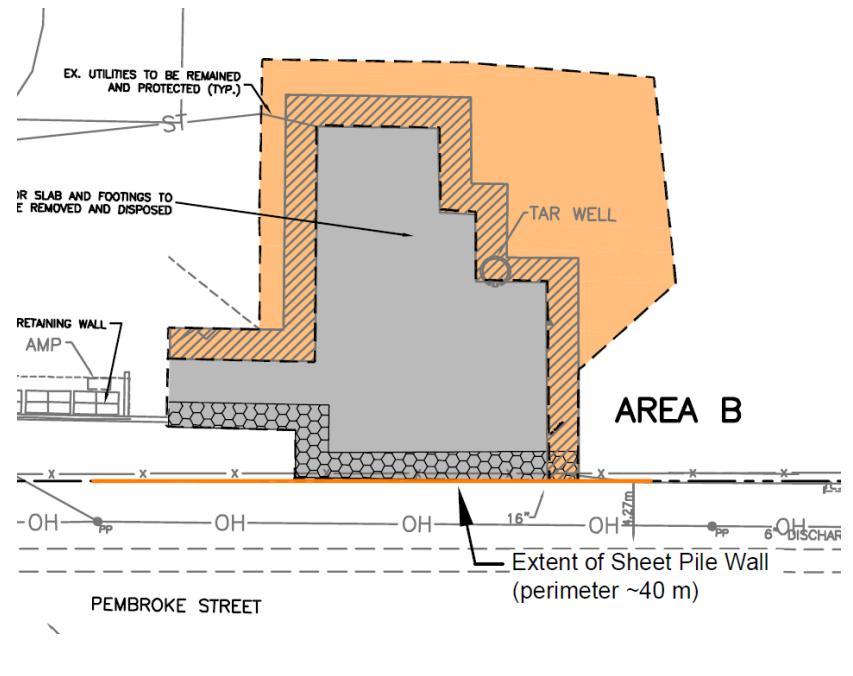
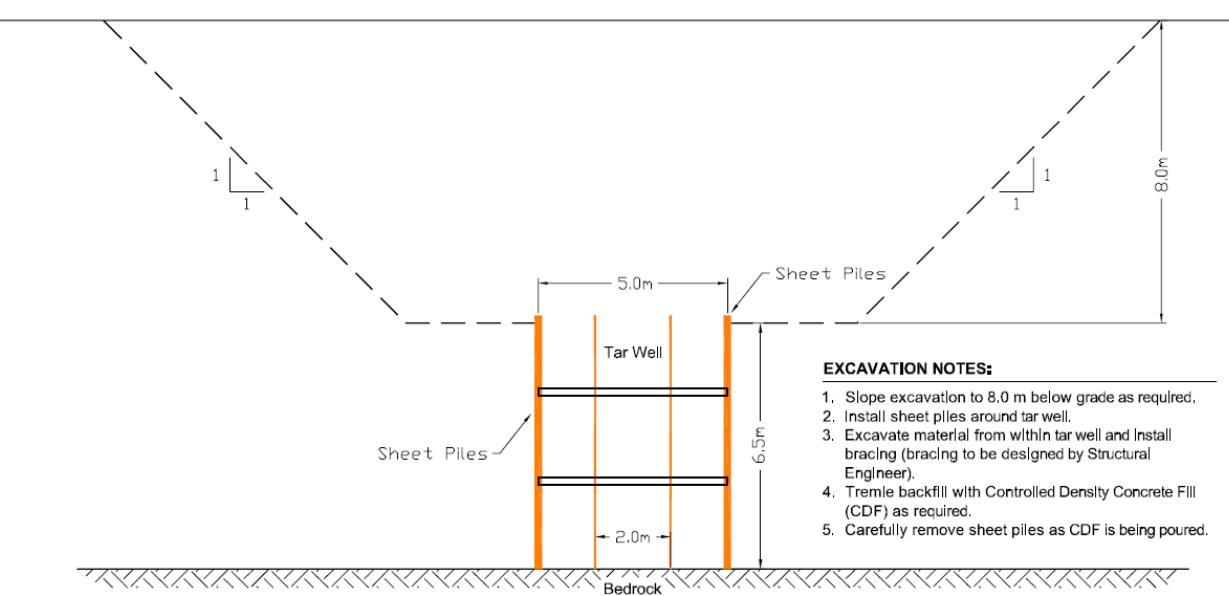
> Temporary Sheetpile Box

- Excavate to 8 m bgs for working platform
- 5 m sheetpile box with bracing around the Tar Well
- Once the contents have been excavated, backfill the Tar Well footprint with CDF and remove the steel sheets

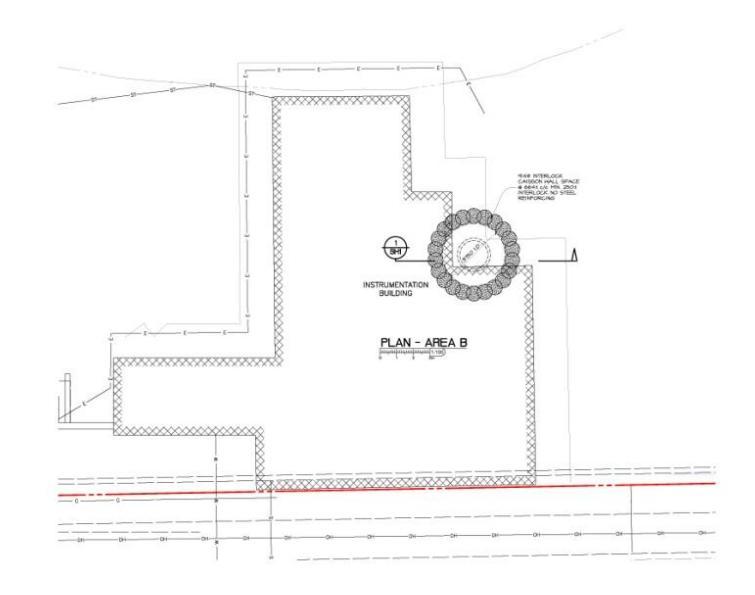
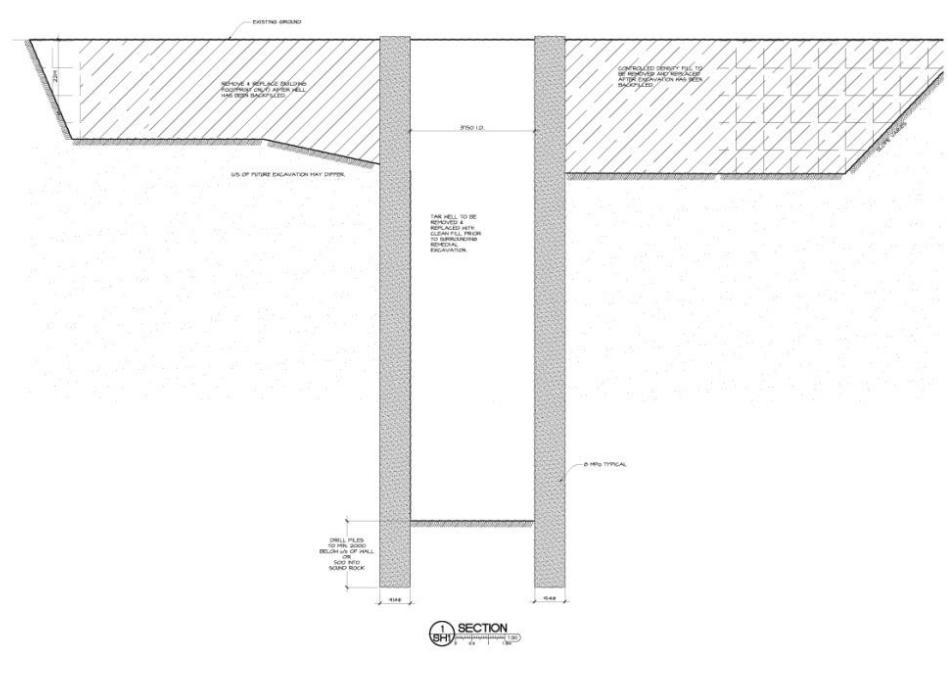
- > Steel Caisson Shorting
 - ~3 m (10 ft) diameter steel pipe driven into the ground around the Tar Well
 - Removal of contents with clamshell attachment on a large lattice boom crane
 - Caisson removed and filled with CDF
- > Secant Barrier Wall
 - 900 mm diameter overlapping secant piles consisting of medium strength concrete columns
 - Removal of contents with clamshell attachment on a large lattice boom crane
 - Secant piles are permanent, filled with CDF upon completion

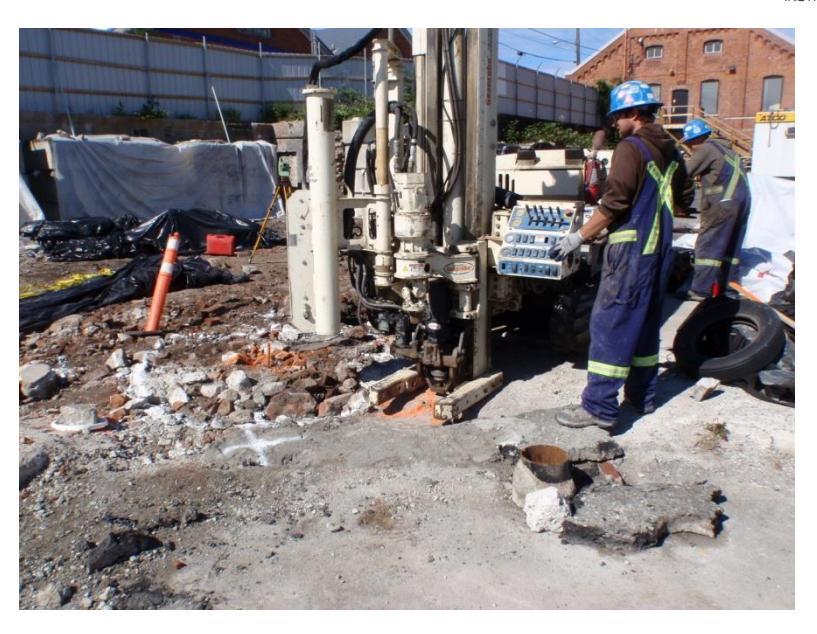
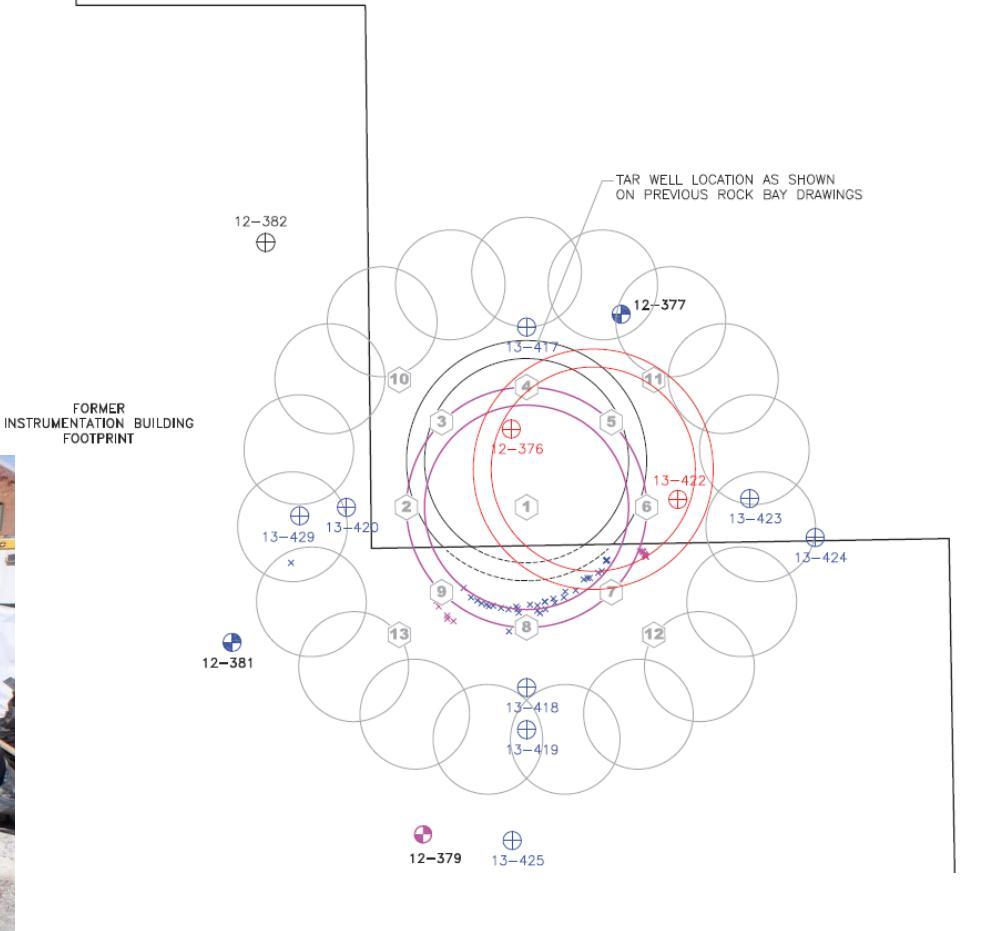
- Tar Well constructed of brick and mortar – potential for tar leakage
- Detailed drilling program to understand impacts around the well
- > 14 boreholes drilled to >14 m depth

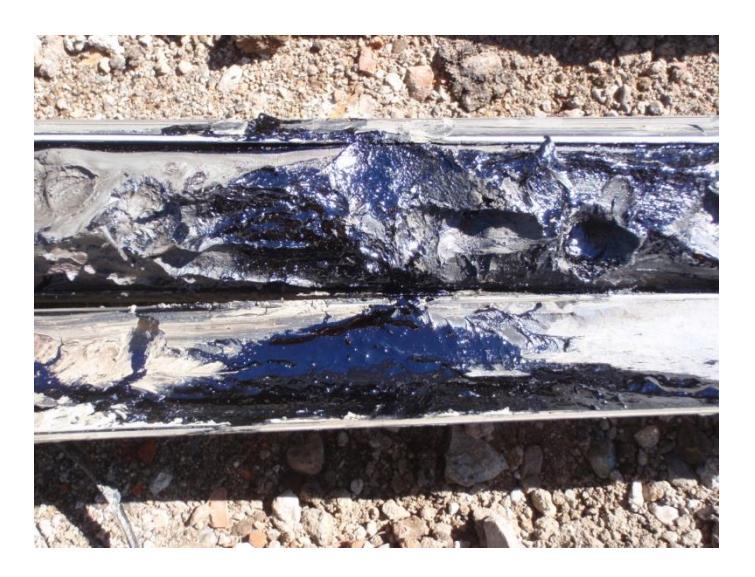
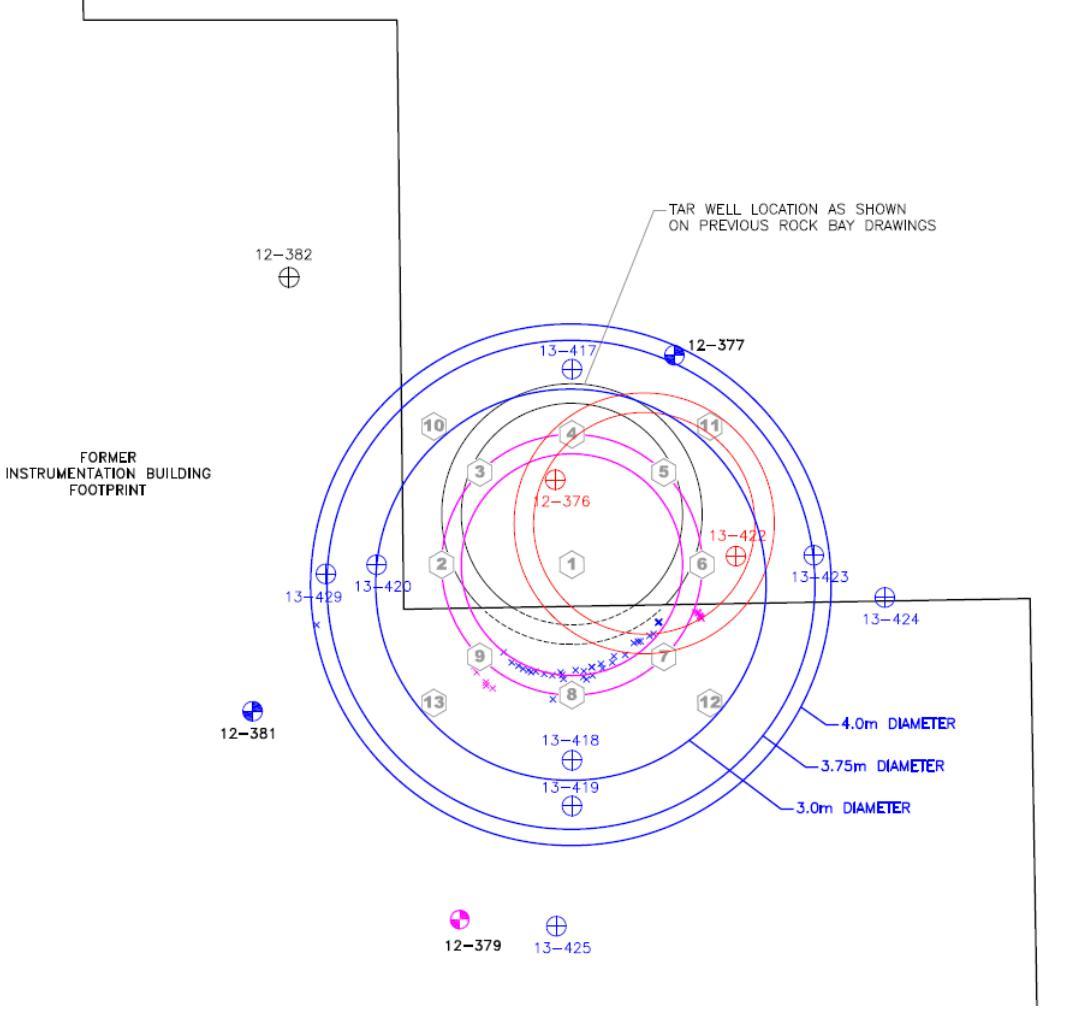
- Detailed drilling program to understand impacts around the well
- > 14 boreholes drilled to >14 m depth
- Ensure the diameter of the Secant Pile Shoring systems captures all contamination

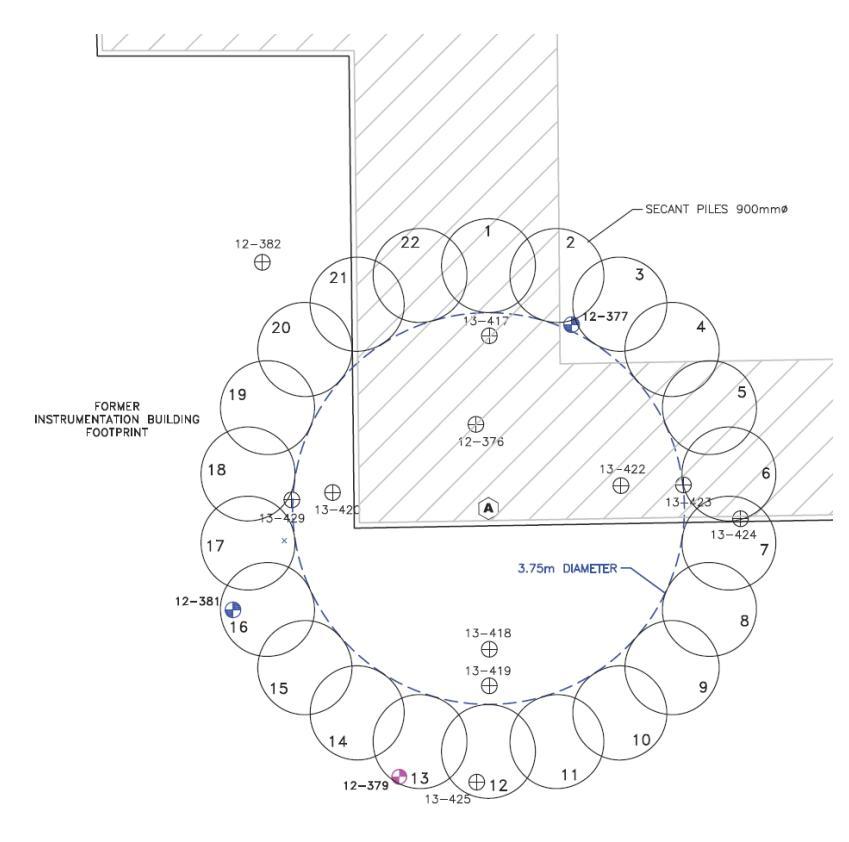
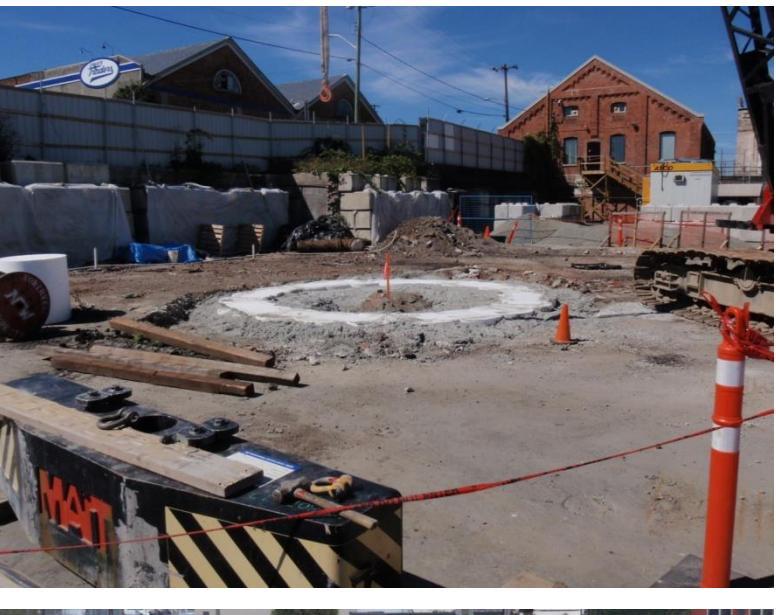
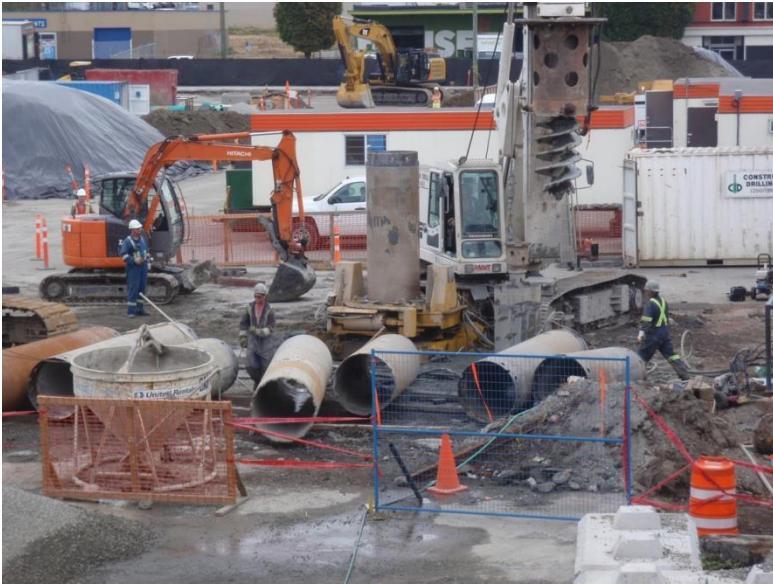
Secant Installation

- > 22 Interlocking Secant Piles @ 3.75 m dia
- > Styrofoam forms used as guide
- > Secants keyed into bedrock

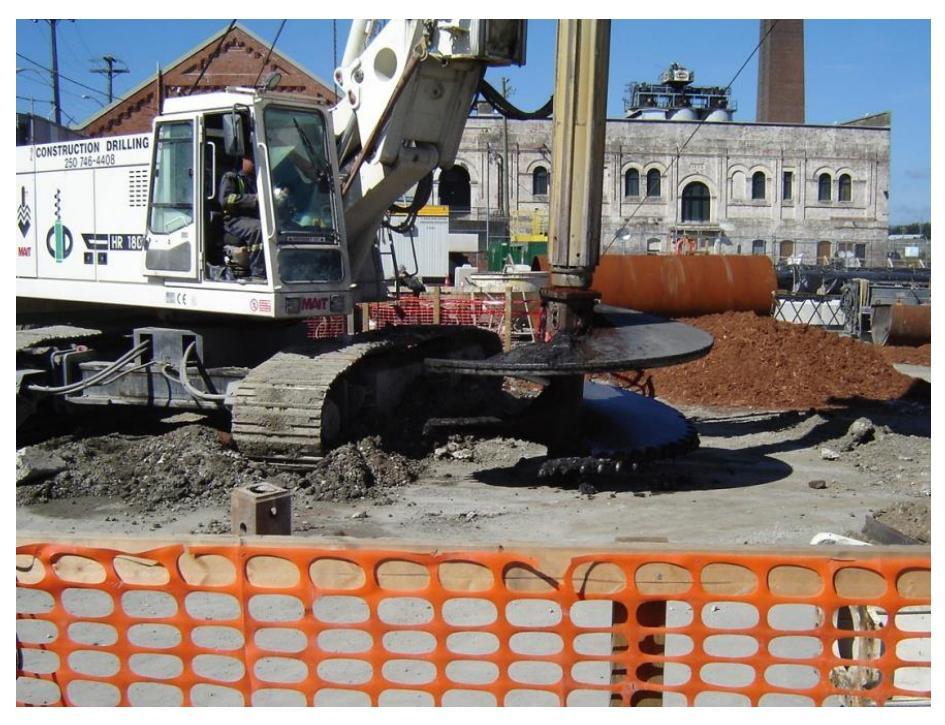
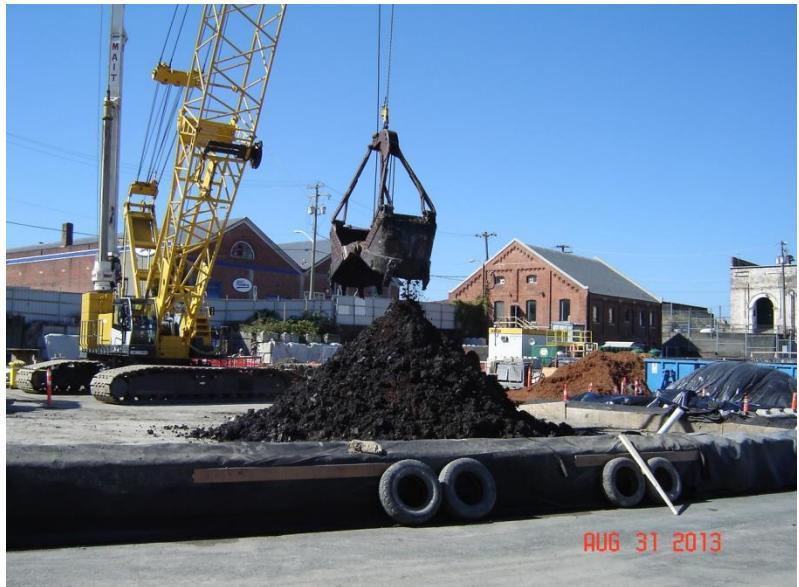
Tar Well Excavation

- Soil, brick and tar removed using various pieces of equipment
- Material stabilization in-situ using hogfuel. Needed to meet specifications of treatment facility (Envirogreen Technologies)
- Specialized equipment to remove residual material and clean the sidewalls of the secant piles
- Shipments carefully planned / coordinated to minimize odour coming from the transport trucks
