Dioxin Degradation and Metals Biovolatilization at a Former Wood Treating Site

RemTech 2017

Leslie Hardy, M.Sc., P.Eng. Amec Foster Wheeler

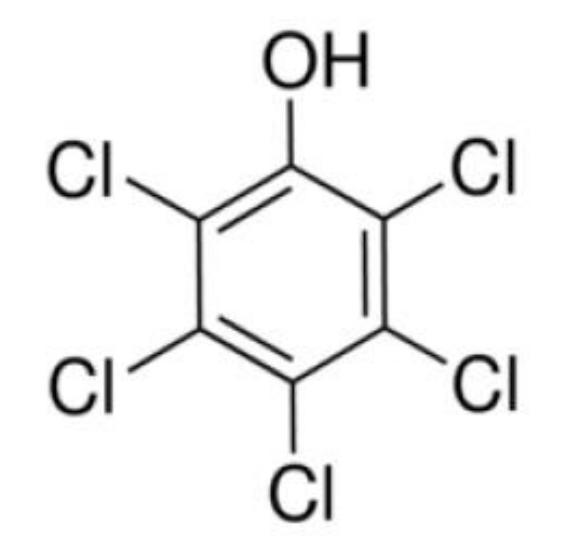
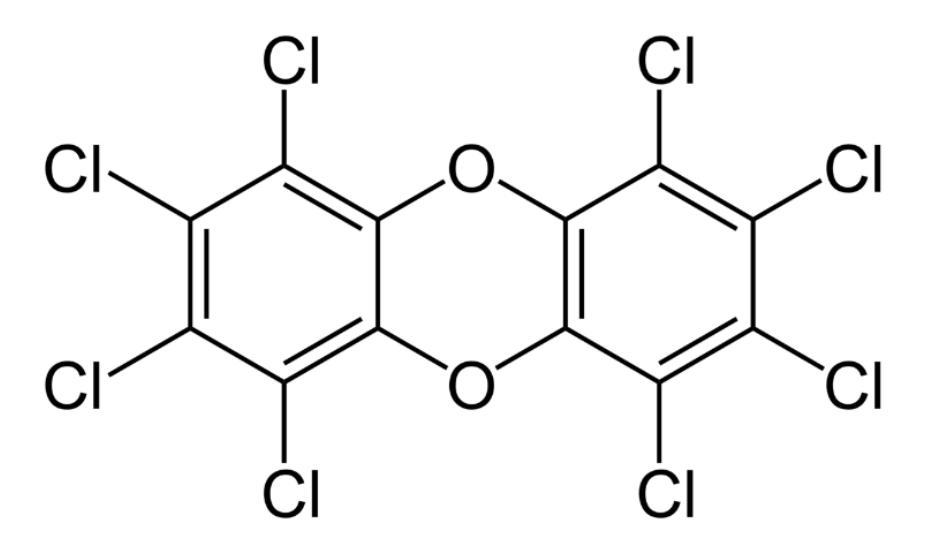
PCP and Dioxins

Pentachlorophenol (PCP)

Octachlorodibenzodioxin (OCDD)

Site has unusually high dioxin concentrations due to burning of the chlorophenol sludge

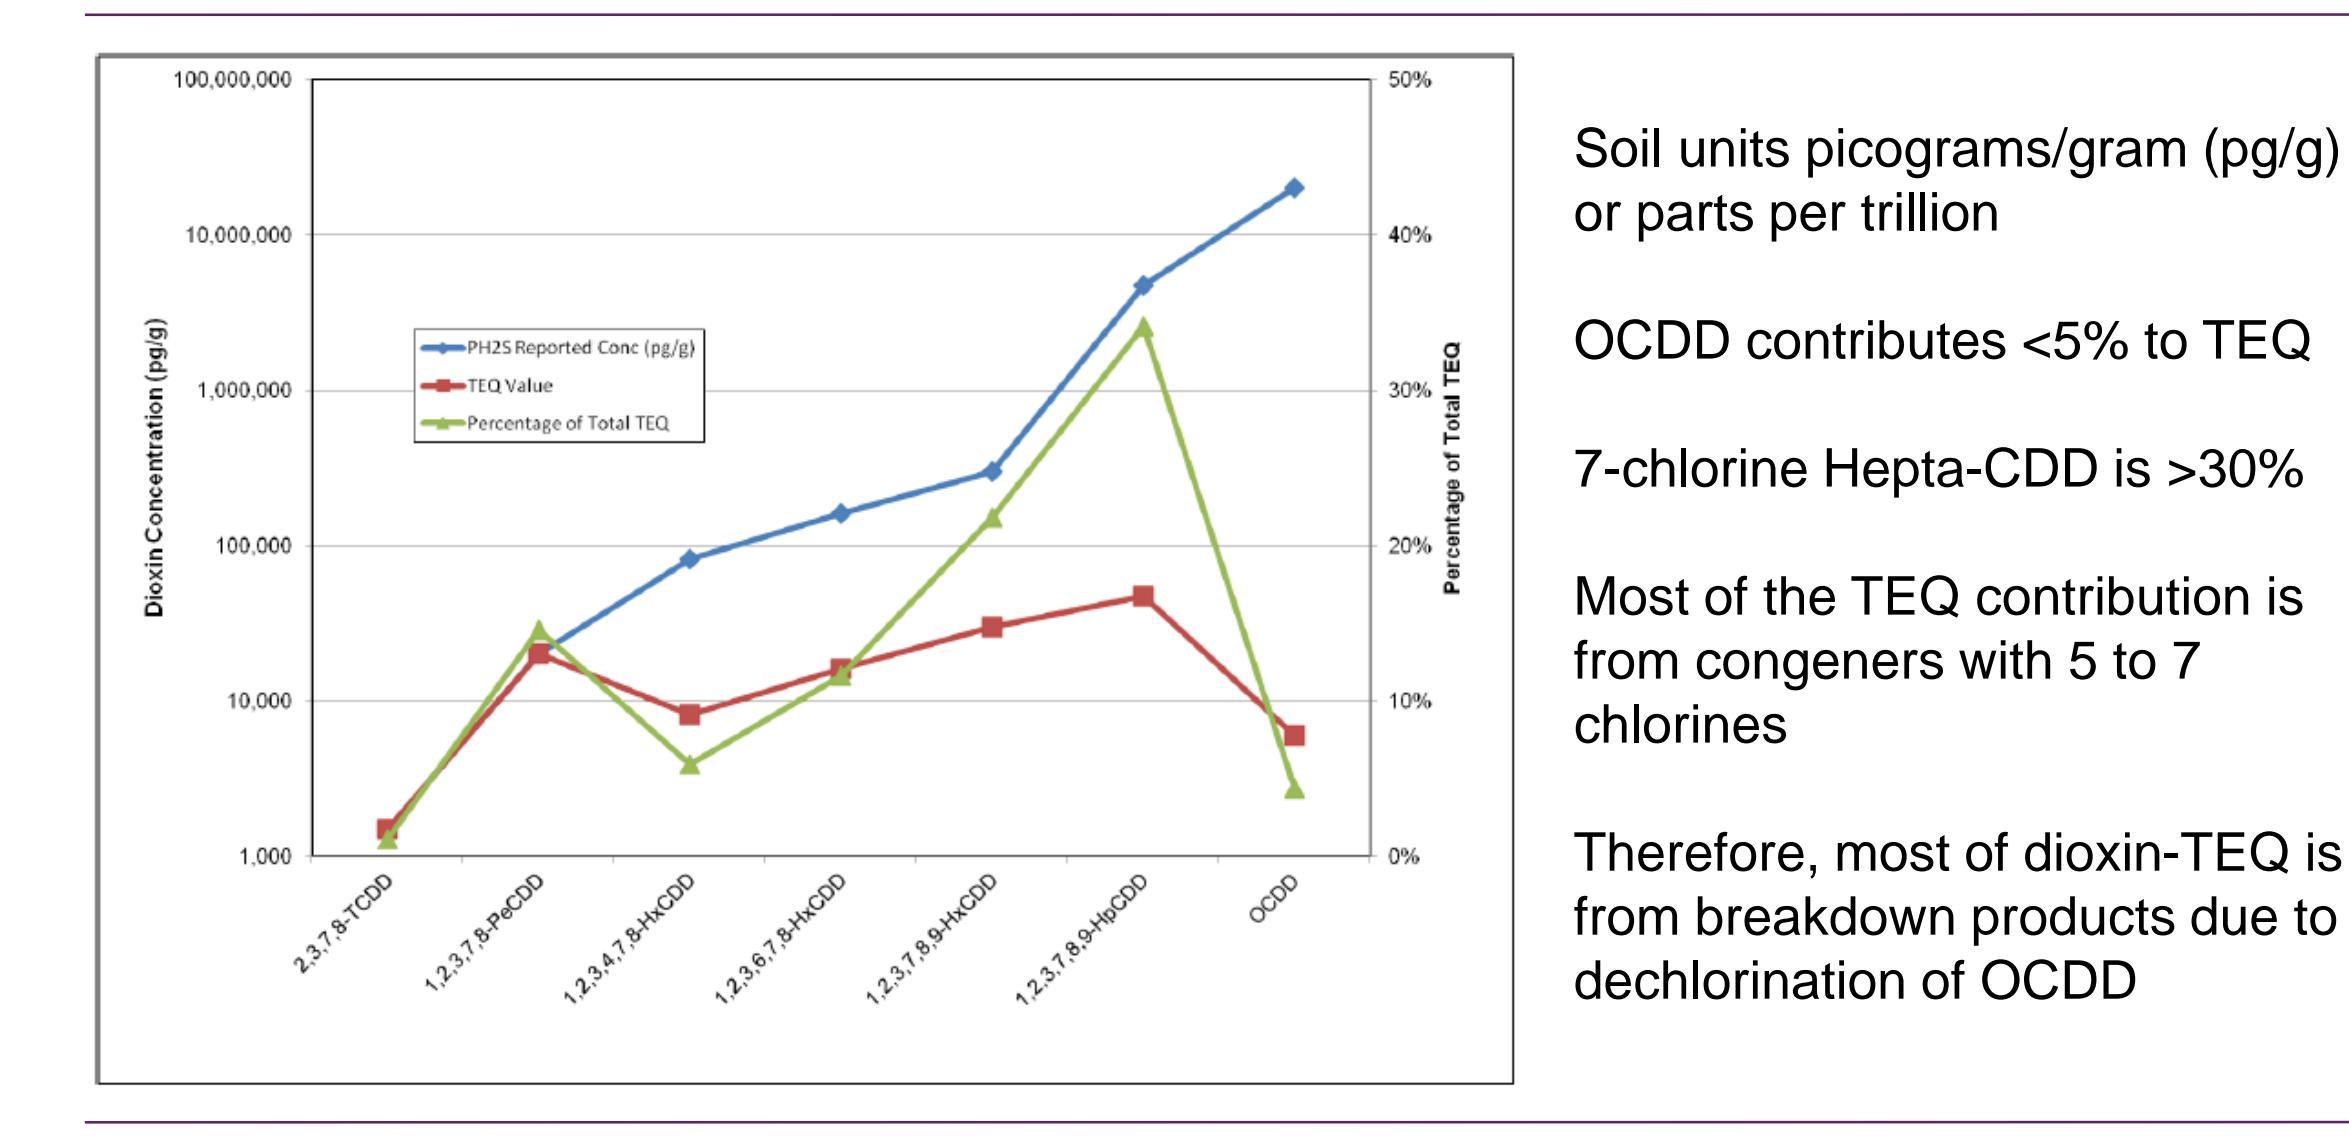
Dioxin Mass and TEQ Contribution Highest Result on Site (137,700 pg/g Dioxin TEQ)

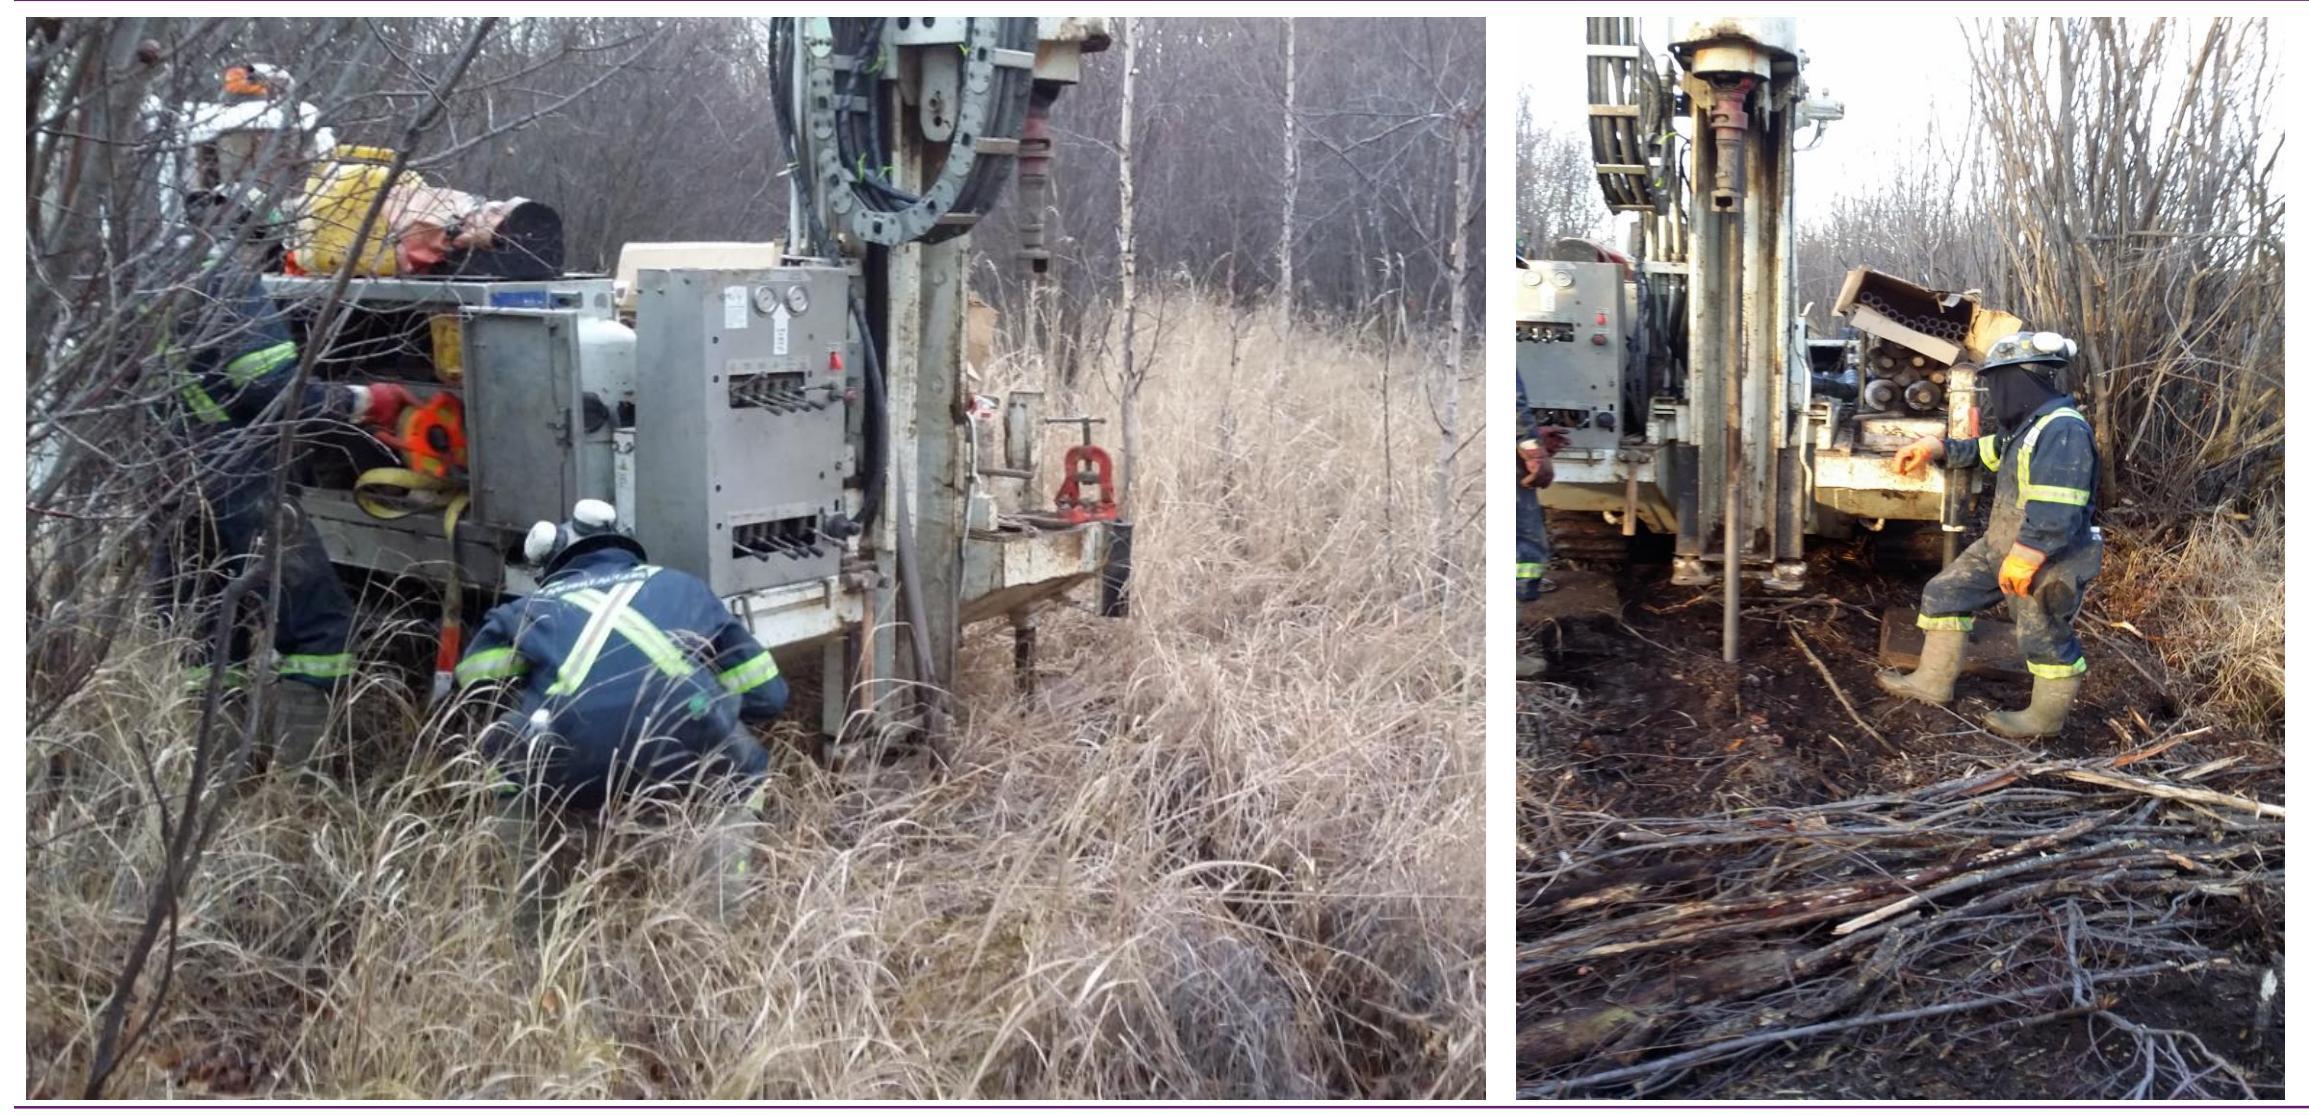
Soil Sampling Direct Push Technique

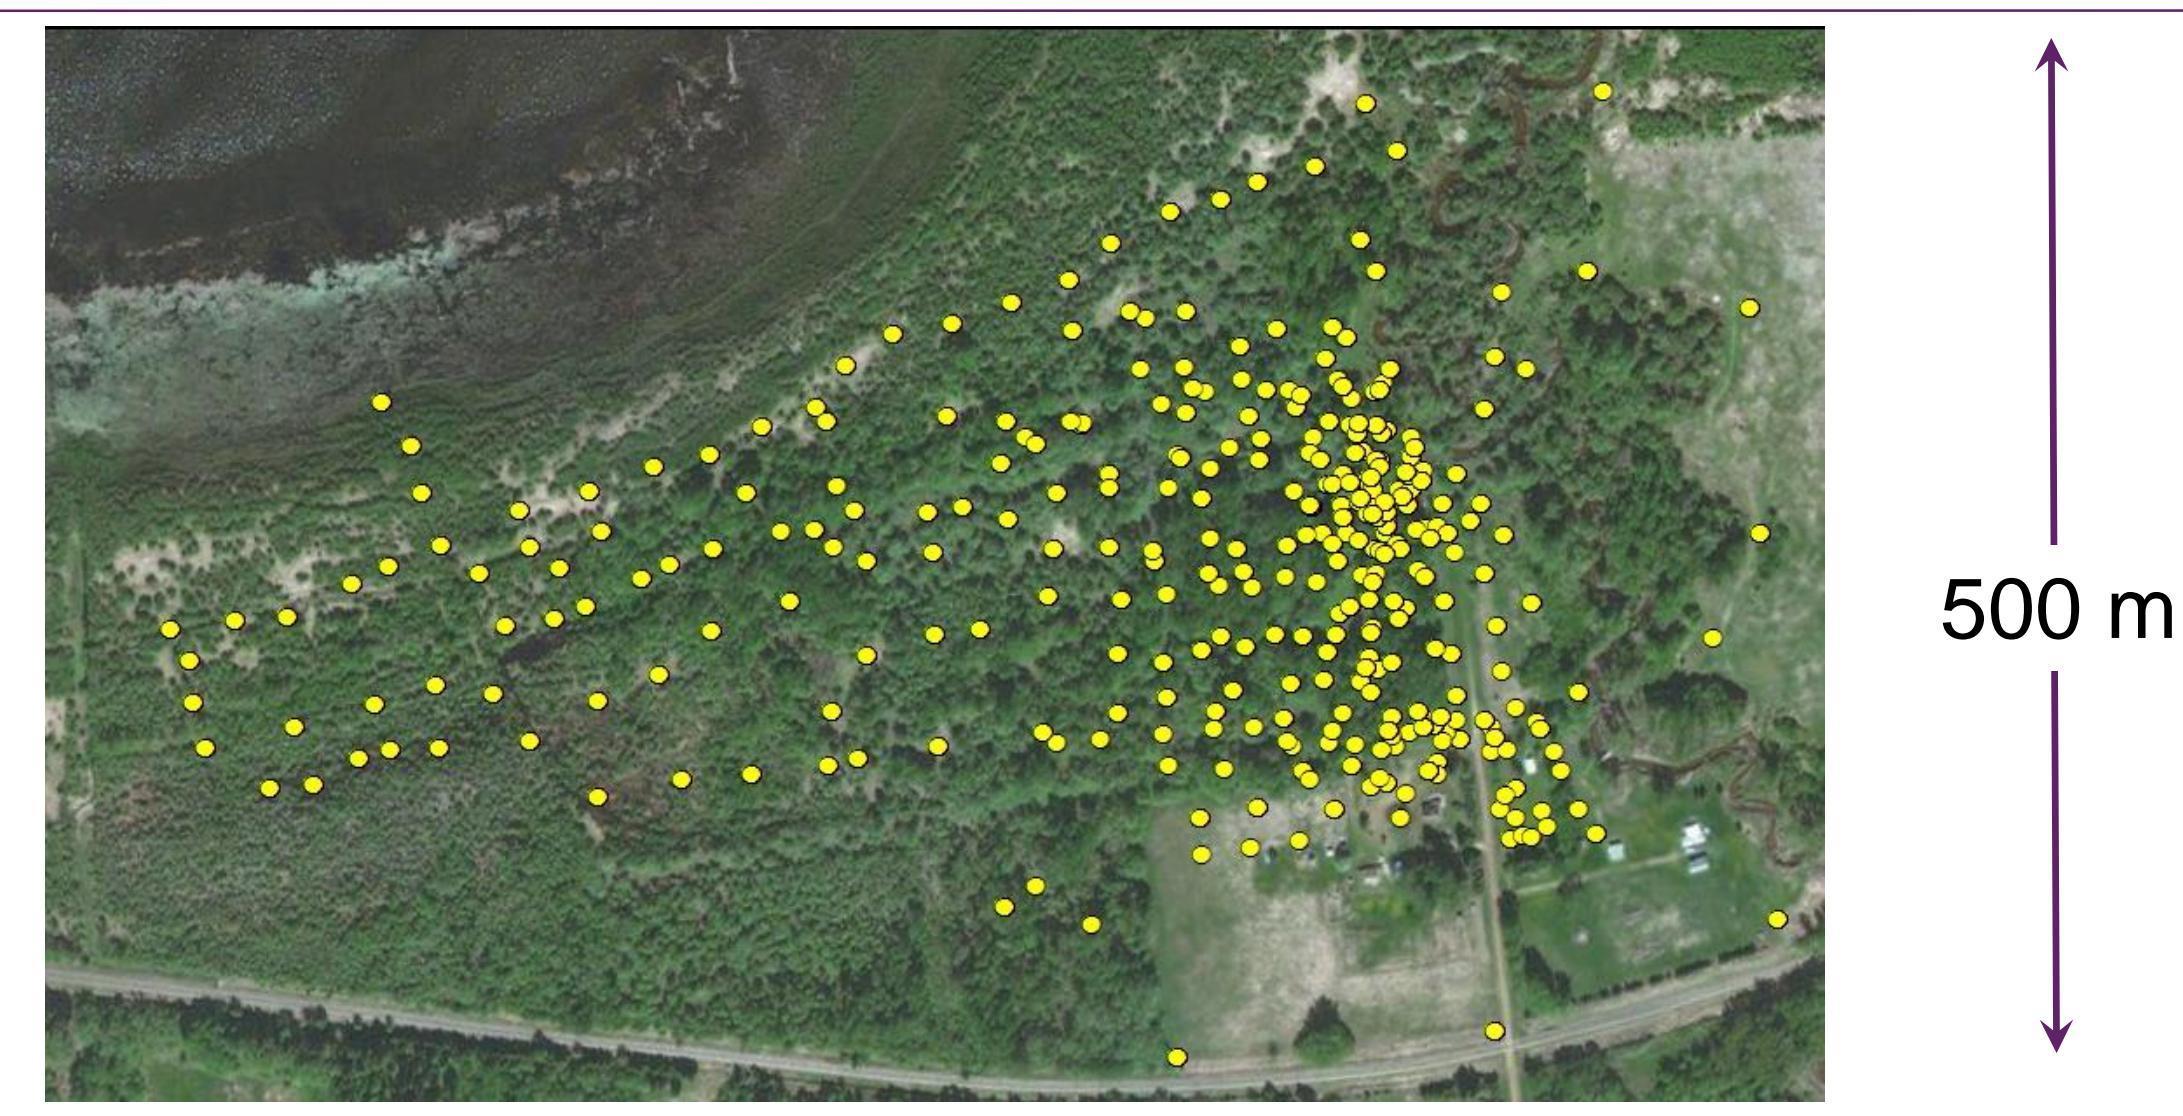
Soil Sample Locations 299 Samples for Dioxins

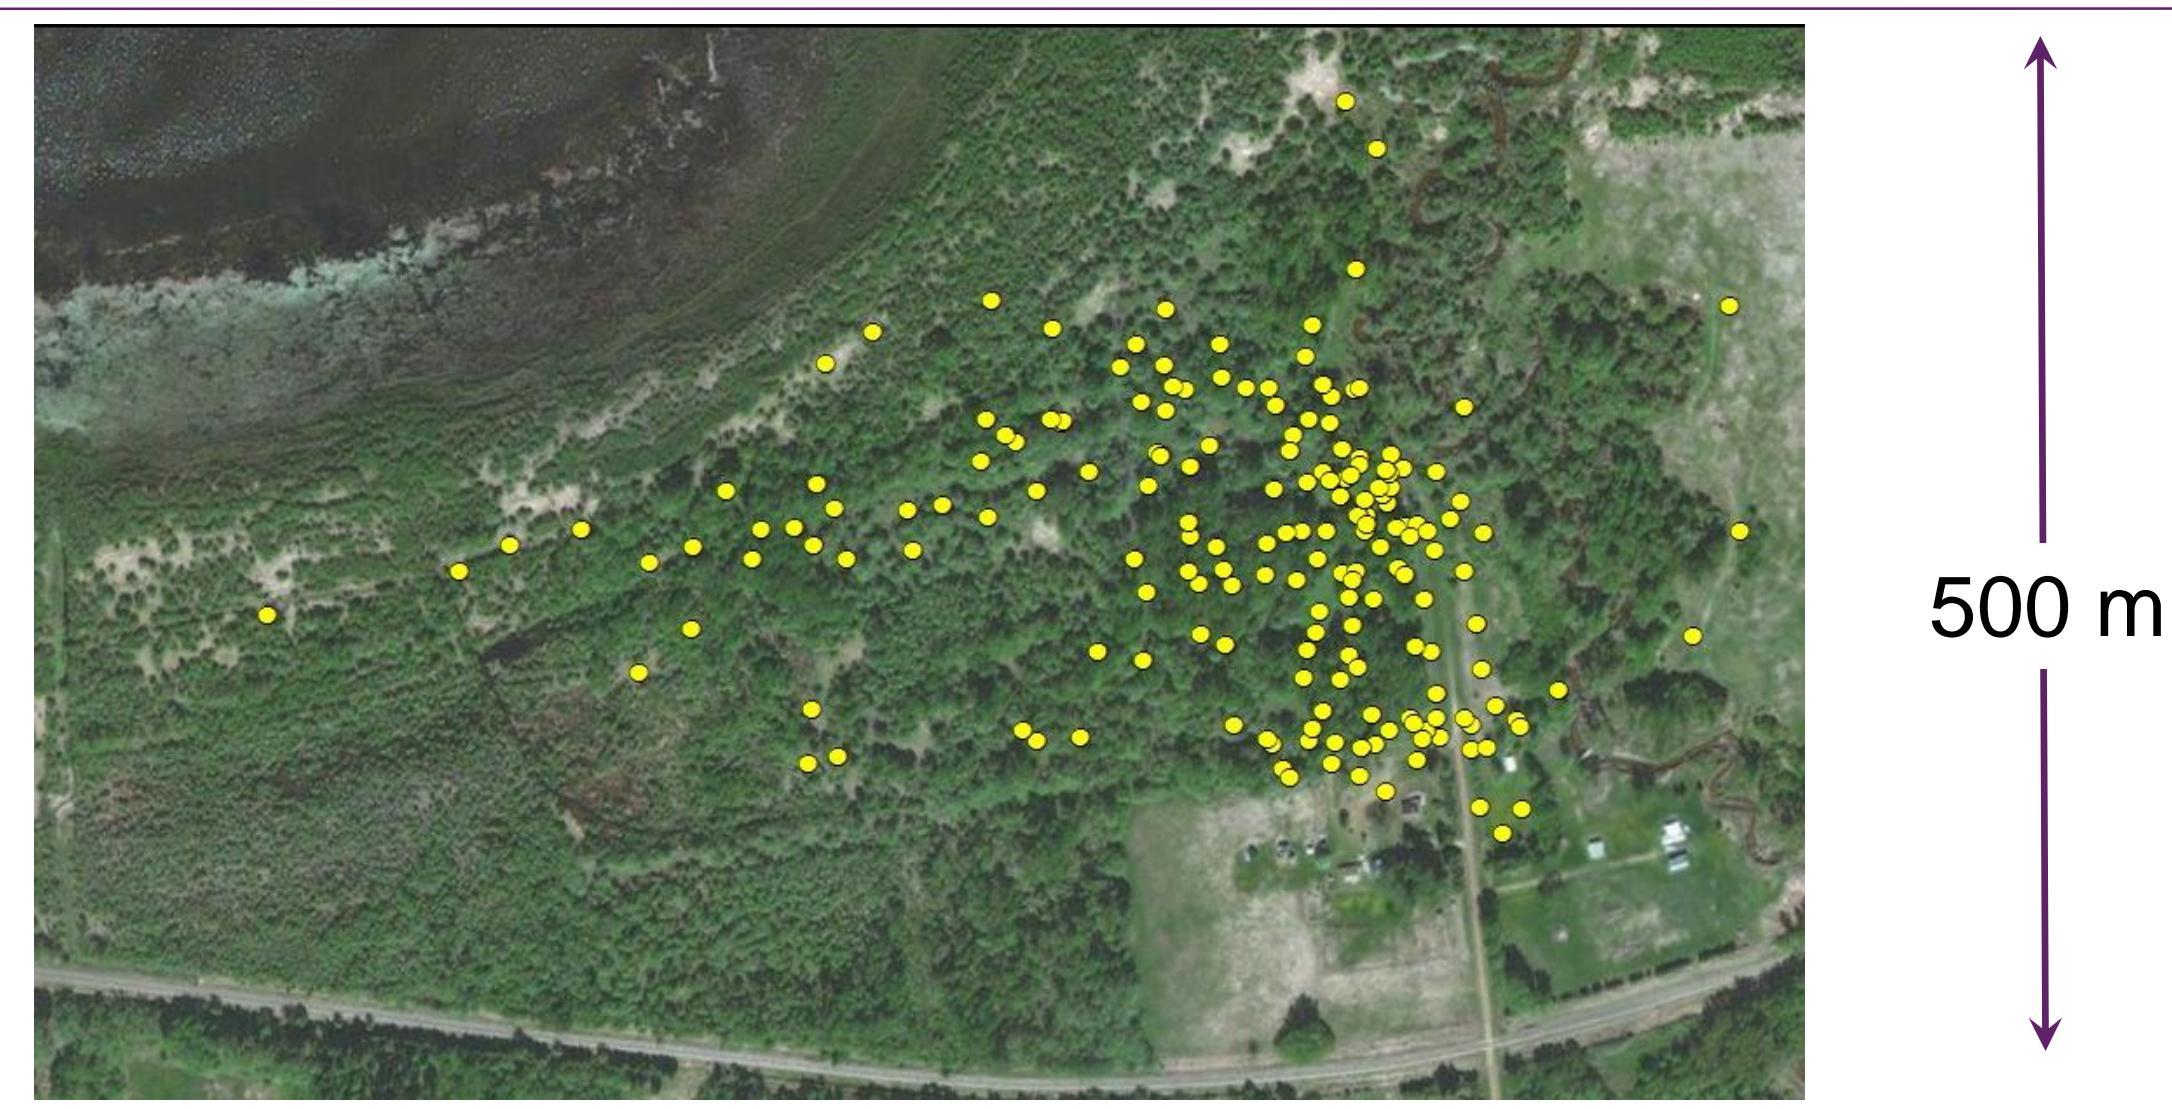
Dioxins – Results > 4 pg/g Alberta Tier 1 Standard – 205 Samples

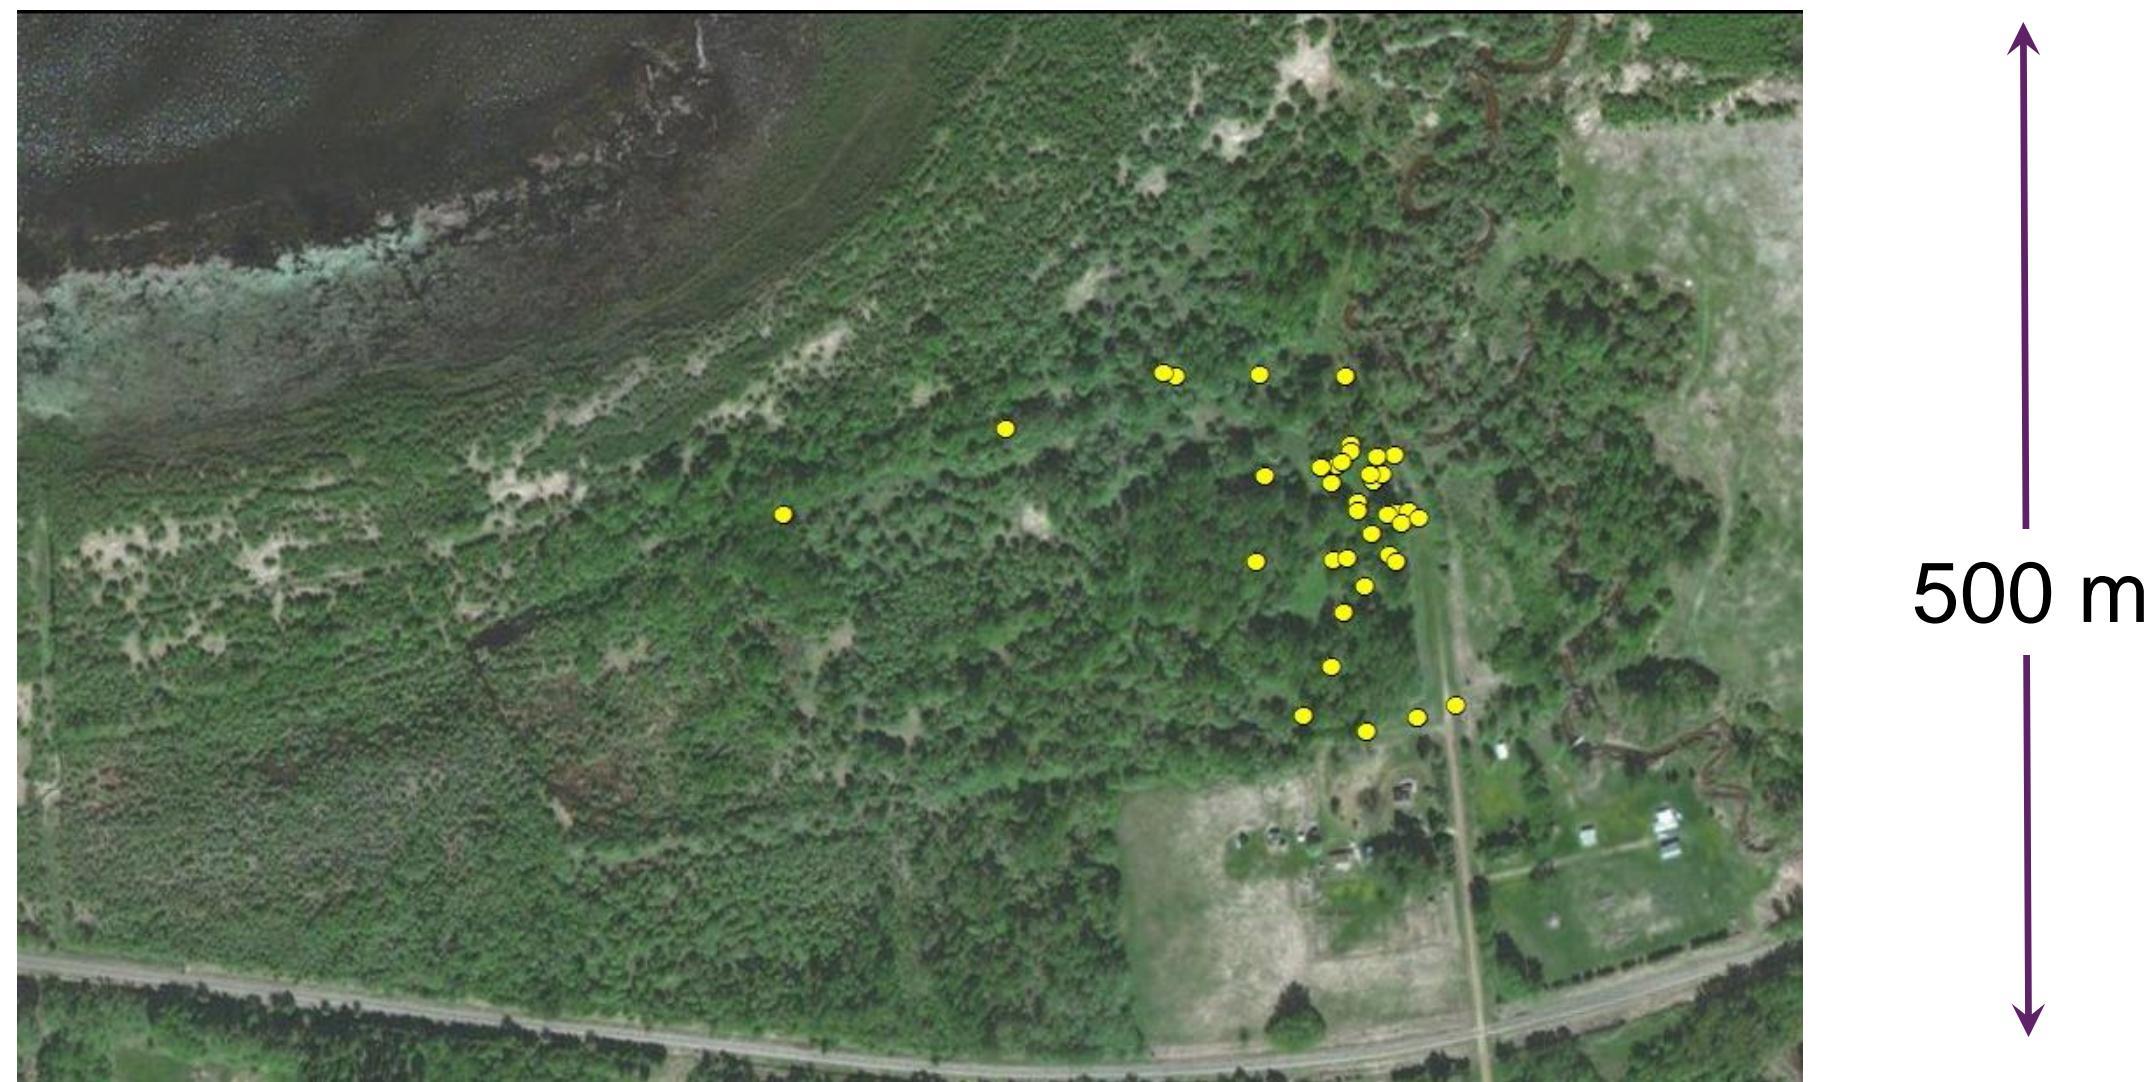
Dioxin Results > 250 pg/g Alberta Tier 1 Natural Area – 41 Samples

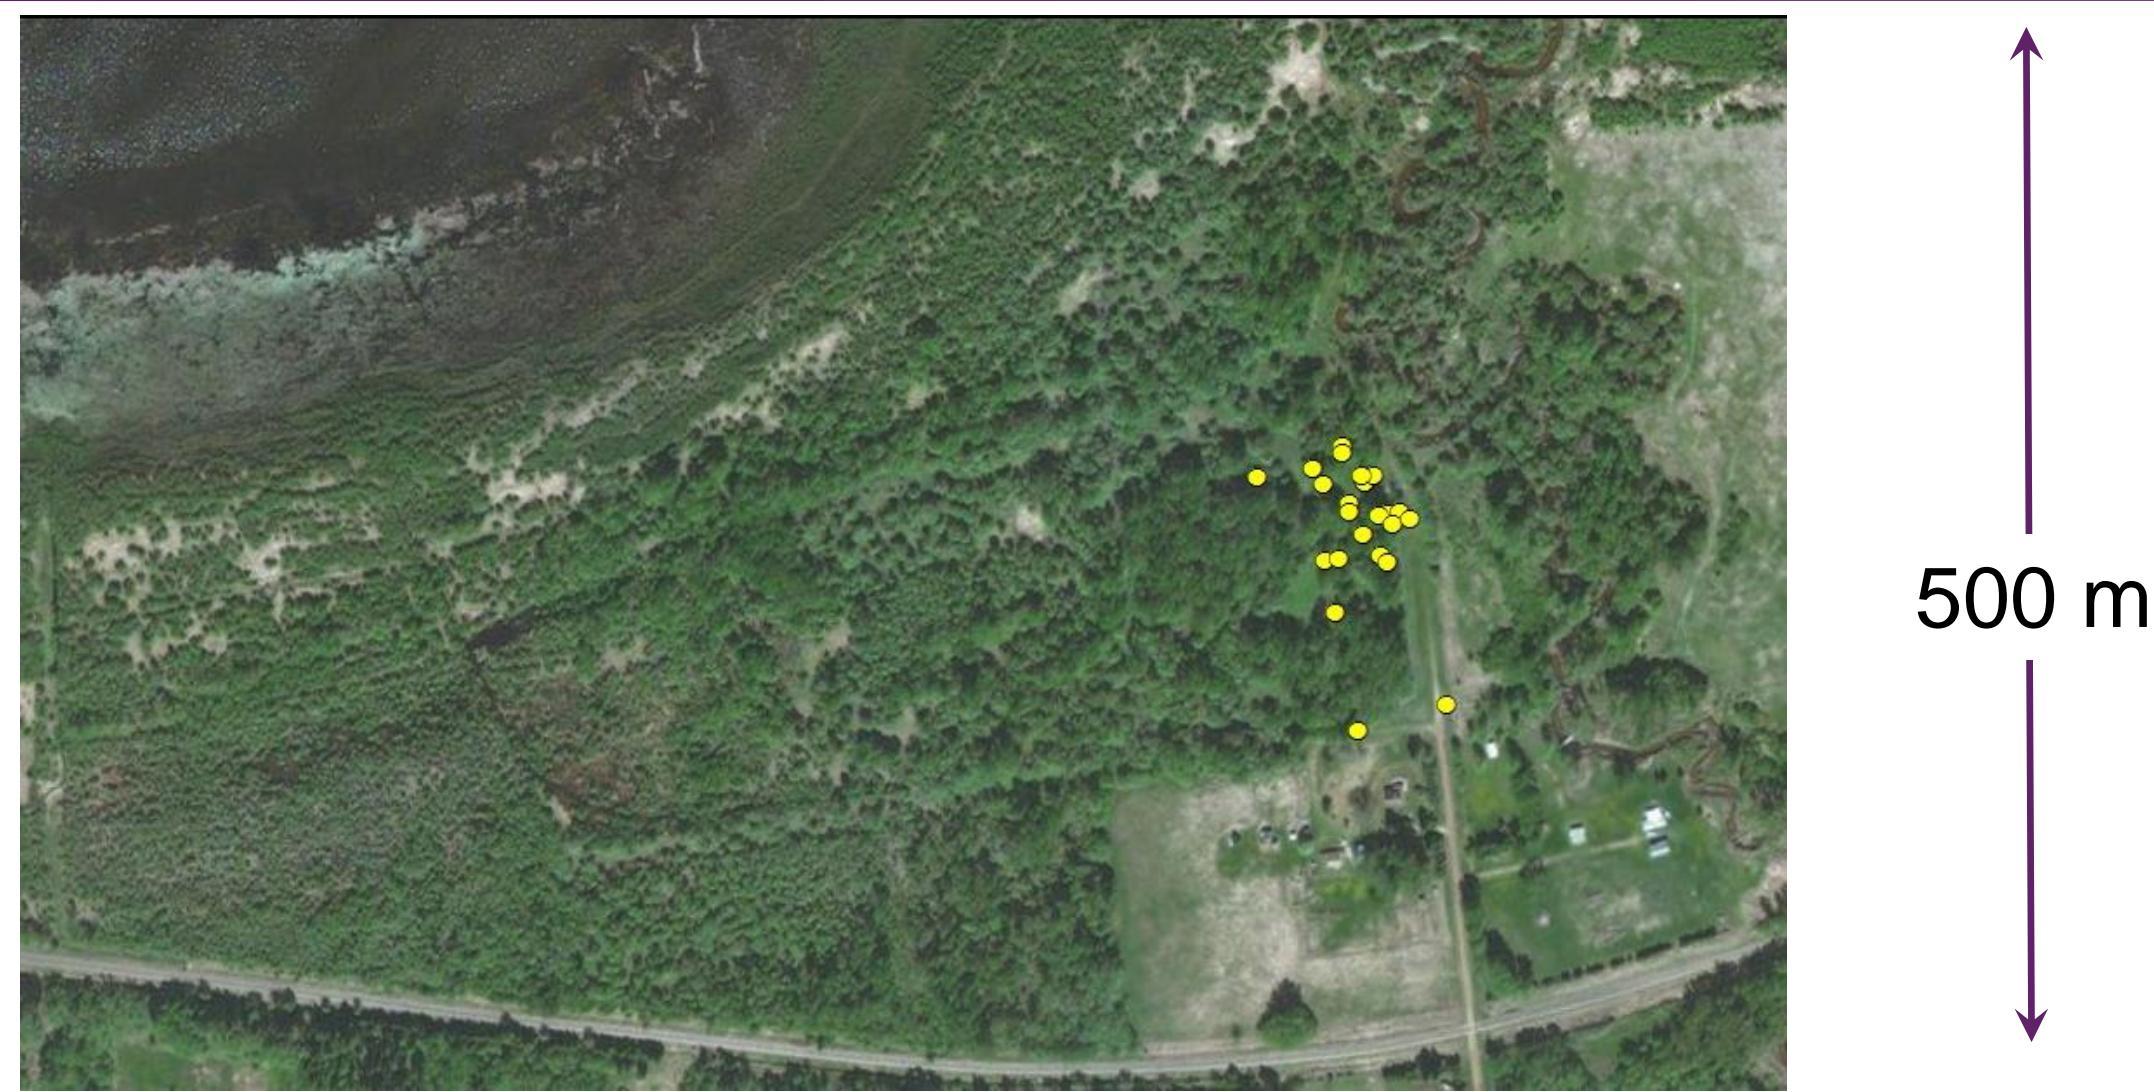
Dioxin Results > 1,000 pg/g – 27 Samples US EPA Draft Industrial Guideline is 950 pg/g

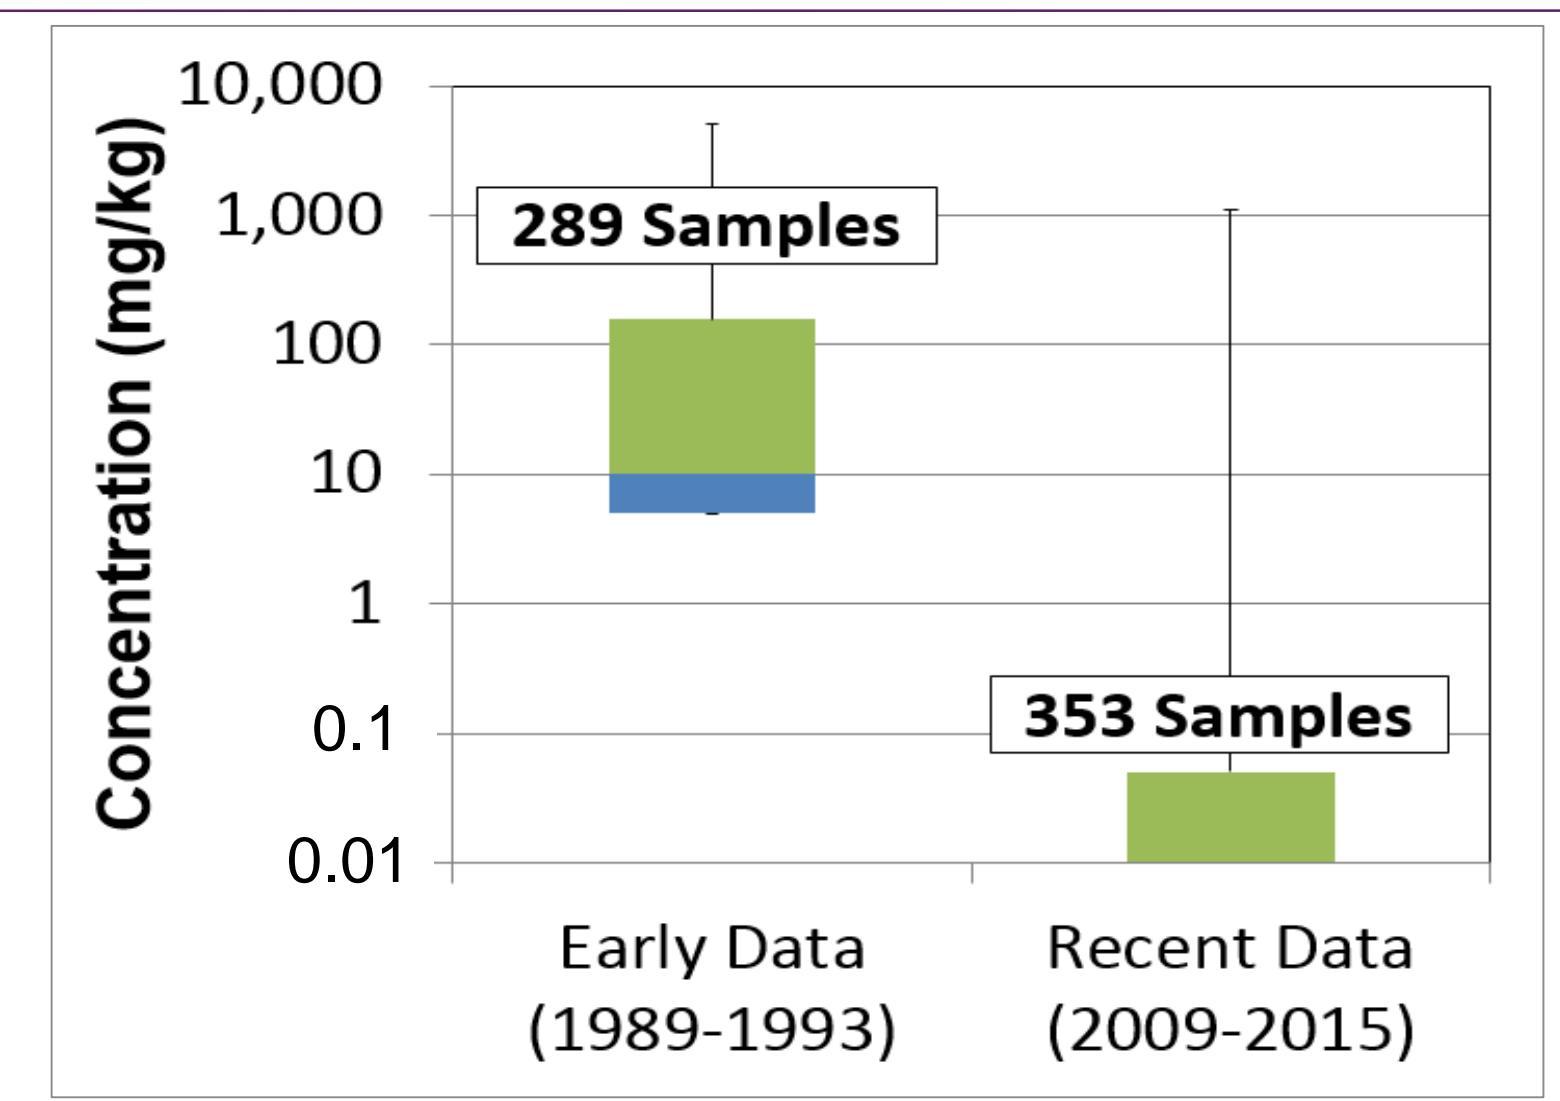
PCP Degradation in Soil Half-Life of 2 years over 22 year interval

Highest PCP in 2015 at ground surface

Consistent with Anaerobic Biodegradation

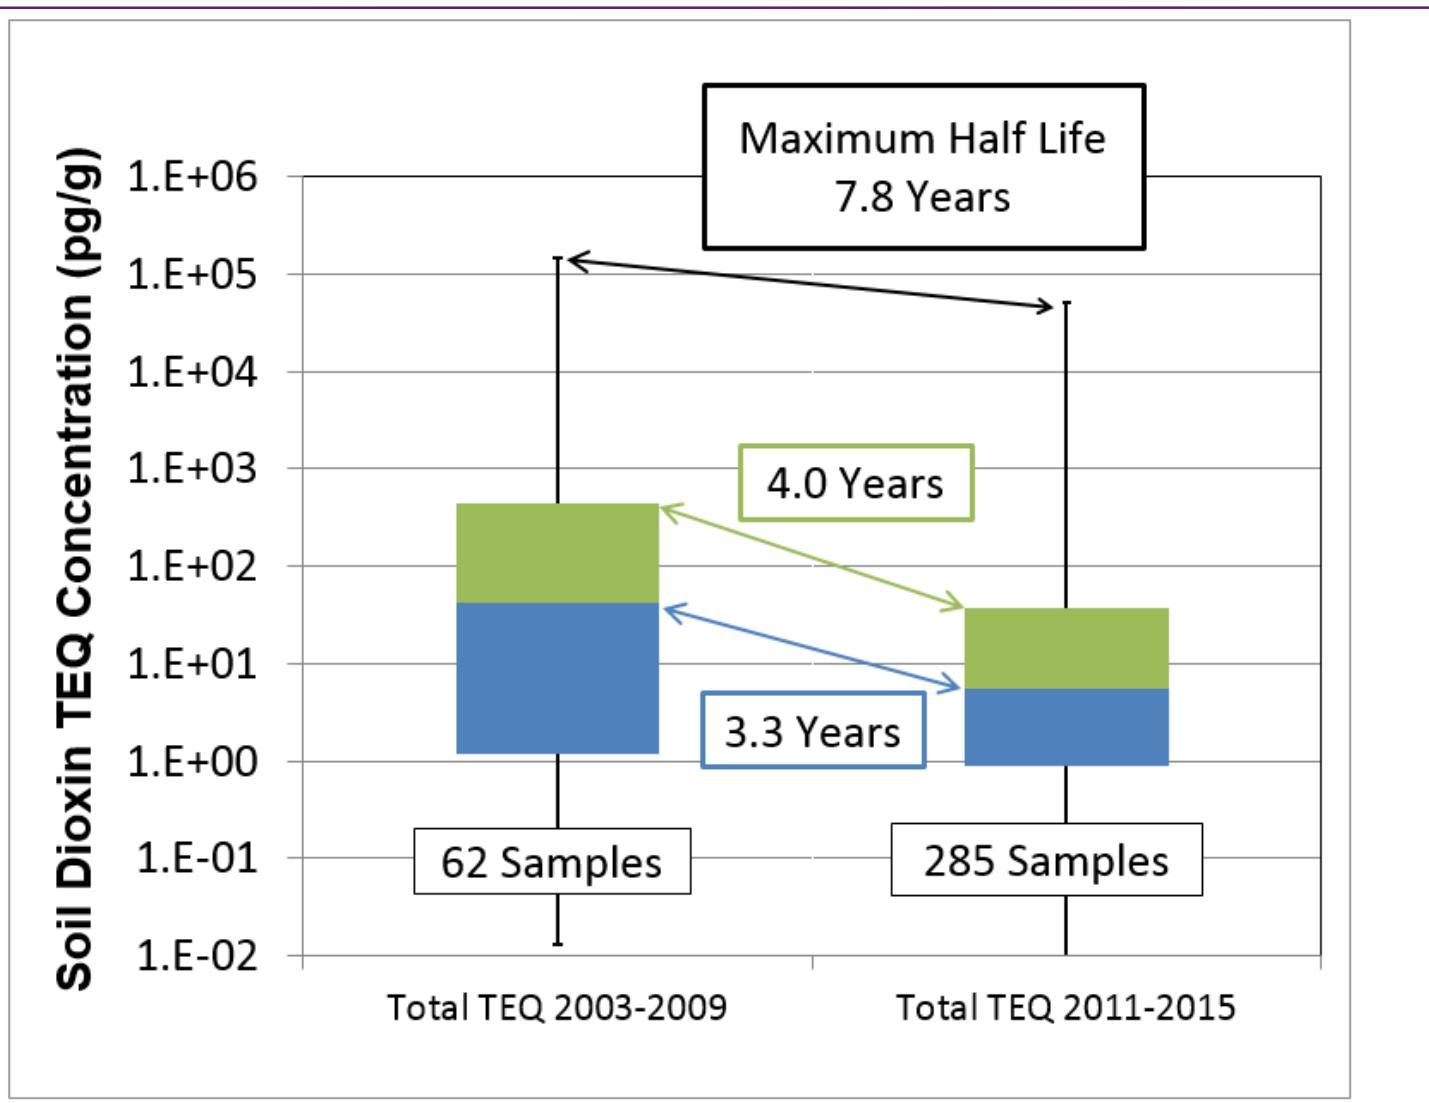
Dioxin-TEQ Approximately 10 Year Interval

223 Analyses by EPA Method1613B (HRGC-GCMS)

146 Analyses EPA Method 4435 (Calux Bioassay)

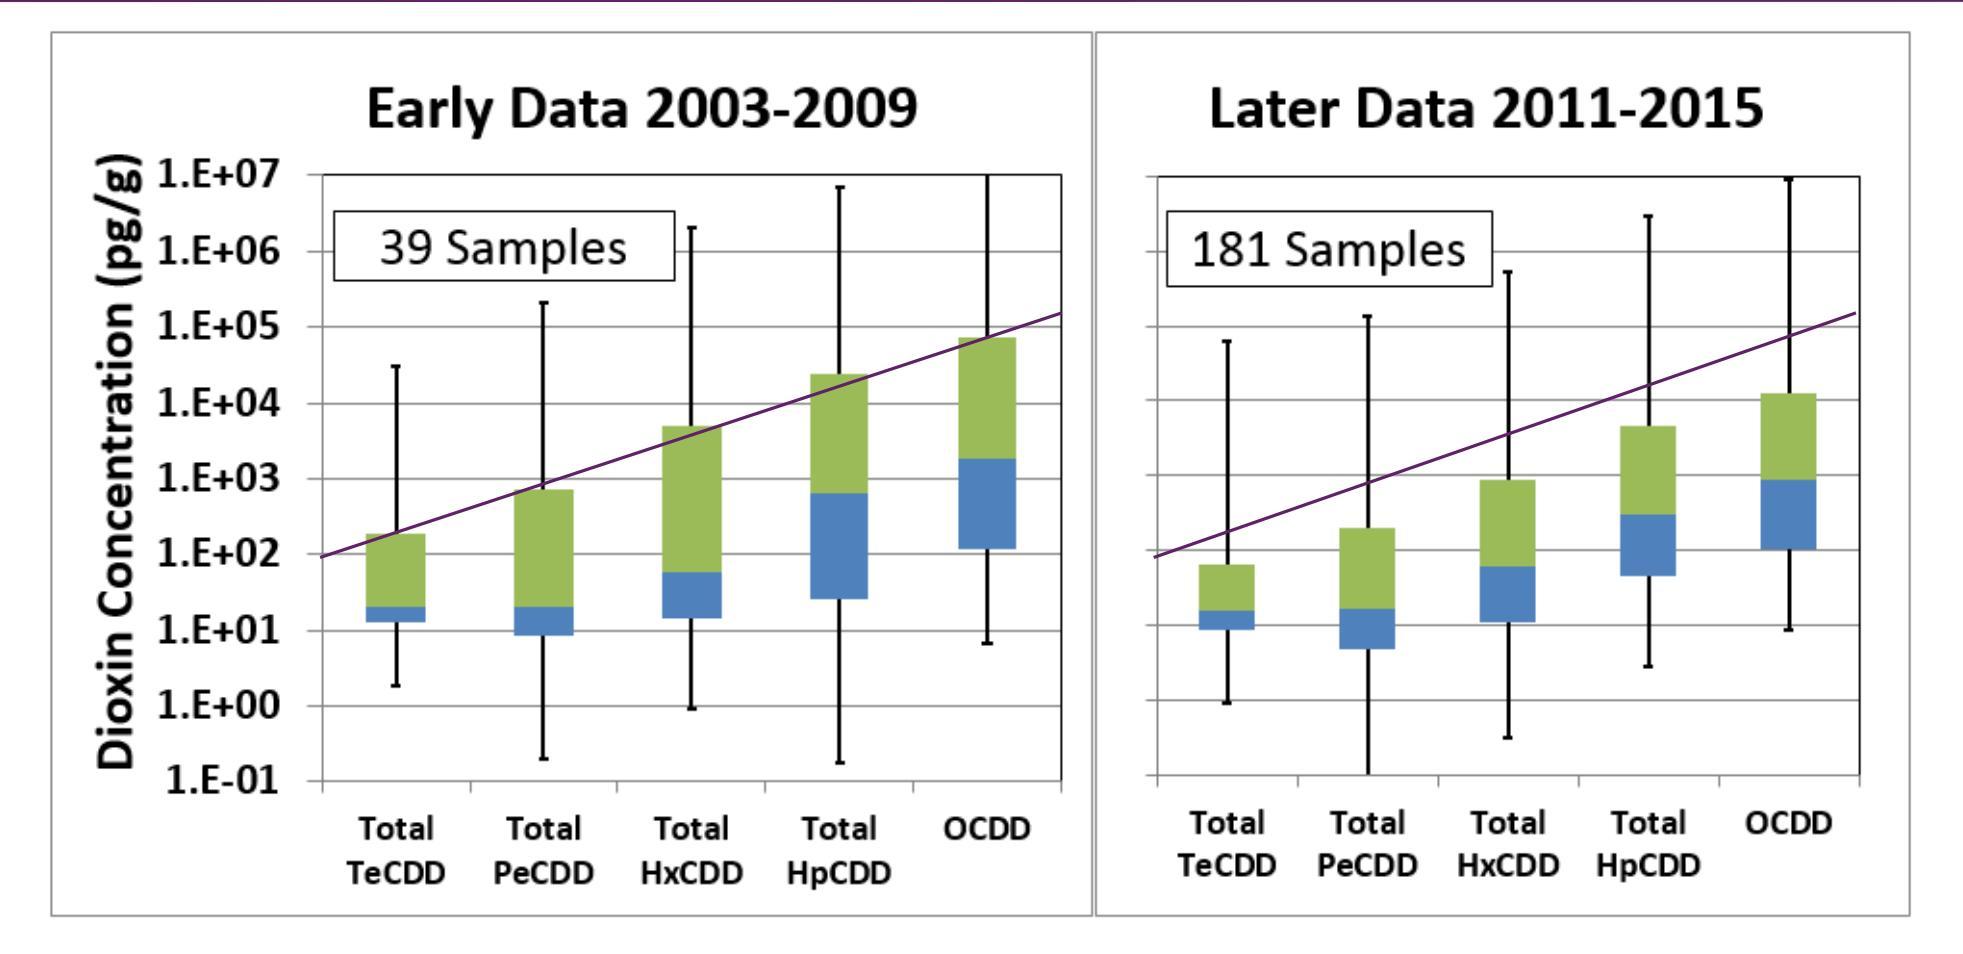
Total Dioxin Mass Decreased and Shifted to Less Chlorinated Dioxins

Total dioxin results are indicative of Reductive Dechlorination Supports interpretation of degradation based on TEQ data

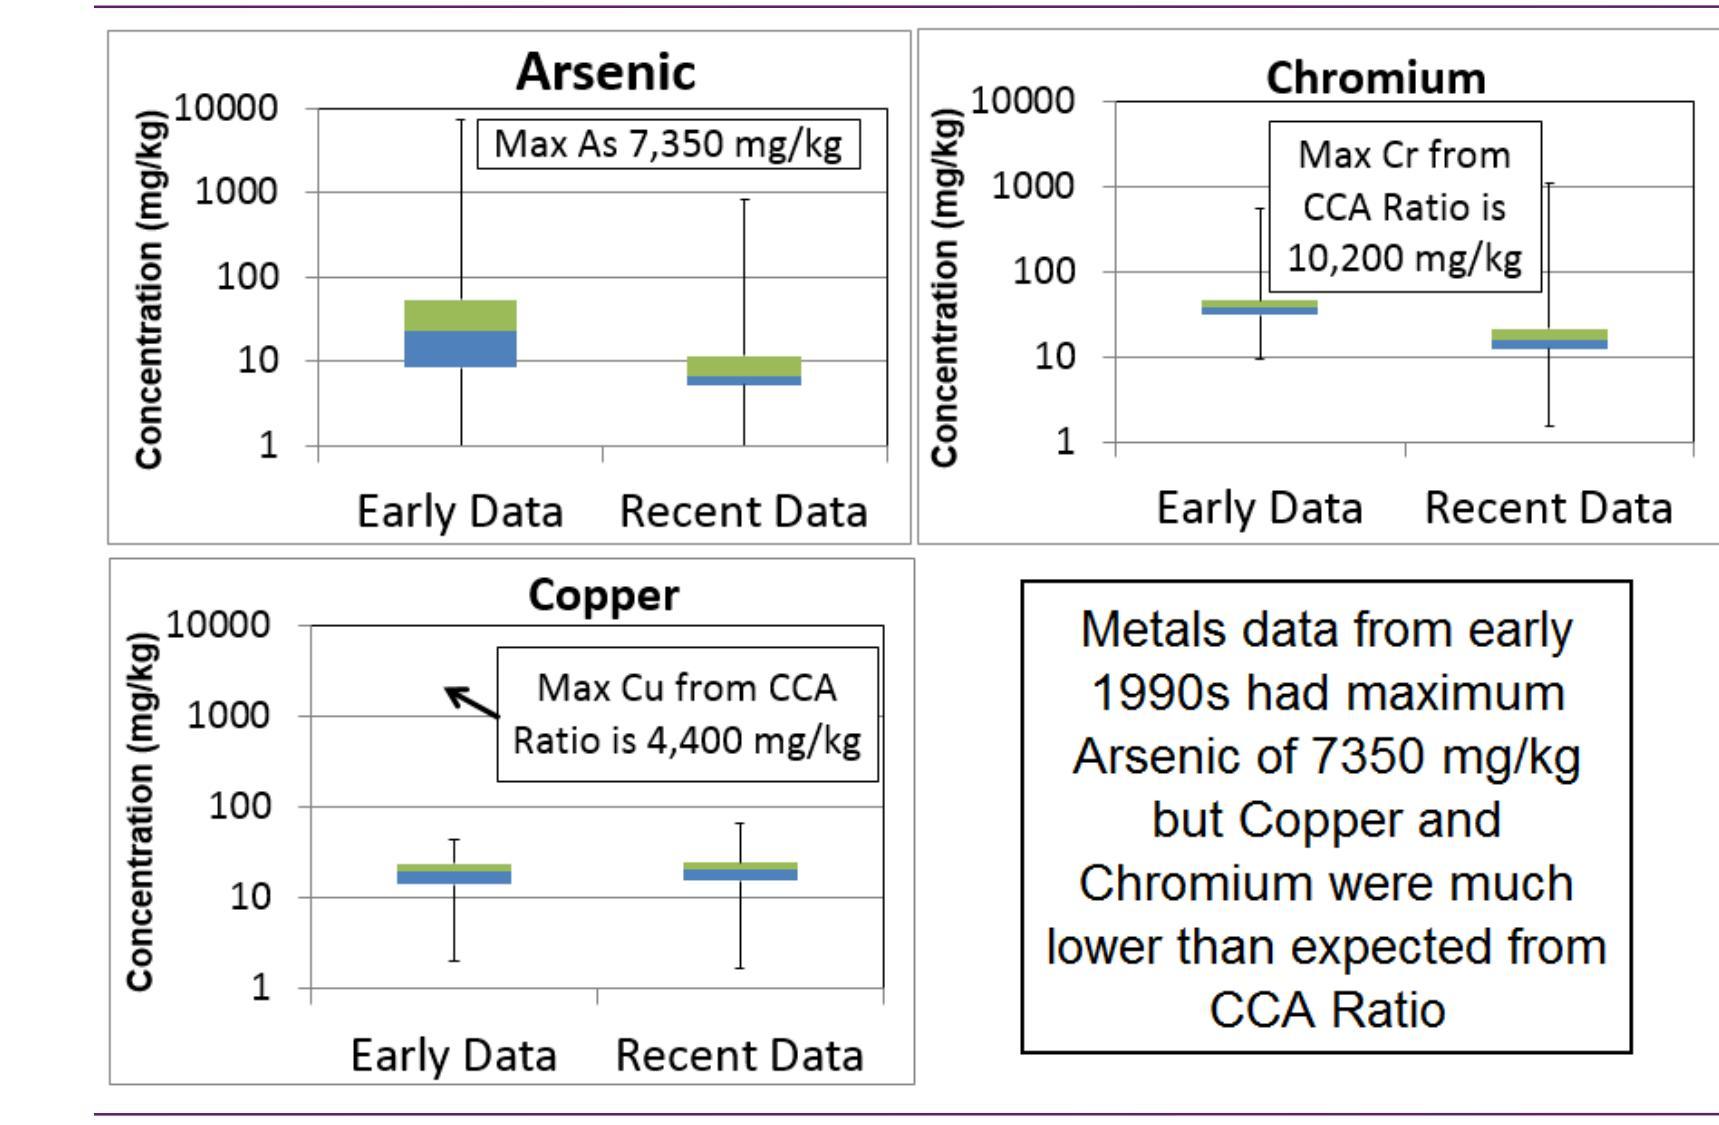
Metals Concentrations

20 years after Site closed, most of Chromium and Copper was already gone

At 50 years, Chromium and Copper are now near background concentrations

Arsenic $t_{1/2} = 8$ years
