Dioxin Degradation and Metals Biovolatilization at a Former Wood Treating Site

RemTech 2017

Leslie Hardy, M.Sc., P.Eng. Amec Foster Wheeler

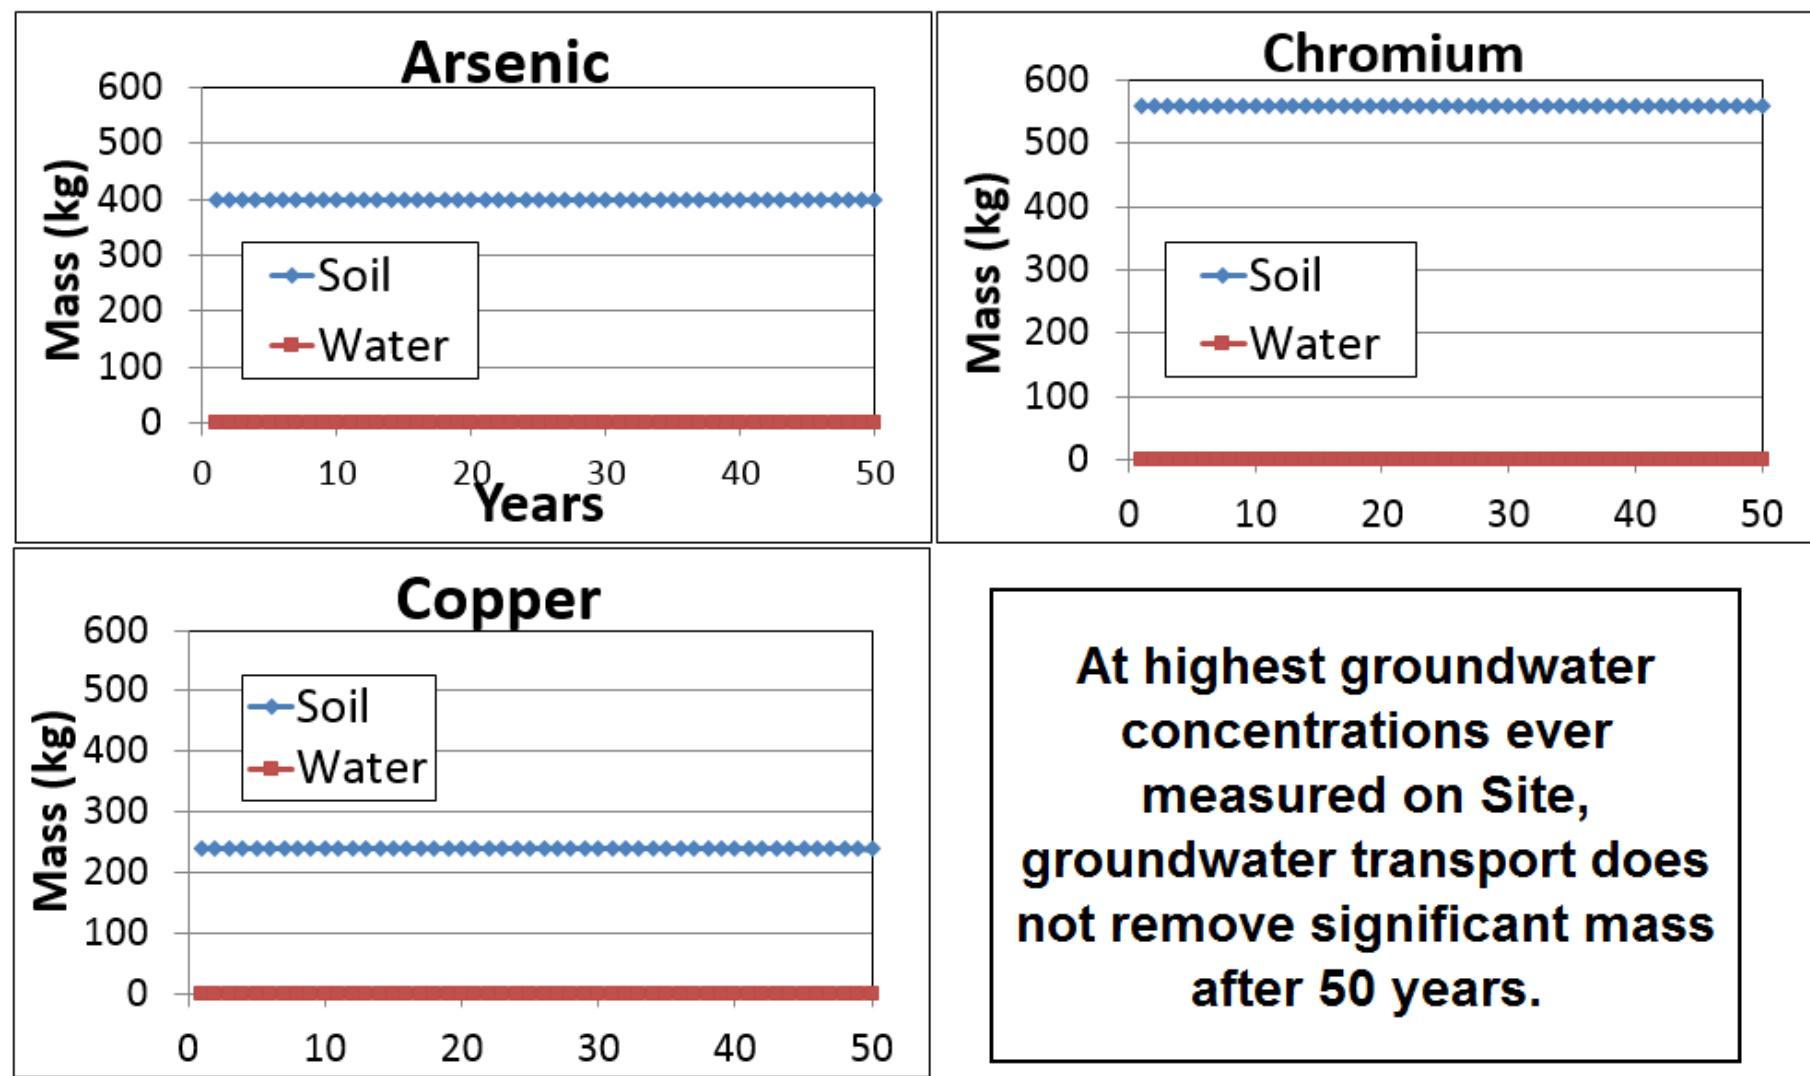
Mass Balance Calculations for Metals

- Also does not explain lower concentrations
- High initial metals mass in soil
- >Not enough metals mass can be removed in groundwater
 - 10 m/year groundwater flow velocity
 - 50 years since contamination
 - Calculations based on 200 m³ soil volume
