Monitoring and Enhancing Natural Source Zone Depletion at a Petroleum Pipeline Release Site in Abbotsford, BC

Matt Rousseau – Senior Technical Director, GHD Arden Wabisca – Project Manager, GHD

→ RemTech 2024

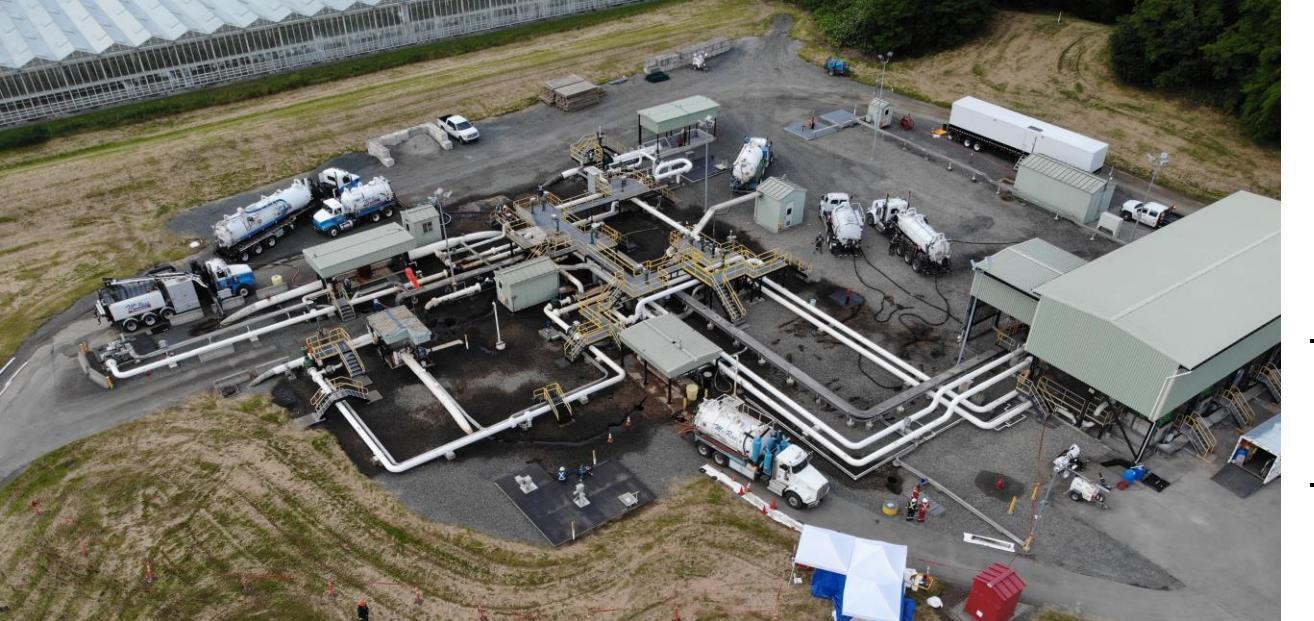
Aerial view of northern portion of Site

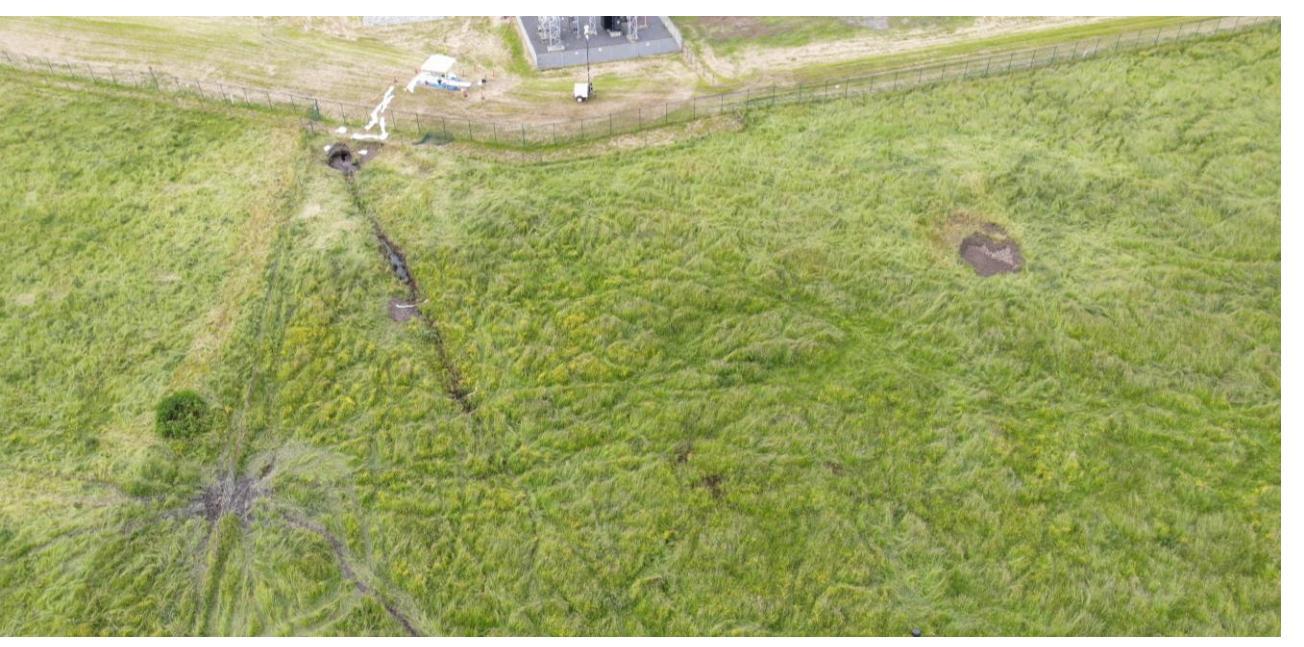
Aerial view of southern portion of Site

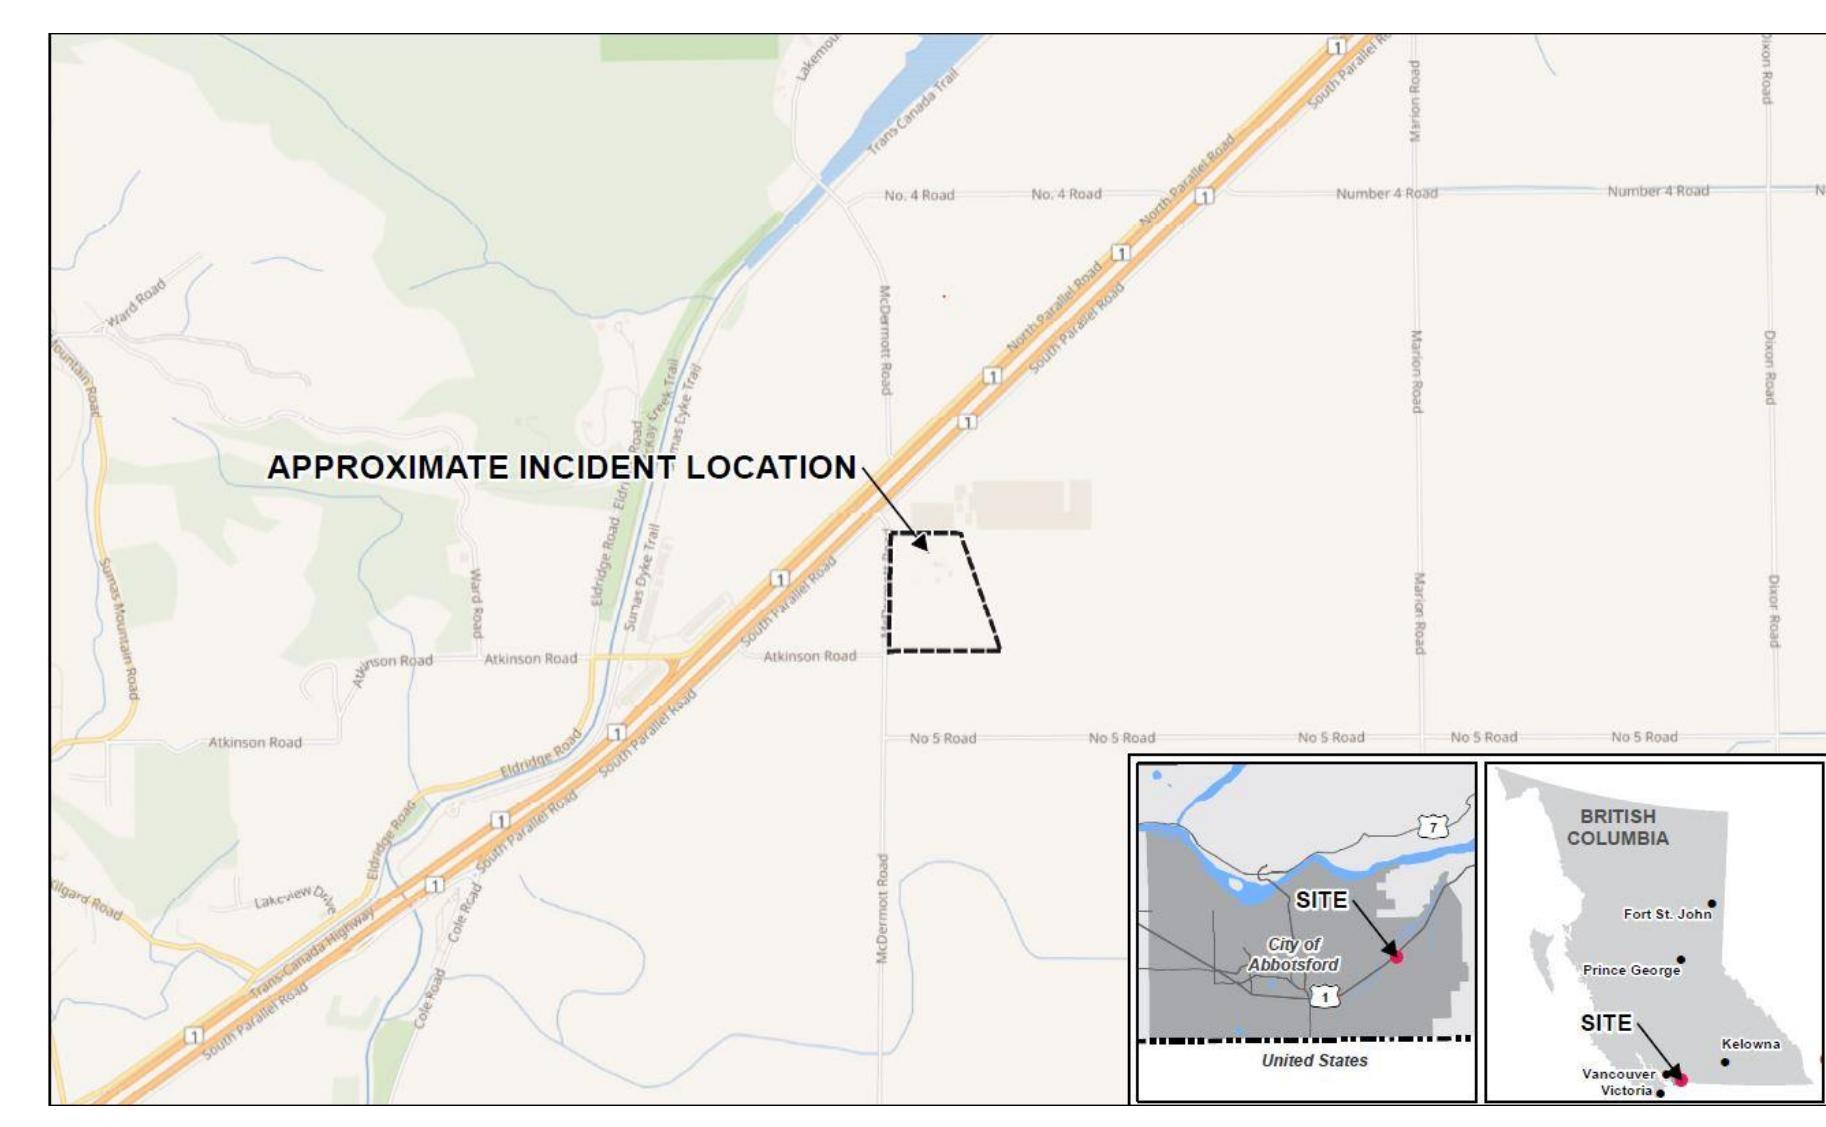
- Within the Sumas Prairie, in the eastern portion of the City of Abbotsford
- Surrounding land is predominantly flat and the closest surface water body is 700 meters to the west (Sumas River)

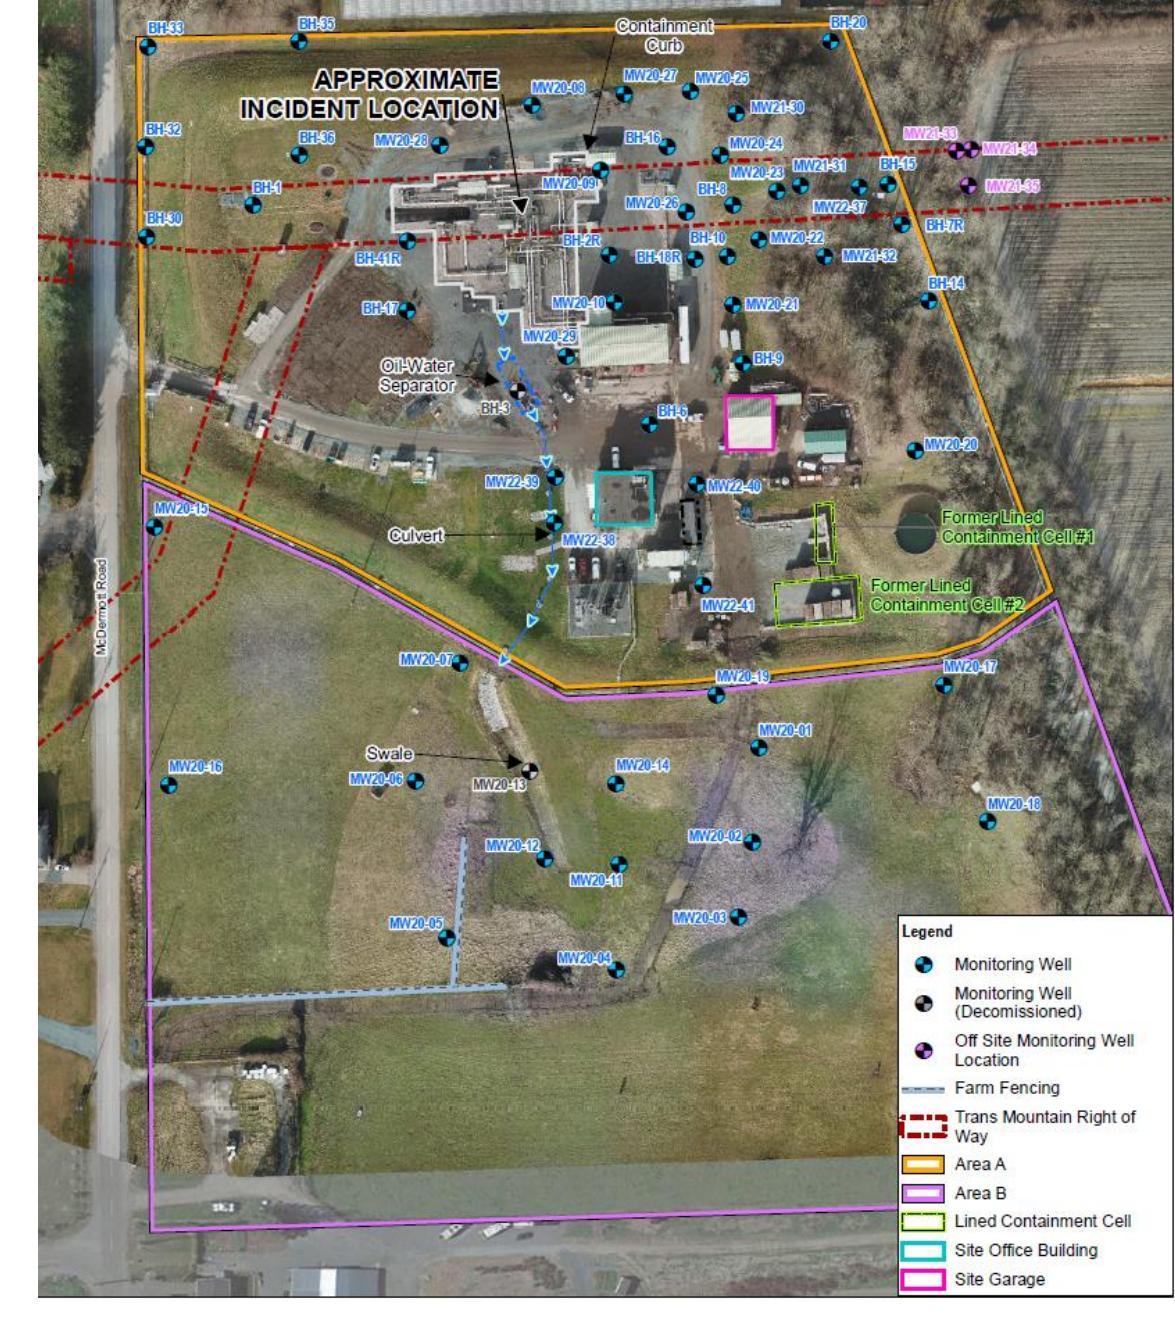
- Area A Sumas Pump Station in the north portion of the property
- Area B Operator owned agricultural field to the south
- Culvert Located between Area A (inlet) and Area B (outlet)

Aerial view of pump station with approximate incident location

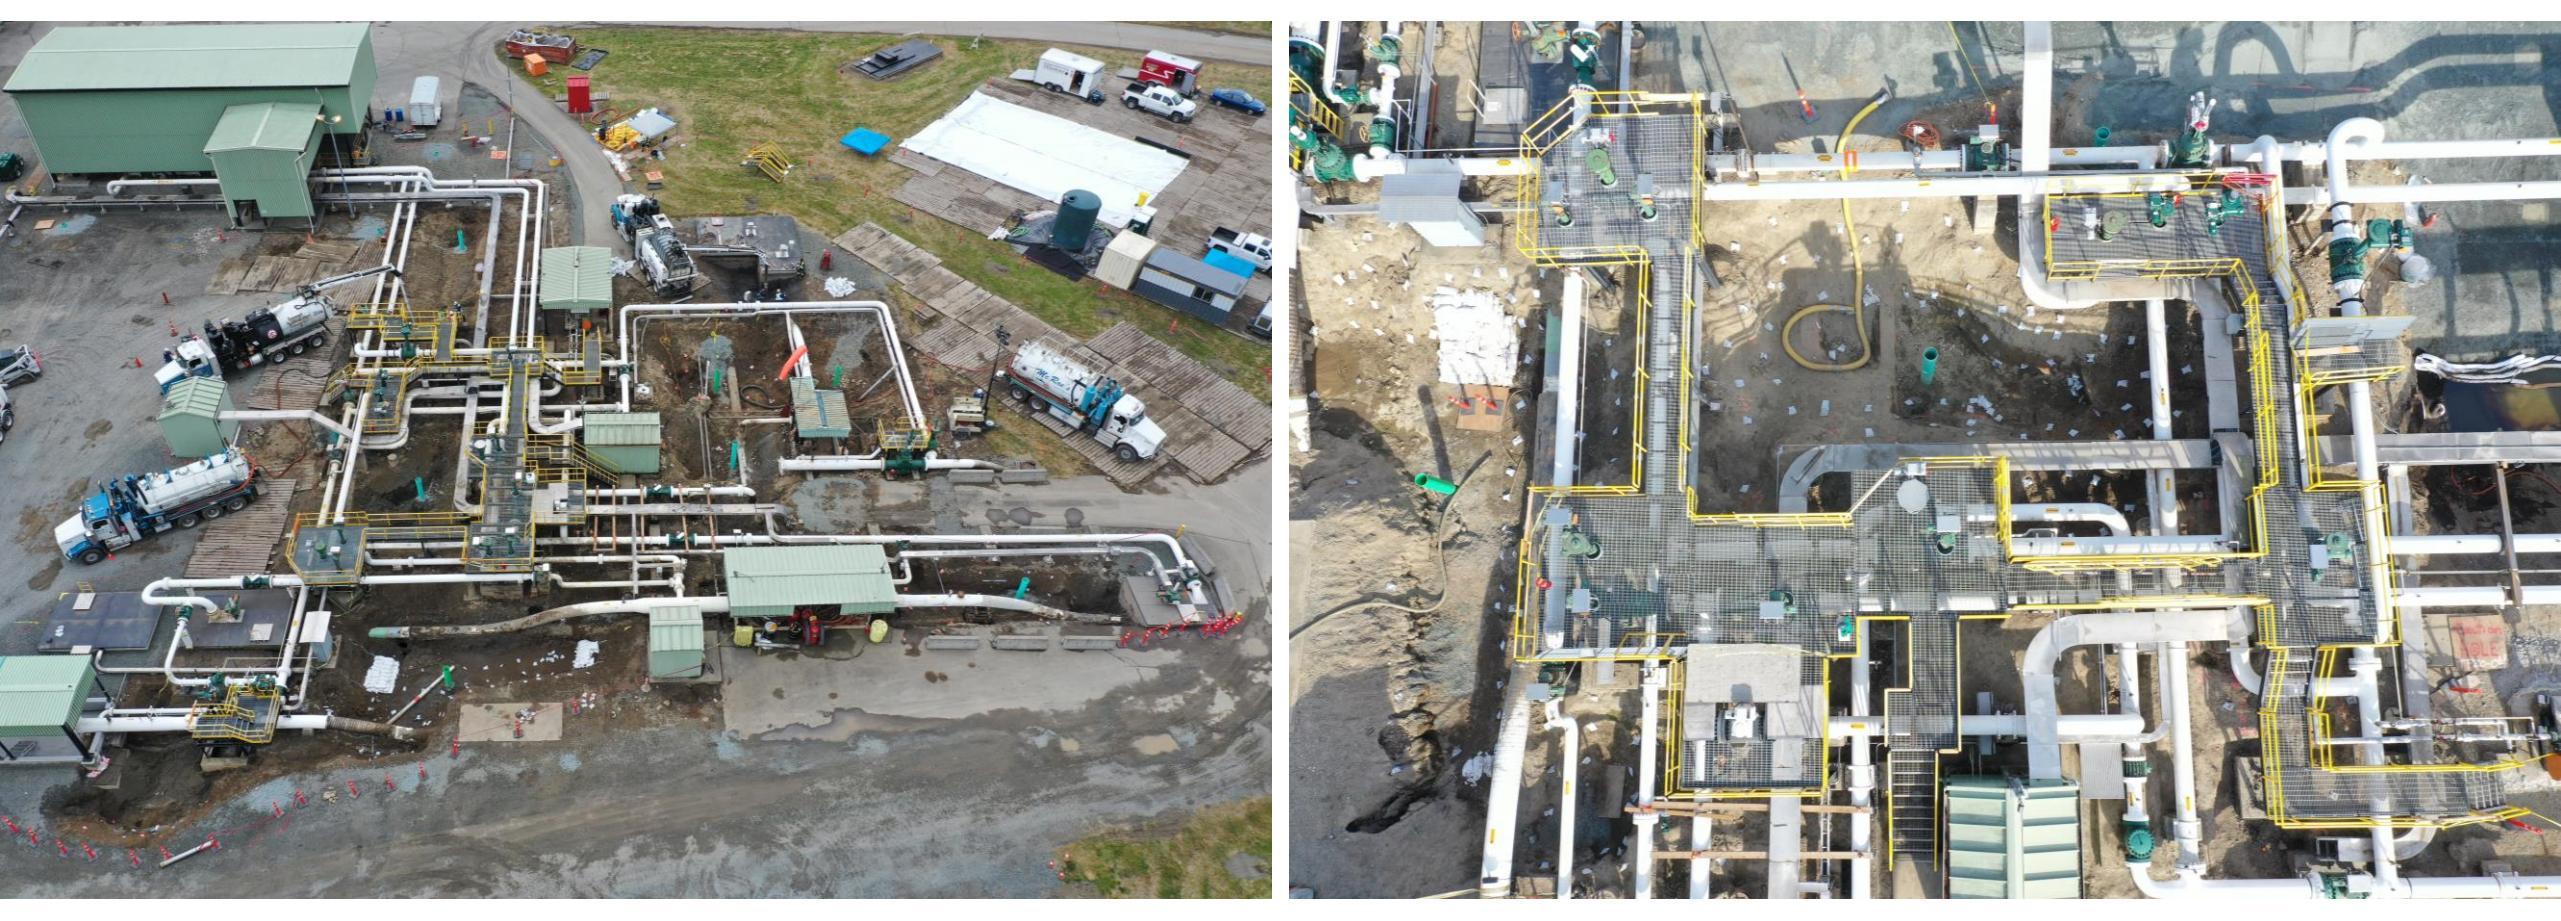
Excavation and product recovery around existing infrastructure

Working within complex geotechnical and facility restraints

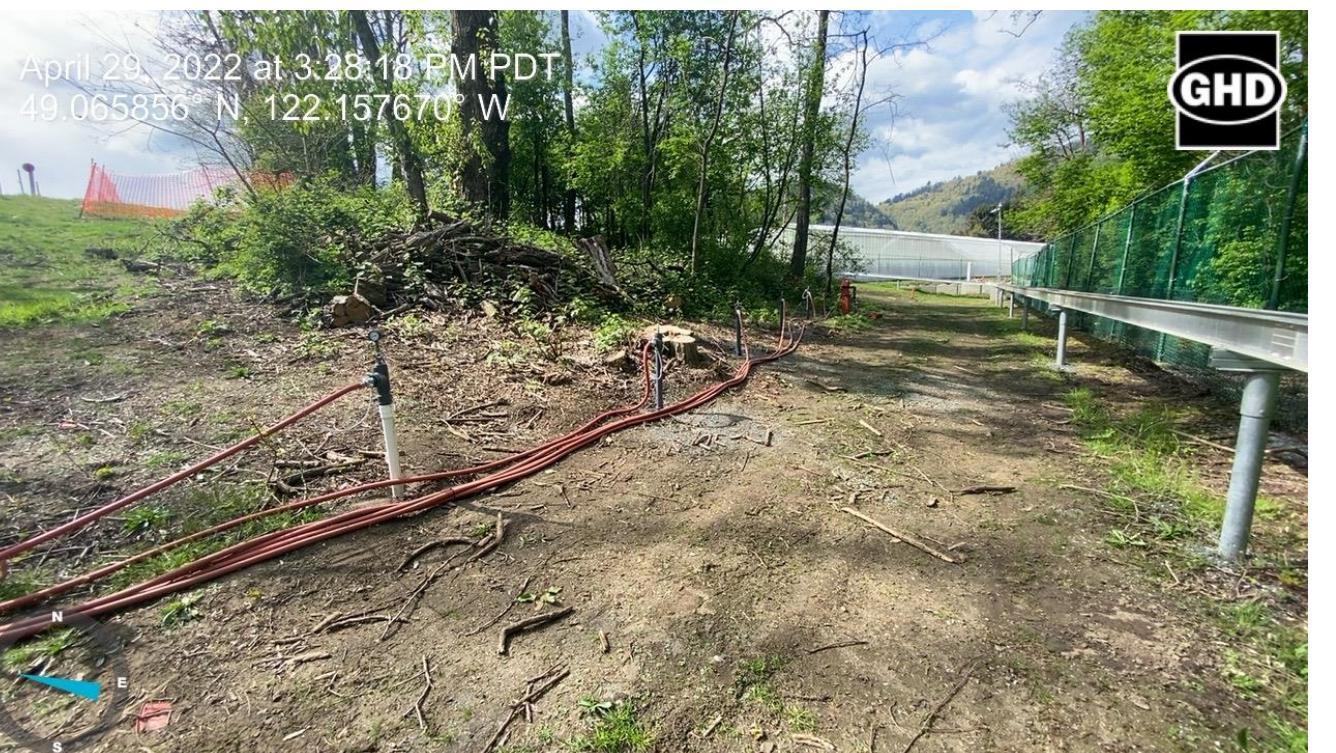
- Seasonal groundwater elevation fluctuations create a dynamic flow system
- Various remediation efforts at the Site have influenced the behaviour of residual impacts and have reduced the extent of dissolved phase migration
 - PetroFix®
 - Biosparge system
- Since the installation of the biosparge system, dissolved phase concentrations have been steadily decreasing

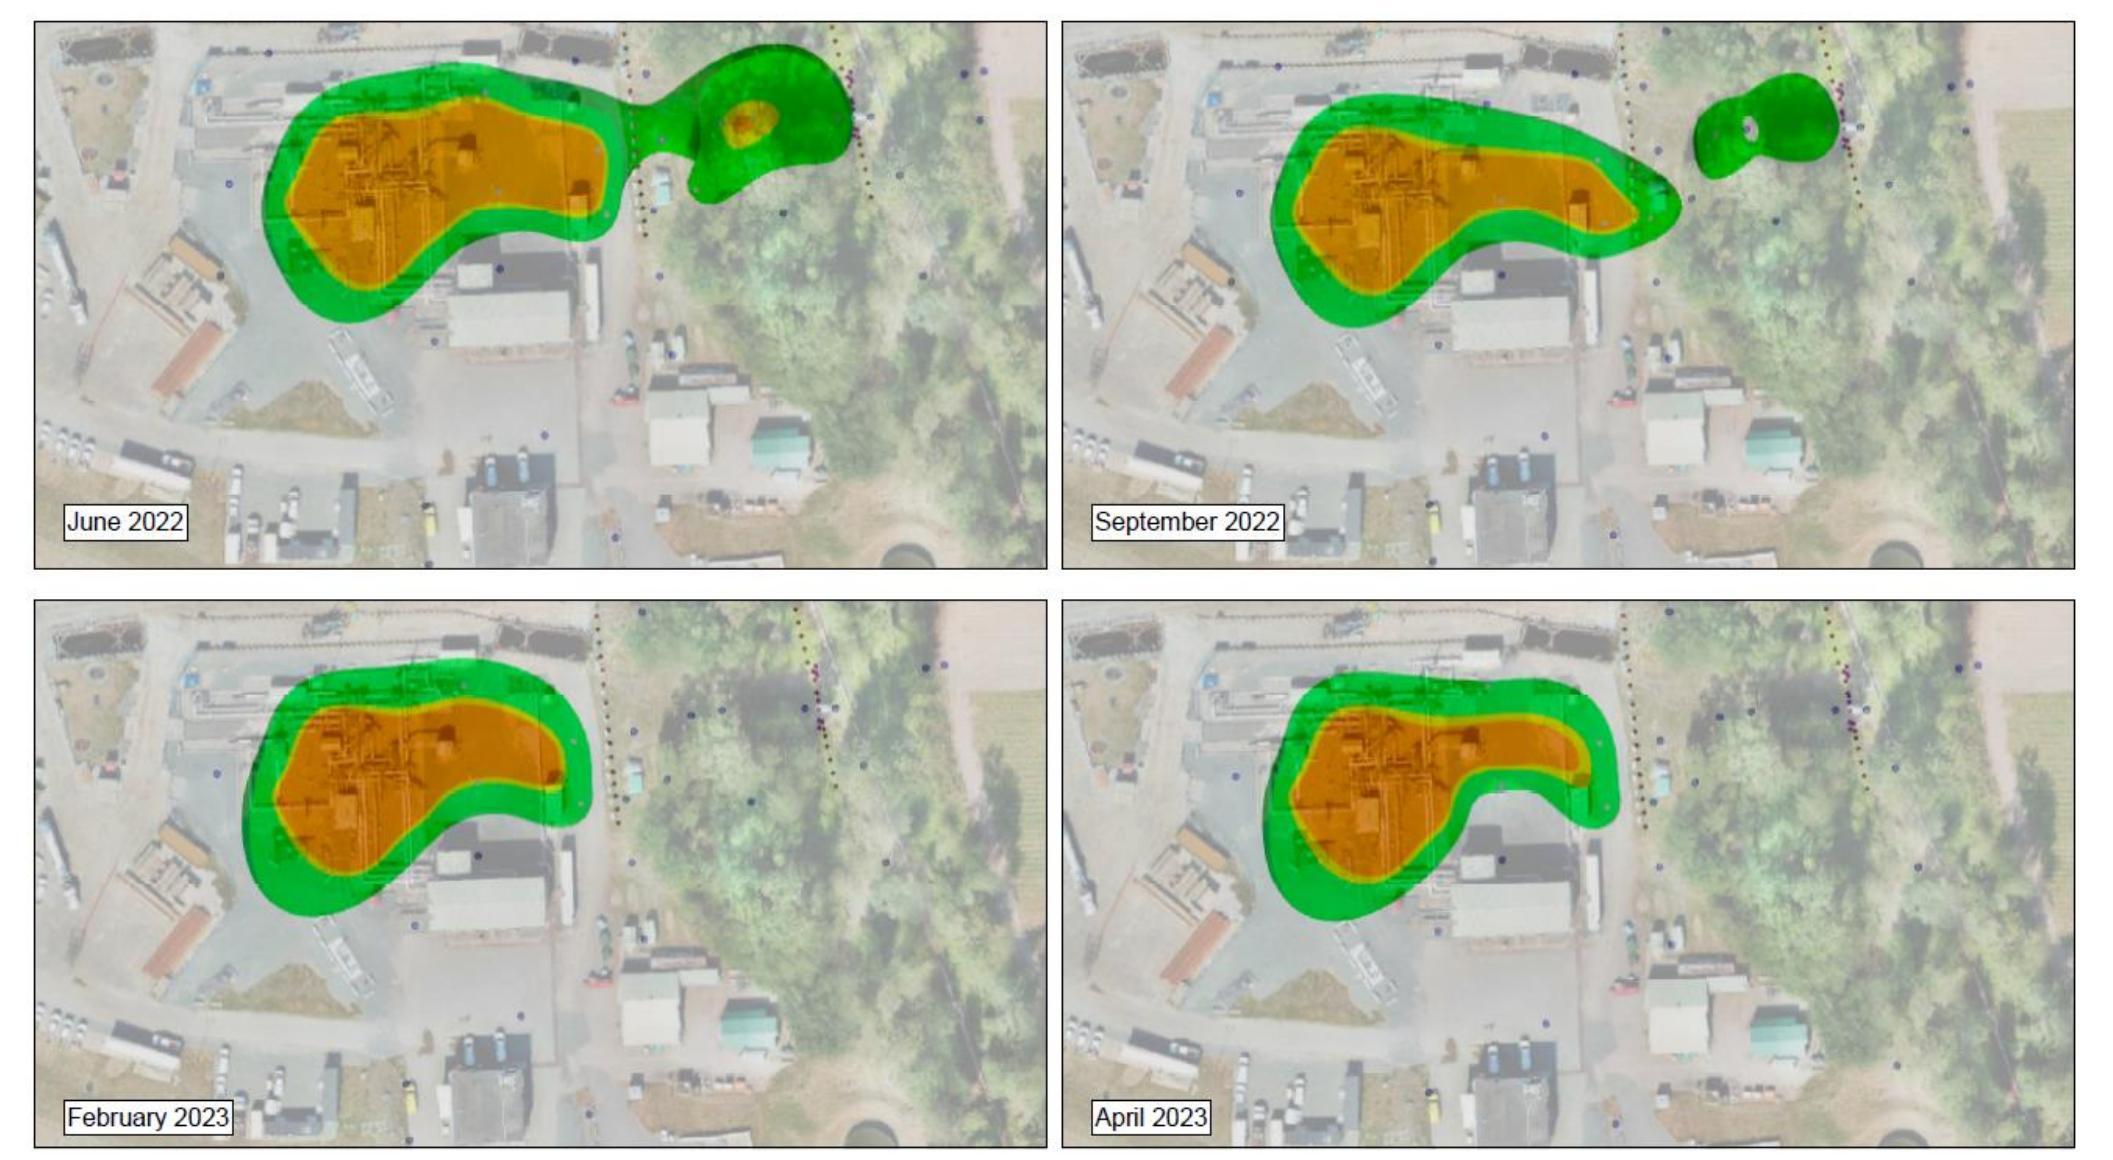
Residual Groundwater Impacts

Monitoring Well (690 – 10,000 µg/L benzene)
Monitoring Well (400 – 690 µg/L benzene)

- Monitoring Weil (400 000 pg/L benzen
- Monitoring Well (5- 400 µg/L benzene)

Monitoring Well (< 5 µg/L benzene)

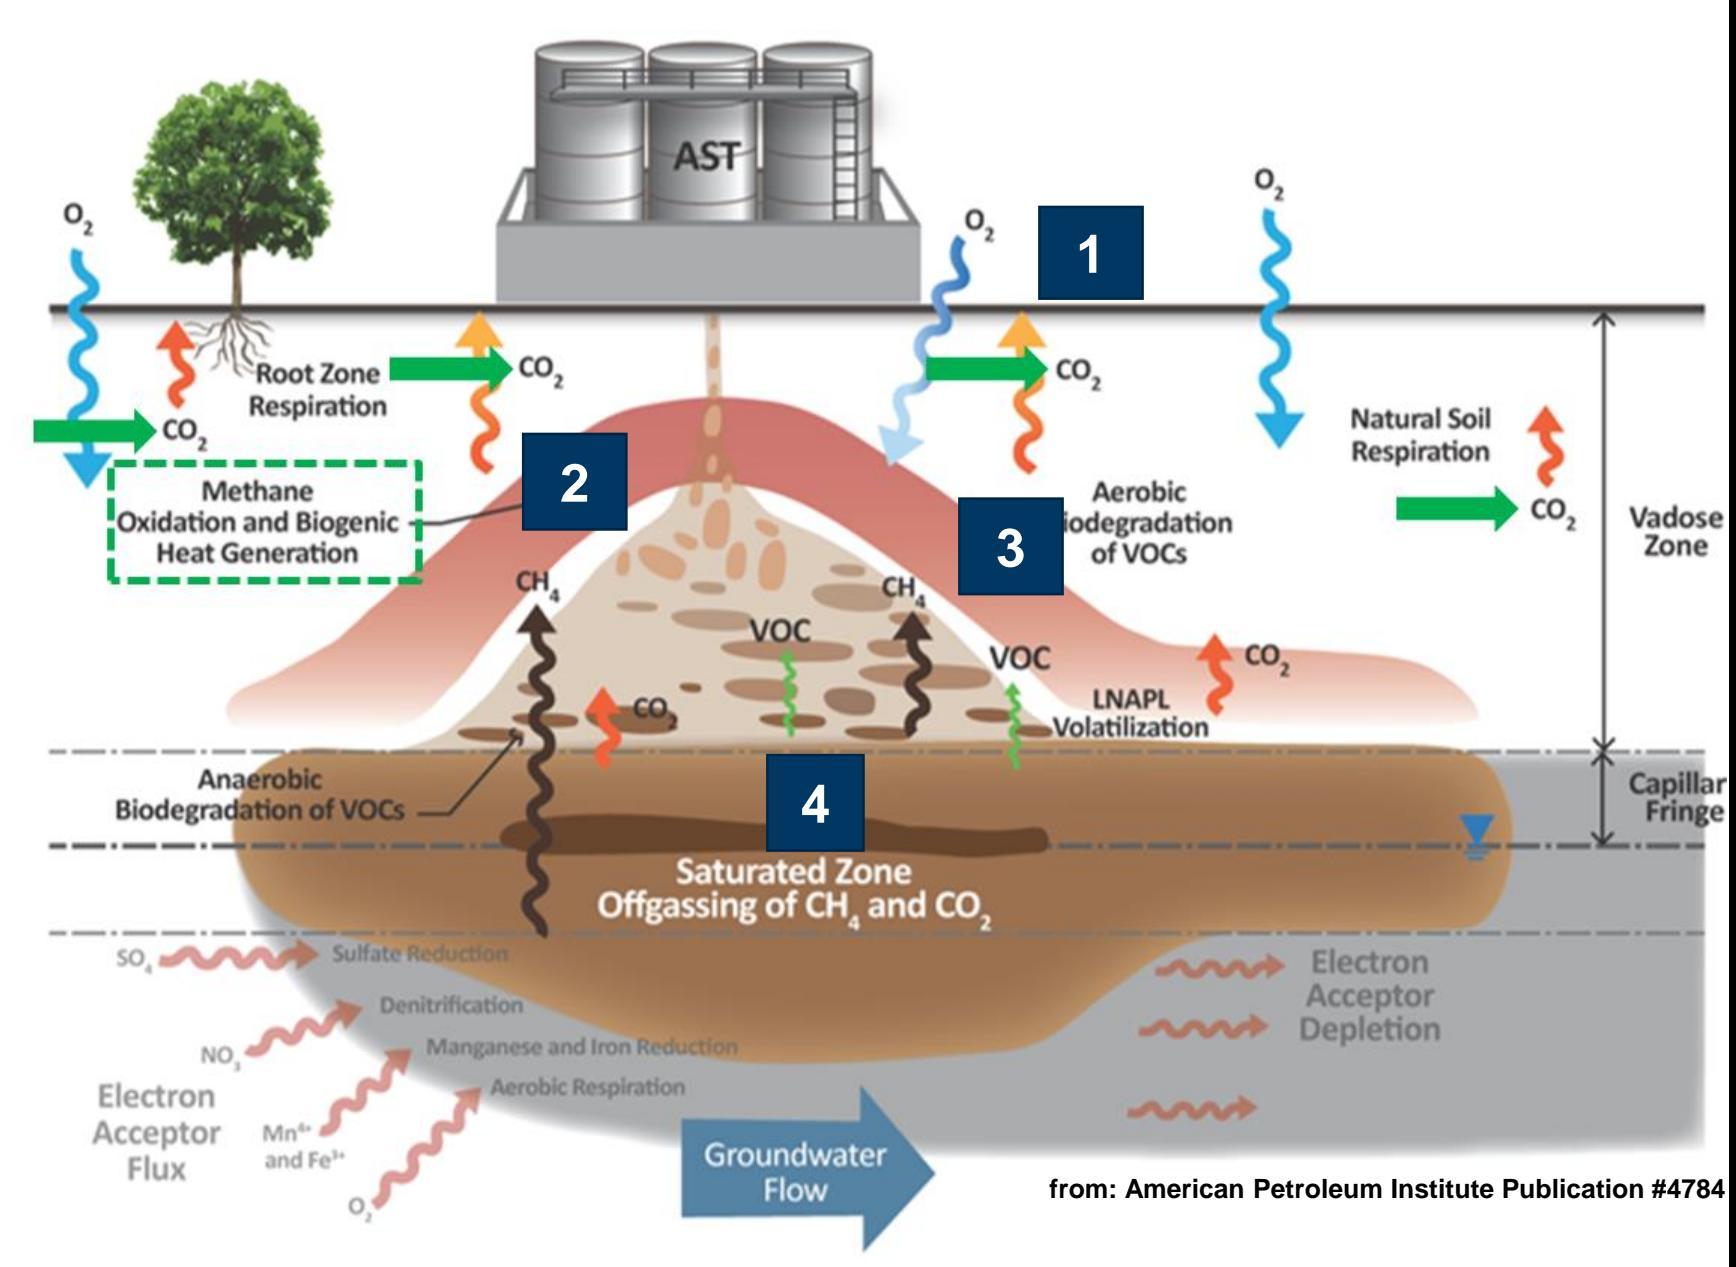
NSZD measurement options

1. Surficial CO₂ Efflux (dynamic closed chamber, CO₂ Trap) 2. Biogenic heat 3. Vertical soil gas gradients (CO_2 , O_2 , CH_4)

4. Compositional change

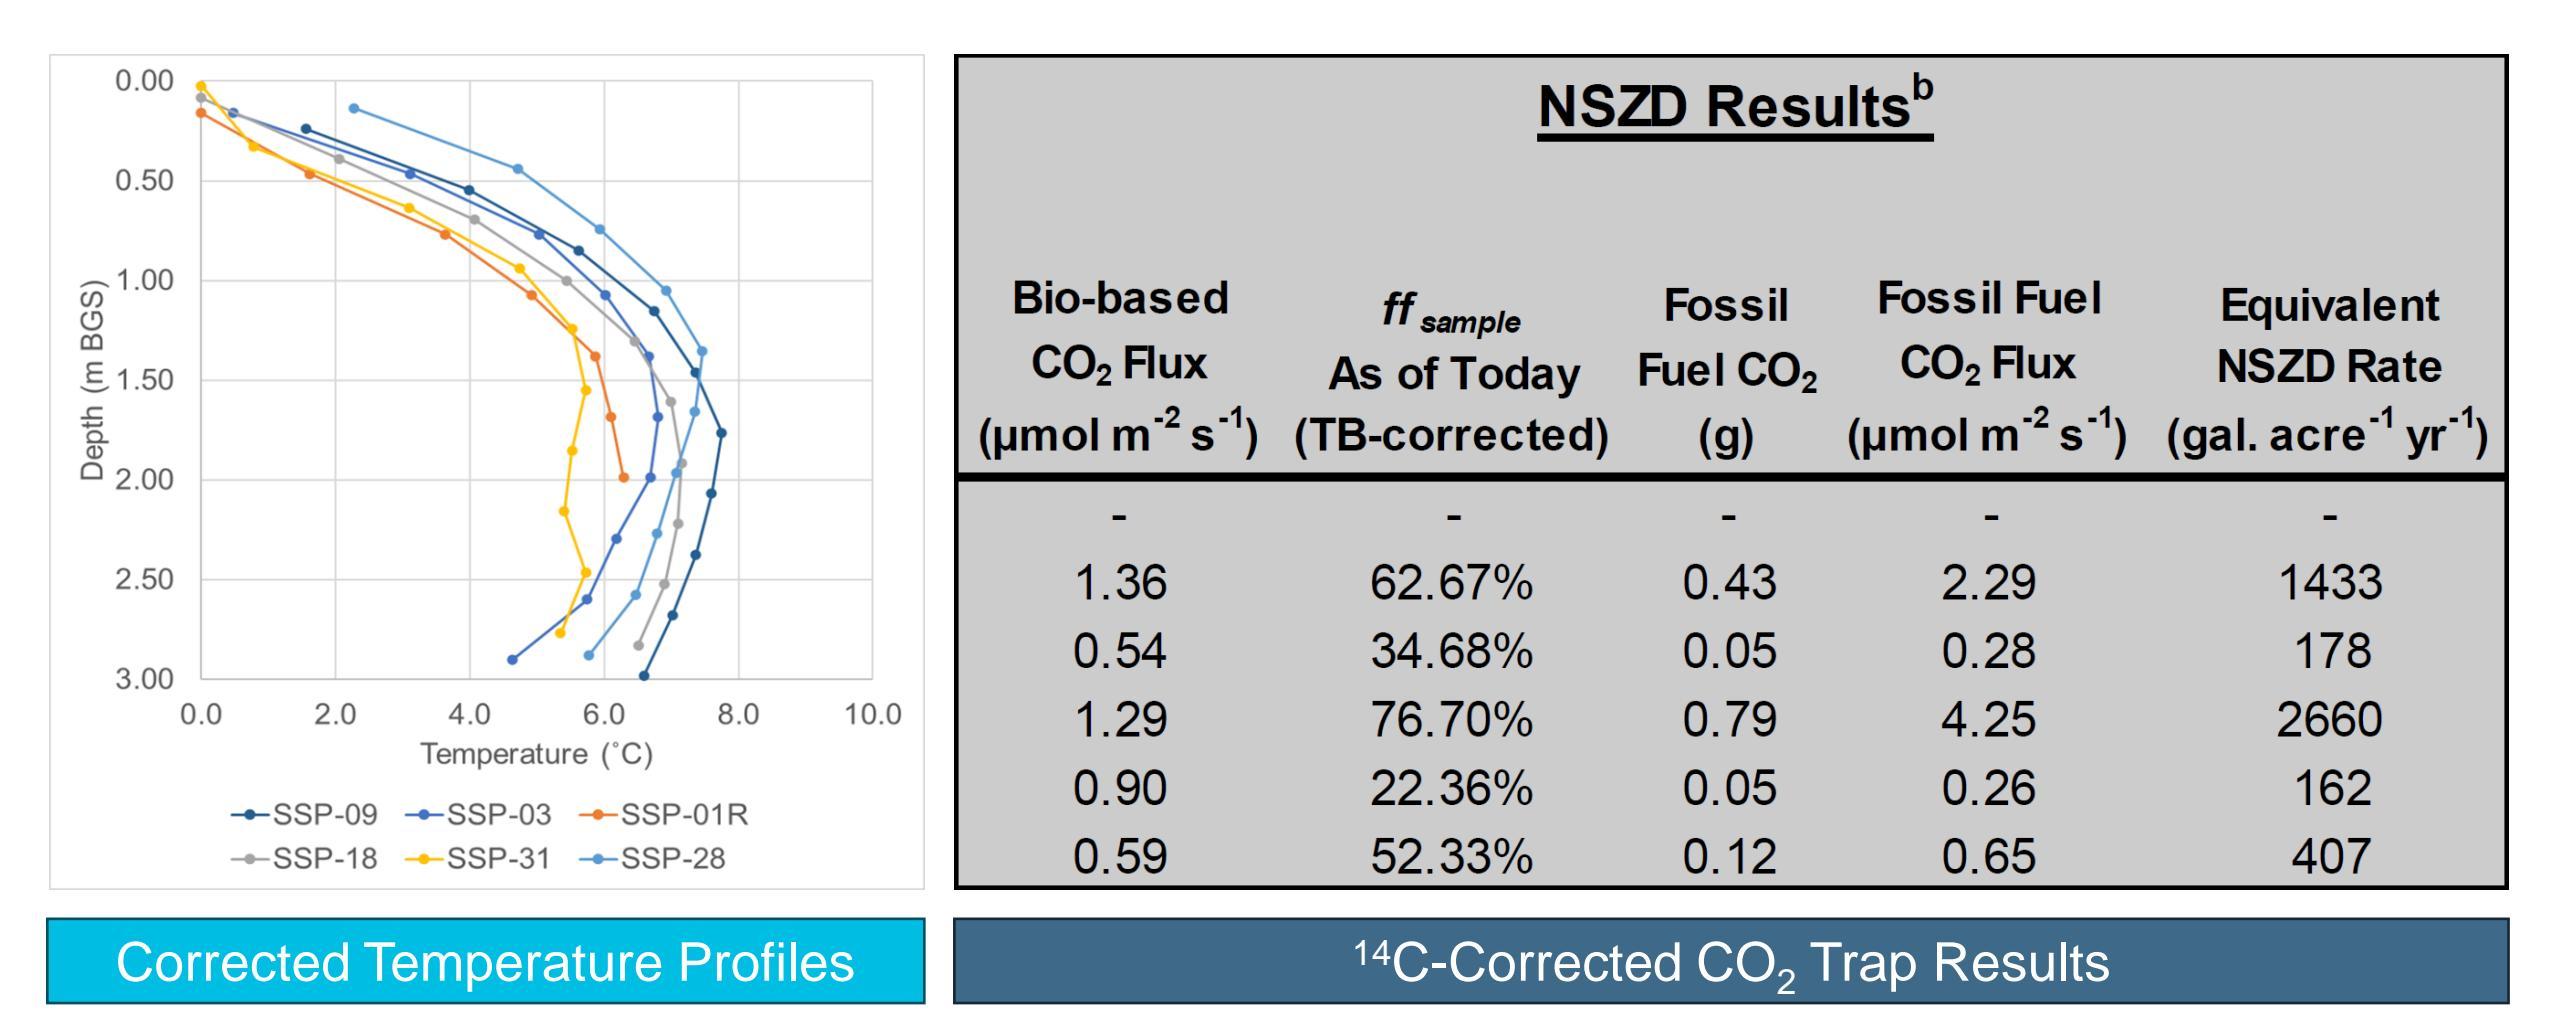
Baseline NSZD Monitoring

Results from NSZD testing conducted to date (CO2 trap testing and temperature profiling) indicate that LNAPL is actively degrading at significant rates via NSZD processes.

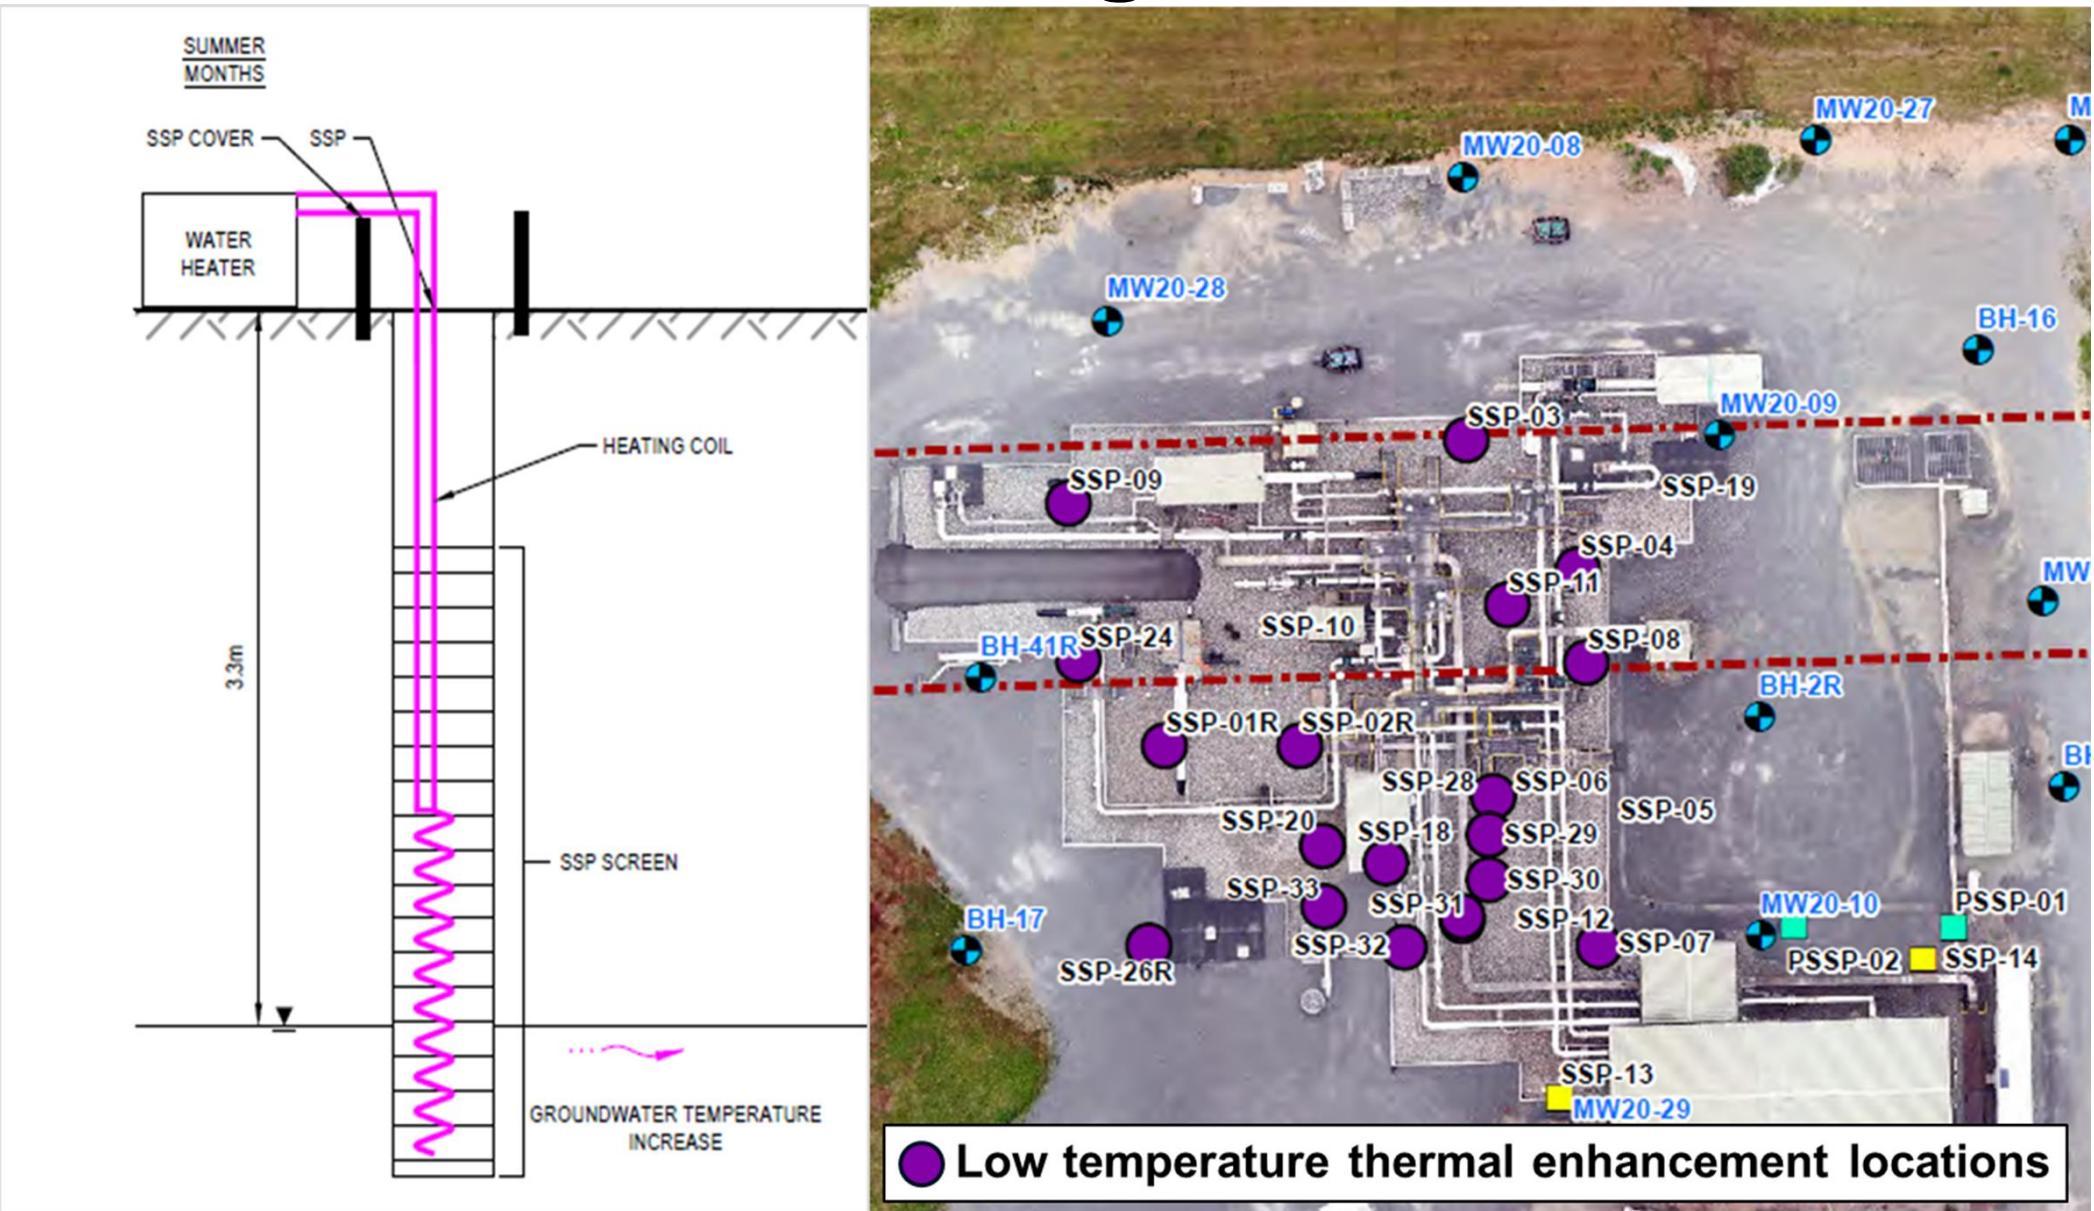
Enhancing NSZD

Continue to operate and adjust thermal remediation systems to enhance NSZD
