The Affect of Salt Impacted Water on the Expansive Capability of Sodium Bentonite Clay – Bench Test Study

Richard Geier, B.Sc., P.Geol
October 19, 2012

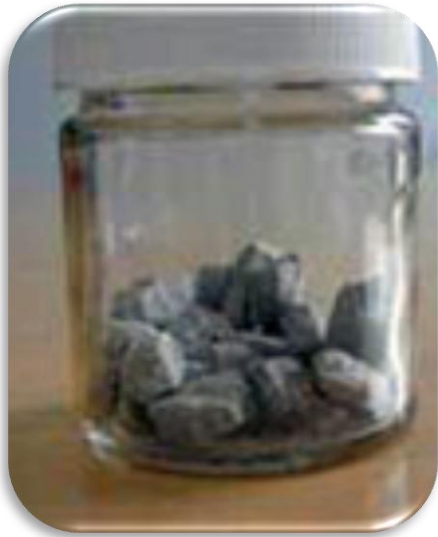
Sodium Bentonite Chips

- 30 grams of sodium bentonite chips
- 100 mL of water in jar
- Varying concentrations of Salt

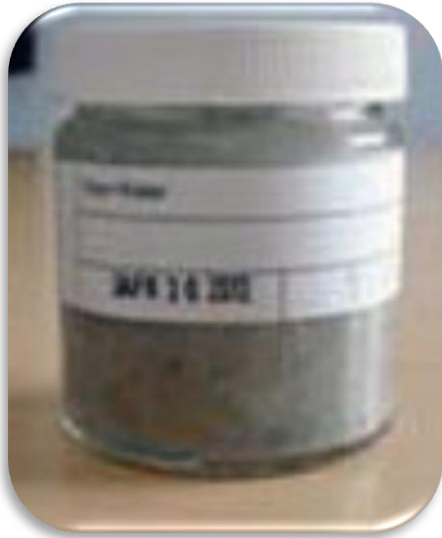
After 6 Hours

Initial Study – Tap Water

- Thick putty consistency
- 4 times original volume
- Shallow voids visible

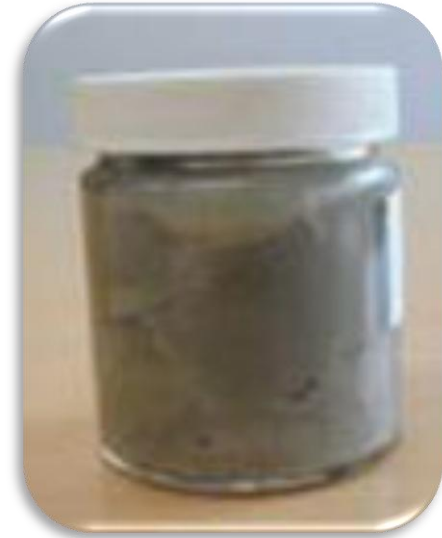
After 24 Hours

- Expanded slightly more
- Voids were not visible
- No free water remained

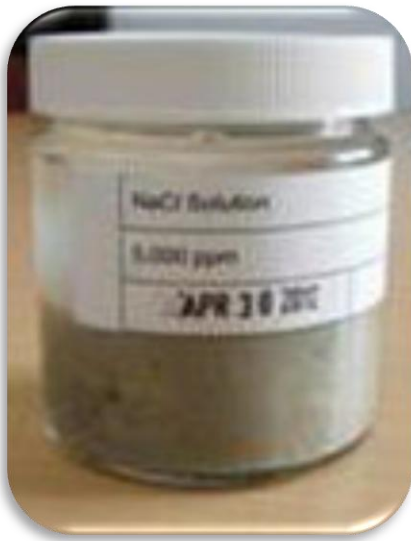
After 6 Hours

Initial Study – 5,000 mg/L NaCl

0.5 g NaCl/100 mL water

- Thick soft paste
- Double the volume
- Appeared silty

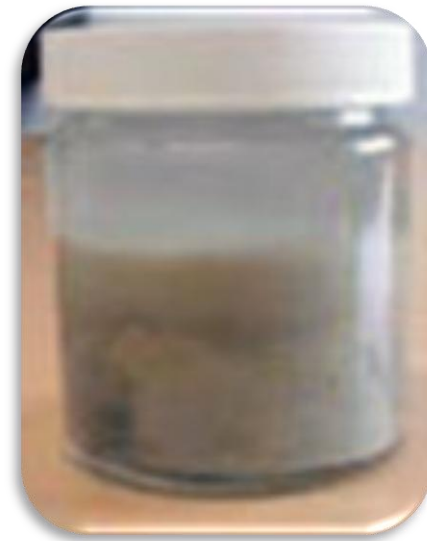
After 24 Hours

- 2.5 times the volume
- Same consistency as 6 hours

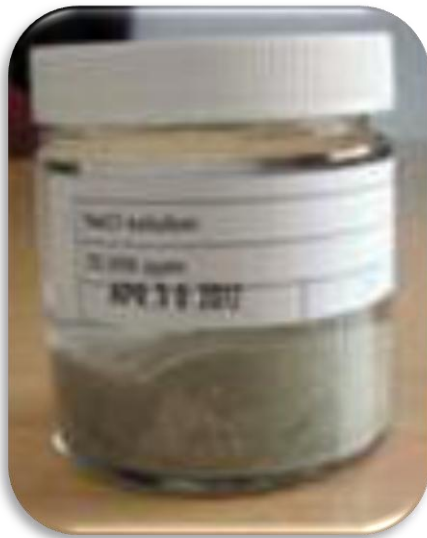
After 10 Minutes

Initial Study – 25,000 mg/L NaCl

2.5 g NaCl/100 mL water

- Chips had crumbled
- Sediment layer at the bottom of the jar

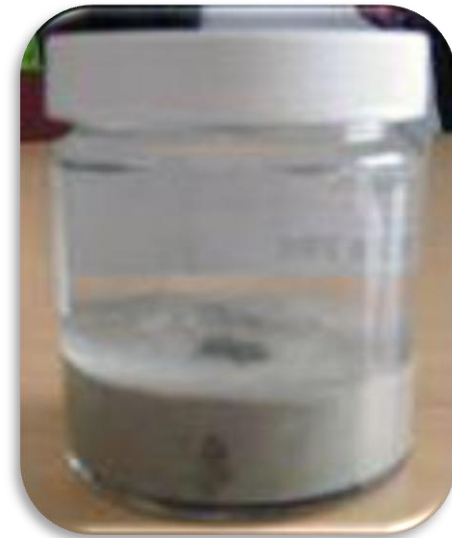
After 24 Hours

- No additional expansion was observed

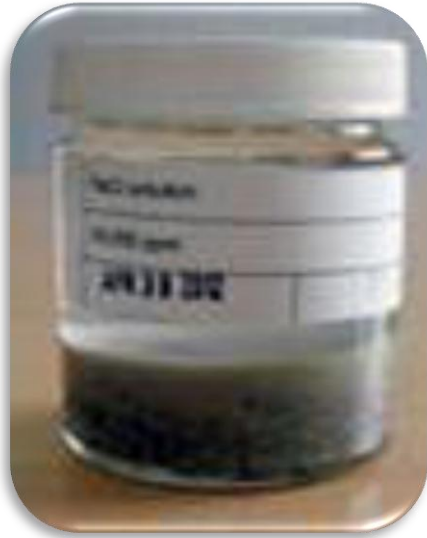
Within 10 Minutes

Initial Study – 50,000 mg/L NaCl

5.0 g NaCl/100 mL water

- Bentonite chips had crumbled
- Sediment layer formed at the bottom of the jar

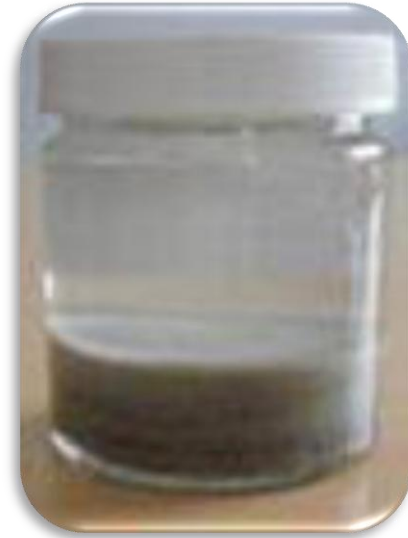
After 24 Hours

- No additional expansion
- Gentle shaking the mixture became muddy and settled into segregated layering

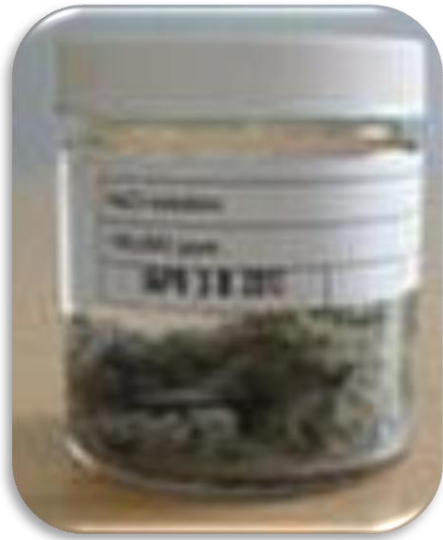
After 24 Hours

Initial Study – 100,000 mg/L NaCl

10 g NaCl/100 mL water

- Chips remained as individual
- No evidence of bonding or expanding
- Some “crumbling” was observed

- No change was observed in bentonite for all test samples

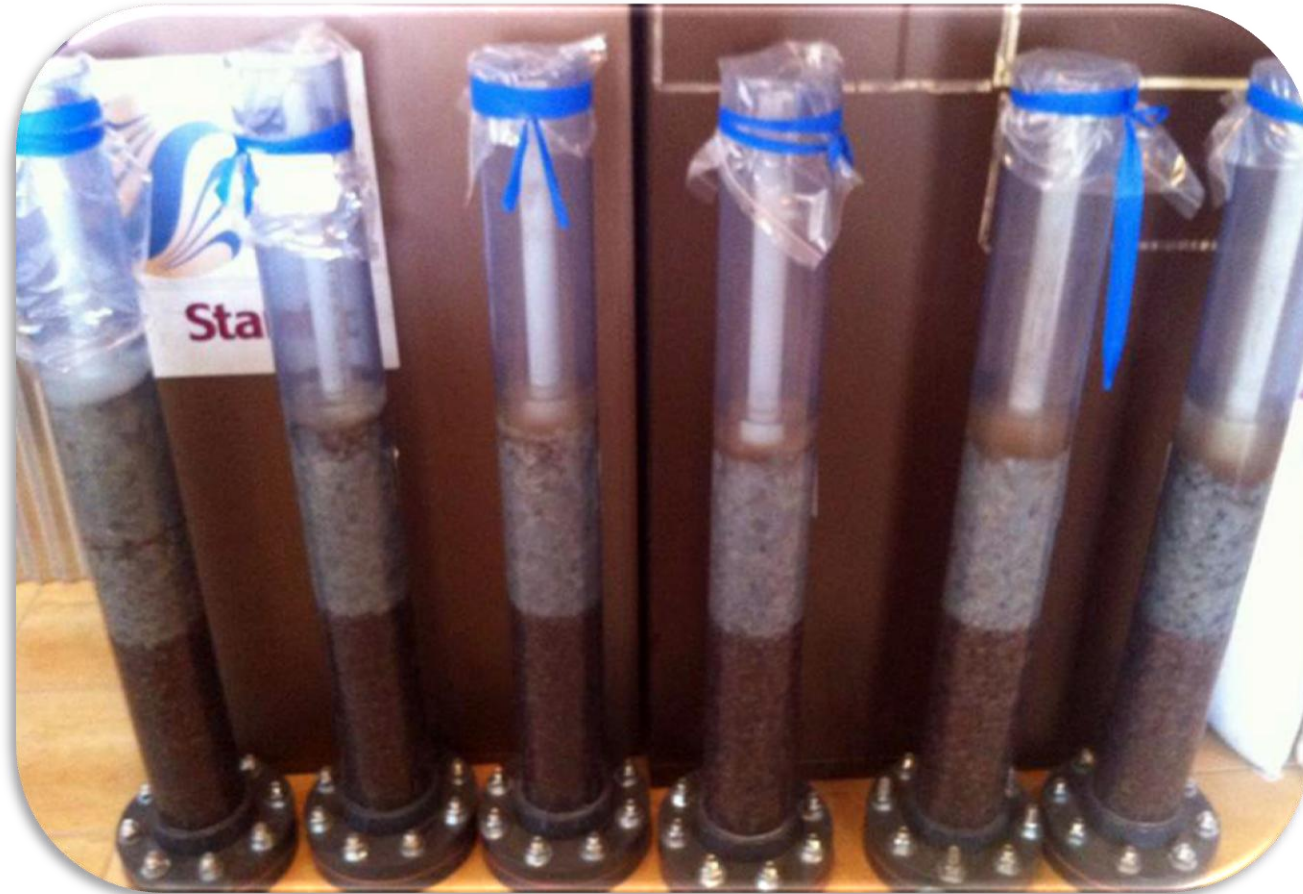
7 Days After Saturation

- Constructed six model monitoring wells
 - 0.3 m of slotted pipe (1 inch diameter)
 - 0.9 m of solid pipe (1 inch diameter)
 - 0.4 m of 4 - 8 sand
 - 0.2 m of Sodium bentonite chips (not hydrated)
- Saturated bentonite using 4 L of water with varying concentrations of NaCl

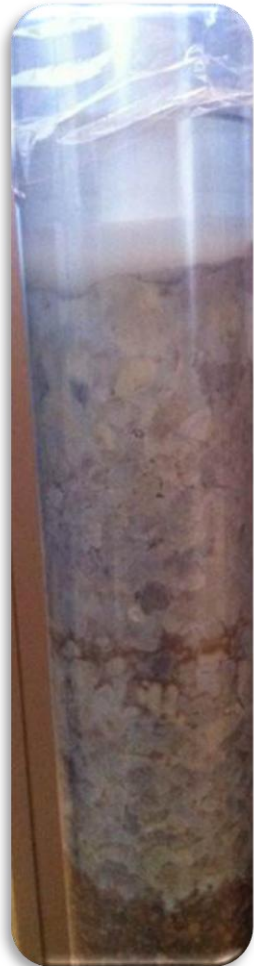
Tap Water
After 7 Days

Bentonite thickness
increased by 12 cm

NaCl (ppm)	Time Elapsed (days)	Initial Thickness of Bentonite Chips (cm)	Final Thickness of Hydrated Seal (cm)	% Change in Thickness of Seal
Tap Water	7	20	32	60%
5,000	7	20	25	25%
10,000	7	20	24	20%
25,000	7	20	23	15%
50,000	7	20	22	10%
100,000	7	20	20	0%

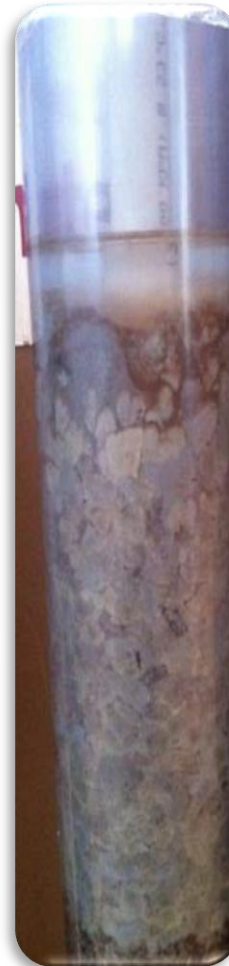
5,000 ppm
After 7 Days

Bentonite thickness
increased by 5 cm

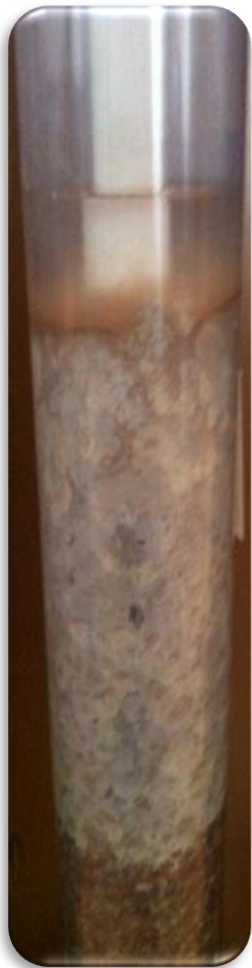
10,000
After 7 Days

Bentonite thickness
increased by 4 cm

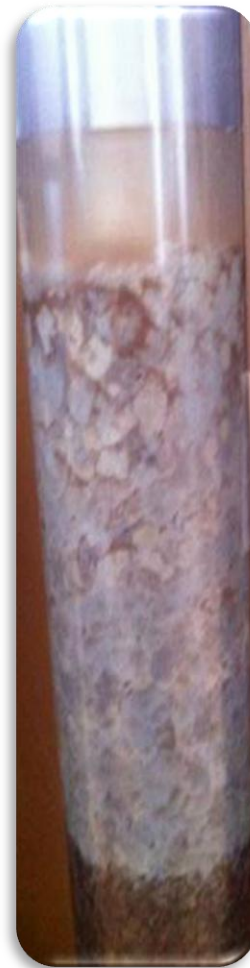
25,000 ppm
After 7 Days

Bentonite thickness
increased by 3 cm

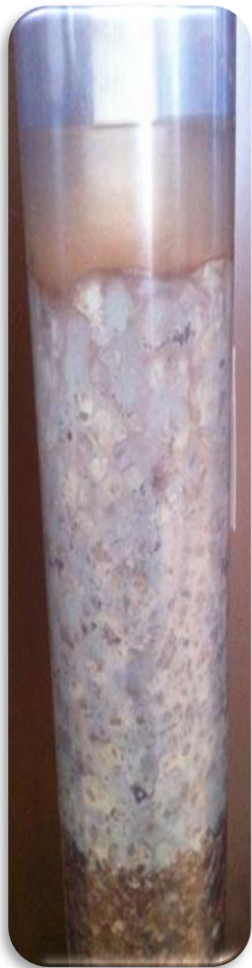
50,000
After 7 Days

Bentonite thickness
increased by 2 cm

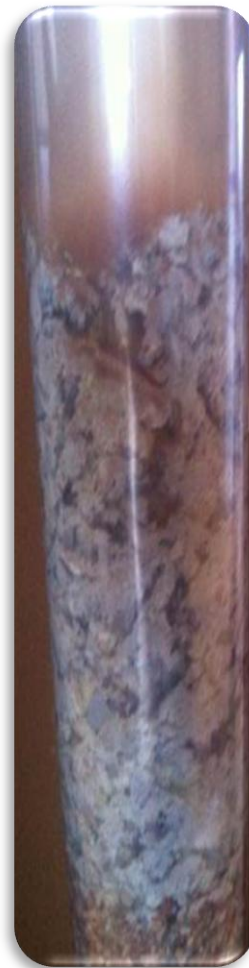
100,000 ppm
After 7 Days

Bentonite thickness
no increase
